## **A novel corrosion resistant repair technique for existing Reinforced Concrete (RC) elements using Polyvinyl Alcohol Fibre Reinforced Geopolymer Concrete (PVAFRGC)**

**Keywords**; corrosion resistance; fibre reinforced geopolymer concrete; repair material; reinforced concrete beams.

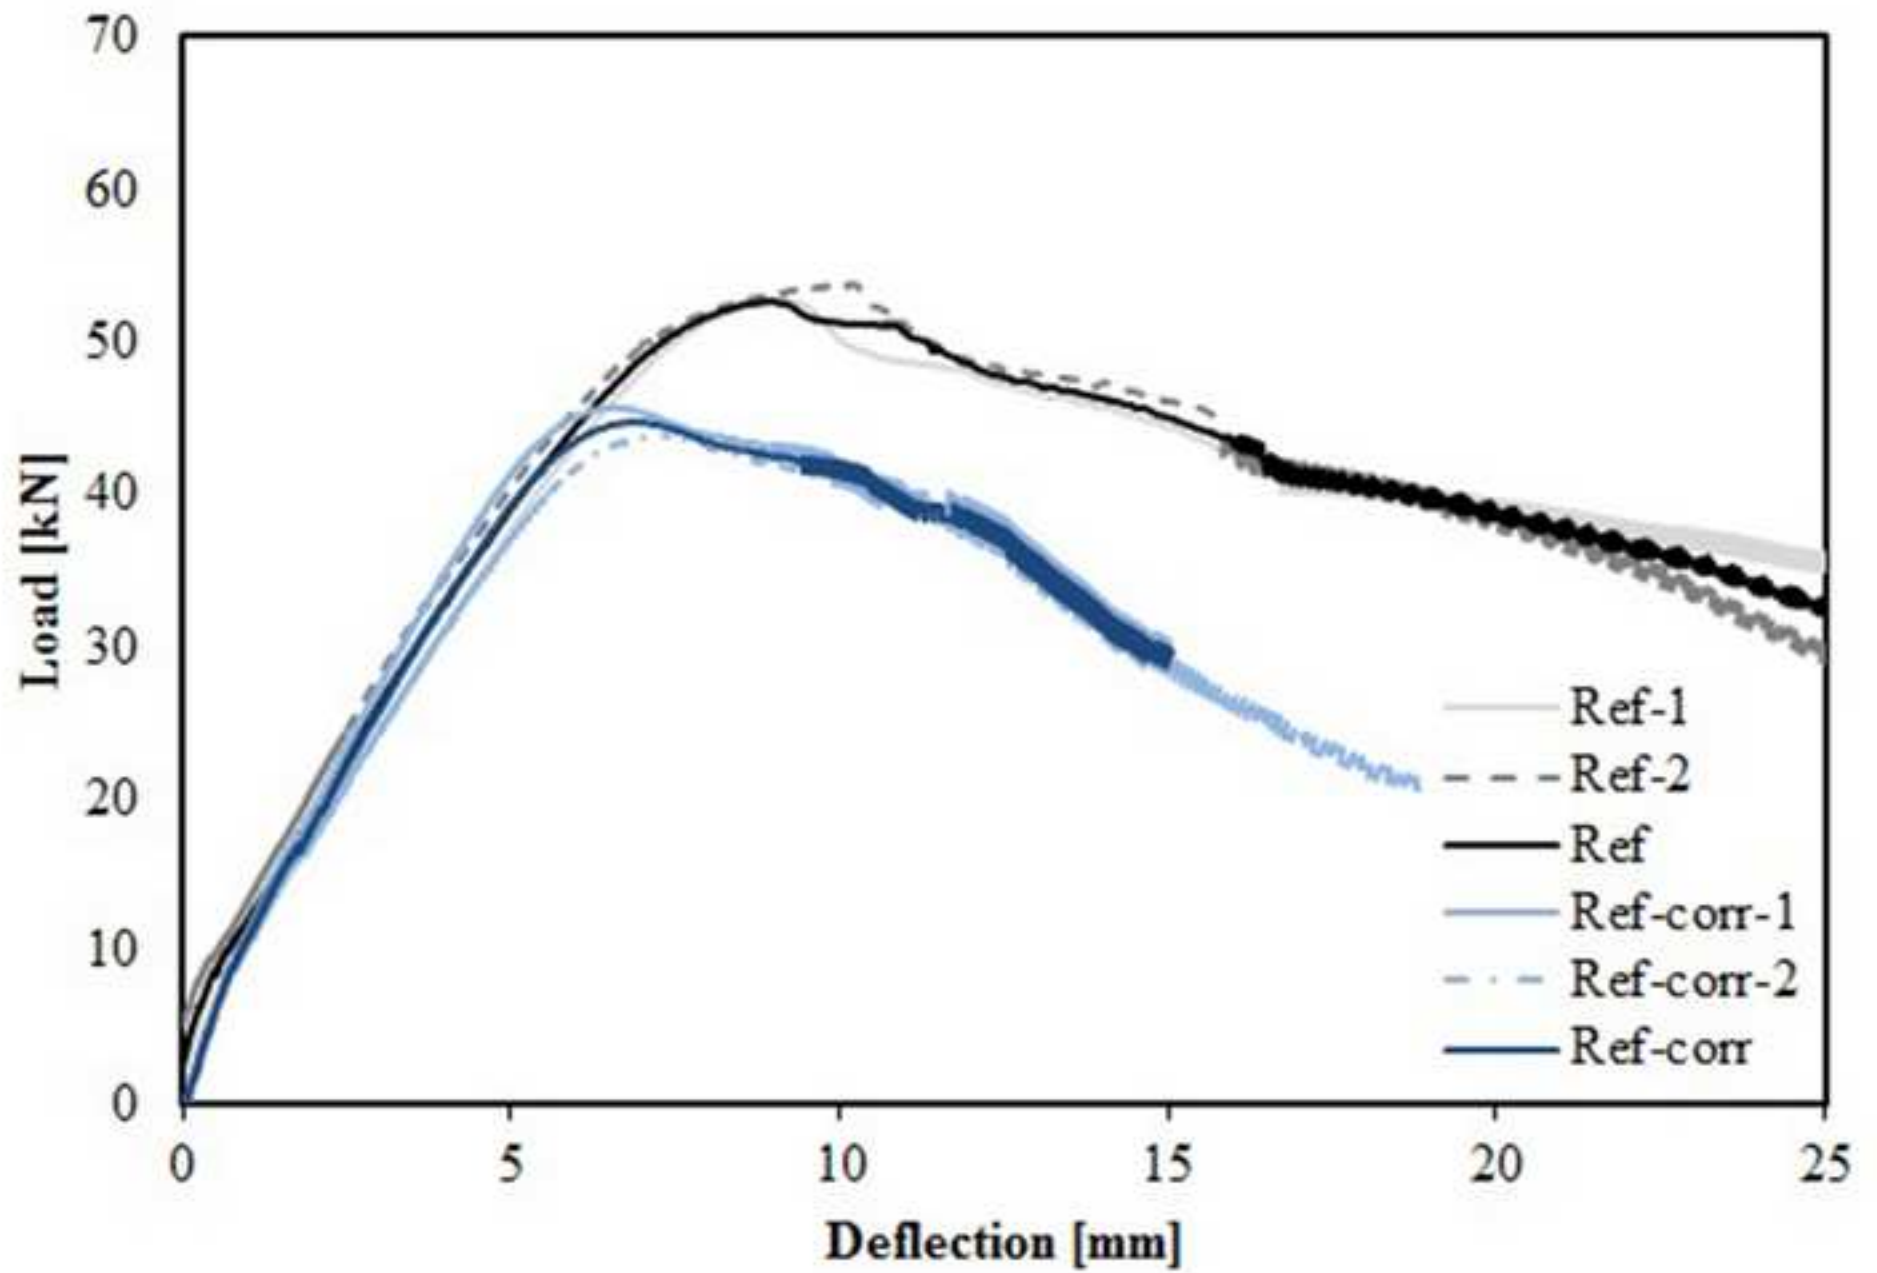
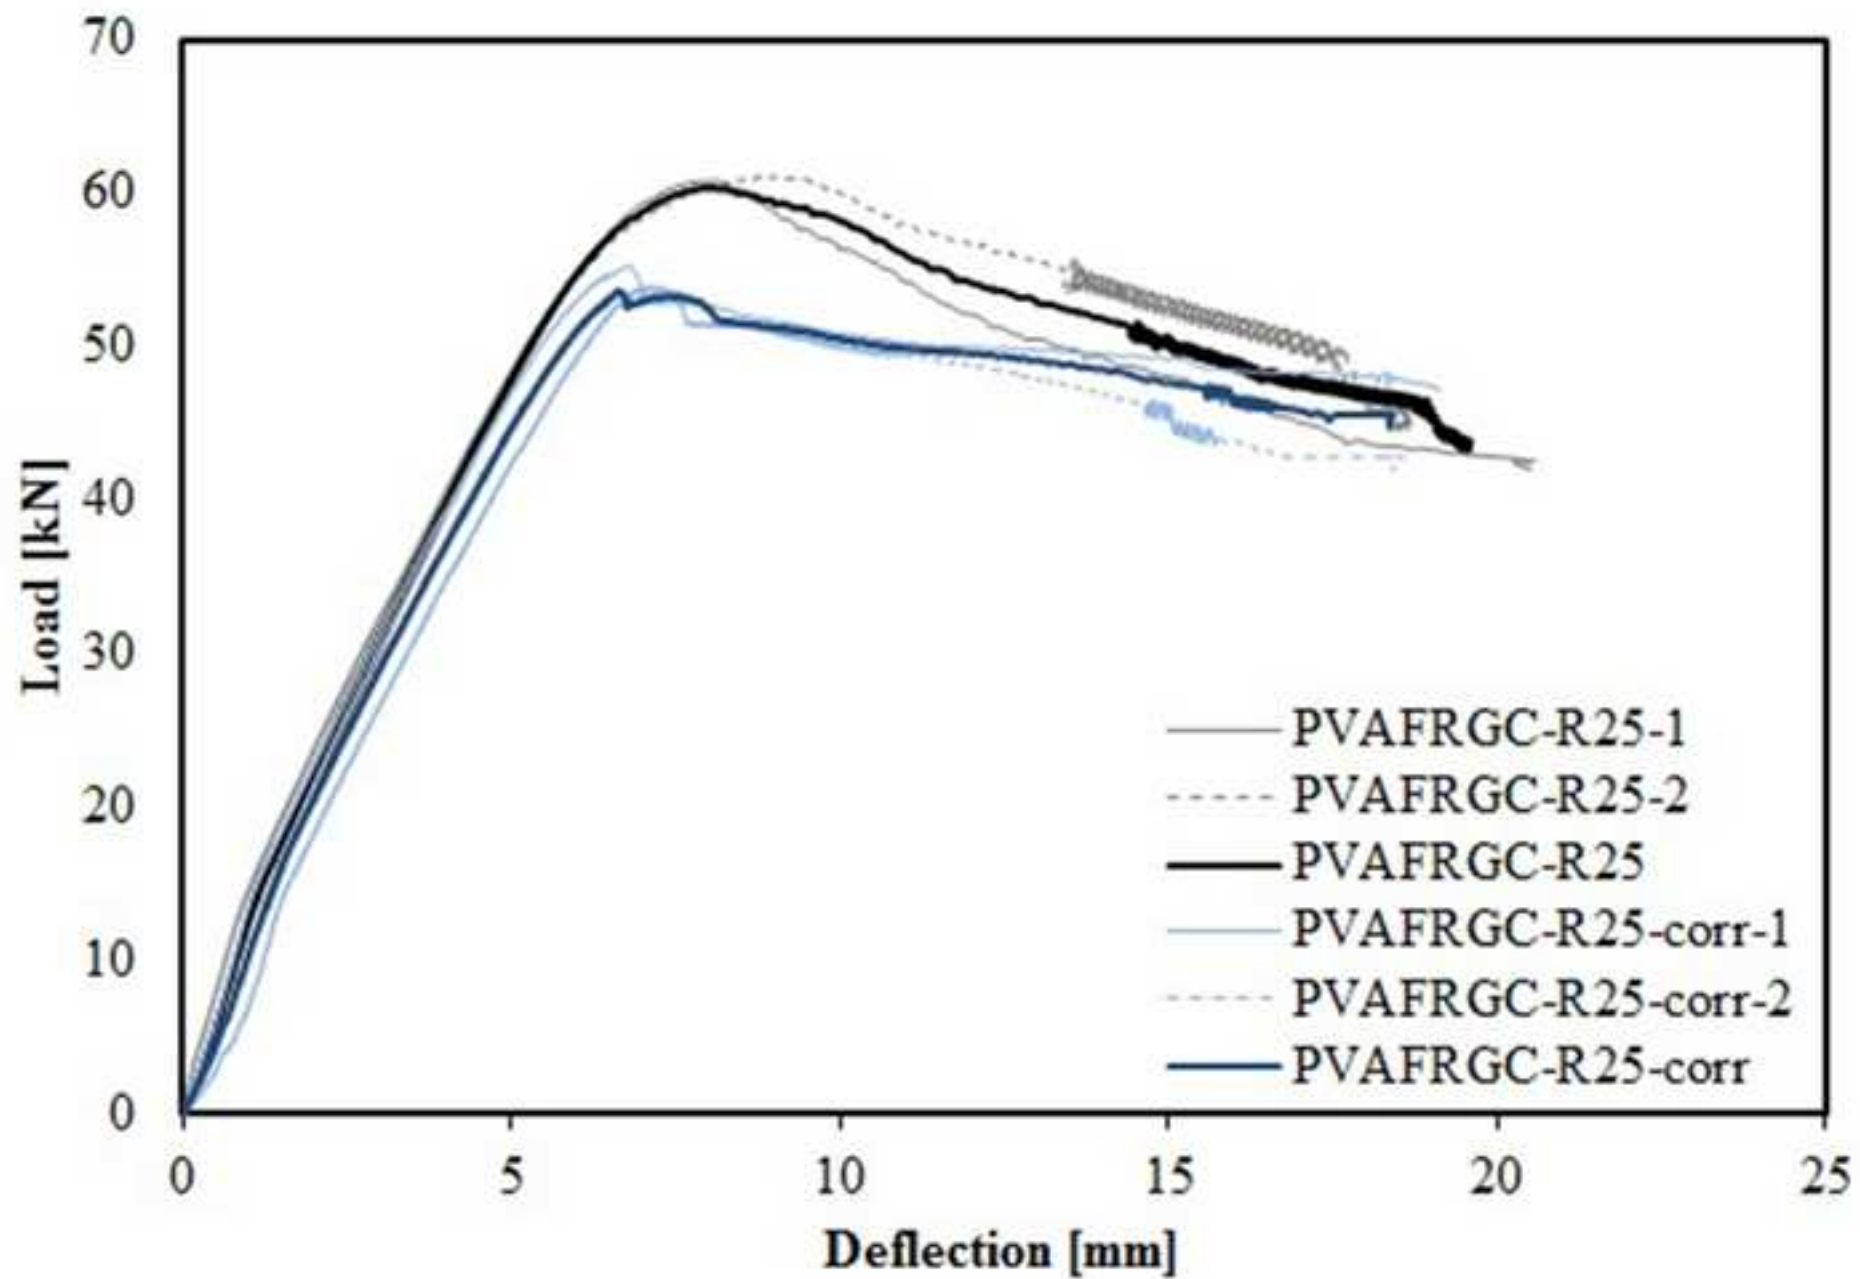
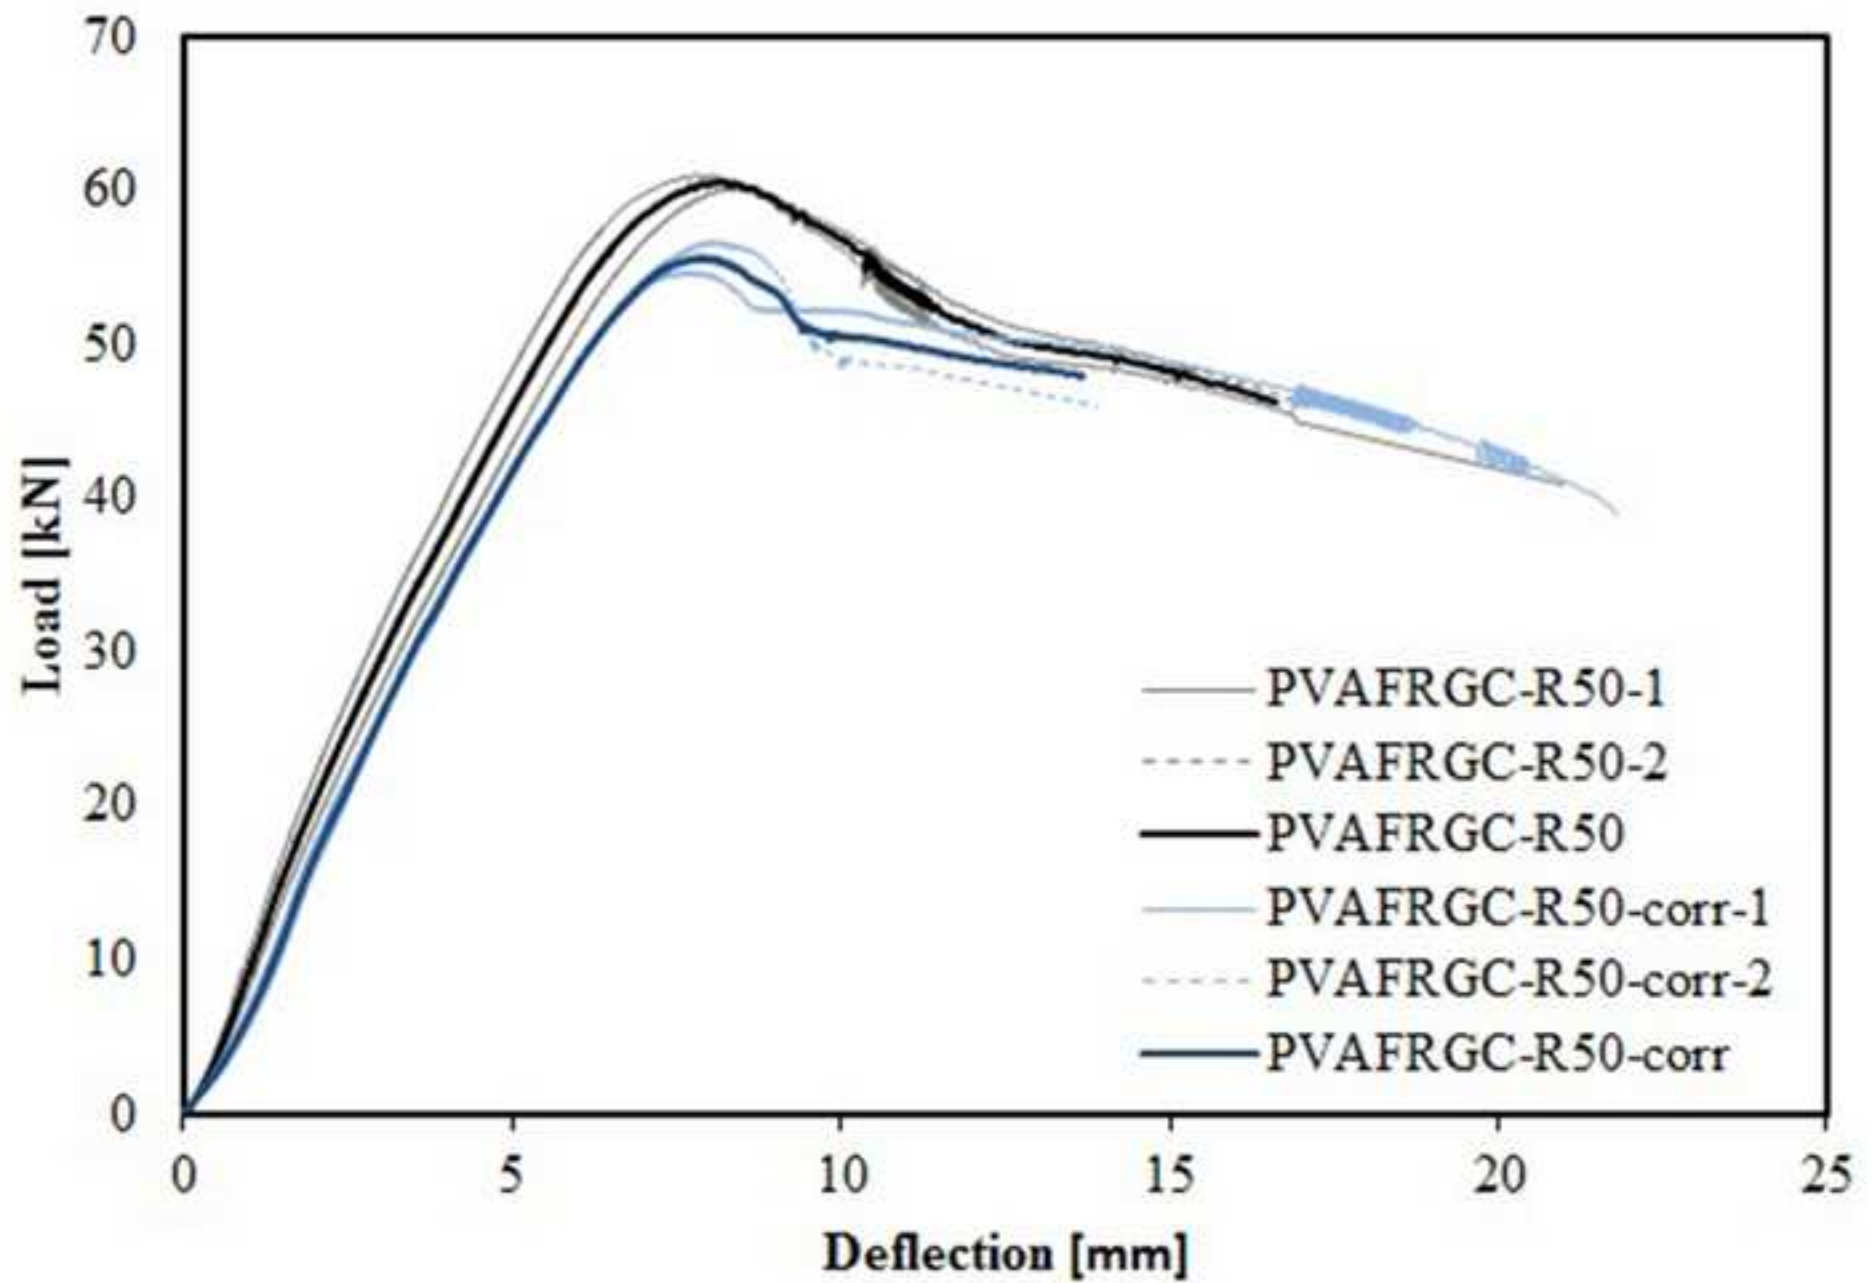
Fig. 21a  
[Click here to download high resolution image](#)

**Figure 21.** Load against deflection curve comparisons; **a)** non-corroded and corroded initial control beams, **b)** repaired RC beams with 25 mm of PVAFRGC layer and **c)** repaired RC beams with 50mm of PVAFRGC layer.

To assess the structural and corrosion resistance differences between the different thicknesses of the repaired material and the control specimens, experimental loads at three points were compared, the first crack loading point, the ultimate load point, and the failure load point of the RC beams. Individual and average test results for all RC beams are presented in Figure 21 and summarized in Figure 22.

Constant current applied for 90 days to accelerate the corrosion procedure reduced the ultimate carrying capacity of the control RC beams by **16 %** (Figure 21a), and caused 8.5% mass loss of the reinforcement bars. Increasing the repair layer thickness from 25 mm to 50 mm in the corroded RC beams considerably enhanced the flexural capacity **(Figure 22)**. These results indicate that increasing the repair material thickness improved the corrosion resistance, which was confirmed by the reduction in the mass loss of the corroded reinforcement bar from 7% for PVAFRGC-R25 specimen to 5.5 % for PVAFRGC-R50 specimen (Figure 21 b-c). This behaviour can be explained by two factors: firstly, the superior durability performance of the thicker repair material in terms of corrosion resistance, chloride and moisture penetrations; and secondly, the impact on the interfacial bond between the overlaid repair material and the RC beam substrate, which is the weakest and most critical section of the repaired member. The interfacial bond is influenced by the geometry (thickness) of the repair material, which subsequently effects the corrosion rate of the reinforcement bars and crack damage. A 50 mm thickness of repair layer ensures higher bonding with the concrete substrate by stronger embedding of the longitudinal and shear reinforcement in the repair material. On the other hand, the interfacial bond between the 25 mm repair layer and the concrete substrate was controlled only by adhesion through the concrete substrate's rough surface.

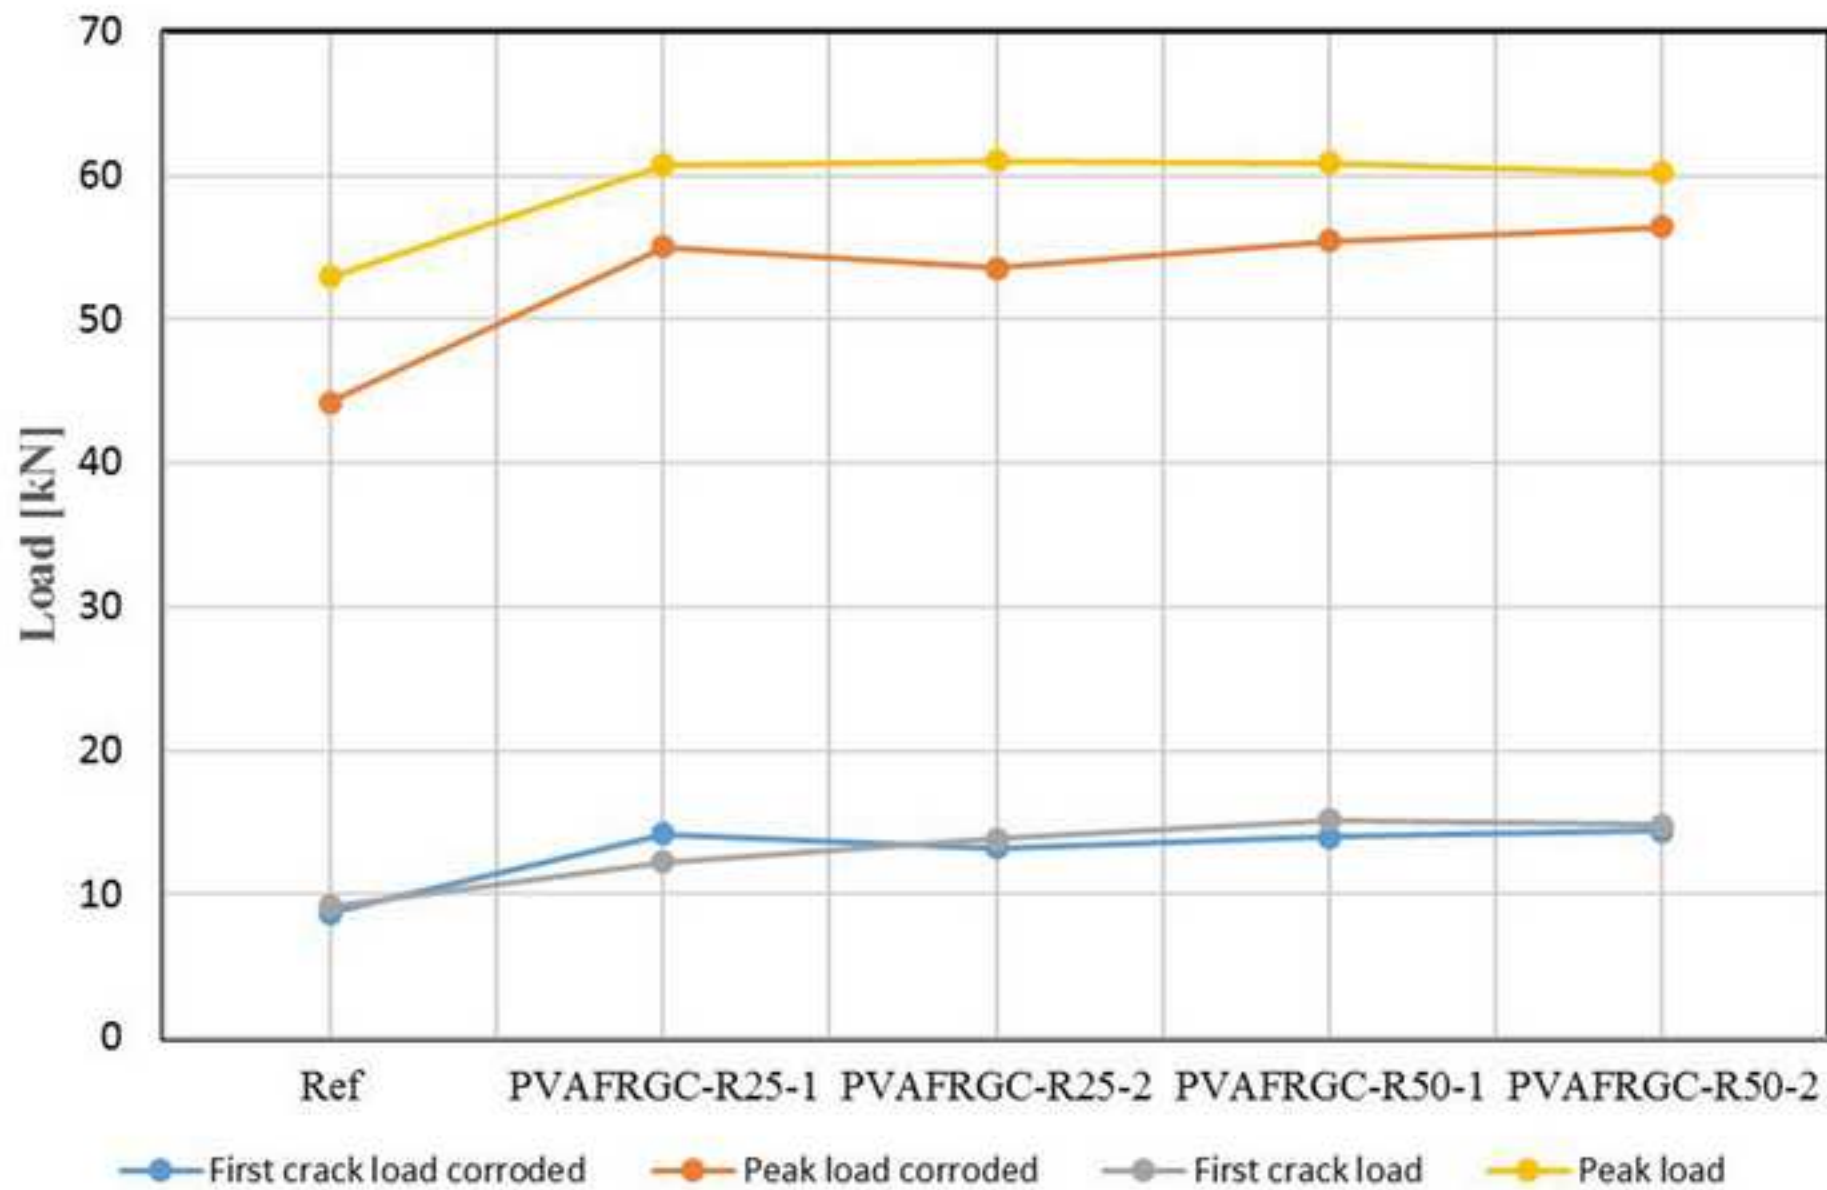
Fig. 22

**Figure 22.** Comparison of the effect of the repair layer on the load-carrying capacity.

Compared to the control RC beams, the repaired beams PVAFRGC-R25-1 and PVAFRGC-R25-2 showed first crack load values which were increased by 41 % on average for the two examined specimens. This means that the stiffness of the repaired RC beams was significantly improved by using 25 mm of PVAFRGC in the tension zone. There is also a 15 % increment of the ultimate failure load of the repaired RC beams for both 25 mm and 50

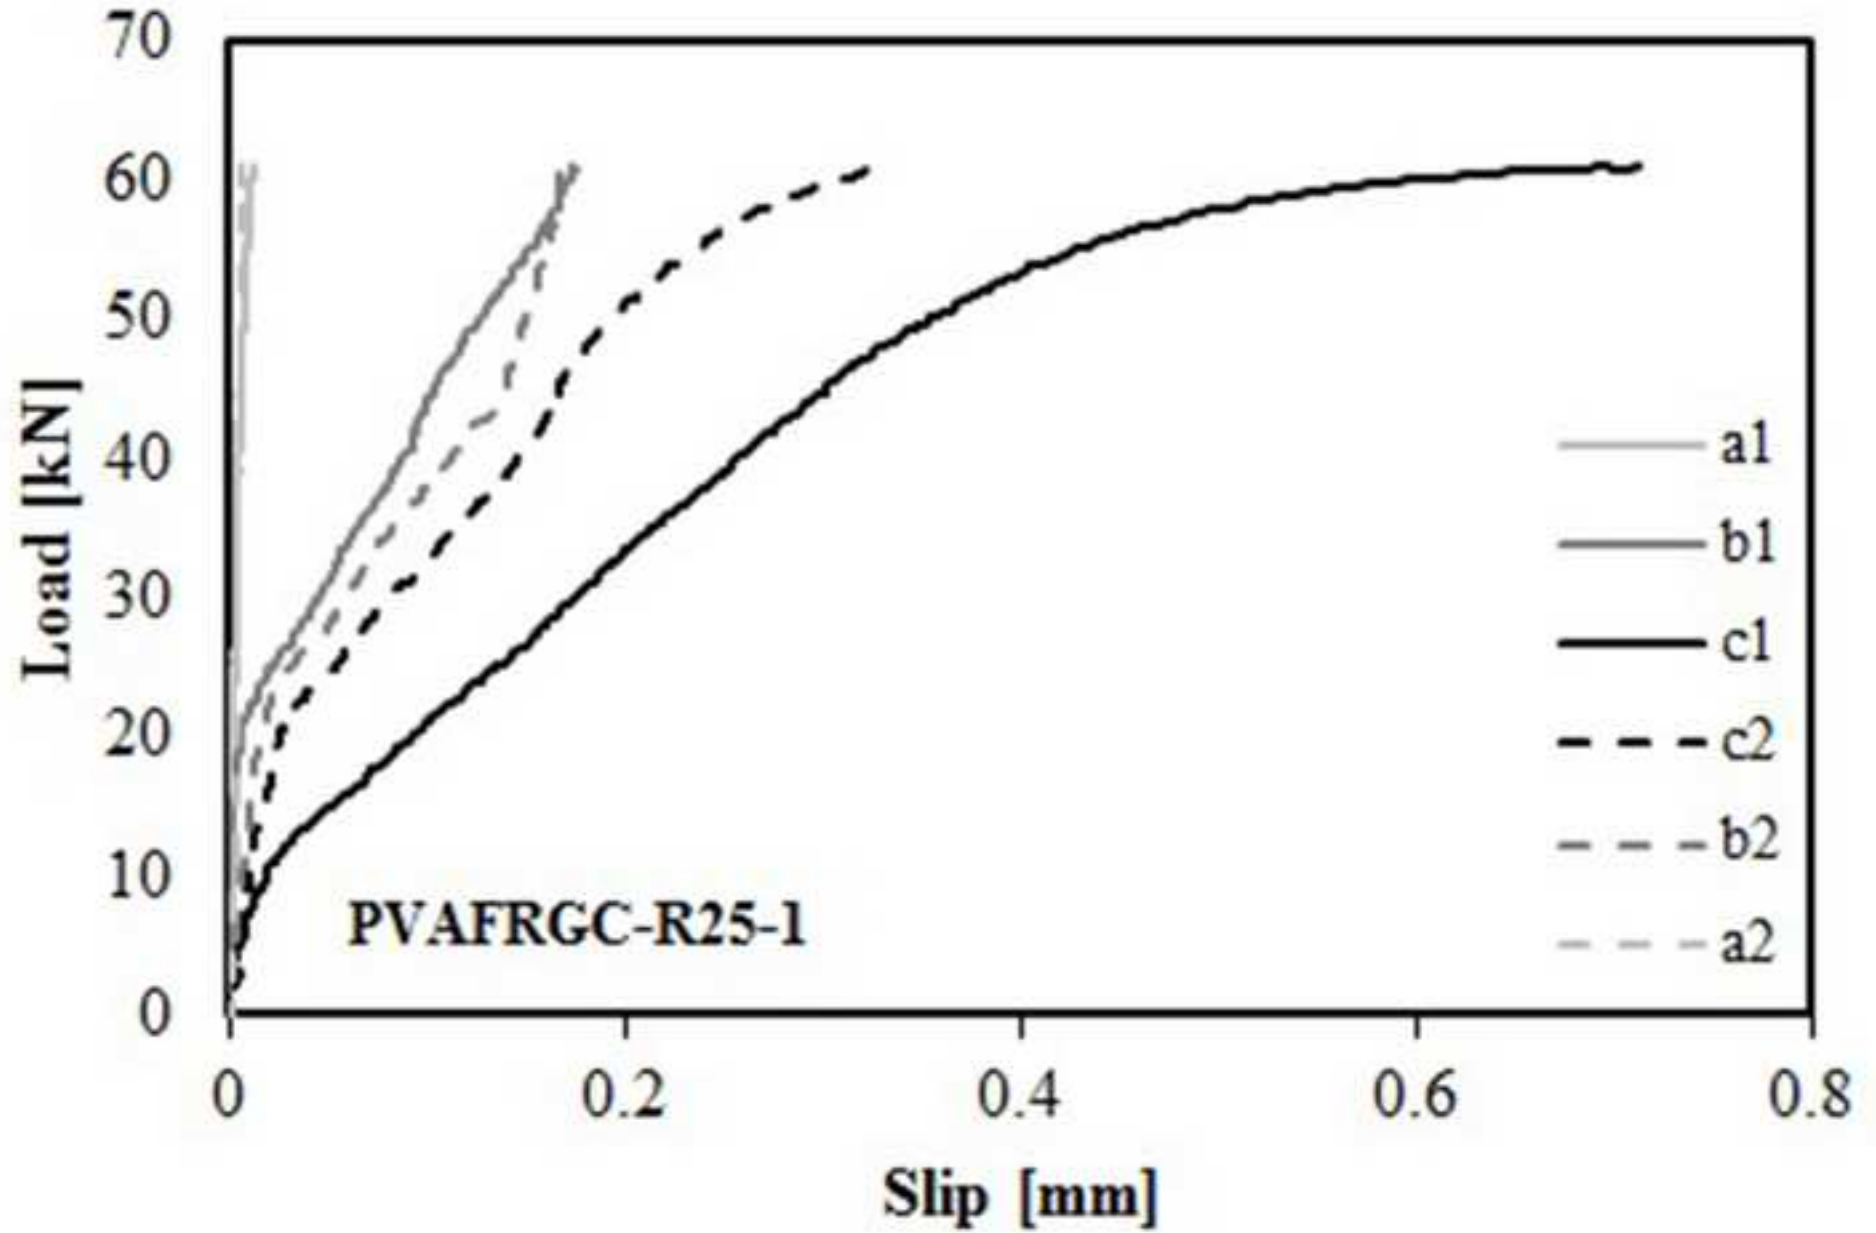
Fig. 23a

**Figure 23.** Load vs slip relationship of repaired RC beams with 25 mm PVAFRGC overlay.

Figures 23 and 24 illustrate the relationship of load slip measurements between the RC beam substrate and the overlay repair material with 25 mm and 50 mm thickness, respectively. The geometry and the loading of the beams were symmetrical and the preparation of the interface was the same along the whole beam length. A similar set up was followed for all RC beams as mentioned in section 2.5 and the slip measurement points  $a_1$ ,  $a_2$ ,  $b_1$ ,  $b_2$ ,  $c_1$  and  $c_2$  are presented in the results. The slip measurements at the interface between the RC beam substrate and the overlay layer presented here are only due to the bending load, and the effects of creep and shrinkage are ignored.

From the results presented above, it can be observed overall that the slip interface measurements of all beams are small, and increased as cracks began to propagate with an increase in the applied load. For instance, in beam PVAFRGC-R25-1, the interface slip measurement was very small (up to  $\leq 0.2$ ) within an applied load of 33 kN, and increased to 0.75 mm at the maximum load of 60.75 kN (Figure 23a and Table 5). Figure 24 illustrates that increasing the repair thickness from 25 mm to 50 mm did not have a significant effect on the interface slip measurements. However, a 50 mm repair thickness delays the respective loads at interface slip values of 0.2 mm, as the first cracking load increased with repair thickness. According to slip measurements for repaired RC beams PVAFRGC-R50-1 and PVAFRGC-R50-2, the respective loads at interface slip values of 0.2 mm were 34 kN and 43 kN, respectively. Exposure of repaired RC beams to accelerated corrosion did not have a major effect on the slip measurement. It can be seen that the interface slip reaches the 1 mm limit only in RC beam PVAFRGC-R50-corr-2 as all specimens failed by flexural cracking, rather than by separation between the substrate beam and the repaired layer. The interface slip measurement along the beam length for RC beams repaired with 25 mm and 50 mm of PVAFRGC, respectively are presented in Figure 25 and Figure 26.

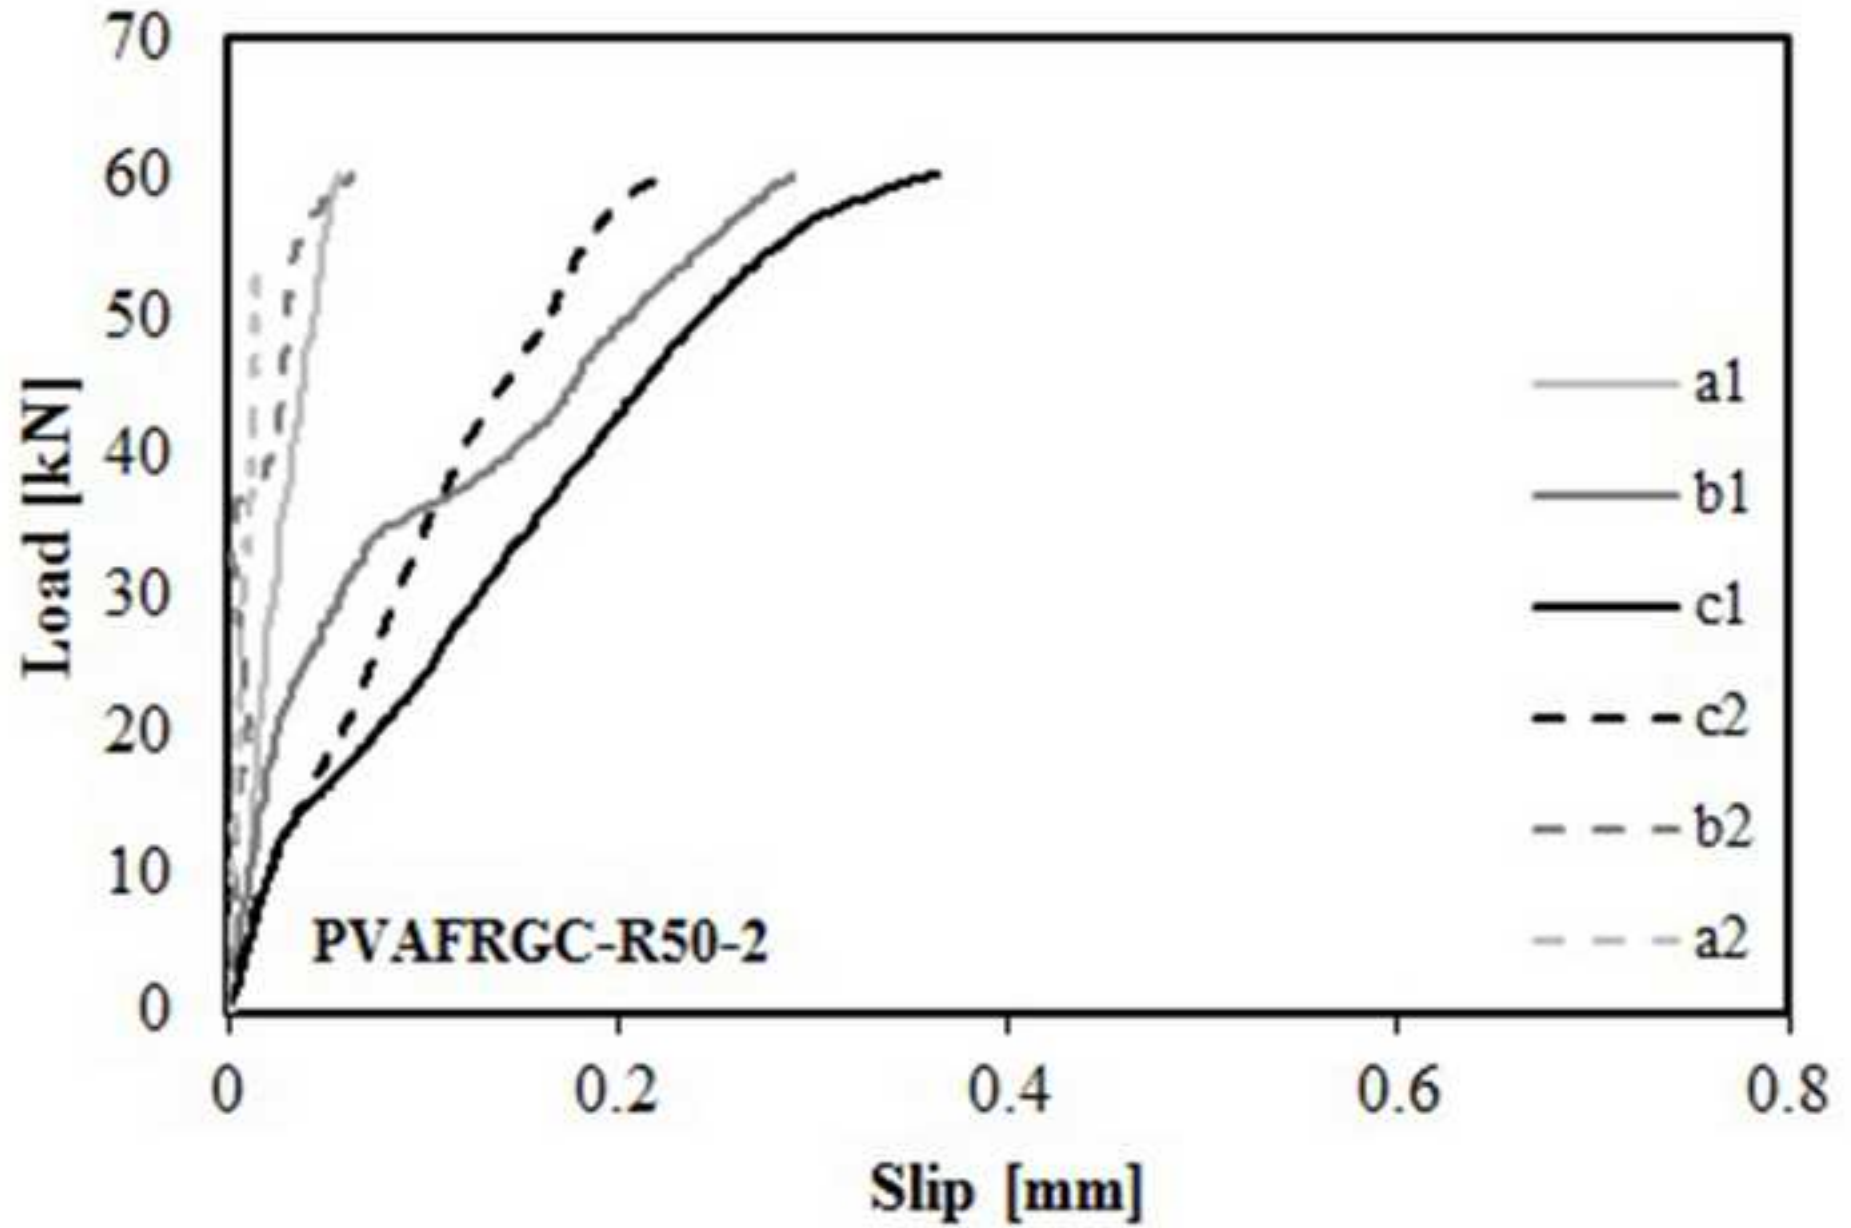
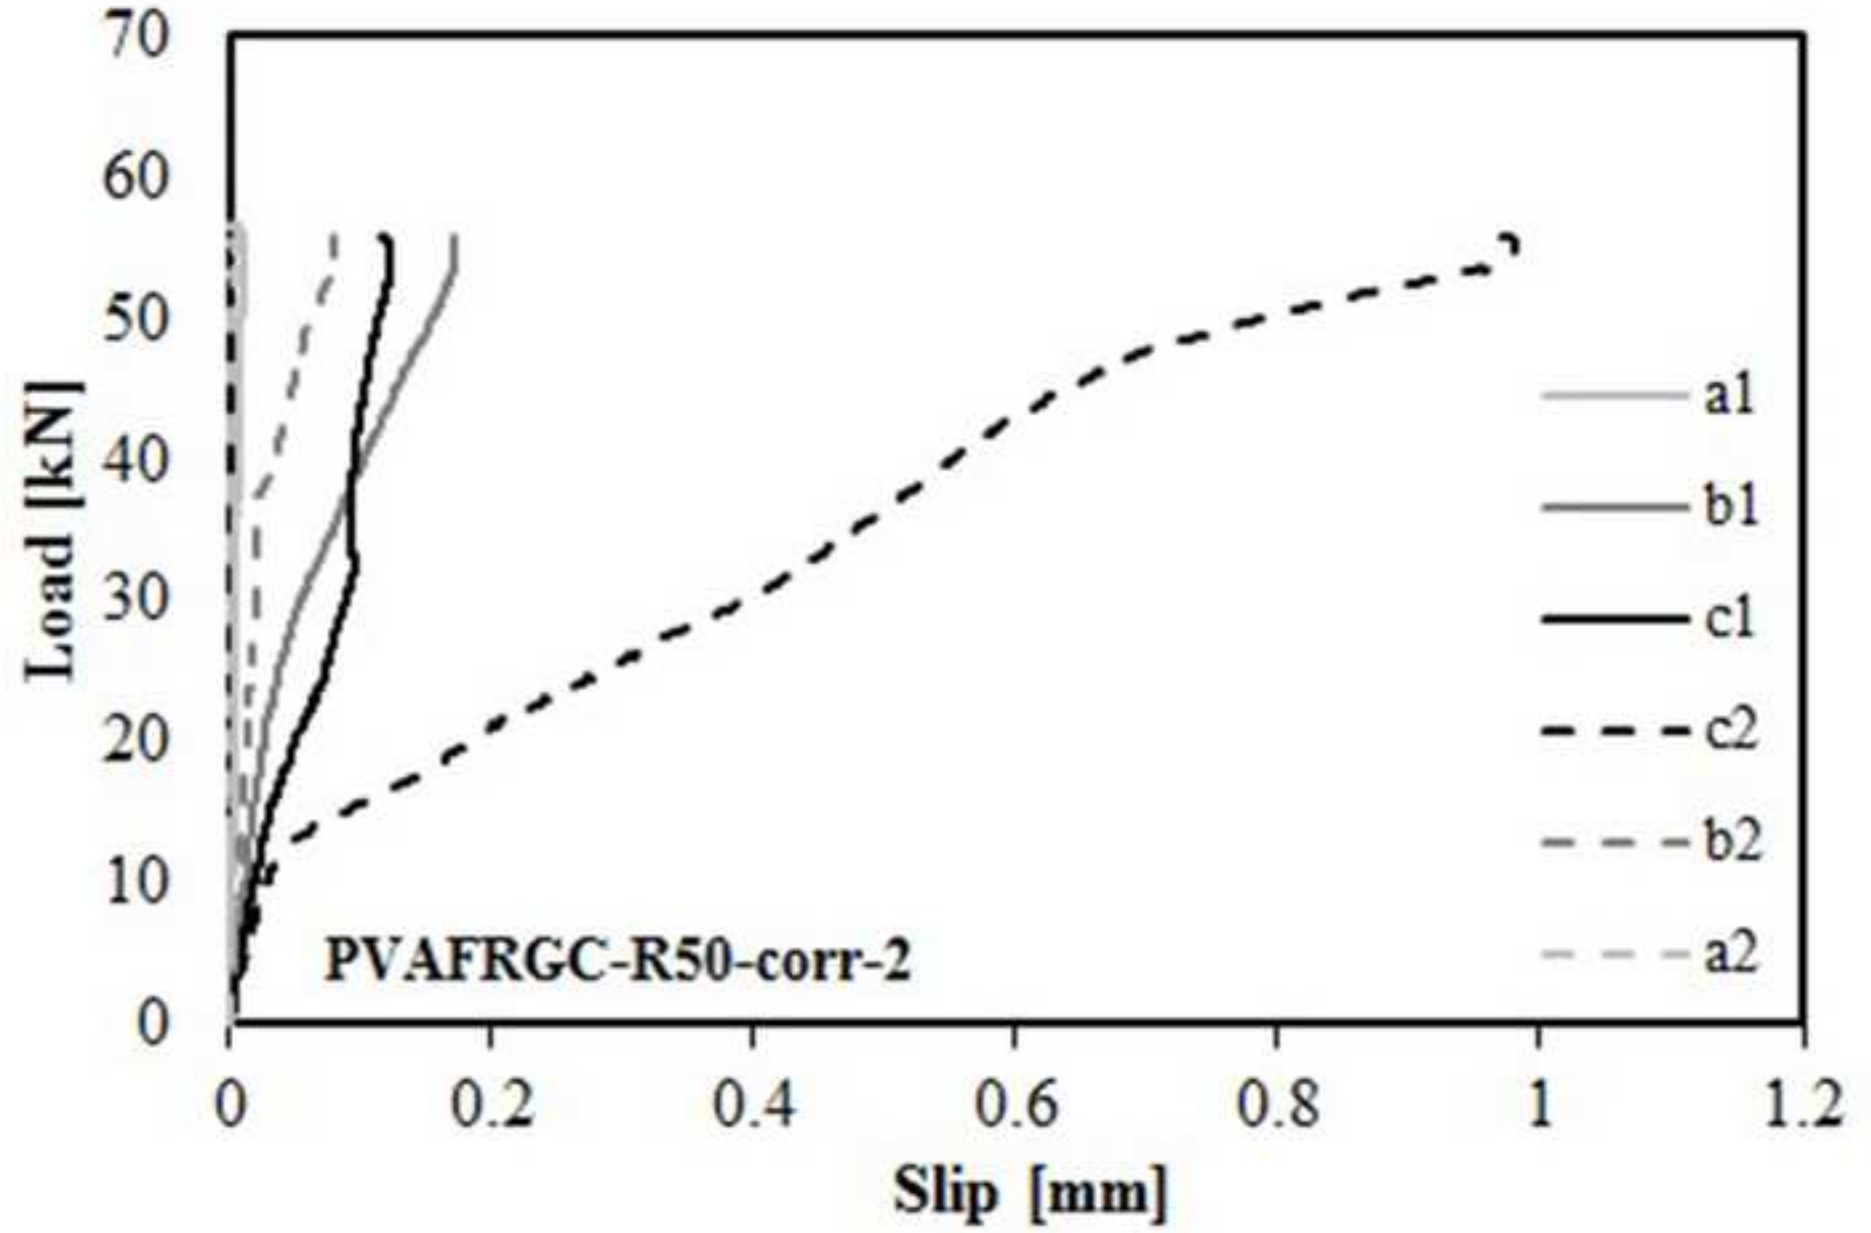
Fig. 24a

**Figure 24.** Load vs slip relationship of repaired RC beams with 50 mm PVAFRGC overlay.

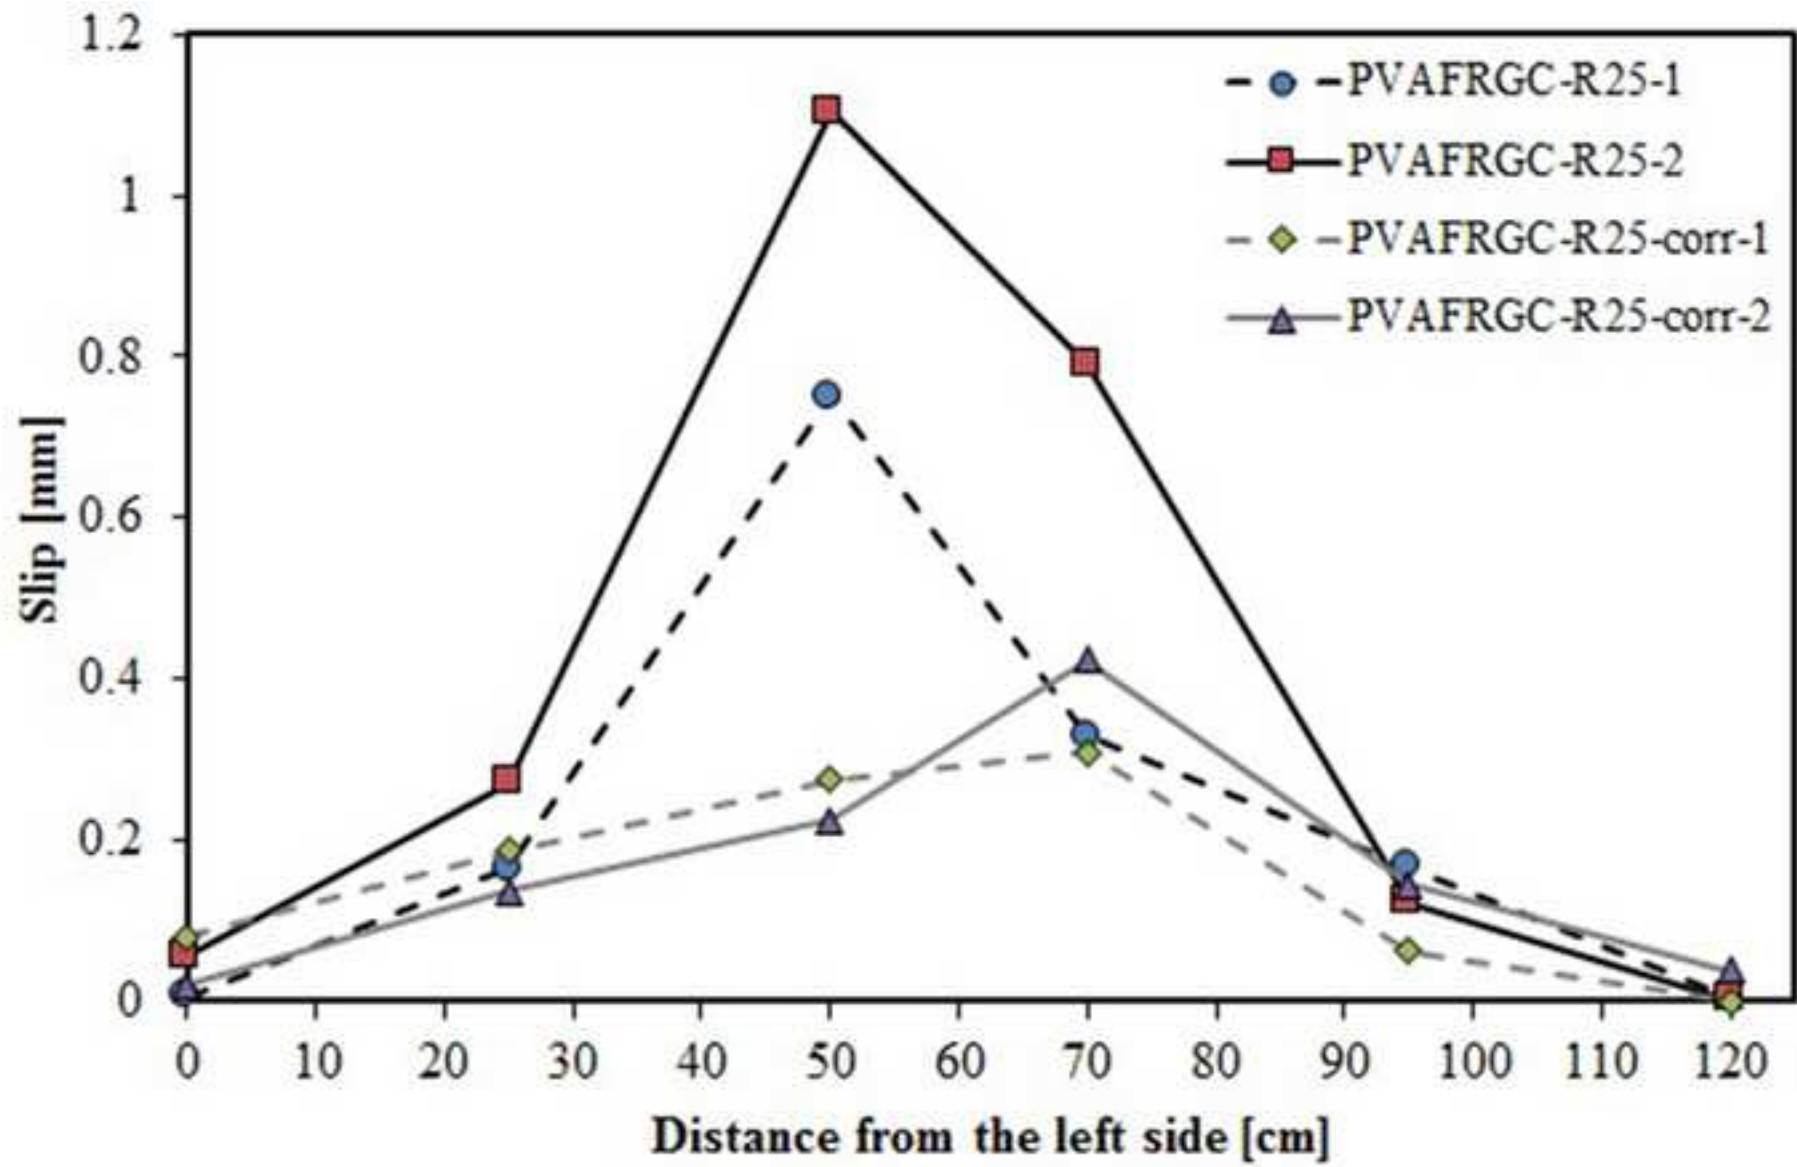
Fig. 25

**Figure 25.** Interface slip measurements at peak load for repaired RC beams with 25 mm PVAFRGC overlay.

It can be observed from Figure 25 and Figure 26 that the interface slip measurements were very low (almost zero) at the supports, and greater near to the collapse cracks at the mid-span interface slip. Despite the symmetry of the RC beam and the loading conditions, the interface slip measurements were not symmetric as the interface adhesion depends on local conditions, as cracks occur asymmetrically [41]. Moreover, the debonding of the repaired layer due to

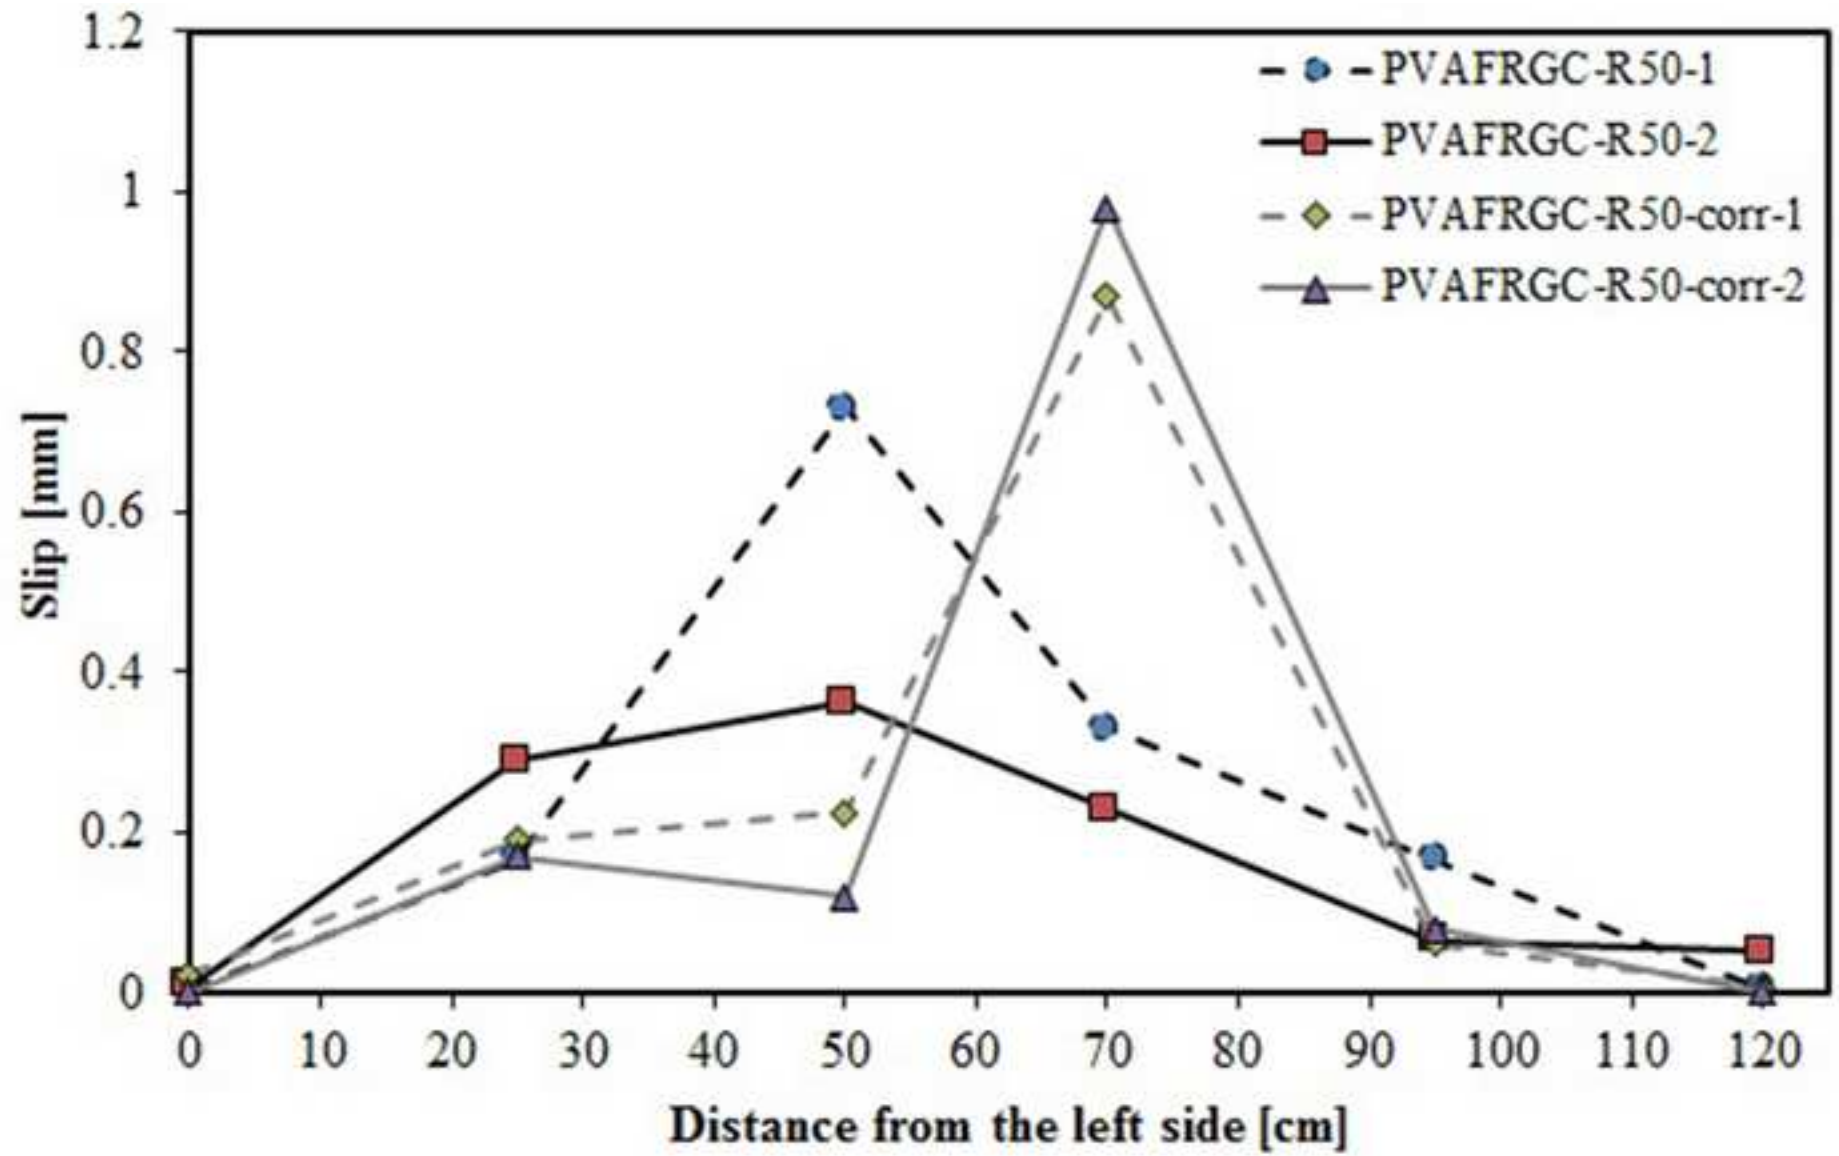
Fig. 26

**Figure 26.** Interface slip measurements at peak load for repaired RC beams with 50 mm PVAFRGC overlay.
