# Dryland Vulnerability and Ephemeral Streams Response To Global Change: Example From The Raya Graben, Northern Ethiopia

P. Billi<sup>1</sup>, B. Demissie<sup>2</sup>, J. Nyssen<sup>3</sup>

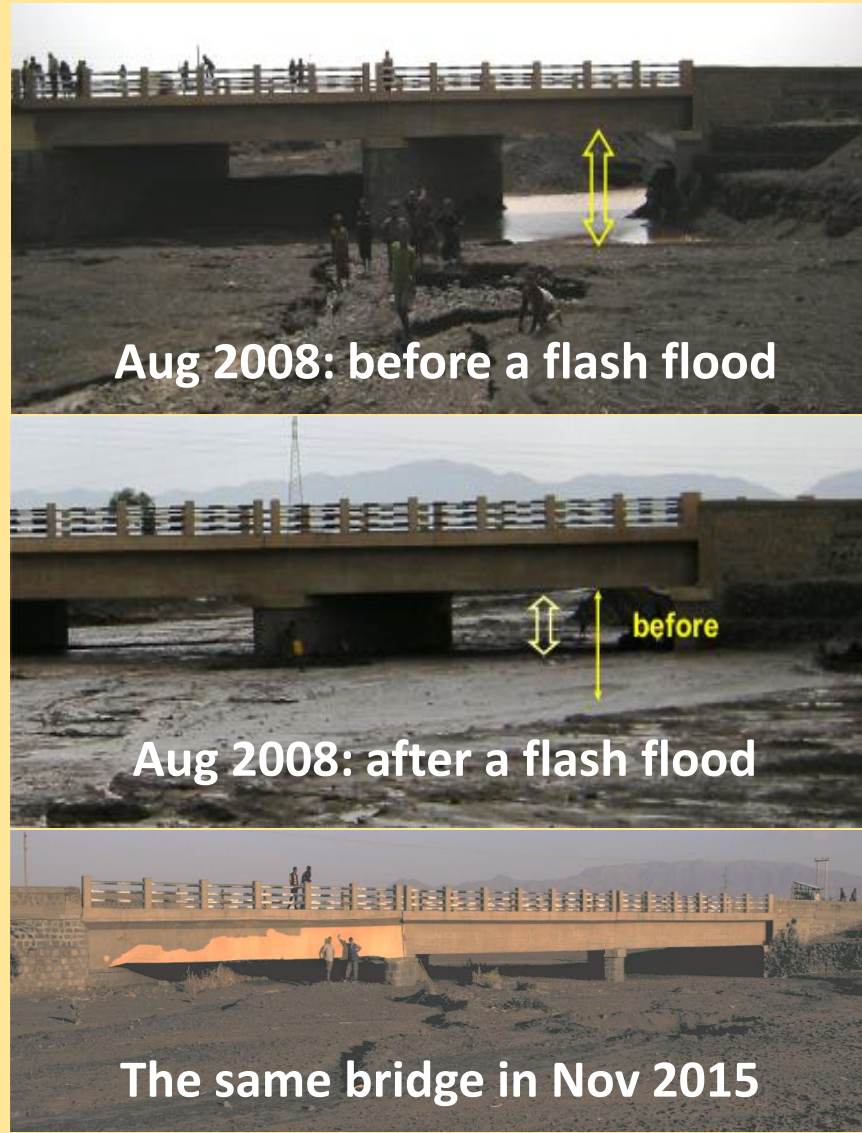
Fig.2 Bridge clogging

The width of many river channels upstream of the main road bridges is substantially larger than the bridge span (Fig. 8). This causes back flow during high floods and thick sedimentation at the bridges, the flow conveyance of which is therefore remarkably reduced (Fig. 2). The forced channel narrowing at the bridges results in overbank flow, further channel widening and avulsion upstream of the bridges (Fig. 9), affecting cultivations and small villages along the main road (Fig. 10).

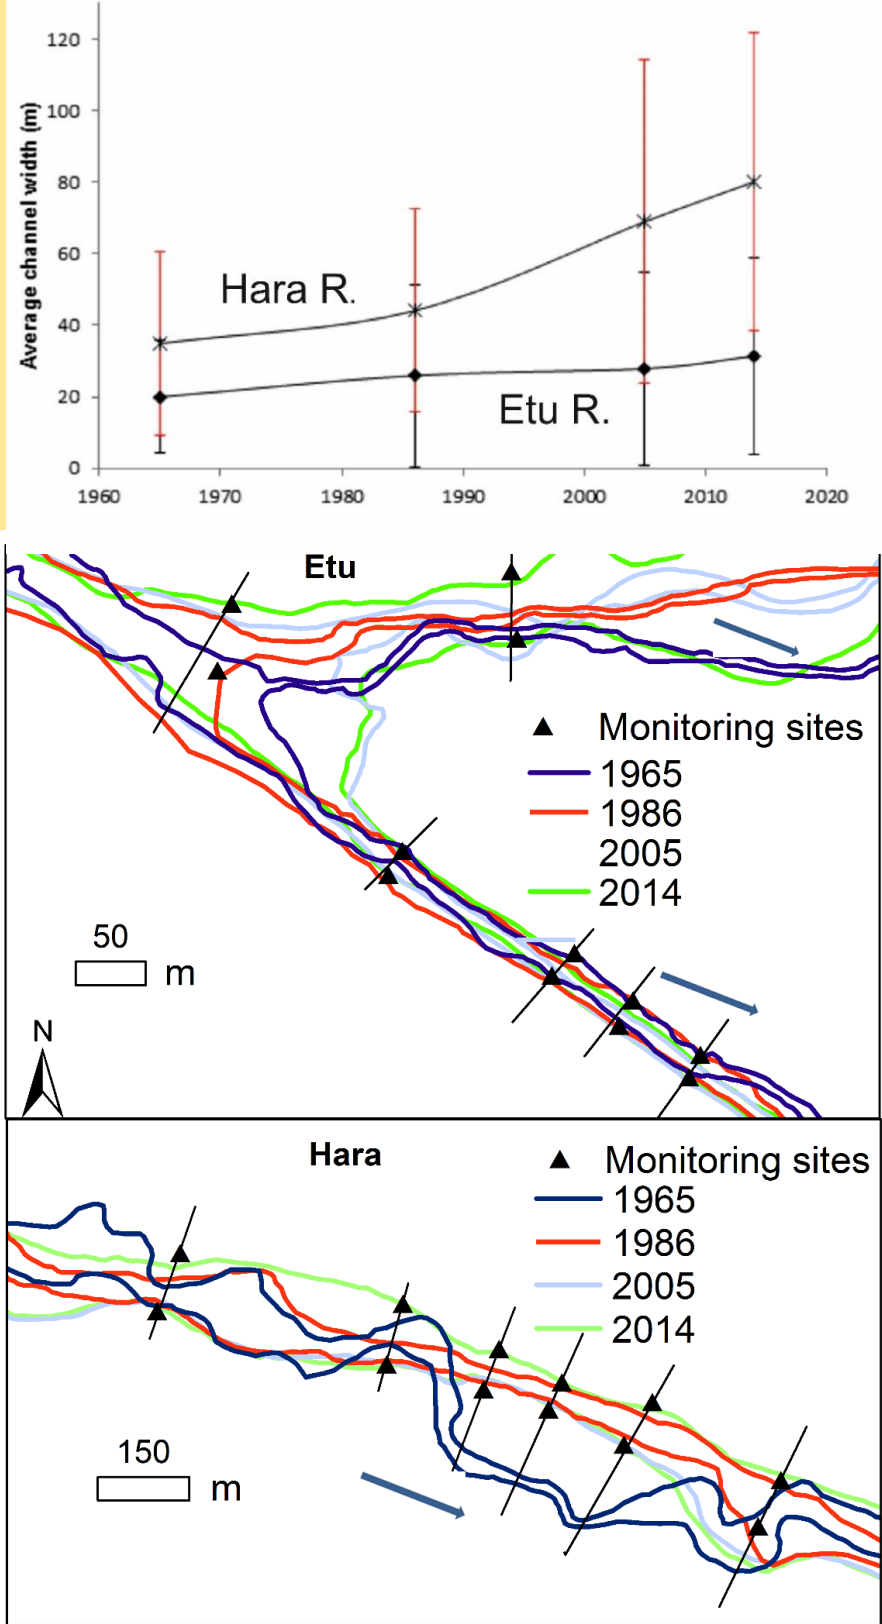
Fig. 3 Channel dynamics and widening in two study streams

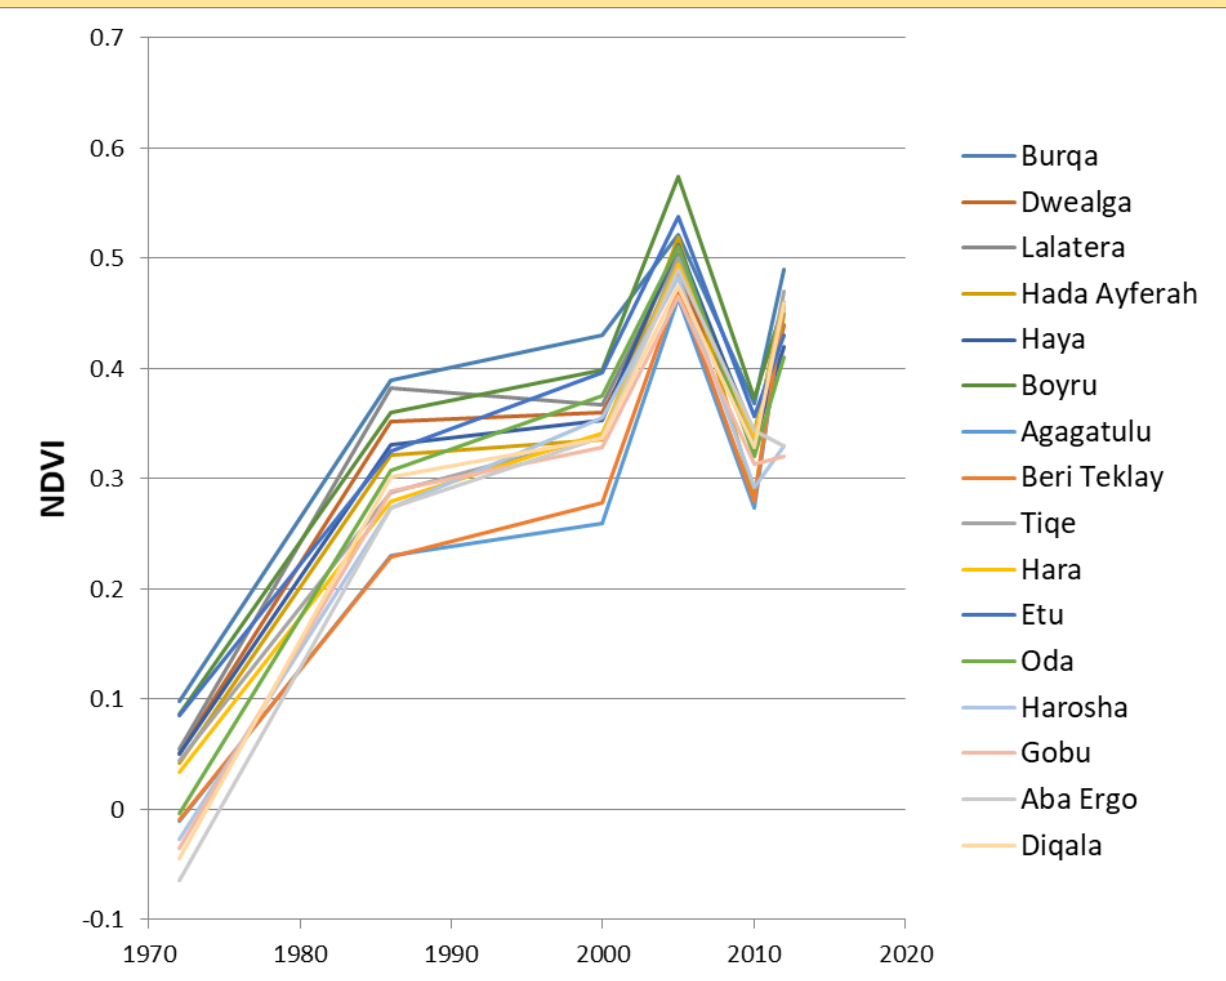
Fig. 7 Time variation of NDVI in the study area

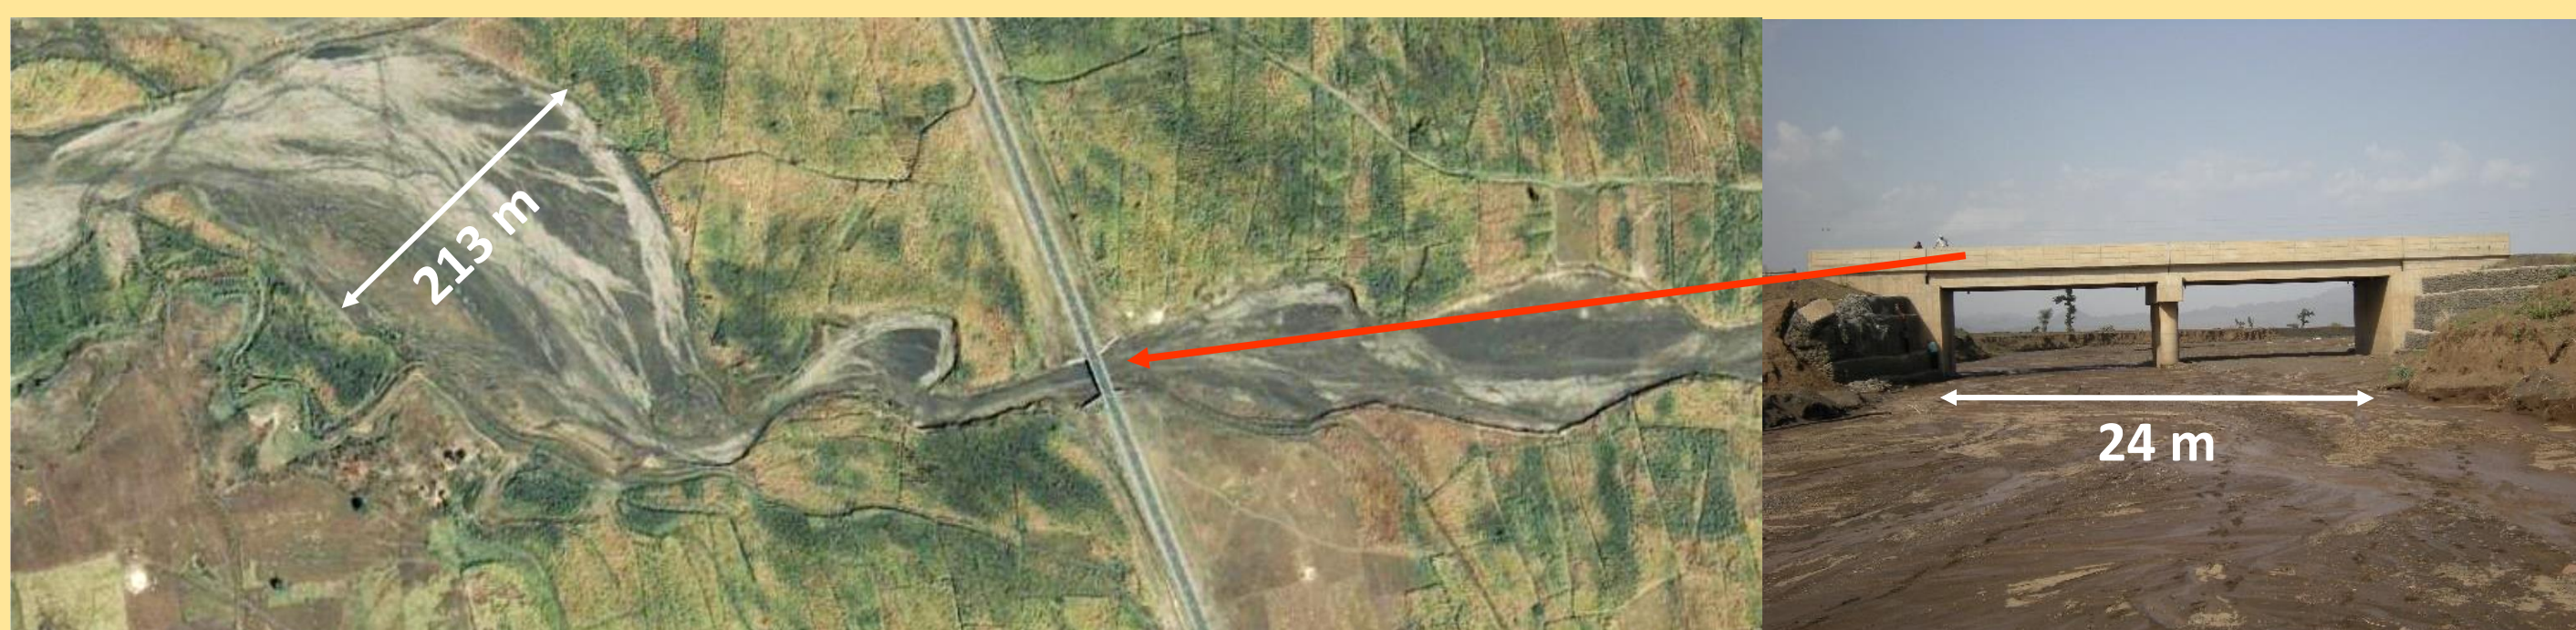
Fig. 8 Gereb Oda R. and road bridge in 2008

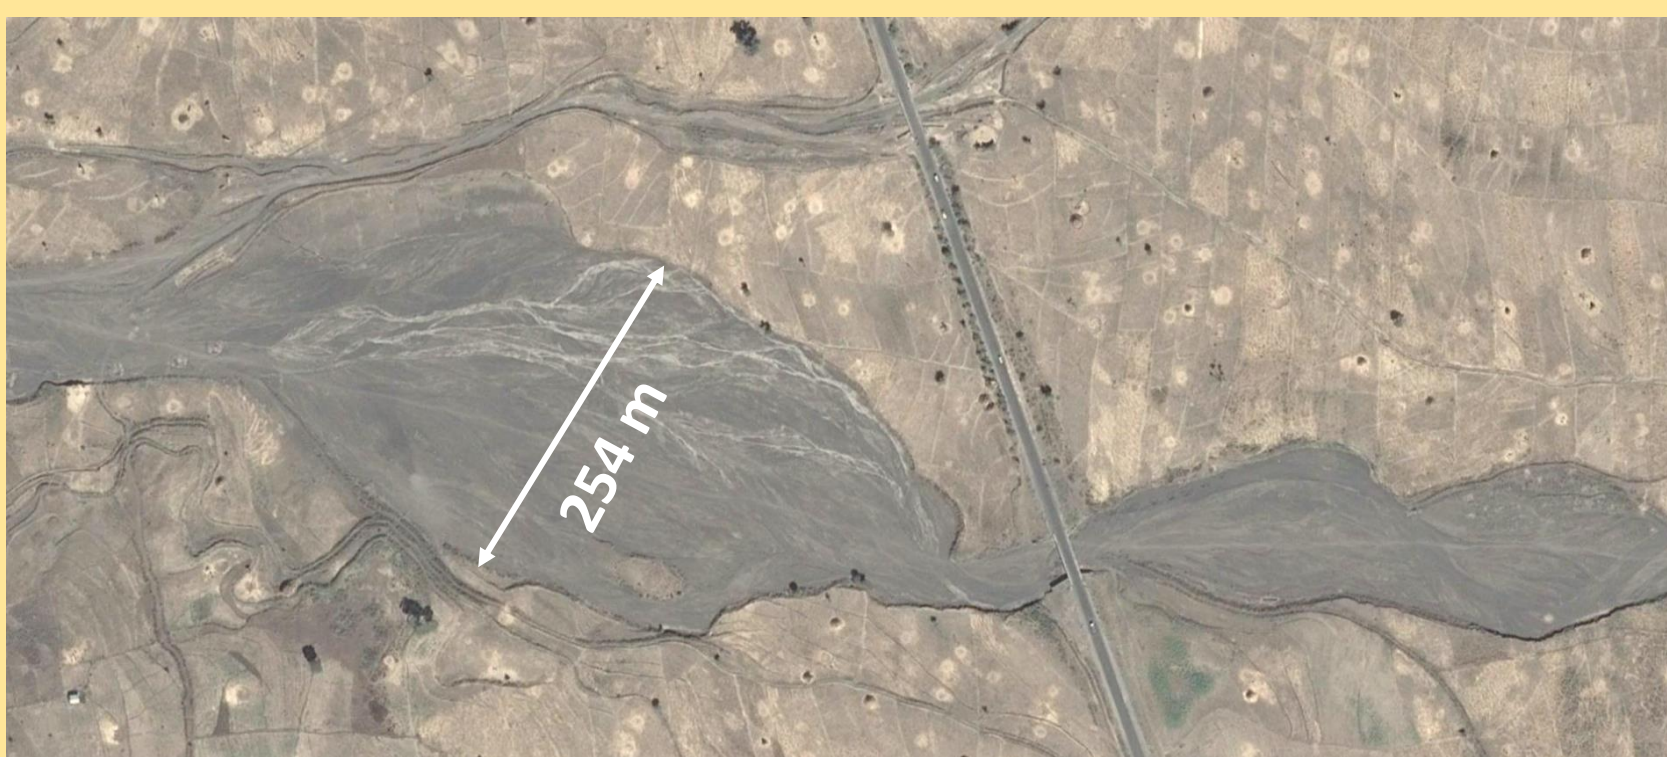
Fig. 9 Gereb Oda R. and road bridge in 2015

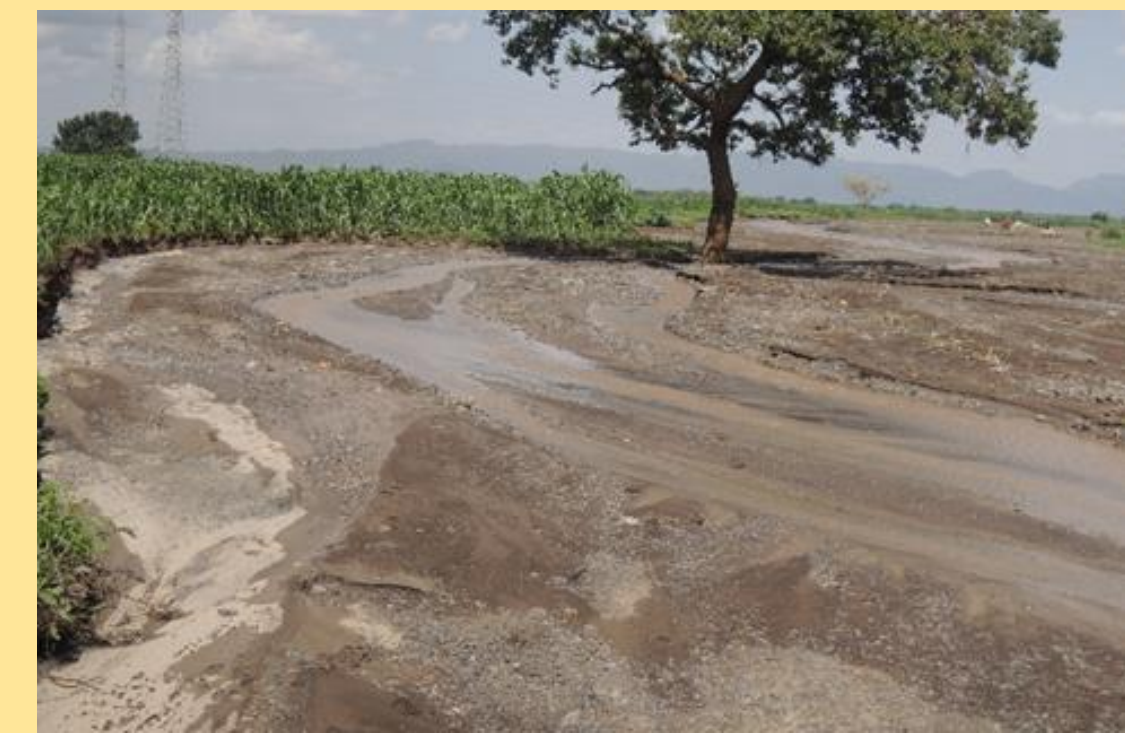
Fig. 4 Cultivation affected by channel lateral shifting

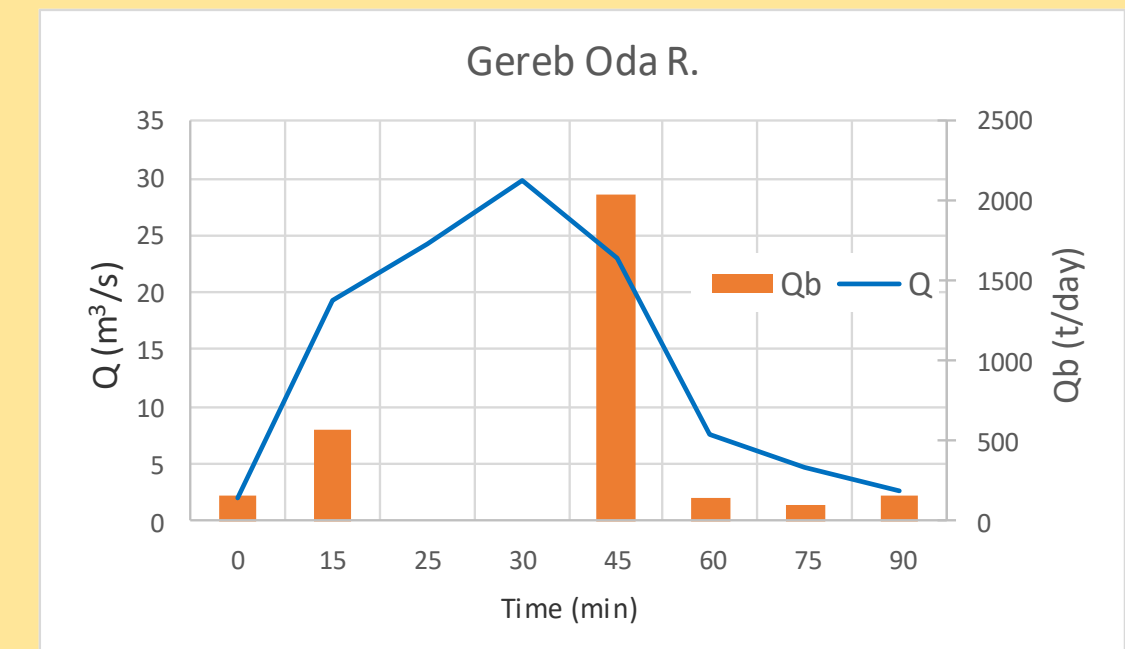
Fig. 5 Sediment transport in the Gereb Oda R.
