Determination of stable spans in UG2 excavations

Synopsis

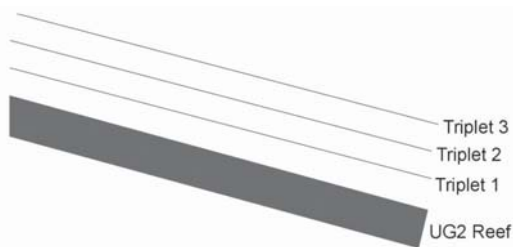
Figure 2—Typical UG2 Reef and the weakly cohesive chromitite stringers (triplets)

The UG2 Reef is widely mined in the South African Bushveld Complex (Figure 1). It is a tabular, gently dipping orebody as shown in Figure 2. The hangingwall of the UG2 Reef is characterized by stratification in the form of thin and weakly cohesive chromitite stringers (triplets) that can vary in number and height above a stope. Traditionally this reef has been extracted conventionally (Figure 3) using mine poles and packs as support. Increasingly it is extracted using mechanized (Figure 3) or partially mechanized mining methods, and these stopes or zones have to be supported on tendons.

For any given situation, the stability of a UG2 hangingwall depends upon the presence or absence of shallow-dipping thrust structures, height and spacing of the chromitite bands (triplets) above the reef (Figure 2), the stopping span, the rock mass rating, the support resistance, and depth of penetration (if tendons are used). The conditions for stability, incorporating all these variables and their interactions, have to be determined in order to develop a design methodology to determine stable spans for the mining of the UG2 Reef.

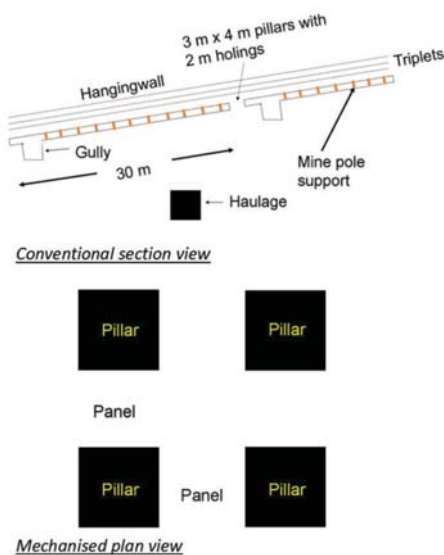
Figure 3—Typical conventional and mechanized mining layouts

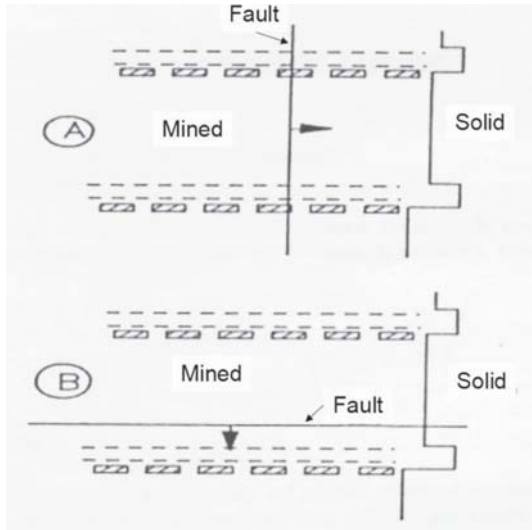
Figure 4—Favourable (A) and unfavourable (B) orientations of fault planes with respect to the yield pillar layouts (after Brummer, 1988)

- Discontinuity orientation. Brummer *et al.* (1988) suggested that faults or persistent joints striking parallel to pillar lines (Figure 4) are considerably less stable than those perpendicular to the pillar lines.

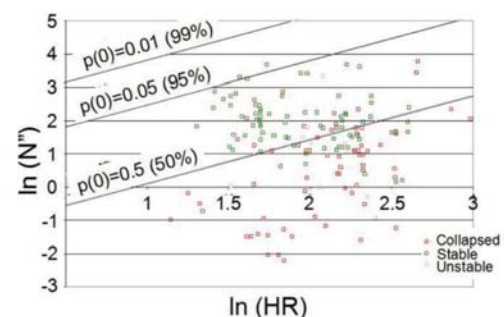
Figure 5—Design chart for N''

The angle of the shallow-dipping thrust fault was changed to 30° to the strata to determine if a slightly steeper angle would increase the height of instability at a particular span, and thus reduce the stable span for a given set of conditions. However, no discernible difference was observed. Hutchinson and Diederichs (1996) also show equal severity across the range of dip angles between 10° and 30° to the strata, and suggest that the worst discontinuity angles are within that range (Figure 5).

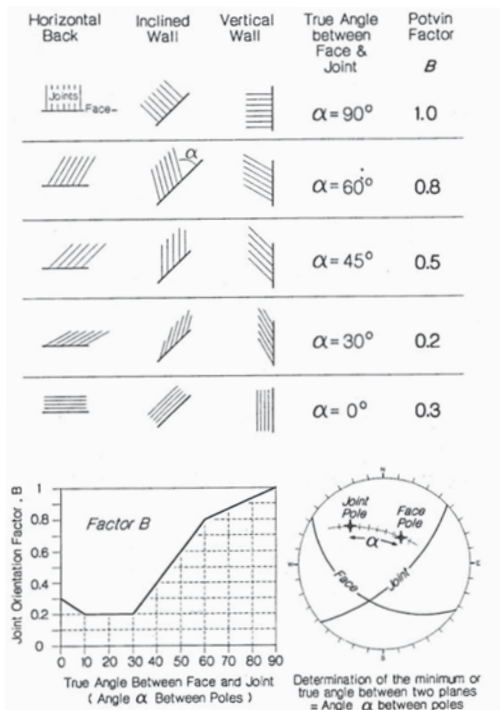
Figure 6—Factor for joint orientation 'B' (after Mathews *et al.*, 1981 and revised by Hutchinson and Diederichs, 1996)

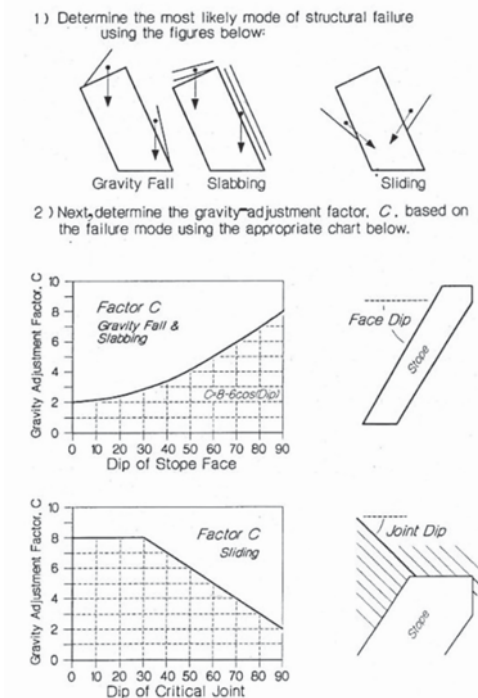
Figure 7—Gravity adjustment factor 'C' (after Mathews *et al.*, 1981 and revised by Hutchinson and Diederichs, 1996)

A statistical evaluation and reworking of the N'' equation (Equation [2]) was done to provide a best fit between collapsed and stable panels. A significantly better fit was found (confidence level: about 93 %) when Equation [5] ($N^{(3)}$) was compared to support resistance (SR) and a factor describing the joint filling. The analysis suggests that support resistance plays a more influential role than span for a given discontinuity condition, within the context of the spans in the database. Note that the dominant parameter in this equation is the B-value, which is a factor accounting for the dip orientation of the most influential discontinuity (Figure 6). The C-value (Equation [1]) accounts for the influence of gravity on the hangingwall blocks (Figure 7).

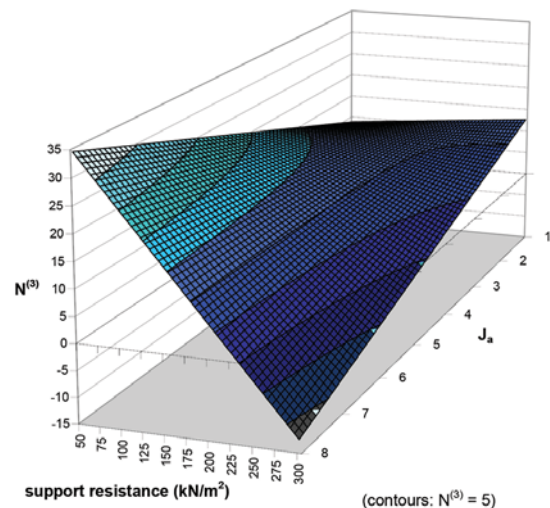
Figure 8—Surface showing a probability of a collapse at <5%

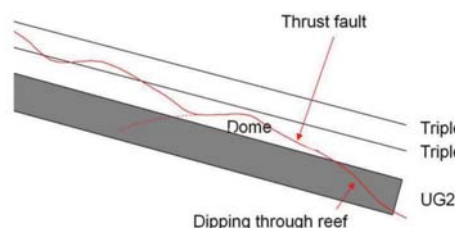
Figure 9—Diagram showing a section through an actual thrust structure

The statistical evaluation of the geotechnical data suggested that the most significant stability parameter is persistent, shallow-dipping or curved discontinuities. Generally, these features are associated with thrust fault structures, which appear to be endemic across the platinum-bearing orebodies of the Bushveld Complex. These discontinuities dip in and out of the reefs, resulting in the development of dome structures in the hangingwall during mining (Figure 9).

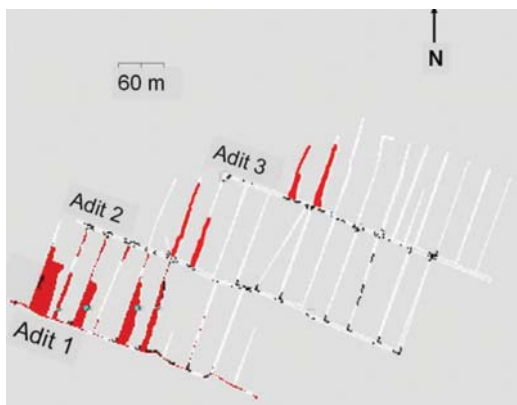
Figure 10—Plan view of the workings at the time of the 'mine A' investigations

A highly appropriate 2D case study was made available at 'mine A'. Stopes were mined from one side of a raise line, from 2 m to a planned 30 m width on strike and about 120 m on dip (Figure 10). A shallow-dipping thrust fault dipped in and out of the reef, causing several panel collapses that were used to calibrate the model. The joint sets at the site were similar to the common joints observed generally across the platinum mines.

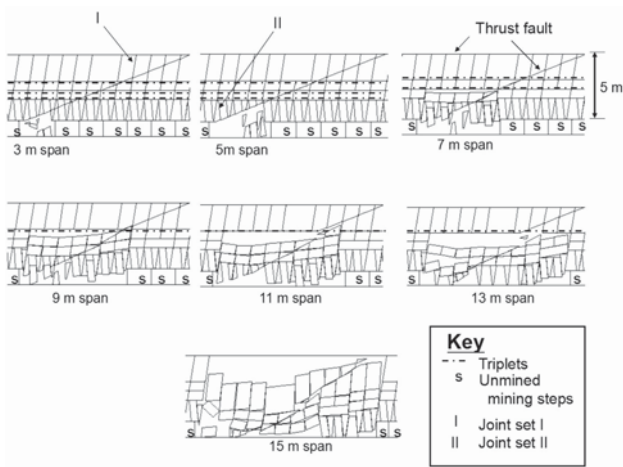
Figure 12—Results of a UDEC model without support

The model above was modified to include thrust faults and a suite of tests was run without support as shown in Figure 12. Blocks that formed between the shallow-dipping

thrust fault and the two joint sets fell out as the span was increased, showing that there is no stable, self-supporting span. At a span of 5 m the rock mass collapsed up to triplet I (1.3 m above the stope). An increase of the span by 2 m resulted in a migration of the unstable zone up to triplet II at 2.0 m above the stope. The conditions at spans of both 5 m and 7 m were observed underground at mine A in unsupported or under-supported panels. At a span of 9 m, the entire rock mass below triplet III (at a height of 2.7 m) became unstable. At a span of 15 m, a collapse occurred up to the horizontal thrust fault at 4.1 m above the stope.

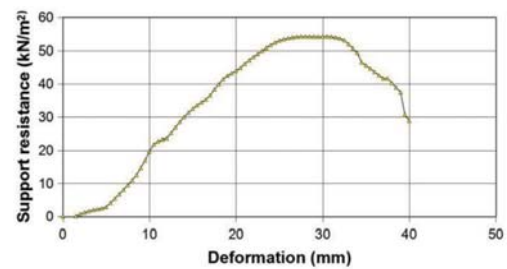
Figure 13—Support resistance with a 99% confidence, assuming large blocks (supported by at least three poles)

A support system of 170 mm diameter mine poles spaced 2 m × 2 m on dip and strike was originally used at the mine. A downrated support resistance of 50 kN/m² was assumed from underground measurements. A curve for the elongate support system is provided in Figure 13. The results of the models are shown in Figure 14. Stable conditions were predicted up to a span of 9 m. At a span of 11 m the model showed that parting had occurred on all three triplets as well as at 4.1 m above the stope. A collapse occurred up to triplet III at a span of 13 m, which is a modest improvement of 4 m over the unsupported scenario.

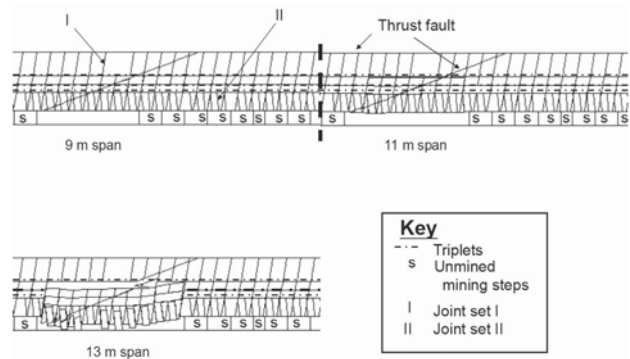
Figure 14—Results of a UDEC model with a support resistance of 50 kN/m²

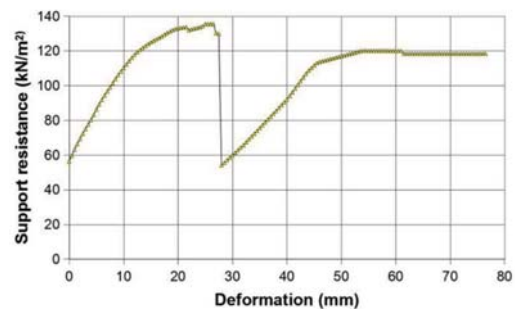
Figure 15—Support resistance profile for the second support system

A new support system was introduced to the mine, which included larger diameter mine poles and packs. This condition was modelled assuming a downrated support resistance of 135 kN/m². In the model, only the mine poles were prestressed (to 150 kN) and the profile of support resistance to closure was determined from underground measurements (Figure 15). A great improvement, both in stable panel span and rock mass conditions, was achieved by this support system (Figure 16). Unstable conditions occurred at a span of 19 m and a final collapse at 22 m. Note that parting initiated at 4.1 m above the hangingwall, when the span reached 17 m. The modelled unstable conditions were observed underground.

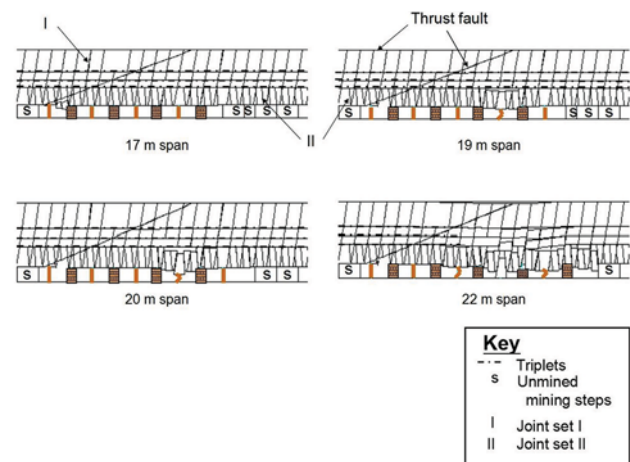
Figure 16—Results of the UDEC model for a pack-elongate support system with a support resistance of 139 kN/m²

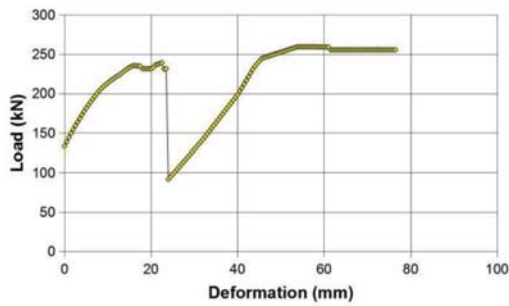
Figure 17—Final support resistance profile (100 kN/m² at installation)

A support system which was prestressed to 100 kN/m² at installation and provided a peak resistance of 200 kN/m² (Figure 17) was introduced to the mine. This support system was technically able to support a rock height of 5 m, with only about 5 mm deformation. To ensure worst-case conditions in the model, a second horizontal discontinuity,

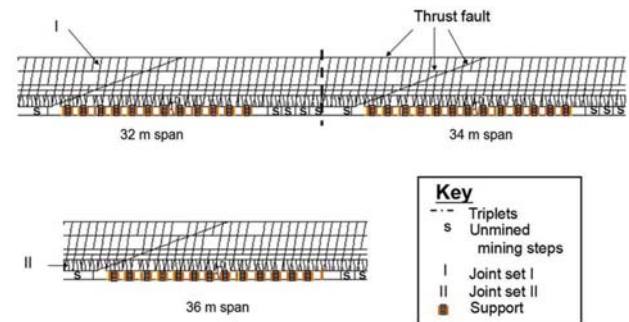
Figure 18—Results of the UDEC model for a support resistance of 200 kN/m². The support-to-face distance was kept to a maximum of 2.8 m

with properties similar to the thrust fault, was set up at 6.1 m above the stope. This was slightly higher than the support capacity. The results are shown in Figure 18. Spans were increased in the model to a maximum of 36 m and stable conditions were predicted in all runs. However, it should be noted that FOGs occurred in the face area when the maximum support-to-face distance was 3.6 m. These FOGs did not occur in the model when the support-to-face distance was reduced to 2.8 m, and this was also confirmed by underground observations. The peak support resistance used at this mine was very high, and it may be unrealistic to apply as a best practice for preventing large-scale instabilities. Mitigation strategies based on knowledge of the height and behaviour of potentially hazardous structures are preferred.

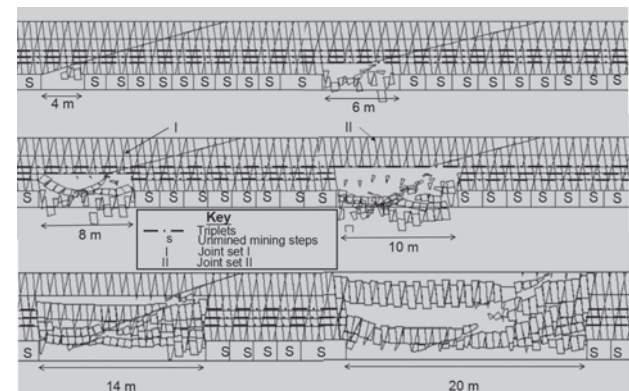
Figure 19—Unsupported model, vertical deformation exaggerated 10x

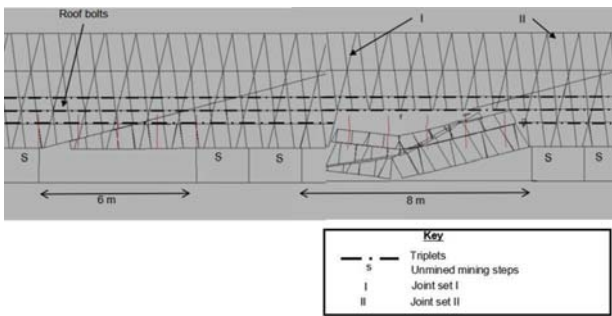
Figure 20—Results of the UDEC model with 18 mm diameter, 1.8 m long, full-column resin roofbolts; vertical deformation exaggerated 10x

A set of models was run with 18 mm diameter, 1.8 m long full-column resin roofbolts, spaced 1.5 m × 1.5 m. The reinforcement properties shown in Table IV were applied in the models, which provided a support resistance of 48 kN/m² over the length of the bolts. The results of the investigation are shown in Figure 20.

Stable conditions with minor FOGs were observed until a span of 8 m. Note that the reach of the bolts extended to just beyond triplet I. The panel collapse occurred up to triplet II at

exactly the same span as in the unsupported models. Importantly, the supported models were able to control most of the FOGs. Suitable surface support is needed to control the small falls between the bolts.

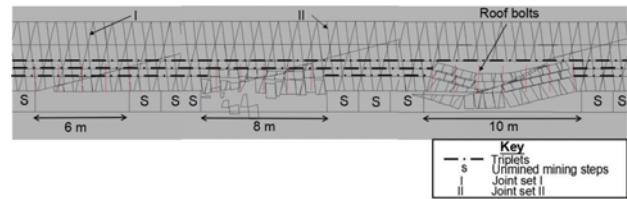
Figure 21—Results of the UDEC model with 18 mm diameter, 2.4 m long, full-column resin roofbolts; vertical deformation exaggerated 10x

A set of models was run to test the effects of increasing the bolt length to 2.4 m. The results showed unstable conditions at a span of 8 m and a collapse at 10 m (Figure 21). The unstable conditions at 8 m were probably the result of parting on triplet II and bolt yield. A collapse occurred up to triplet III at a span of 10 m; again as observed in the unsupported model.

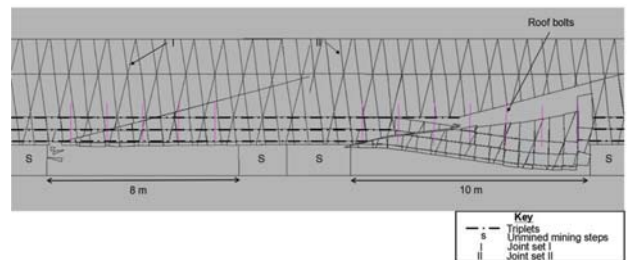
Figure 22—Results of the UDEC model with 18 mm diameter, 2.4 m long, full-column resin roofbolts (triplet at 0.2 m); vertical deformation exaggerated 10x

The model shown in Figure 22 (thrust fault at 20°) was re-run once more with a pre-tension of 38 kN on each bolt at installation. A collapse occurred at a smaller span (Figure 23). The reason for the earlier failure is not clear. Previous modelling work by consultants showed that a small pre-tension on tendon support elements definitely improves deflection and thus stability. However, the thrust structure was not included in those models.

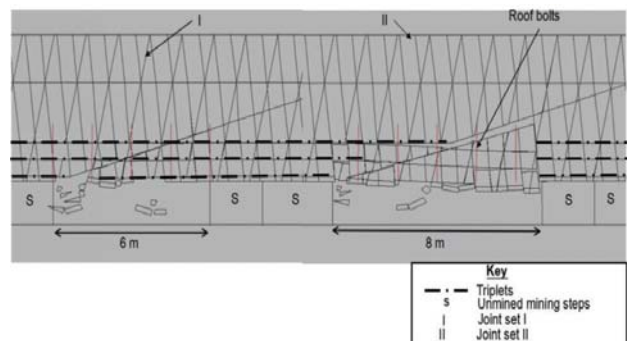
Figure 23—Results of the UDEC model with pre-tensioned 18 mm diameter, 2.4 m long, full-column resin roofbolts (triplet at 0.2 m); bolts pre-tensioned to 38 kN, vertical deformation exaggerated 10

Pre-tensioning of the bolts resulted in premature unstable ground conditions at 8 m. The reason for the earlier collapse is not clear. Note that much larger lumps fell out during the collapses, which is also observed underground in areas supported with roofbolts.

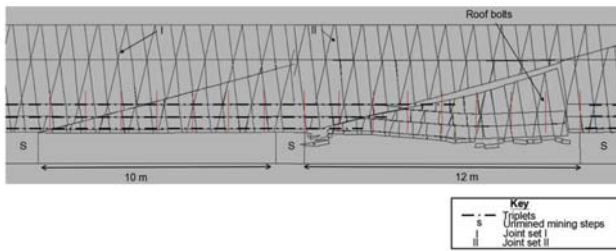
Figure 24—Results of the UDEC model with 18 mm diameter, 2.4 m long, full-column resin roofbolts at a spacing of 1.5 m × 0.8 m (triplet at 0.2 m); vertical deformation exaggerated 10x

An investigation was conducted to determine the effect of changing the support resistance on stability. The spacing of roofbolts used in Figure 21 was reduced to 1.5 m × 0.8 m. The support resistance was thus increased from 48 kN/m² to 92 kN/m², but the length and diameter of the bolts were kept the same. The results showed an improvement in span with support resistance, with the critical span increasing from 10 m to 12 m (Figure 24). A similar set of models (with the higher support resistance) was run with the triplets at 1.3 m

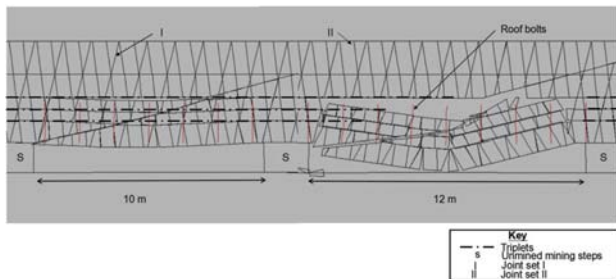
Figure 25—Results of the UDEC model with 18 mm diameter, 2.4 m long, full-column resin roofbolts at a spacing of 1.5 m × 0.8 m (triplet at 1.3 m); vertical deformation exaggerated 10x

(same as in Figure 21). In this instance the bolts did not penetrate through the upper triplet, but the critical span remained at 12 m (Figure 25). However, significantly more vertical displacement was calculated at a span of 10 m in this model than when the triplets were closer to the reef, due to

parting on the upper triplet. Parting took place on this upper triplet at the same span as a collapse in the unsupported scenario (10 m), but the support was able to prevent a collapse and increased the critical span by 2 m.

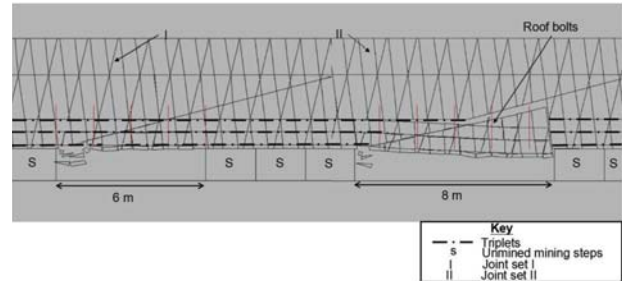
Figure 26—Results of the UDEC model with 22 mm diameter, 2.4 m long, full-column resin roofbolts (triplet at 0.2 m and $k = 0.5$) at 400 m depth below surface ; vertical deformation exaggerated 10x

A set of models was run to determine the effect of k-ratio on stability. The height and orientations of discontinuities were as shown in Table V, and all parameters as for the model depicted in Figure 22, except the k-ratio, which was reduced to 0.5. The results show that k-ratio does affect stability conditions, and the decrease in k-ratio resulted in a decrease in stable-span width (Figure 26) for the given support and geotechnical conditions. A collapse occurred at 8 m (2 m less than in Figure 22). A similar set of models was run at depths of 200 m and 1000 m, keeping the k-ratio at 0.5. The stable span was the same at 200 m, but there was an improvement at 1000 m (Figure 27).

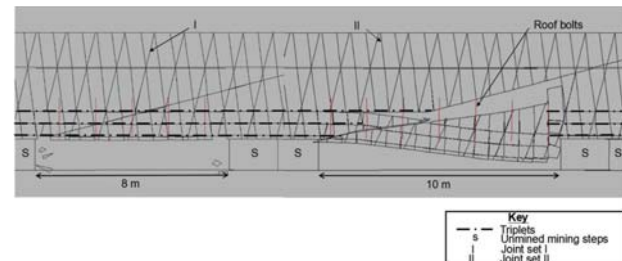
Figure 27—Results of the UDEC model with 22 mm diameter, 2.4 m long, full-column resin roofbolts (triplet at 0.2 m and $k = 0.5$), at 1000 m depth below surface; vertical deformation exaggerated 10x

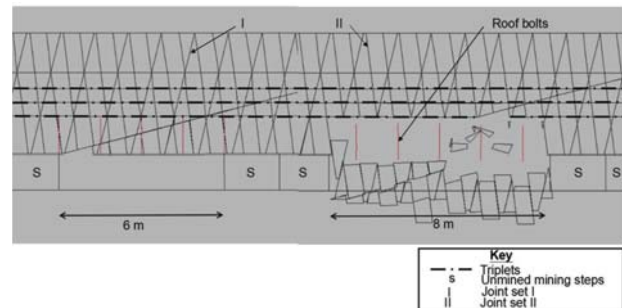
Figure 28—Results of the UDEC model with 18 mm diameter, 1.8 m long, full-column resin roofbolts, lowest triplet beyond the reach of the roofbolts; vertical deformation exaggerated 10x

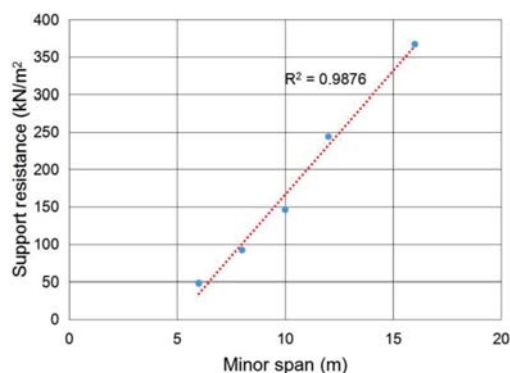
Figure 29—Relationship between span and support resistance for 1.8 m long roofbolts and triplets above 1.3 m

Under ideal conditions, the maximum achievable stable span with a bolt spacing of 1.5 m × 1.5 m (48 kN/m²) was shown to be about 8 m. Larger stable spans are often observed underground, even with the same tendon support as used in the models. It should be emphasized, though, that the shallow-dipping thrust fault is not always in the vulnerable position modelled. The models are showing a worst-case scenario. Should it be possible to determine where these structures exist with a high degree of confidence, it would be possible to mine safely at larger spans, accounting for these structures where they exist. At mine B the thrust structures were easily identifiable. Spans of 10 m were mined successfully in areas where the thrust structure did not intersect the stope hangingwall. This scenario agrees with the results shown by the model without a thrust structure (Figure 11). However, the areas affected by the thrust structure had to be properly supported on a separate support system using 4.5 m and 6.0 m long anchors on a close spacing. The actual length and support resistance were calculated at the height of the structure above the hangingwall. Since the introduction of this system, instances of large FOGs have reduced almost to zero, except for instances of human error.

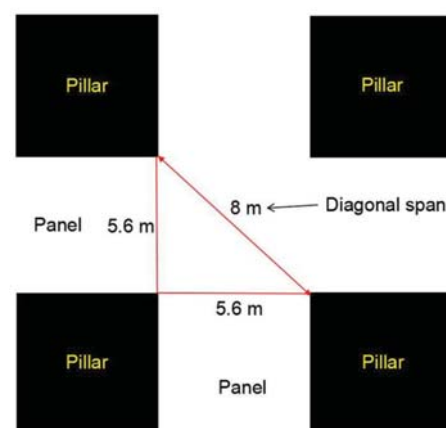
Figure 30—Excavation spans to accommodate a critical diagonal span across an intersection

It should be noted that the model assumed an infinitely long panel (into the page). However, in reality there are intersections, or holings, between orthogonal panels. These intersections represent areas of larger span and should also be treated differently, or the spans of the panels should be reduced to ensure that the diagonal across the intersection does not exceed the critical span. For an 8 m critical span, a safe panel span for two equal sized panels intersecting would be 5.6 m (Figure 30).
