Original research paper

Microscope observations of ART excavated cavities and restorations

ES Grossman, S Mickenautsch

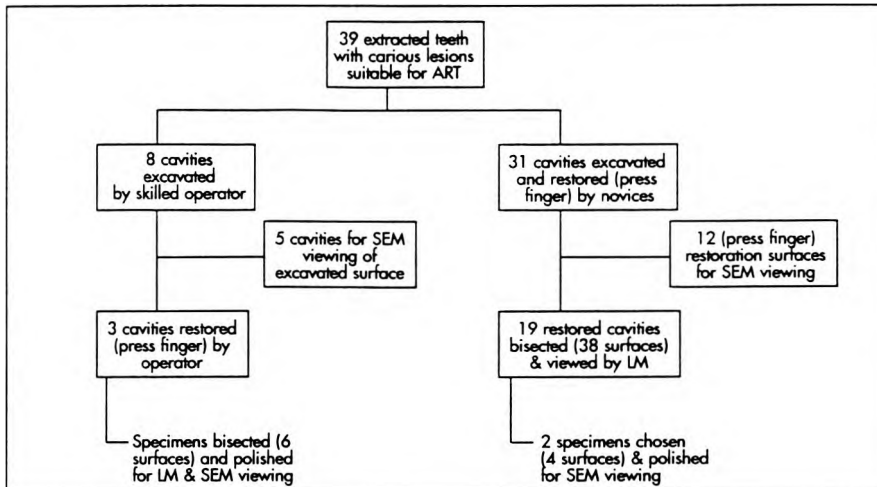
Fig. 1. Flow diagram of specimen numbers and treatments.

The carious lesions in the remaining eight teeth were hand excavated by a dentist skilled in ART. Five specimens were mounted and sputter coated to permit examination of the excavated cavity surface using SEM. The other three cavities were restored by the 'skilled' dentist according to ART using 'press finger'. These three restored specimens were embedded, sectioned through the restoration, re-embedded and the sectioned surface polished for SEM viewing as described for the 'novice' specimens above, to enable examination of internal restoration features. These sectioned specimens were studied, in addition to the two cavities restored by the 'novice' practitioners, to establish if there were differences between restorations prepared by 'novice' and 'skilled' operators. A flow chart of specimen breakdown and preparation is given in Figure 1.

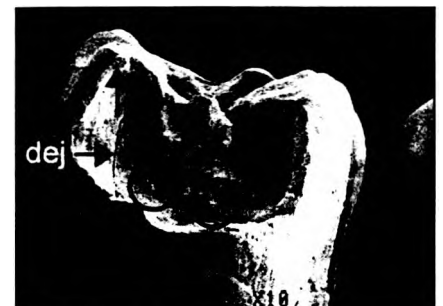
Fig. 2. This cavity surface shows pocketing, grooving, crevicing, ridging and furrowing on both enamel and dentine surfaces. Unsupported enamel is evident (\leftarrow). Note the chunks of surface debris (circled) and dehydration crack indicating the dentino-enamel junction (dej).

lesion. From the specimens examined it was not possible to define a typical cavity configuration; however all cavities examined in this study encompassed both enamel and dentine (Fig. 2). Crests of unsupported enamel were evident (Fig. 2). The cavity margins did not form a right angle to the tooth surfaces but were generally chipped and indented and followed an irregular course (Fig. 3). Fractured enamel surfaces were evident but generally enamel surfaces were smeared and debris covered, obscuring the enamel prism structure. Cavity shape varied tremendously between specimens and it was not possible to determine the point at which the cavity wall became the cavity floor. At low magnification the excavated cavity surface had a complex surface arrangement: pocketing was evident, as well as grooving, crevicing, ridging and furrowing on both enamel and dentine (Fig. 2). All dentine surfaces were covered or smeared with debris but in some areas the underlying dentine structure was visible showing occluded dentinal

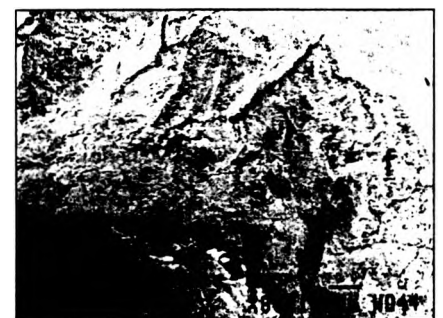
Fig. 3. Chipped and indented cavity margin with fractured (f) and smeared (s) enamel surfaces.

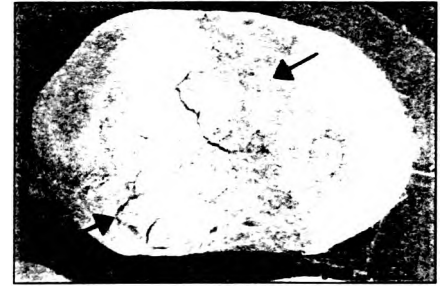
Fig. 11. Low power view of the ART restored occlusal tooth surface showing the rough 'press finger' surface. Note that the GIC margin is difficult to follow with ditching (top arrow) and raised ledges (bottom arrow). The cracks in the GIC are dehydration artefacts.

All ART restoration surfaces were rough. Gross roughness took the form of grooves and pits presumably caused by carving. Banked margins, peaks of GIC and rippled surfaces (Fig. 11) were also seen. At magnifications higher than X500 scratches, pits, porosities, chipping and voids were evident (Fig. 12). Restoration margins were not always readily apparent as the 'press finger' technique was able to merge the GIC to a fine edge on the occlusal surface. In other specimens the GIC formed a ridge at the restoration periphery.

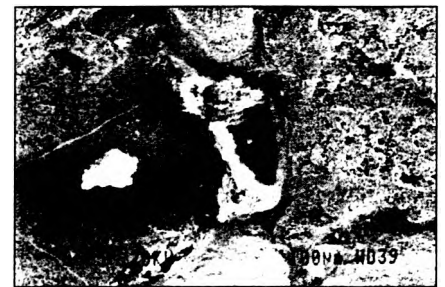
Fig. 12. High magnification micrograph showing the irregular nature of the GIC surface and a large crevice in the centre of the field 300 µm long and 200 µm wide.
