**Failure of Pump Systems Operating in Highly Corrosive  
Mine Water at Otjihase Mine**

Doctor of Philosophy

Silas Ithete Hango

A thesis submitted to the Faculty of Engineering and the Built  
Environment, University of the Witwatersrand, Johannesburg,  
in fulfilment of the requirements for the degree of  
Doctor of Philosophy

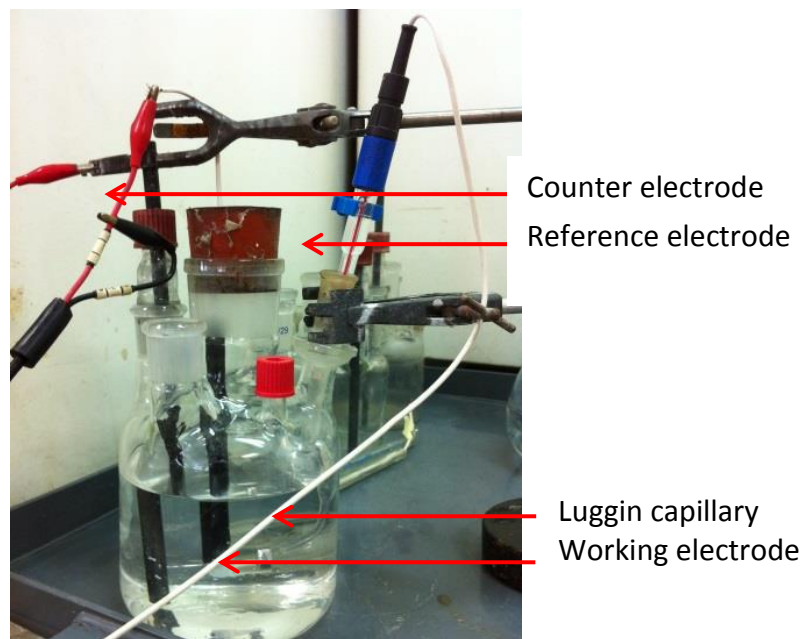
**Figure 3.1.** Electrochemical corrosion cell, showing the electrode and the Luggin capillary.

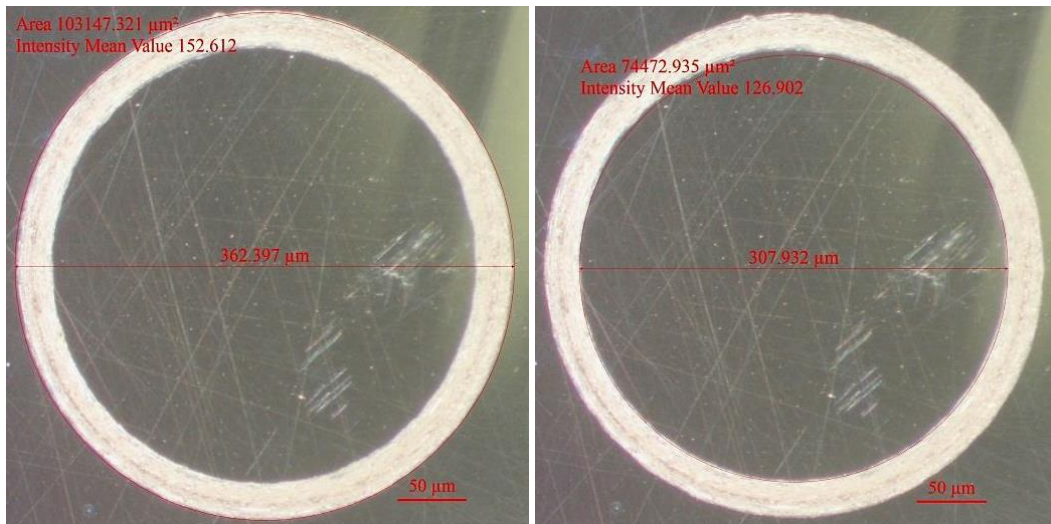
**Figure 3.3.** Examples of measurements of the diameters of the wear tracks on the samples.

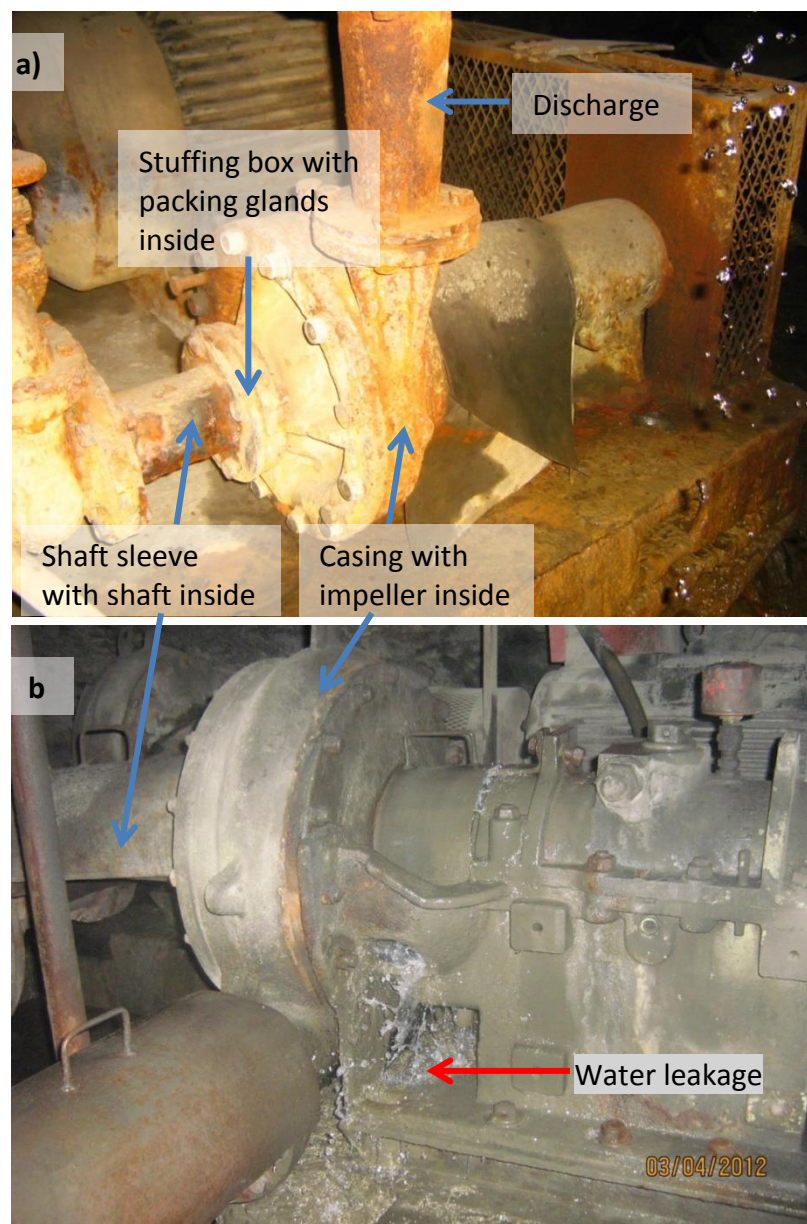
**Figure 4.1.** Pump components at Otjihase Underground Mine, showing: a) corroded pump and little leakage of mine water, and b) leakage from the stuffing box.

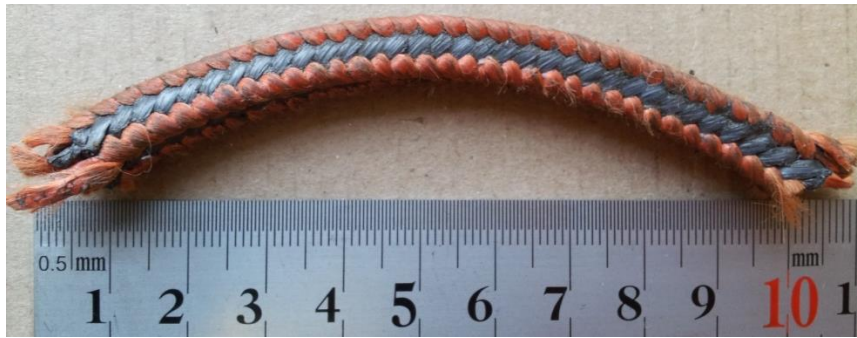
**Figure 4.2.** Graphite filament packing gland which wears the shaft sleeves.

Pump systems operating in highly corrosive mine water at Otjihase Mine experience a high rate of replacement and high maintenance due to corrosion and wear of the pump components. When the pump operates (Figure 4.1), its shaft often experiences corrosion from slurry and wear from debris trapped in the packing gland (Figure 4.2), which further accelerates corrosion.<sup>146</sup> The pump components removed from the mine for investigation were the coated shaft sleeves, and cast iron valves. Their compositions were analysed by optical emission spectrometry (OES) to be mild steel substrates (AISI 1526 grade) with nickel-chromium-iron (Ni-Cr-Fe) coatings (INCONEL Alloy 600, UNS N06600 grade) for the shaft sleeves, and valves made from cast iron (UNS F32800, A536).

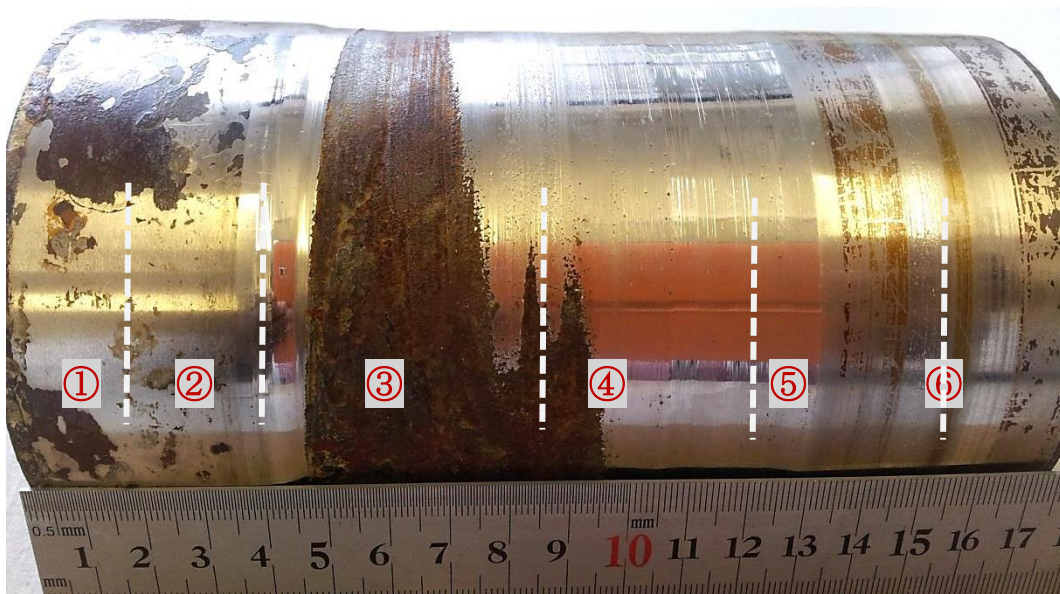
**Figure 4.3.** Photograph of whole corroded shaft sleeve and the selected parts from Sections 3 and 4 from a pump at Otjihase Mine, Namibia.

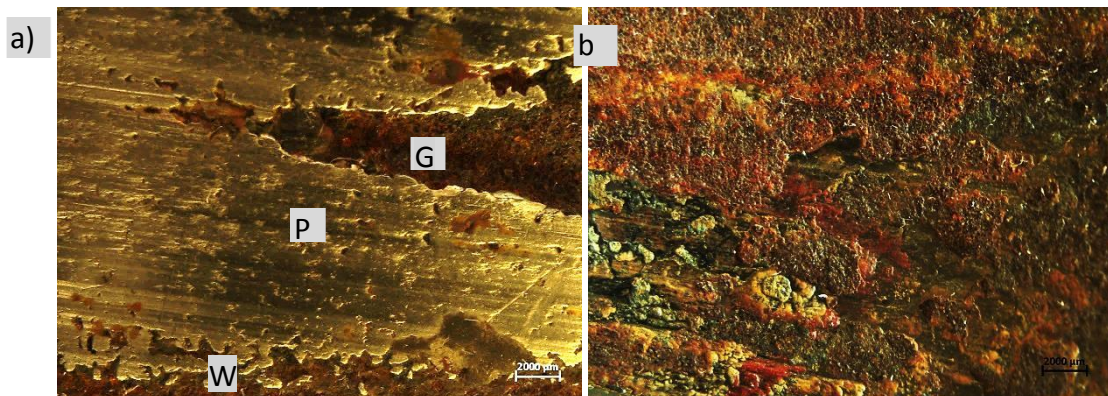
**Figure 4.4.** Micrographs of shaft sleeve sections showing: a) coating partially removed by wear (W), pitting (P), general corrosion of the substrate (G), and b) attacked substrate after coating removal during service.

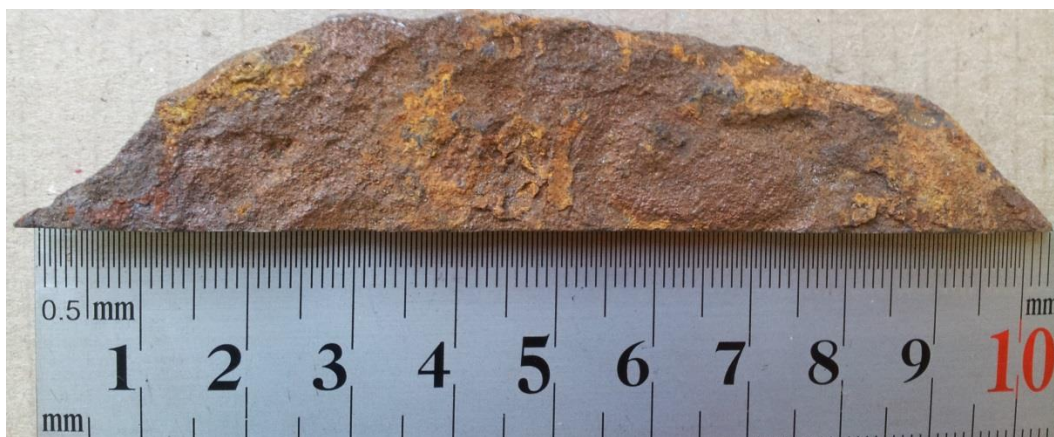
**Figure 4.6.** Photograph of a corroded cast iron valve from a pump at Otjihase Mine, Namibia.

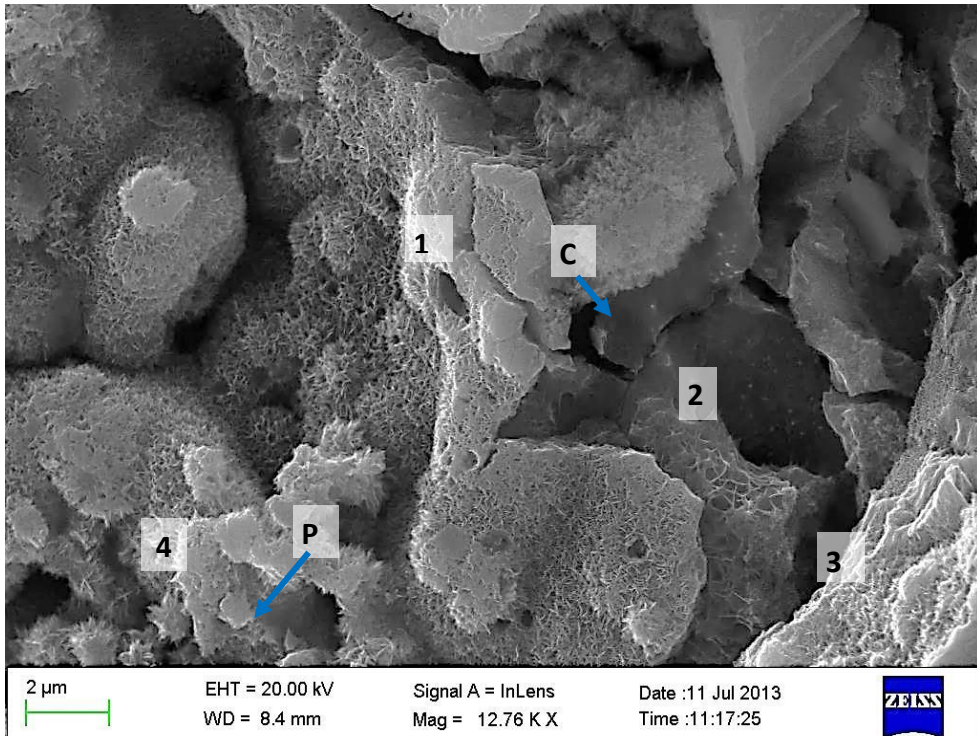
**Figure 4.7.** SEM In-Lens image of shaft sleeve, showing pits (P) and cracks (C) in substrate attacked region. (Numbers give EDX analysis positions)

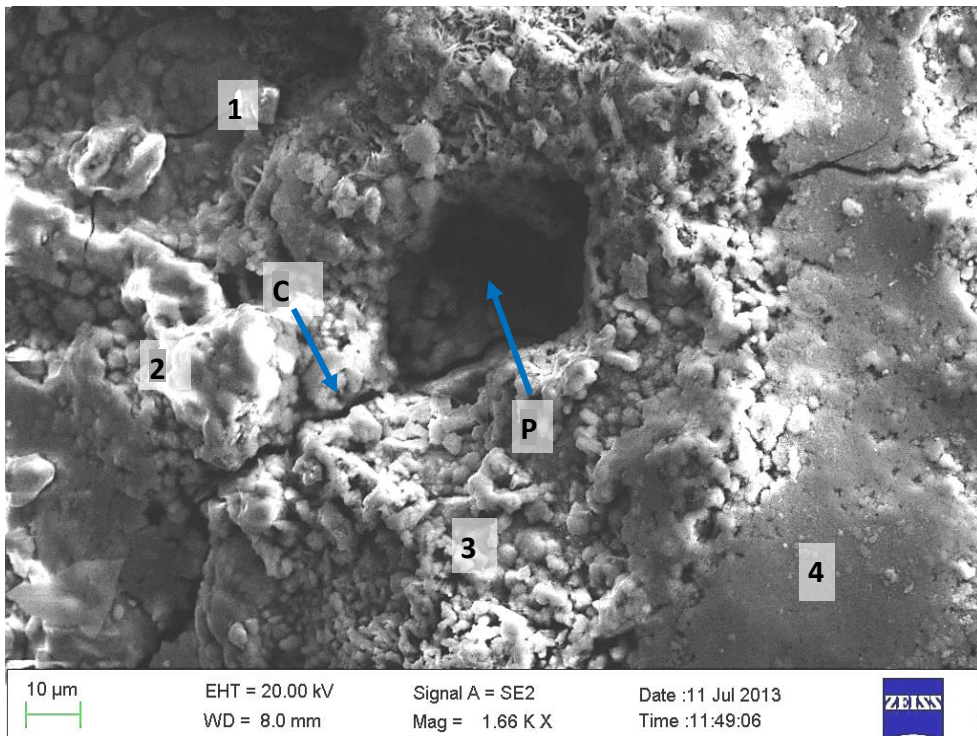
**Figure 4.8.** SEM-SE image of the cast iron valve, showing pits, cracks and globular corrosion products. (Numbers refer to EDX analysis positions.)

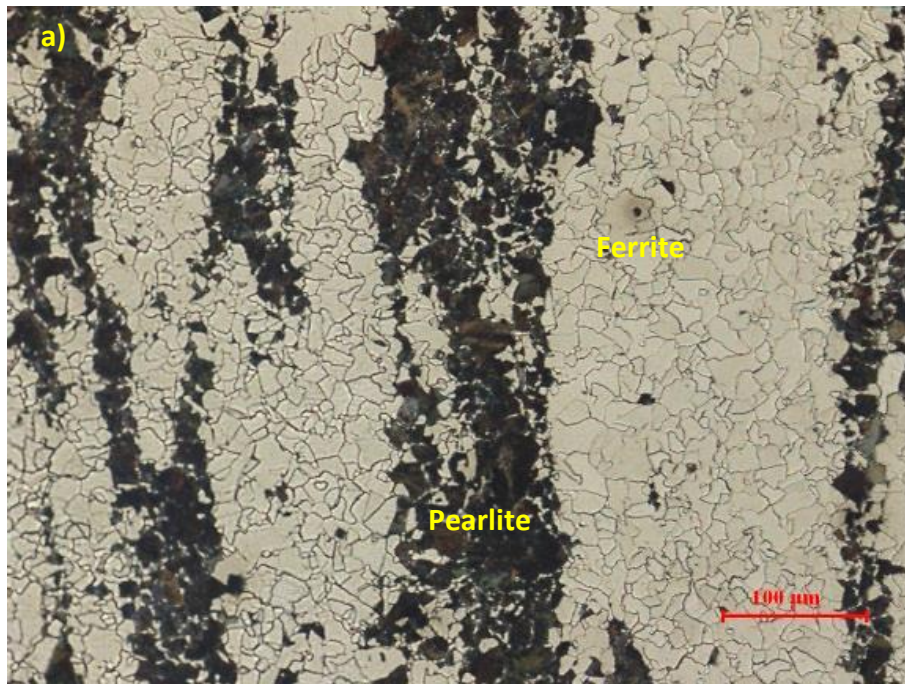
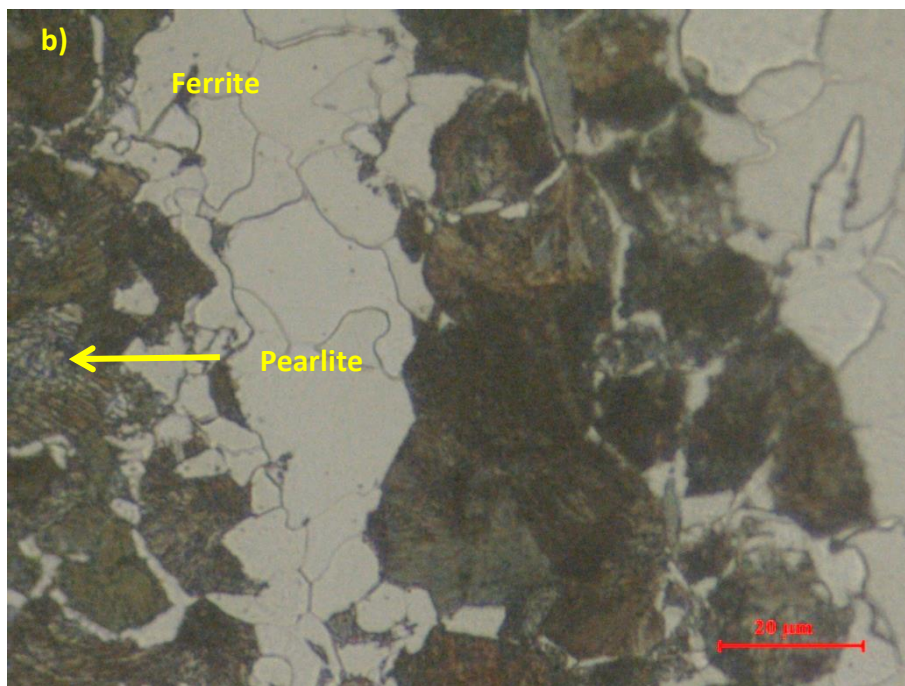
**Figure 4.10.** Optical micrographs of a corroded shaft sleeve substrate from an unattacked region, showing: a) ferrite (light) and pearlite (dark), and b) pearlite resolved showing ferrite and cementite alternating layers (arrow).

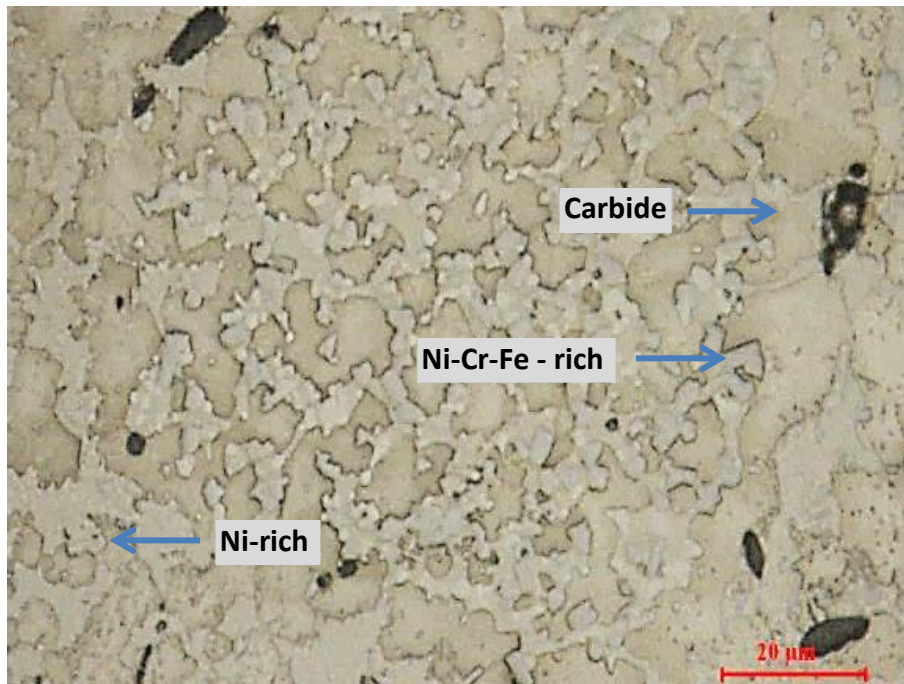
**Figure 4.11.** Optical micrograph of a corroded shaft sleeve coating from an unattacked region, showing Ni-Cr-Fe matrix (light brown) and Ni-rich regions (light), with carbides of Cr and Mo (dark).

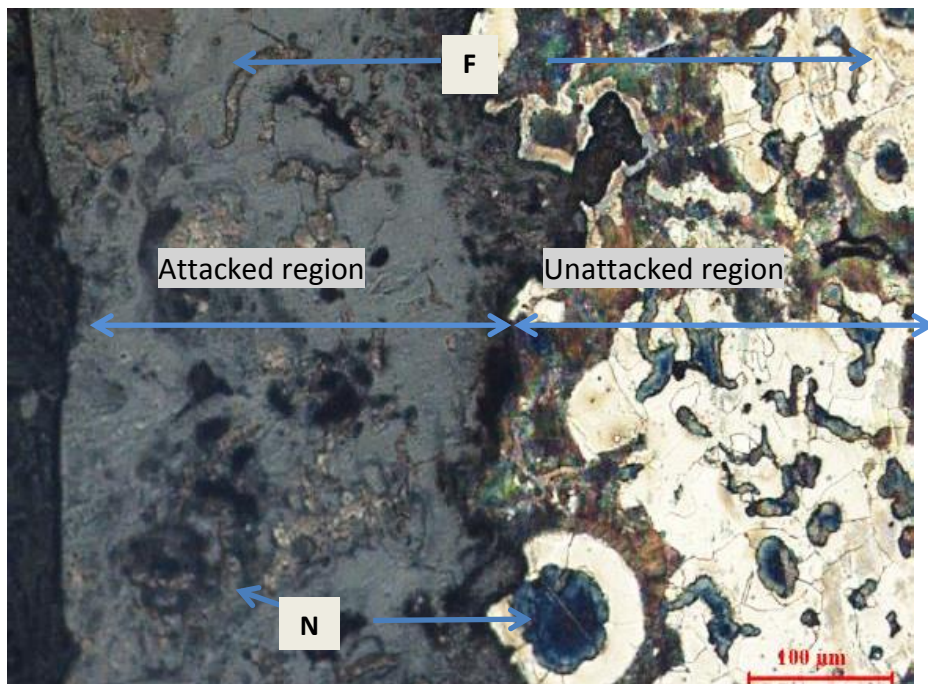
**Figure 4.12.** Optical micrograph of a corroded cast iron valve cross-section, showing the depth of corrosion ( $\sim 250 \mu\text{m}$ ) on the top exposed surface and the unattacked region underneath. Graphite nodules (N) and flakes (F) appear light in the attacked region, and dark in the unattacked region.

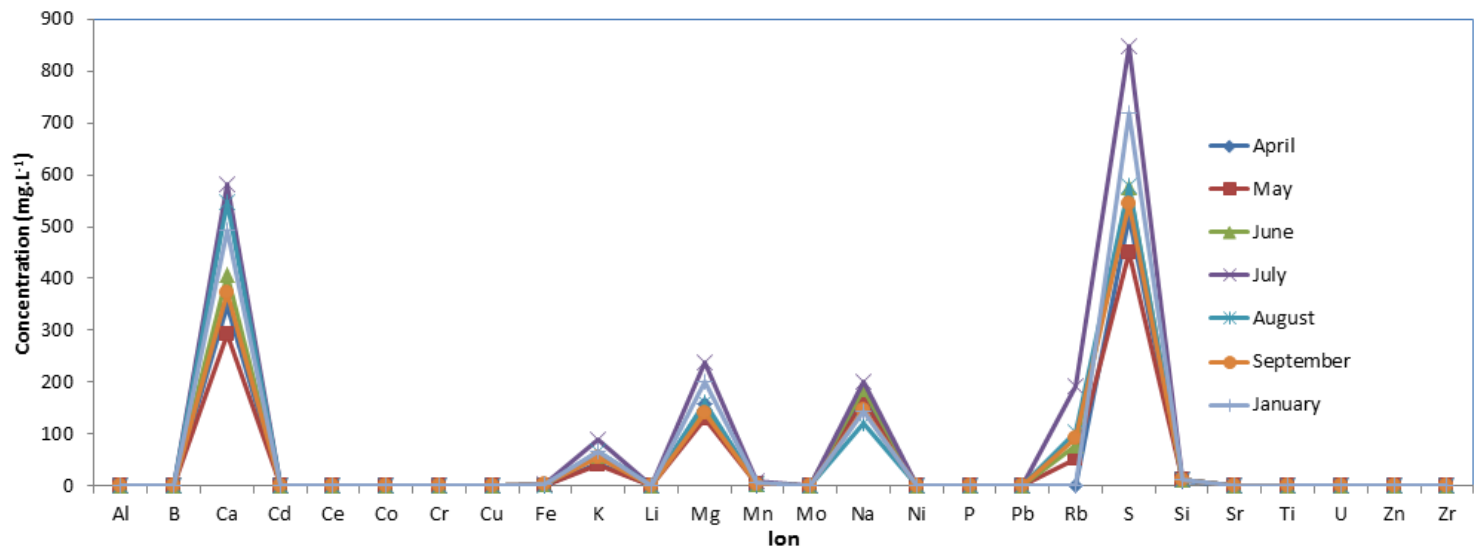
**Figure 4.13.** Chemical analysis of mine water from Kuruma pump, Otjihase Mine, Namibia, for April-October 2012 and January 2013.

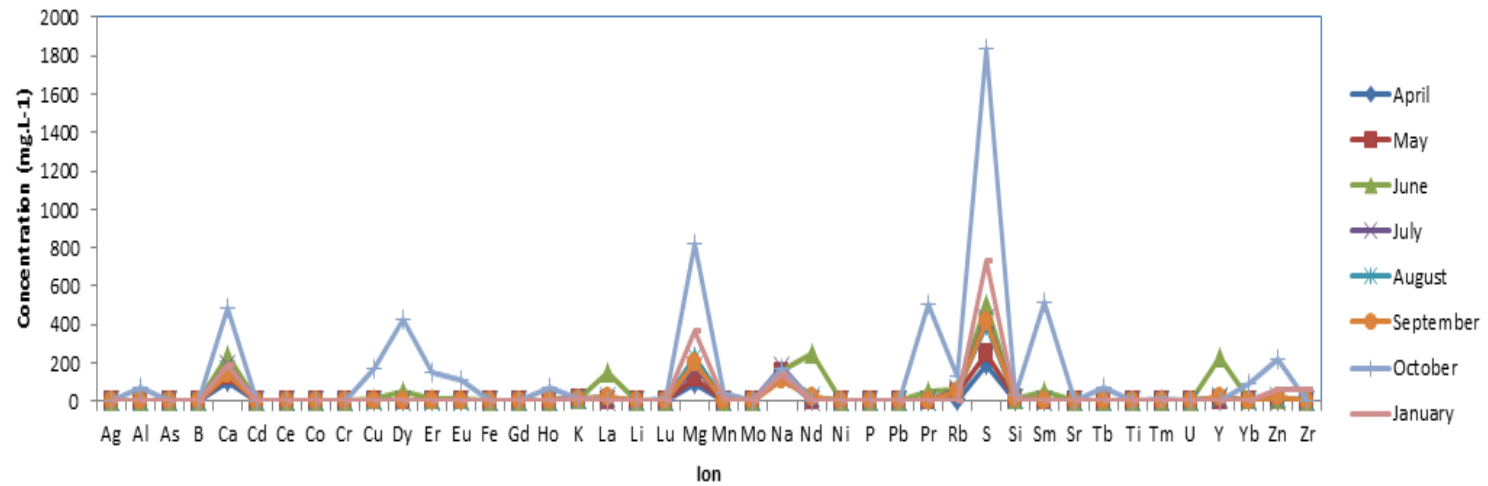
**Figure 4.15.** Chemical analysis of mine water from Conveyor No. 6 pump, Otjihase Mine, Nambia, for April-October 2012 and January 2013.

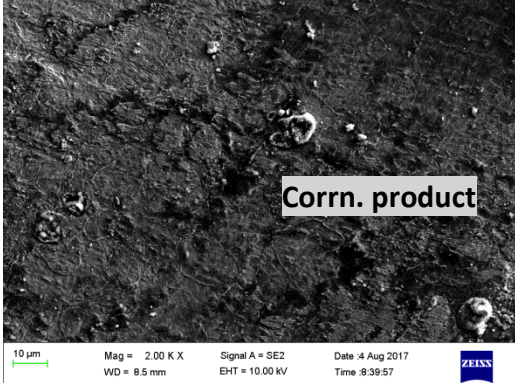
<p>10 μm    Mag = 2.00 K X    Signal A = SE2    Date :3 Aug 2017 WD = 8.5 mm    EHT = 10.00 kV    Time :15:34:24    ZEISS</p>	<p>General and pitting corrosion (arrows) with corrosion products on the surface.</p>
<p><b>Mild steel</b></p>

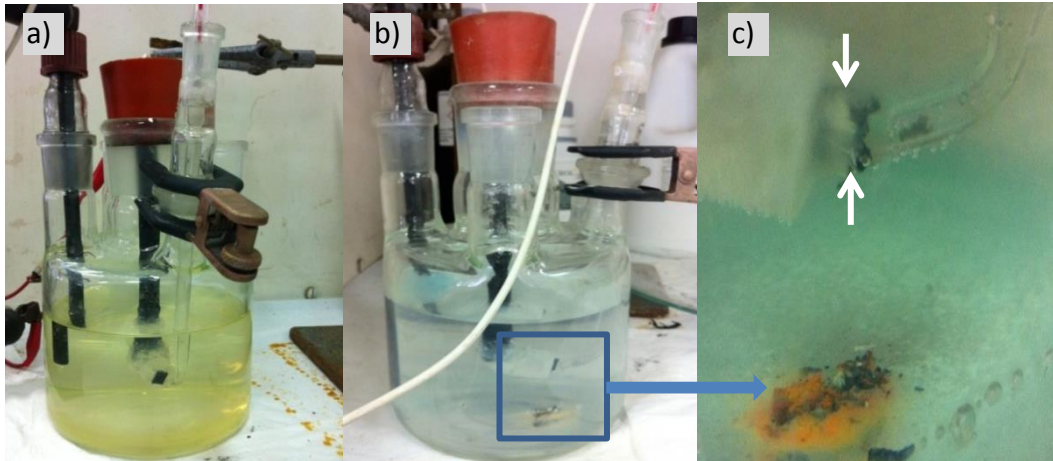
**Figure 5.6.** Cyclic potentiodynamic polarisation. Photographs of: a) ULTIMET and Stellite 6B (solution turned yellow), b) ToughMet 3 (solution turned blue), and c) ToughMet 3 sample: thick surface layer (arrows) and rust in the corrosion test cell.

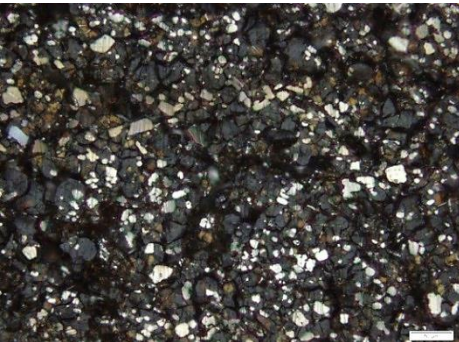
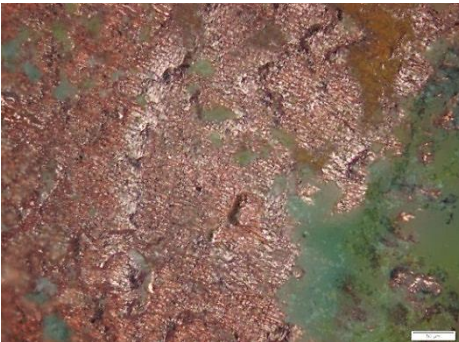
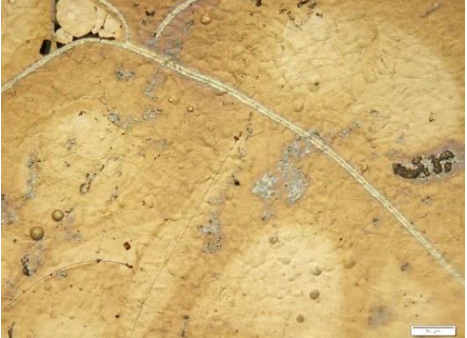
<p>ULTIMET: general and intergranular corrosion.</p> <p>Stellite 6B: intergranular corrosion, surface oxides and carbides in pits.</p> <p>ToughMet 3: pitting, general and selective corrosion, with a partial layer on the surface.</p>
3

<p>ULTIMET: more general + intergranular corrosion.</p> <p>Stellite 6B: attacked much more than at pH 6 and 3.</p> <p>ToughMet 3: attacked similar to that at pH 6.</p>

**Figure 5.8.** Optical micrographs of ULTIMET, Stellite 6B and ToughMet 3 samples after cyclic potentiodynamic polarisation in synthetic mine water at pH 6, 3 and 1.

The optical micrographs of the surface morphologies of the samples after corrosion tests are given in Figure 5.8. ULTIMET showed general and intergranular corrosion. Stellite 6B showed intergranular corrosion, oxides on the surface and carbides, and ToughMet 3 had pitting, general and selective corrosion, with a thick layer on the surface. This is a two-fold reaction layer formed when copper is in a chloride containing electrolyte. It consists of copper (I) chloride (CuCl) and copper (I) oxide (Cu<sub>2</sub>O) underneath.

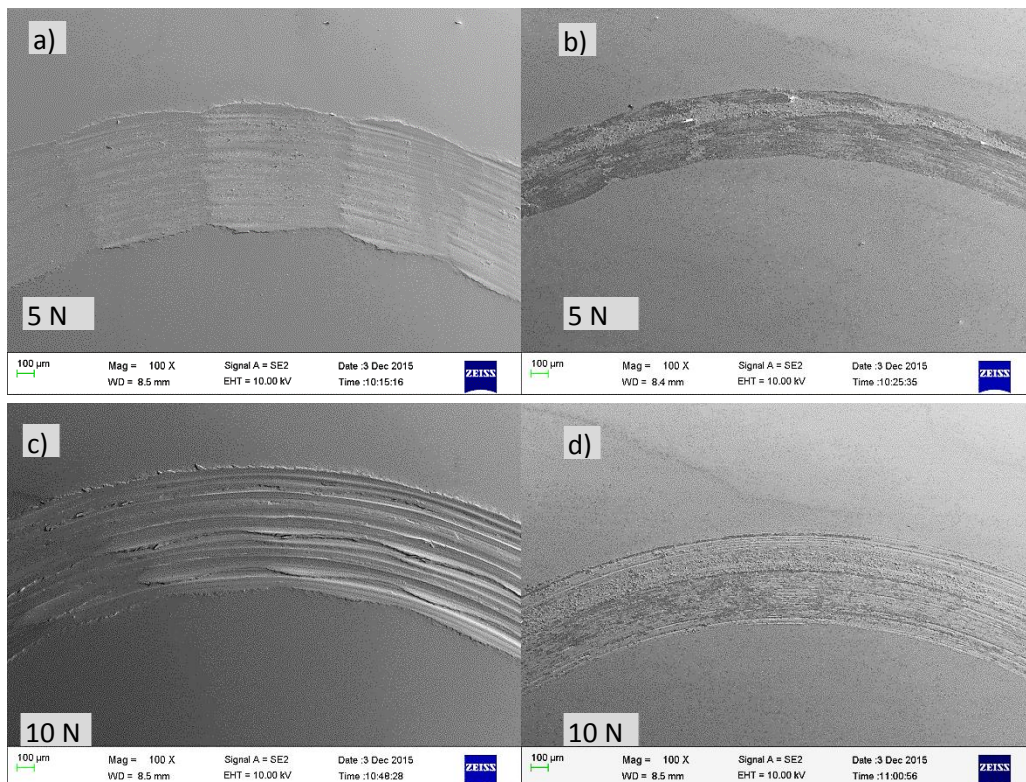
**Figure 5.20.** SEM-SE micrographs of: a) and c) ULTIMET, and b) and d) Stellite 6B after ball-on-disc sliding wear at 5 N and 10 N, showing wider wear tracks of ULTIMET than Stellite 6B at both loads.

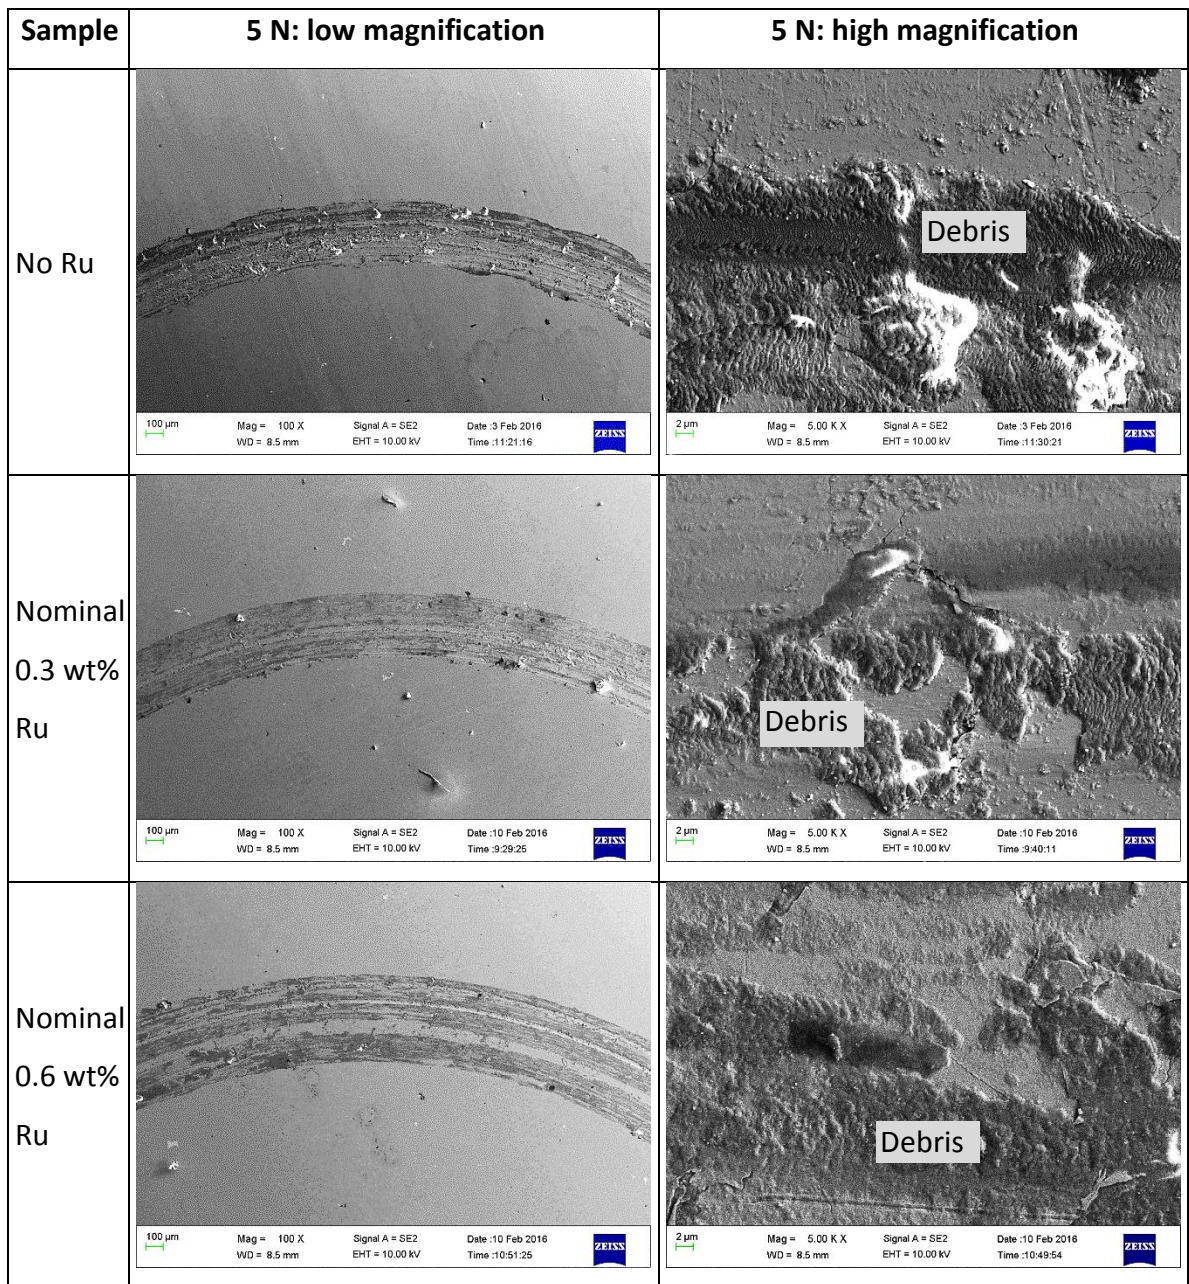
**Figure 6.54.** SEM-SE micrographs of Stellite 6 coatings with no Ru, nominal 0.3 wt% Ru and nominal 0.6 wt% Ru after ball-on-disc sliding wear at 5N, showing wide wear tracks and damage with debris on the surface.

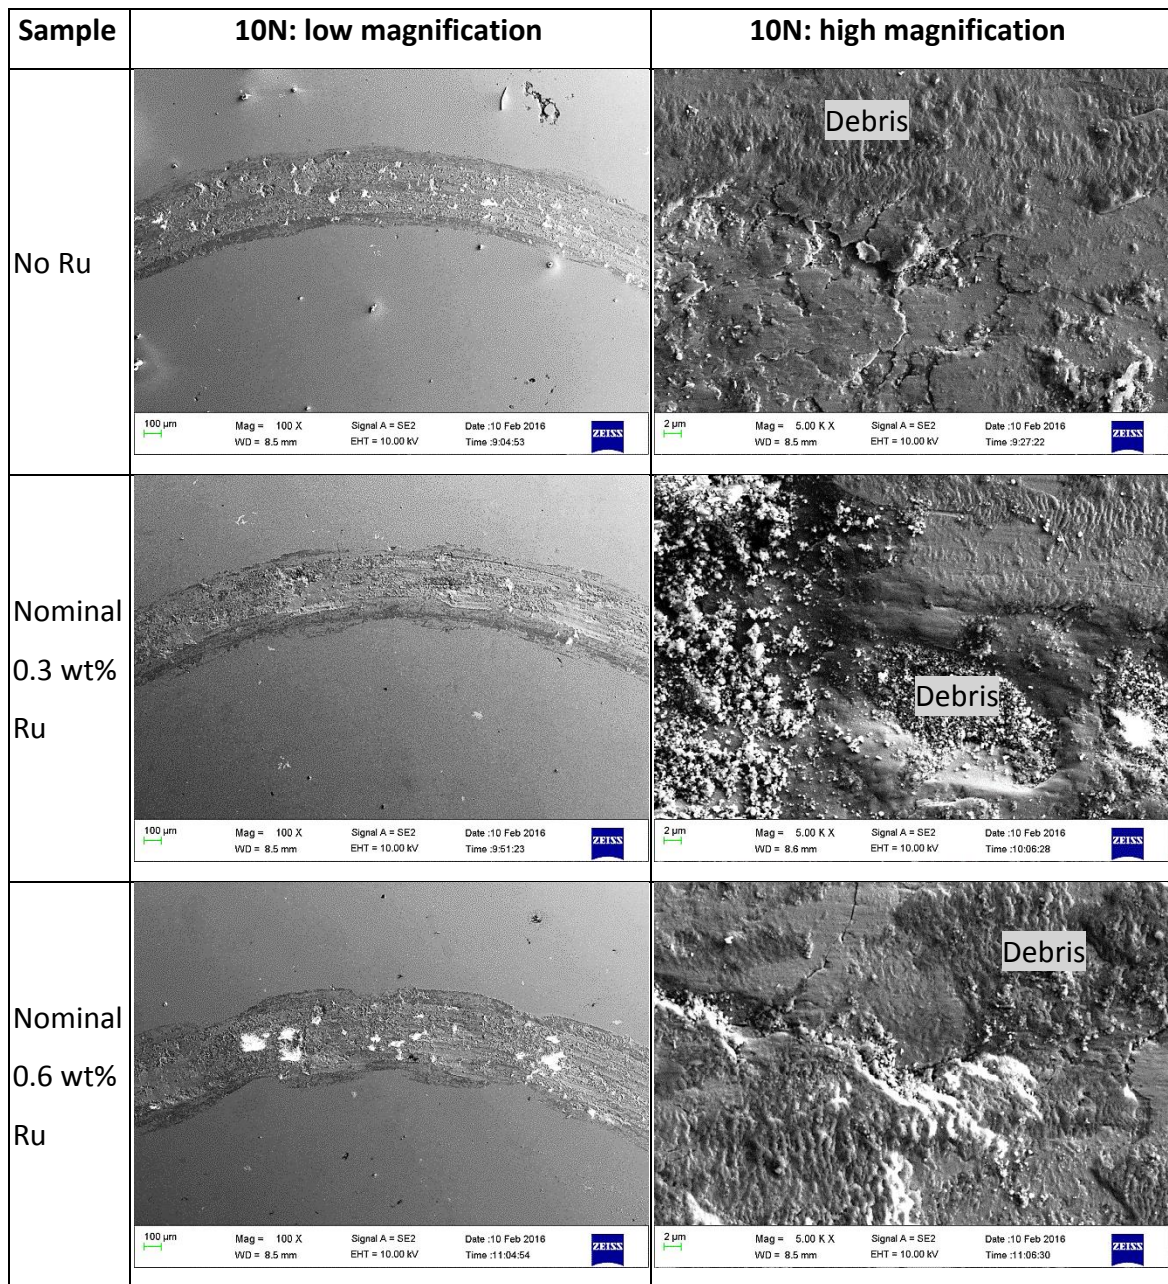
**Figure 6.55.** SEM-SE micrographs of Stellite 6 coatings with no Ru, nominal 0.3 wt% Ru and nominal 0.6 wt% Ru after ball-on-disc sliding wear at 10N, showing wide wear tracks and damage with debris on the surface.

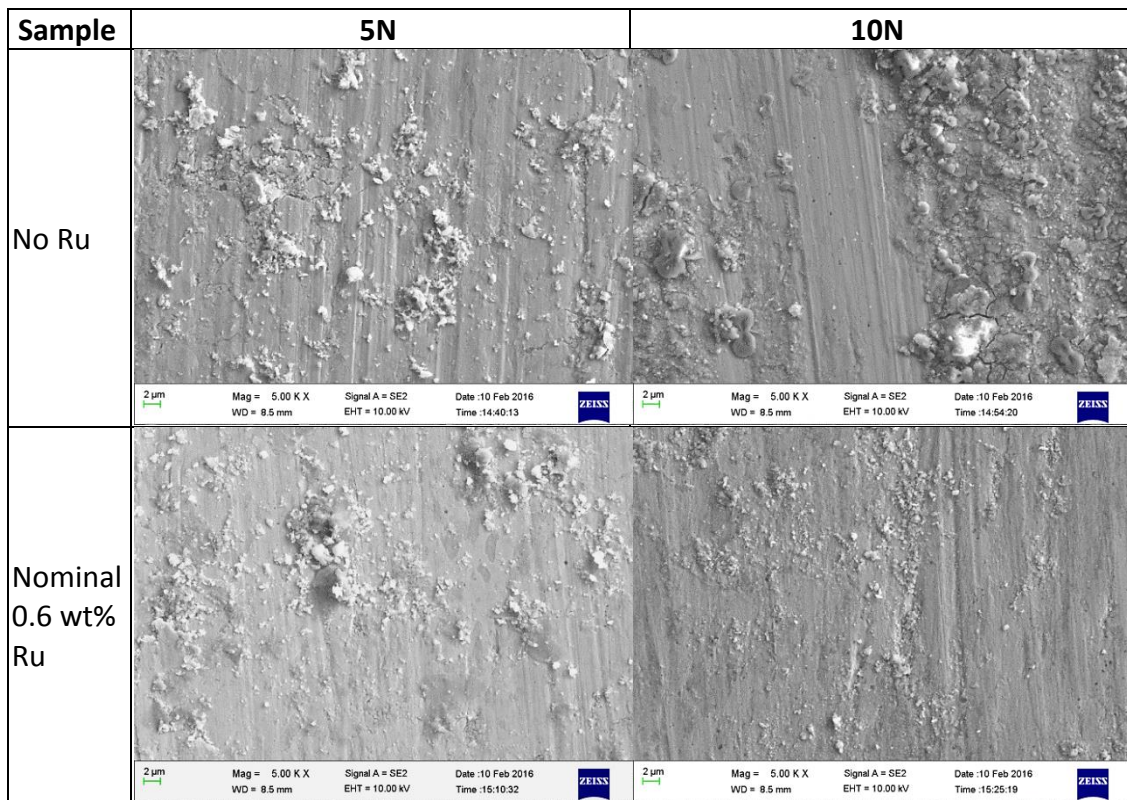
**Figure 6.65.** SEM-SE micrographs of ULTIMET coatings with no Ru and nominal 0.6 wt% Ru after reciprocating ball-on-disc at 5N and 10N, showing damage on wear tracks and debris in furrows.

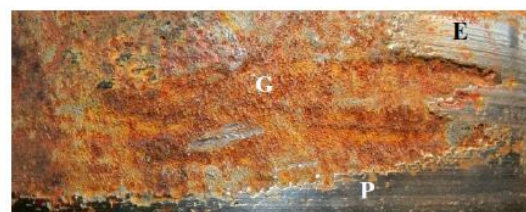
Figure 1. Macrograph of a corroded shaft sleeve sample from Otjihase Mine, showing general (G), pitting (P) and erosion (E) corrosion.

The pump shaft sleeves had been coated (Fig. 1), and the coating had scratches (E) caused by the suspended particles, as well as small pits (P). In places, the coating had been completely removed, and the substrate had experienced general corrosion (G). The mine water was cloudy when collected, and became clearer on standing once fine sediment settled out. Analysis identified large amounts of alkali earth metals and rare earth elements, as well as high levels of total dissolved solids (TDS) of sulphates, nitrates and chlorides, and gases such as oxygen and chlorine. The emission of SO<sub>2</sub> and Cl<sub>2</sub> from vehicles' fuel combustion in the close confines of the mine equipment oxidized in water to H<sub>2</sub>SO<sub>4</sub> and HCl and contributed to the observed corrosion<sup>3</sup>.

The SEM-EDX results showed that the shaft sleeve substrates were medium-carbon steel, which was confirmed by XRD, and the coating was a nickel-chromium alloy of composition: 58.4 Ni, 36.8 Cr, 2.7 Fe and 2.1 Si (wt%). Although designed to protect the medium-carbon steels, the coating was worn by erosion from the solid particles suspended in the mine water (average particle size was ~12.3 μm), and also pitted from the acidic water (Fig. 1). Once the protective

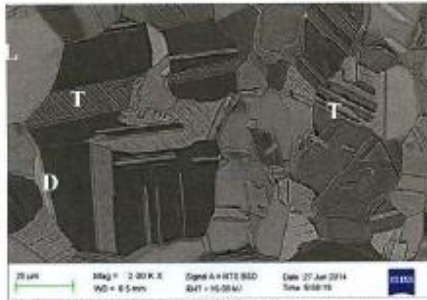
Figure 1. SEM-BSE micrograph of ULTIMET before wear tests, showing equiaxed and twinned  $\gamma$  grains.

The SEM-BSE micrographs of the ULTIMET and Stellite 6B before wear tests are shown in Figures 1 and 2. ULTIMET and Stellite 6B had well defined grain boundaries with equiaxed, mechanically twinned  $\gamma$  grains, which were easier to see in ULTIMET. Table 2 shows EDX analyses of the ULTIMET, and there were similar compositions of the light (L), dark (D) and twinned grains (T) of Figure 1, with Co and Cr as major components in the alloy. These were also found on the grain boundaries, but the analyses of the fine grain boundary precipitates were compromised by the surrounding matrix. They may be  $\gamma$  or Cr<sub>7</sub>C<sub>3</sub><sup>5</sup>.

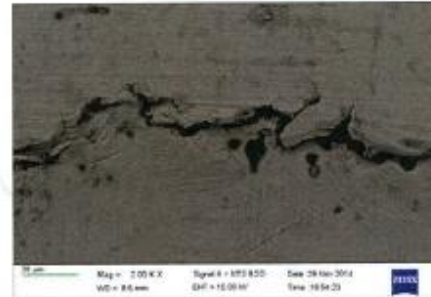
Figure 5. SEM-BSE micrograph of ULTIMET, showing slip bands and slip steps on the surface near the wear track.

The surface of the ULTIMET (Figure 5) was worn more than the Stellite 6B (Figure 6) sample, meaning Stellite 6B alloy was more resistant to abrasive wear. The worn surfaces showed furrow marks, indicating that the material was removed from the surface during wear. ULTIMET experienced slip bands and slip steps on the surface near the wear track (Figure 5). Stellite 6B had debris collected in the grooves. The matrix phase was ploughed out, leaving carbides on the surface (Figure 6).
