SCUOLA DI DOTTORATO IN INGEGNERIA CIVILE E ARCHITETTURA
DOTTORATO IN INGEGNERIA STRUTTURALE E GEOTECNICA

**Seismic vulnerability assessment
of New Zealand unreinforced
masonry churches**

XXVIII Ciclo – A.A. 2015/2016

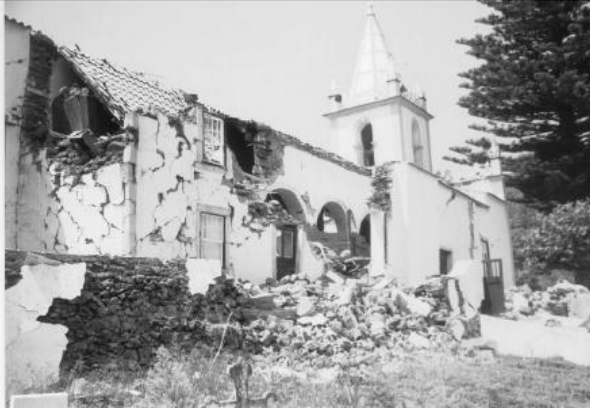
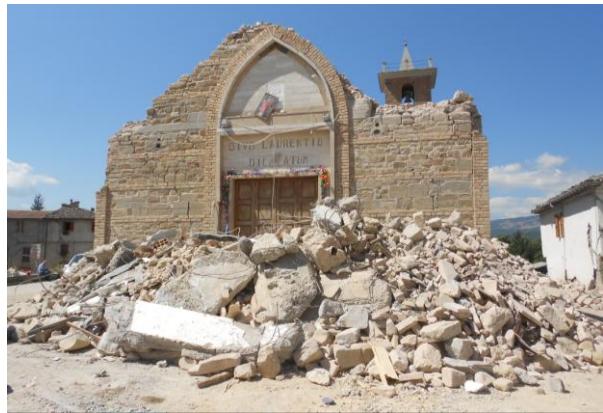
Ribeirinha church, Faial Island, Azores (1998)
(photo from Guerreiro et al. 2000)

Basílica del Salvador, Santiago, Chile (2010)
(photo from Sorrentino et al. 2011)

San Lorenzo a Flaviano, Amatrice, Italy (2016)

Figure 1.1. Examples of damage caused to churches by recent earthquakes.

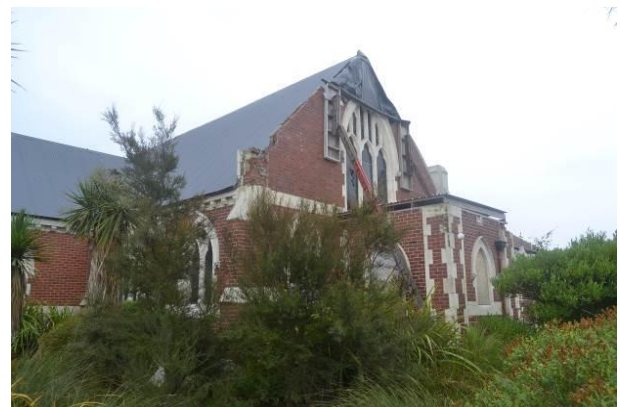
(b) St Joseph's Church (1921), Christchurch

Figure 2.1. Examples of damage caused by the 2010-2011 Canterbury earthquakes.

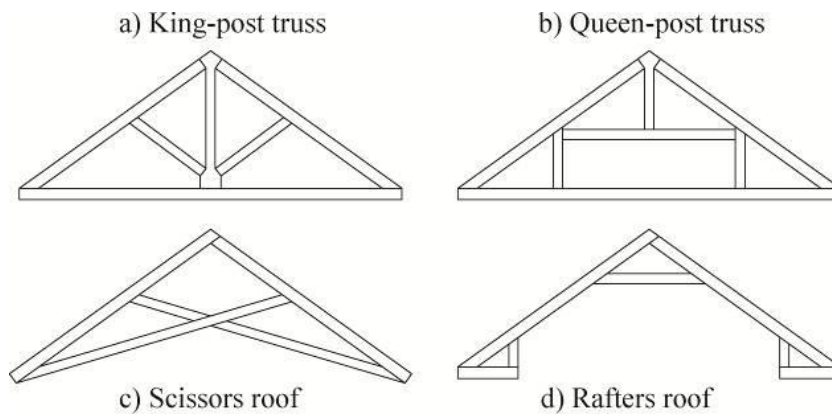
Figure 2.27. Statical schemes of New Zealand sloping roofs.

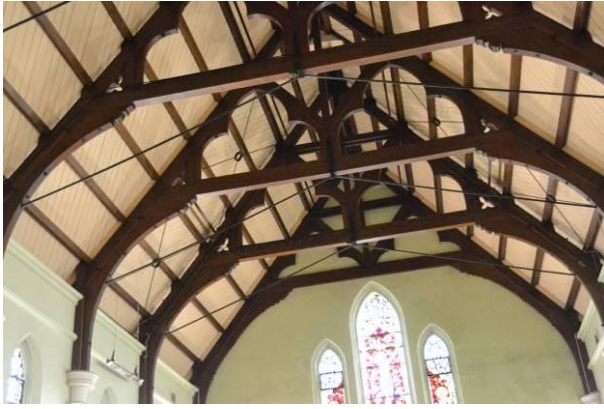
St Gerard's Church (1908), Wellington - King-post truss

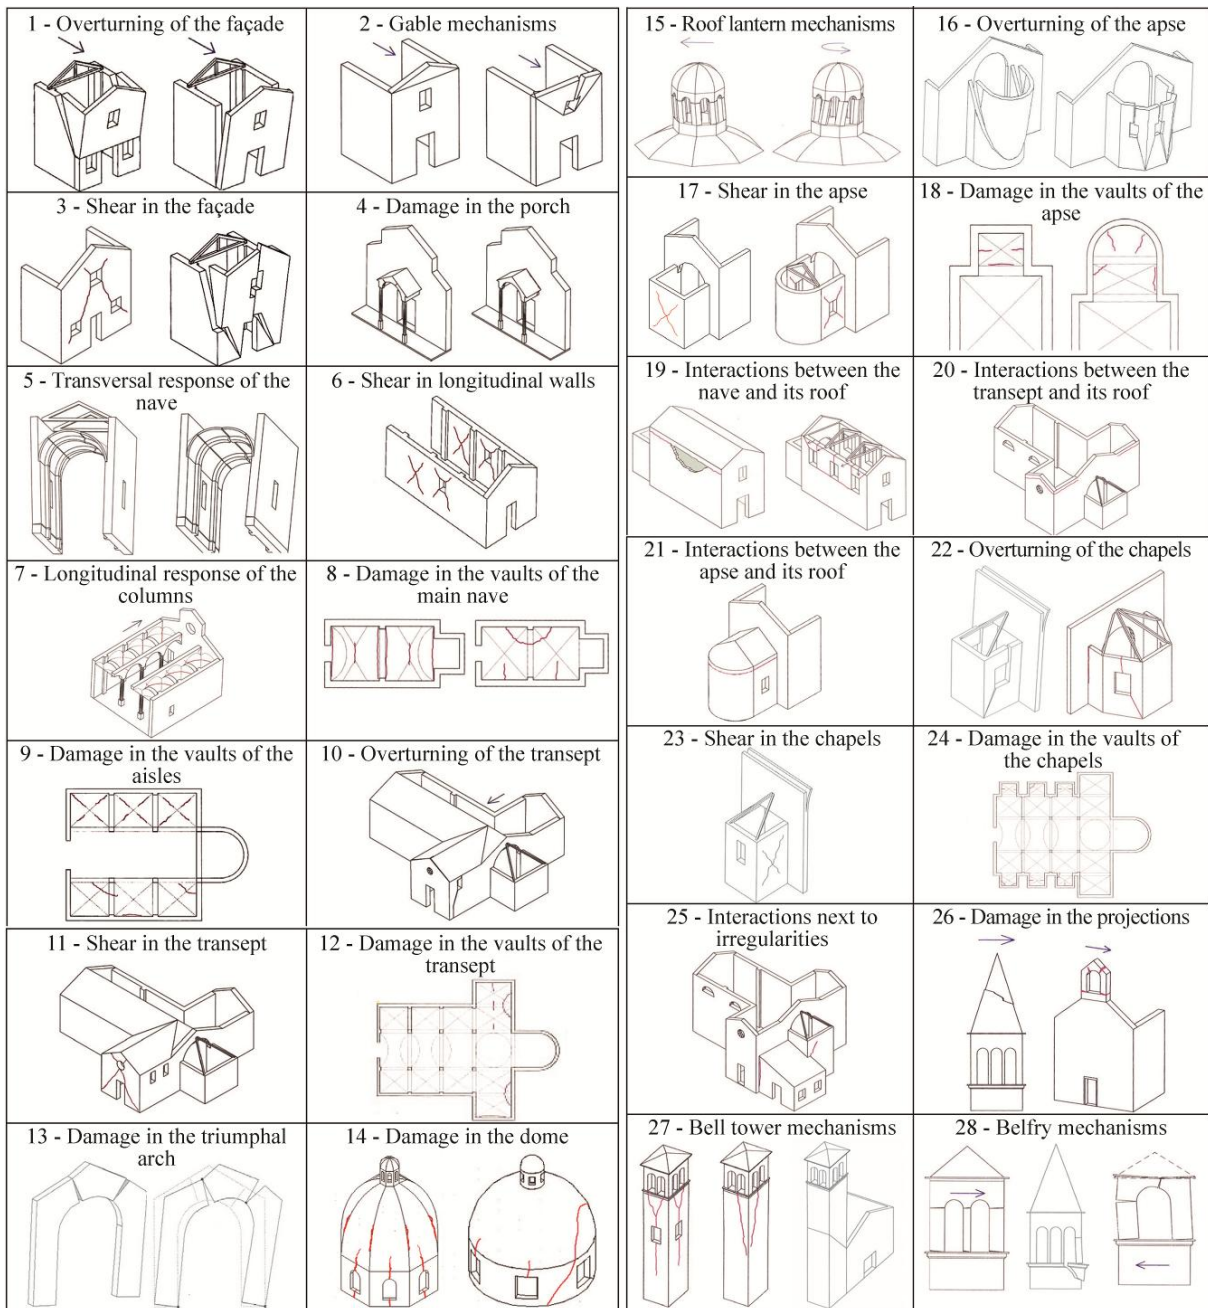
Figure 3.3. Collapse mechanisms in the Italian survey form for churches (PCM-DPC MiBAC 2006).

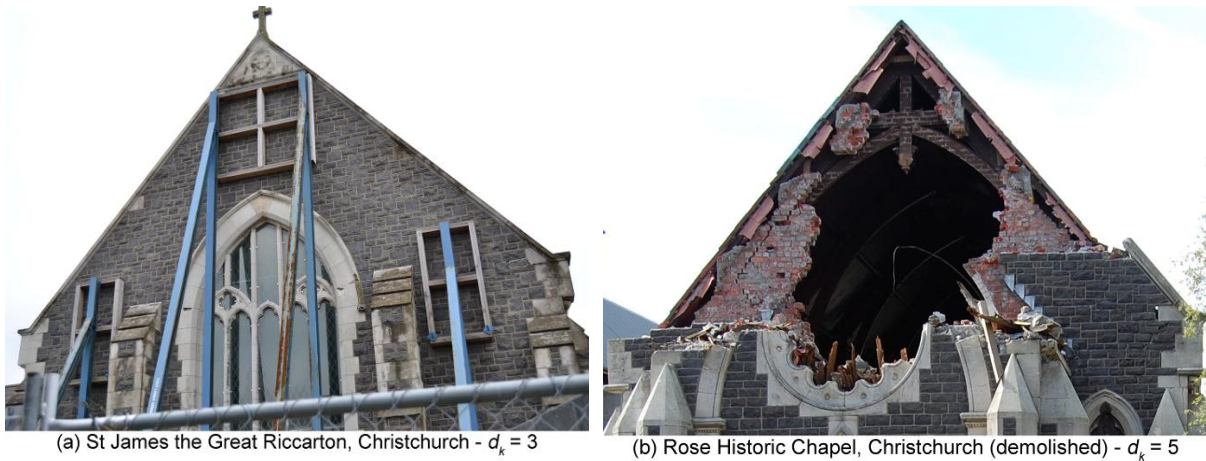
Figure 3.4. Examples of damage ascription for mechanism no. 2 (gable mechanisms). Photo (b) is courtesy of João Leite.

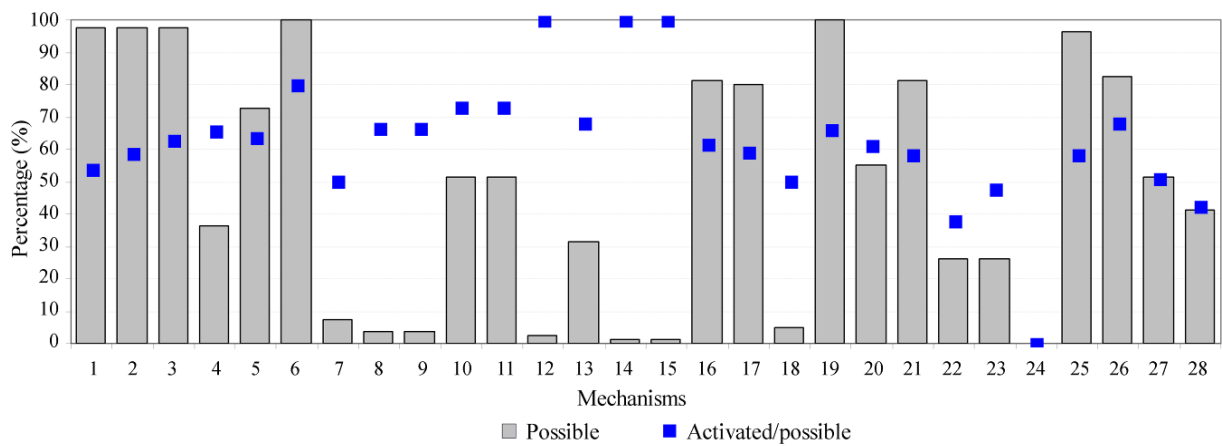
Figure 3.5. Percentage of possible (over the sample of 80 churches) and activated (over the sample of possible) mechanisms depicted in Figure 3.3.

The percentages of mechanisms whose activation is possible are presented in Figure 3.5, alongside a ratio of activated-over-possible mechanisms. The first parameter highlights the simplicity of the architecture of New Zealand URM churches (as already pointed out in §2). One macro-element, vaults in the chapels (related mechanism: #24) is not present at all, some other mechanisms (12, 14-15) showed systematic activation but their macro-elements, vaults, domes and roof lanterns, are present in just one or two buildings. Because of their rather poor sample size, these mechanisms, together with 7-9 and 18, are not further discussed in the following. Within the 20 remaining mechanisms, the most vulnerable one is the shear response of the longitudinal walls (#6, Figure 3.6a), activated in 80% of possible cases. Overturning (#10, Figure 3.6b) and shear (#11) in the transept present the same activation rate (73%). Sixty-eight % of projections (#26, Figure 3.6) and triumphal arches (#13) were damaged, whereas interactions between nave and its roof (#19, Figure 3.6d) and damages in the porch (#4) were observed in 67% of cases.

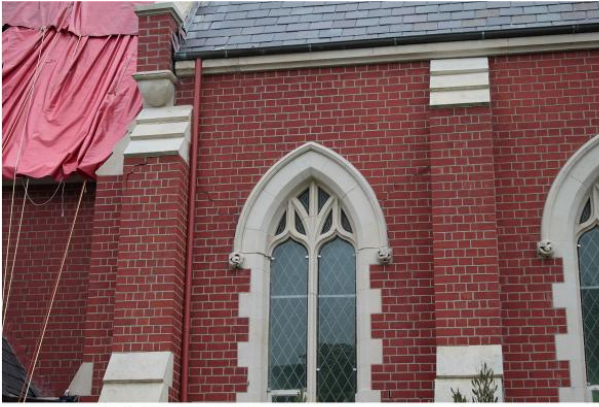
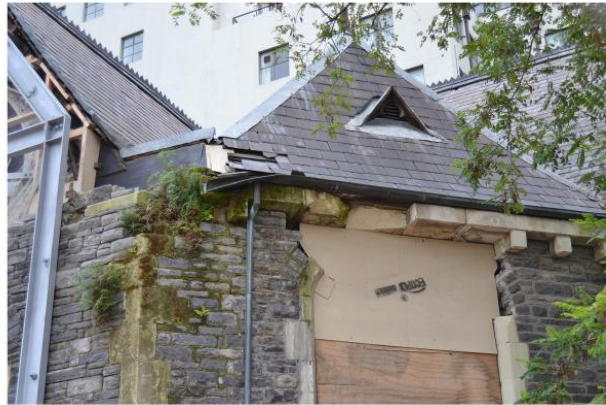
(a) Shear in the longitudinal walls -
Our Lady Star of the Sea, Sumner, Christchurch

(c) Damage in the projections -
Christchurch North Methodist, Papanui, Christchurch

(d) Interactions between nave and its roof -
Trinity Congregational, Central Christchurch

Figure 3.6. Examples of some of the most activated mechanisms. Photo (a) is courtesy of João Leite.

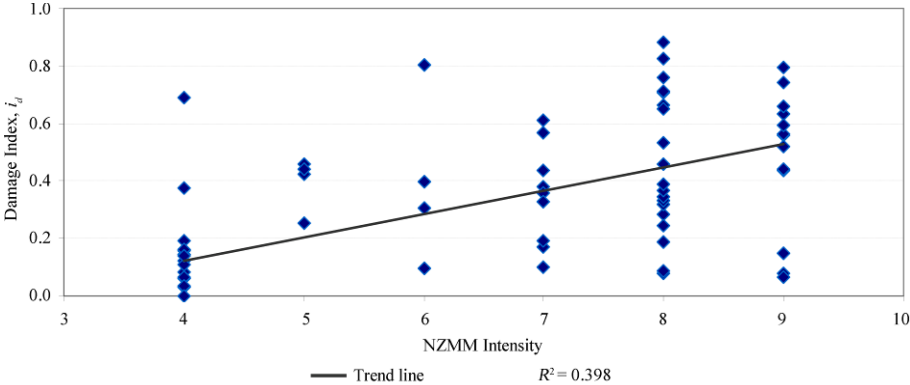
Figure 3.8. Distribution of the damage index, i_d , with NZMM intensity.

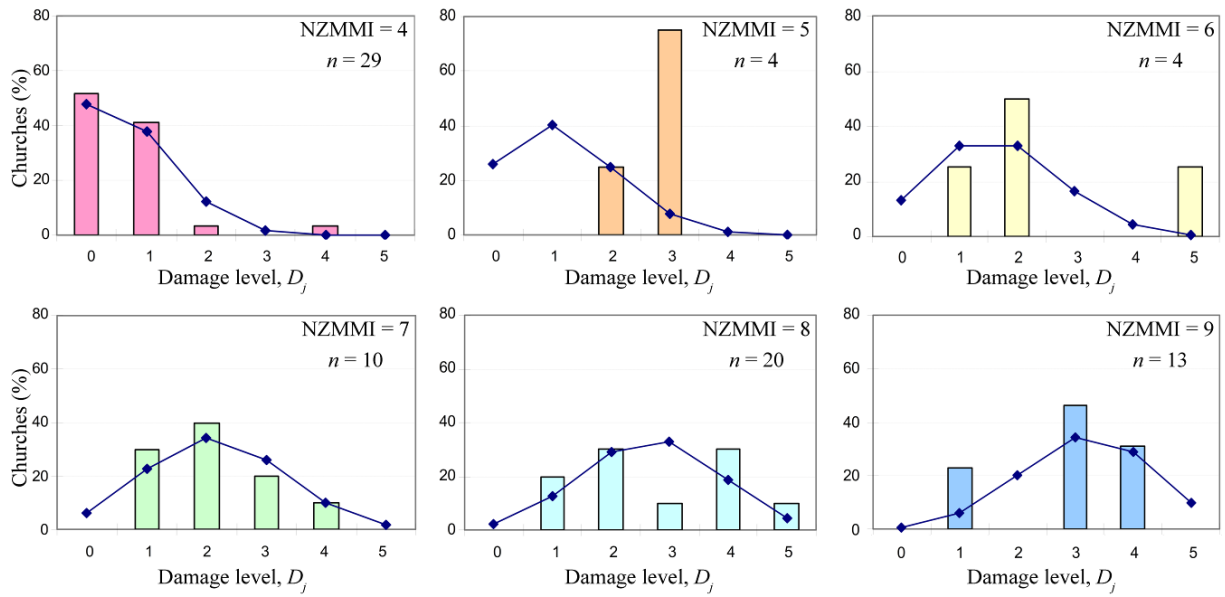
Figure 3.10. Damage Probability Matrices and binomial distribution of the 80 observed churches for given intensities.

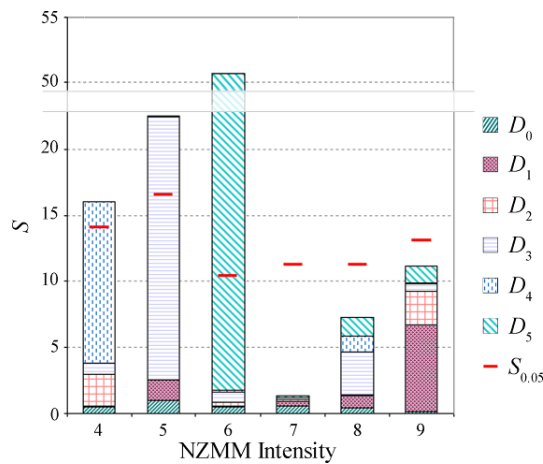
Figure 3.11. Goodness-of-fit test of the 80 observed churches for given intensities. The contribution of each damage level to the statistic S , Eq. (6), is reported. The ordinate values are cut between approximately 25 and 50.

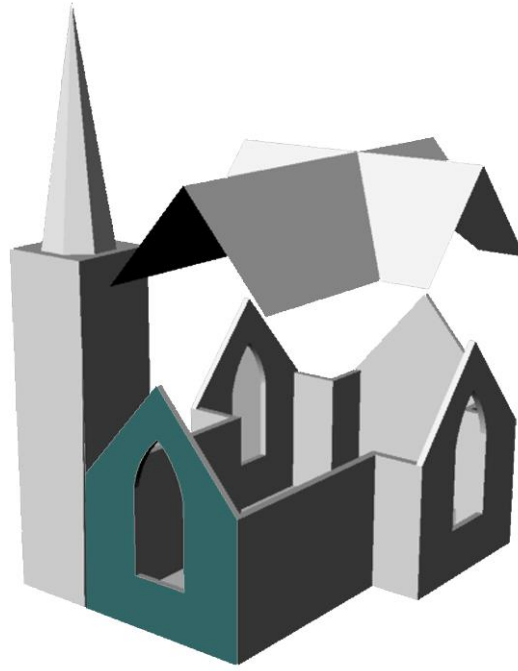
Figure 4.3. Surface area of the façade macroelement (associated to mechanisms #1 and #3) and church total surface area.

In buildings with multiple mechanisms it is important to define a synthetic index expressing the overall severity of damage. For a risk analysis it would be ideal to have reparation costs related to each mechanism, but unfortunately such information is currently not available for New Zealand. However, part of the reparation cost estimation entails accounting for the geometrical size of the macro-elements. For this reason, following Cattari et al. (2015), the damage of each mechanism can also be weighted based on the surface area of the associated macro-element when compared to the church surface area (Figure 4.3).

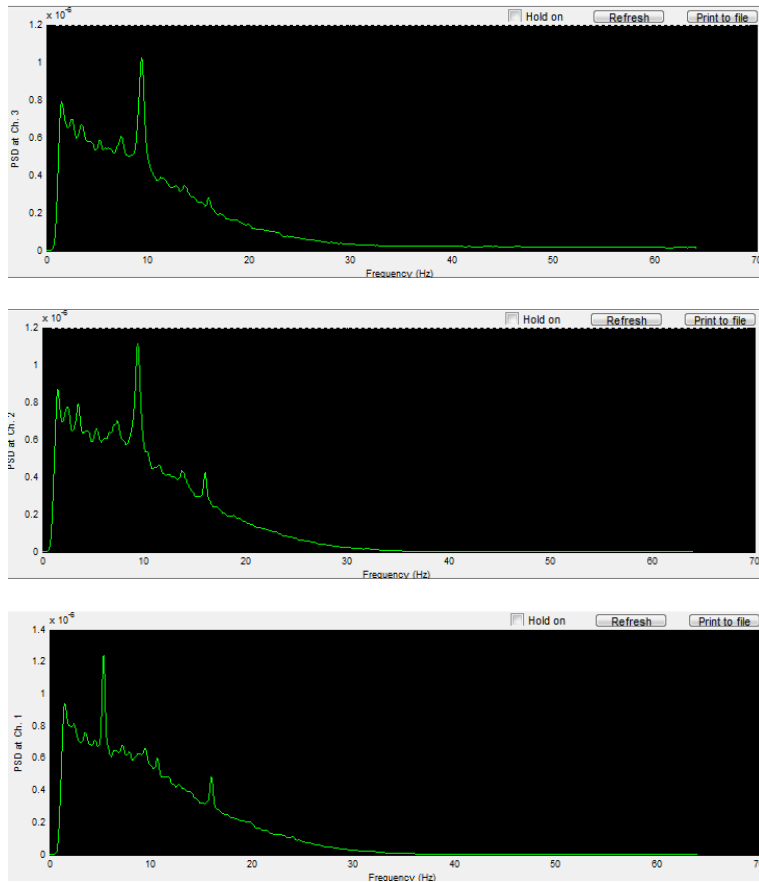
Figure 5.5. Power Spectral Density plot of the Z (out-of-plane) component of three vertically aligned sensors in the façade of the Church of Our Lady of Assumption.

Church	Element	f (Hz)
St Pauls	Pinnacle	8.6
	Façade	8.8
Our Lady of Assumption	Façade	9.3
	Transept	8.9
St Matthew in the City	Apse	8.1
St Francis de Sales and All Saints	Façade	6.6
