1 First UK field application and performance of 2 microcapsule-based self-healing concrete

15 Maintaining the health and reliability of our infrastructure is of strategic importance. The current
16 state of the UK infrastructure, and the associated huge costs of inspection, maintenance, repair and
17 eventual replacement, is not sustainable and is no longer environmentally viable. The design of
18 infrastructure, mainly concrete, remains traditional and poor material performance continues to be
19 the main cause of deterioration and failure in our infrastructure systems. Biomimetic materials, that
20 emulate natural biological systems in their ability to self-healing, provide an exciting and plausible
21 solution. Embedding cementitious materials with in-built capabilities to sense and respond to their
22 environmental triggers could potentially eliminate all external interventions and deliver a resilience
23 infrastructure. The work presented in this paper forms part of a national initiative that has been

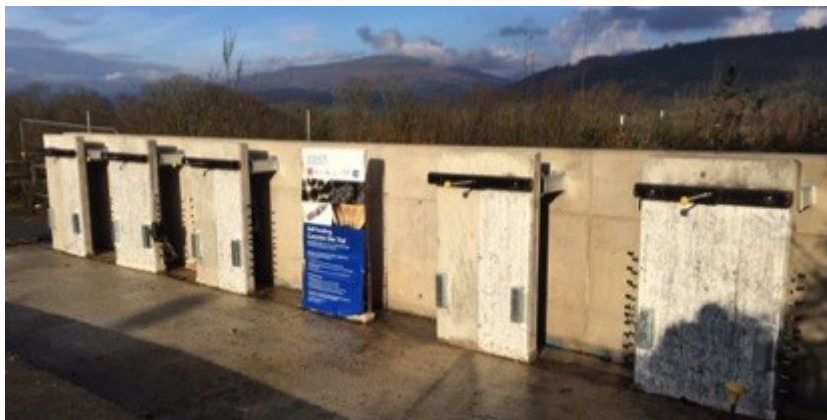
215
216 **Figure 3 Self-healing concrete wall panels constructed within the EPSRC and industry funded**
217 **Materials for Life (M4L) project [35].**

210 (shown in Fig. 3). Details of the design and execution of the field trials were presented elsewhere
211 [34,35]. One of the panels contained the developed microcapsules and there was a control panel
212 without any microcapsules with which a comparison was made. This paper focuses on the former. It
213 presents details of the scaling up of the microcapsules and their use in the field trials and
214 subsequent performance and monitoring.

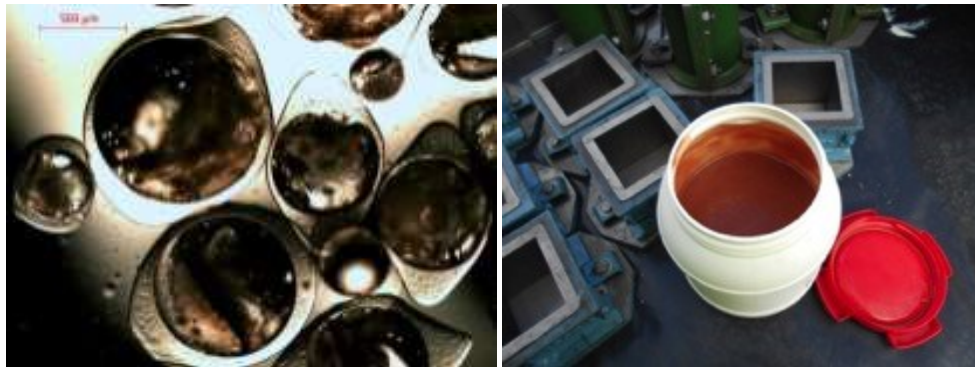
233 The concrete mix composition is detailed in Table 1. The microcapsules were first washed with water
 234 and filtered from their preserving solution before being added, in their slurry form, directly into the
 235 ready-mix C40/50 concrete using a portable 120L Belle concrete mixer. The microcapsules were
 236 added at 8% by volume of the cement, corresponding to $\sim 2.67\%$ by weight of the cement and
 237 $\sim 0.47\%$ of the total concrete mix. A small quantity of water was used to wash out the microcapsules
 238 from the container and as a result the effective water-to-cement (w/c) ratio of the concrete mix
 239 increased from ~ 0.43 to ~ 0.45 . A control panel was also cast without any microcapsules.

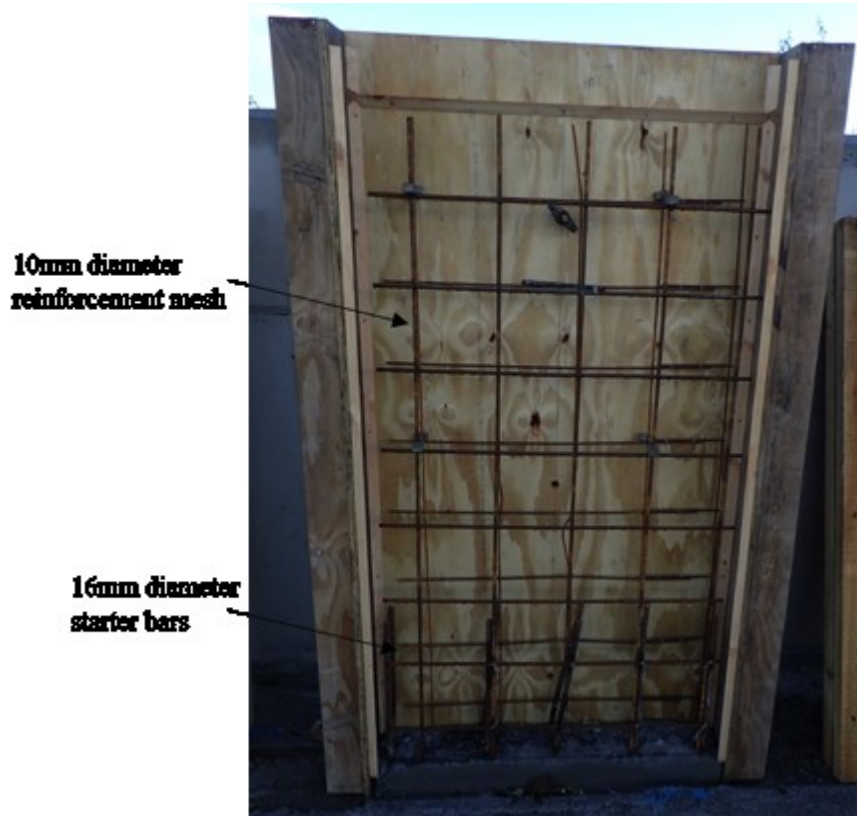
271
272 **Figure 5 Wall panel reinforcement design to ensure cracking at ~500mm from the base of the wall**
273 **panel.**

249 The wall panels were designed to crack 500mm from the base upon loading, which was facilitated by
 250 using 16mm diameter starter bars on the front face up to the designed crack location, before
 251 changing to the 10mm diameter mesh to create a weak section in the panel as seen in Fig. 5. Loading
 252 was applied using a hydraulic jack positioned 1.5m above the base of the panels, i.e. near the top of
 253 the wall, that was used to pull a threaded bar; thereby inducing a cantilever load. A wailing beam
 254 attached to the front of the panel allowed a distribution of load across the width of the wall. Full
 255 details of the design and construction of the walls is given elsewhere [35]. Panels were painted with
 256 a black-and-white speckle pattern for digital image correlation (DIC) analysis to monitor wall
 257 displacements and associated strains that arise during loading and unloading (Fig. 6).

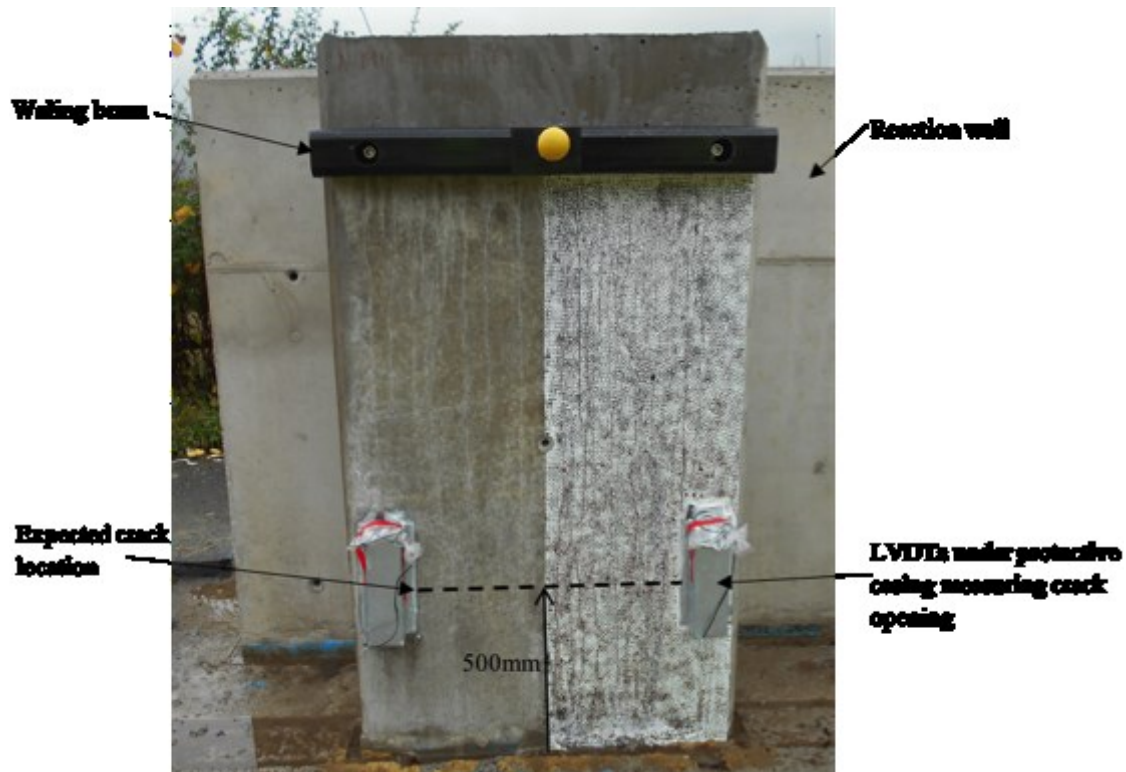
274
 275 **Figure 6** The microcapsule wall panel half painted with a black-and-white speckle pattern for DIC
 276 analysis

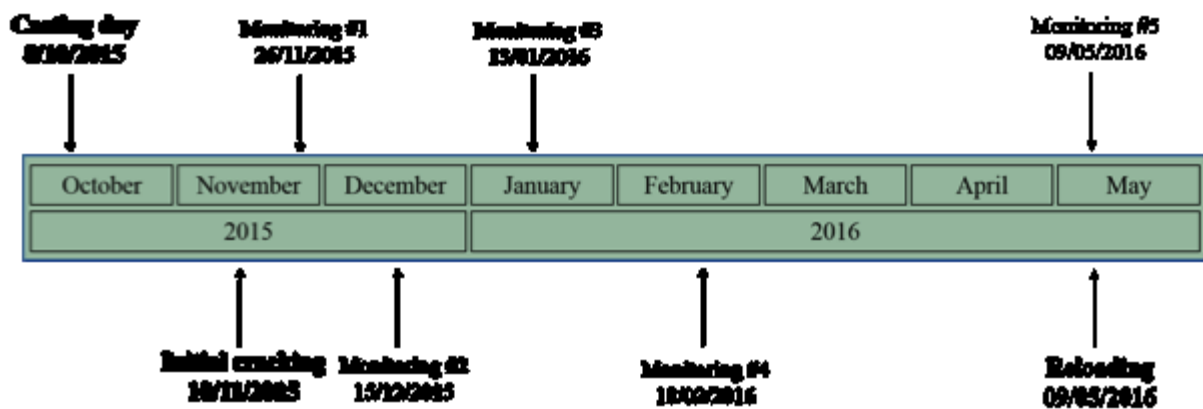
298 Figure 8 Timeline of wall panels testing and measurement collection dates
 299

281 A timeline of the field trials experimental programme is given in Fig. 8. The wall panels were initially
 282 loaded 5 weeks after their casting day and then reloaded after a 26-week healing period. Loading
 283 was applied until a noticeable crack appeared at the designed height and a large drop-off in load was

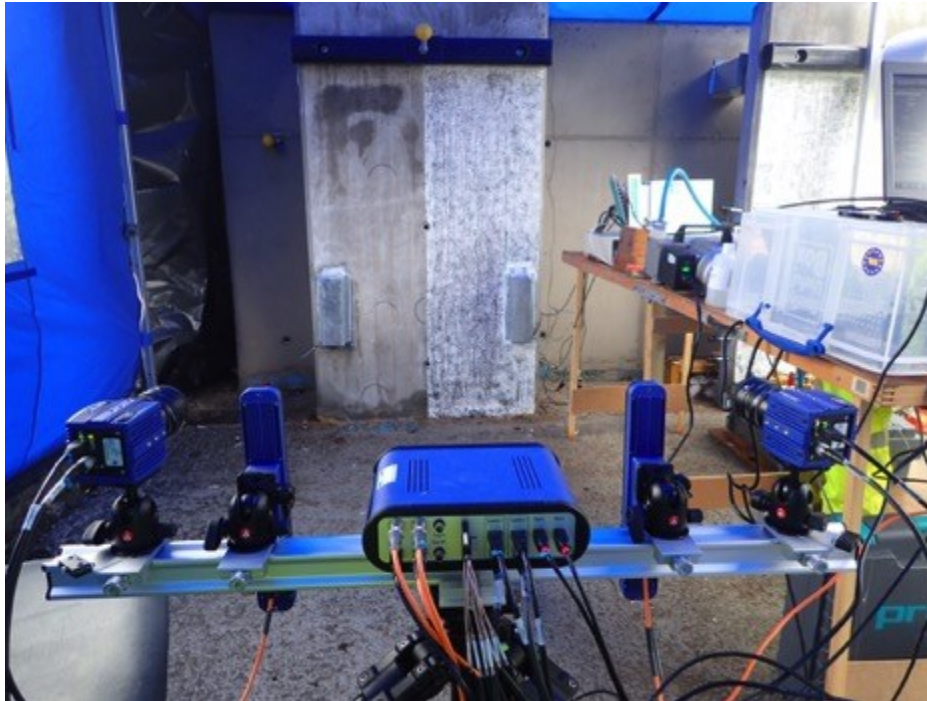
316
317 **Figure 10 Digital Image Correlation camera and tripod set-up on the microcapsule wall.**

304 The DIC software measured displacements through the comparison of images to monitor movement
 305 in the speckle pattern. Photographs of the wall were taken at each kN load applied (or released)
 306 using two digital cameras and flash equipment set up on a tripod facing the wall panel (Fig. 10). The
 307 use of DIC allowed monitoring of crack initiation, coalescence and propagation. The covering of one-
 308 half of the wall face only in the speckle pattern offset any potential variations in obtained
 309 measurements due to the hydrophobic/water repellent nature of the paint. After initial cracking, a
 310 strip of thermal insulation foil roll was placed across the middle section the microcapsule wall to
 311 reduce its exposure to the environment. This was to examine the effect of sealing on the overall
 312 healing progress for both halves of the wall although the insulation was permanently removed after

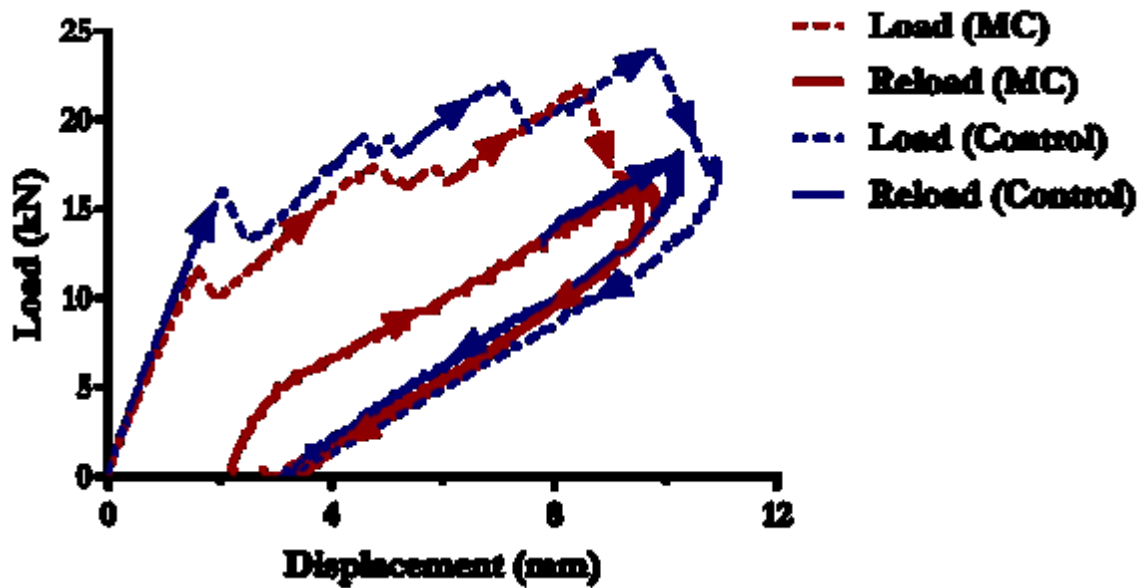
374 **Figure 11 Initial and reload load-displacement curves for the microcapsule and Control wall panels.**

364 The load-displacement relationship for both panels for initial loading and reloading seen in Fig. 12
365 confirm that the strength of the panel as not compromised by the addition of the microcapsules.
366 This figure shows that both the initial peak loads obtained, 23.9kN and 21.9kN for the control and
367 microcapsule panels respectively, and the residual loads, 17.4kN and 16.2kN respectively, suggest a
368 smaller decrease (\sim 8%) due to the presence of the microcapsules. Similarly, the concrete stiffness
369 values were also seen to only decrease by \sim 8% from 7.8kN/mm in the control panel to 7.1kN/mm in
370 the microcapsule panel. These results are in better agreement with the cylindrical compressive
371 strength results for microcapsule-loaded concrete samples cast and tested in the laboratory (\sim 9%)
372 [36] as well as previous laboratory observations for mortars [21].

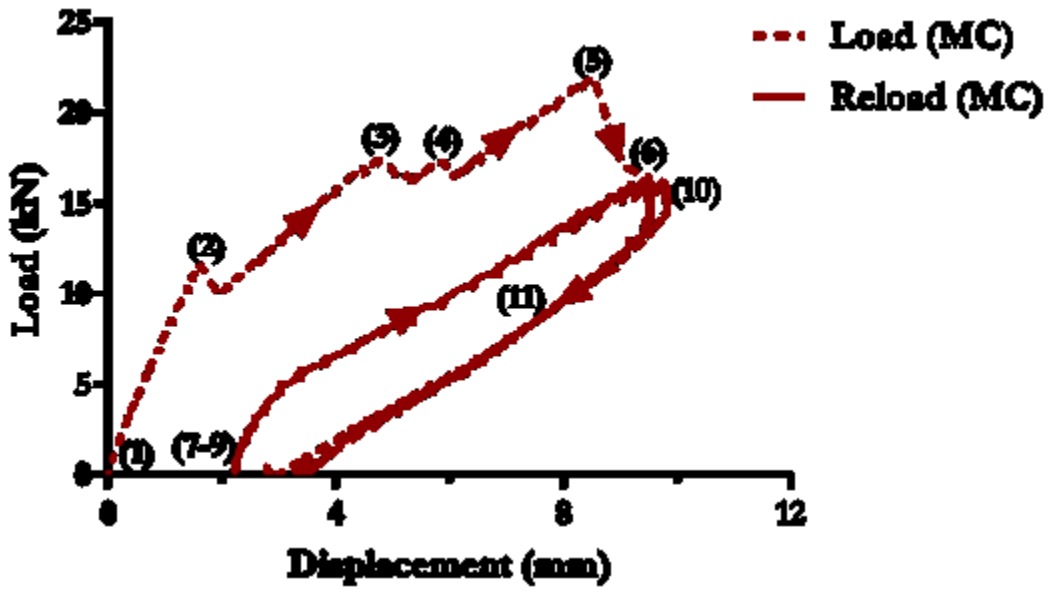
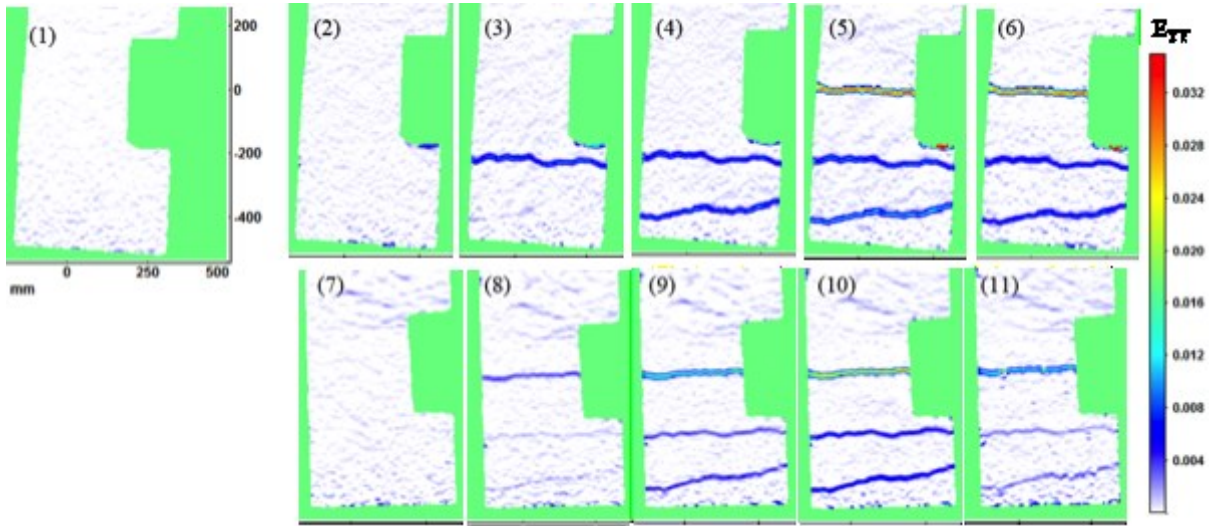
Figure 12 (a) Loading and reloading of the microcapsule wall and (b) corresponding DIC images.

375 Several microcracks were formed during loading, evident from the various drops in the load-
 376 load-displacement curves (Fig. 12a and 13a). The first crack was noticed at 16.1kN (~72% of maximum
 377 load) and 11.6kN (~55% of maximum load) in the control and microcapsule walls respectively. This
 378 microcracking was also clearly visualised in the DIC images showing vertical strain E_v , since loading
 379 induced tensile stresses normal to the plane of the crack (i.e. mode I crack separation). In the
 380 microcapsule panel, a microcrack formed at ~280-300 mm from the base before a second
 381 microcrack formed below this at between 30-100mm (Fig. 12b). In comparison, for the control
 382 panel, a microcrack first formed closer to the base at 50-100mm and then a second between 200-
 383 250mm (Fig. 13b). Despite those differences, two significant microcracks were formed in both walls
 384 between the designed crack location and the wall's joint with the base slab. The third crack was then

387 The DIC results show that during reloading it was the main crack that first re-opened before the
 388 opening of the other two microcracks occurred in both the microcapsule (Fig. 12b) and control wall
 389 (Fig. 13b), confirming that low strength regain is possible by autogenic healing or mineral based-
 390 autonomic healing. This is in agreement with previous unconfined compressive strength (UCS) and
 391 flexural laboratory tests on the microcapsule-based concrete system [36] where an addition of 8%
 392 microcapsules achieved 10% more strength than the control and an absolute strength recovery of
 393 25% over the monitored period.

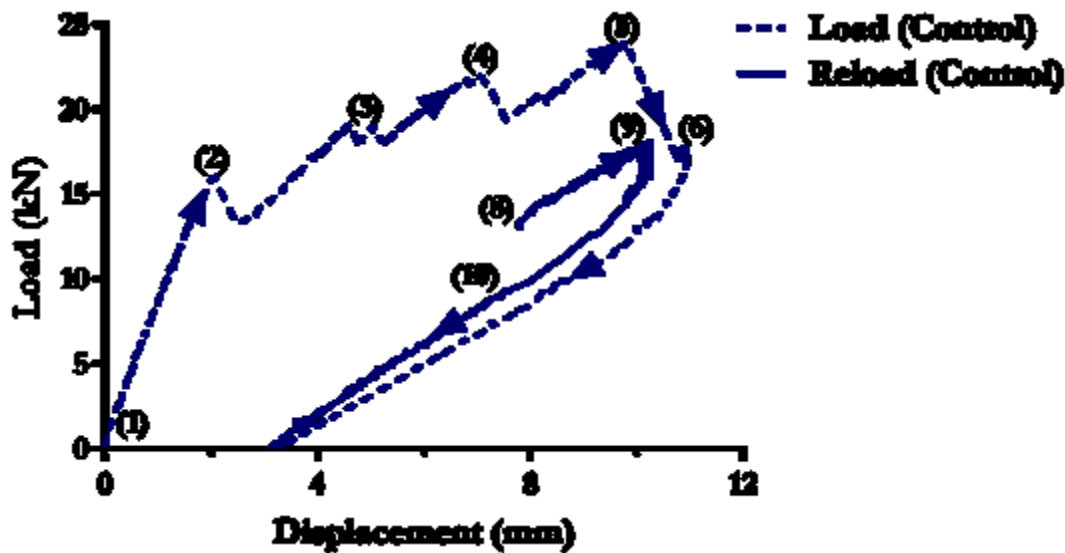
405 **Figure 13 (a) Loading and reloading of control wall and (b) corresponding DIC images.**

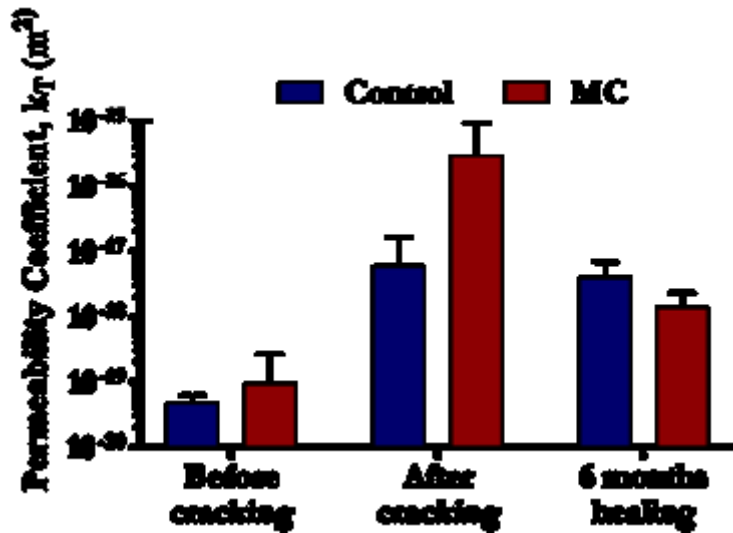
Figure 17 (a) Permeability of wall panels before cracking, after cracking and after a 6-month healing period and (b) Air permeability measurement locations after loading and subsequent cracking of concrete wall panel.

The coefficient of air permeability values measured at three periods are shown in Fig. 17a, showing very similar values of $\sim 10^{-19}$ kT for both walls before cracking suggesting that the microcapsules did not significantly alter the initial porosity of the concrete. This value is typical for concrete of very low permeability [42]. After cracking, the air permeability of the microcapsule wall was noticeably greater than the control wall by ~ 2 orders of magnitude. Since the microcapsule wall failed at $\sim 8\%$ lower load than the control panel and hence slightly weaker, it is possible that this had induced a greater content of internal microscale damage and cracking. It should be noted here, that it was not possible to obtain air permeability measurements after cracking from all of the same locations prior to cracking. When placing the device in locations directly over the induced crack, the device was unable to create a vacuum and therefore obtain a reasonable measurement. Since the crack passed through the initial measurement locations, new locations adjacent to previous measurement locations were chosen (Fig. 17b). At monitoring stage #5 (6 months of healing), the permeability of the control panel reduced only slightly, while that for the microcapsule wall recovered significantly, by >2.5 orders of magnitude, to $\sim 10^{-18}$ kT. The permeability of the microcapsule wall was half an order of magnitude less than the control wall and was consistent with trends observed in the laboratory using sorptivity tests. The average sorptivity coefficients calculated across control and microcapsule-containing concrete samples after a 28-day healing period show that the rate of water absorption by microcapsule loaded samples is generally lower than that of the control [36]. Nonetheless the permeability of both walls remained greater than the permeability prior to cracking indicating only partial self-healing at that stage.

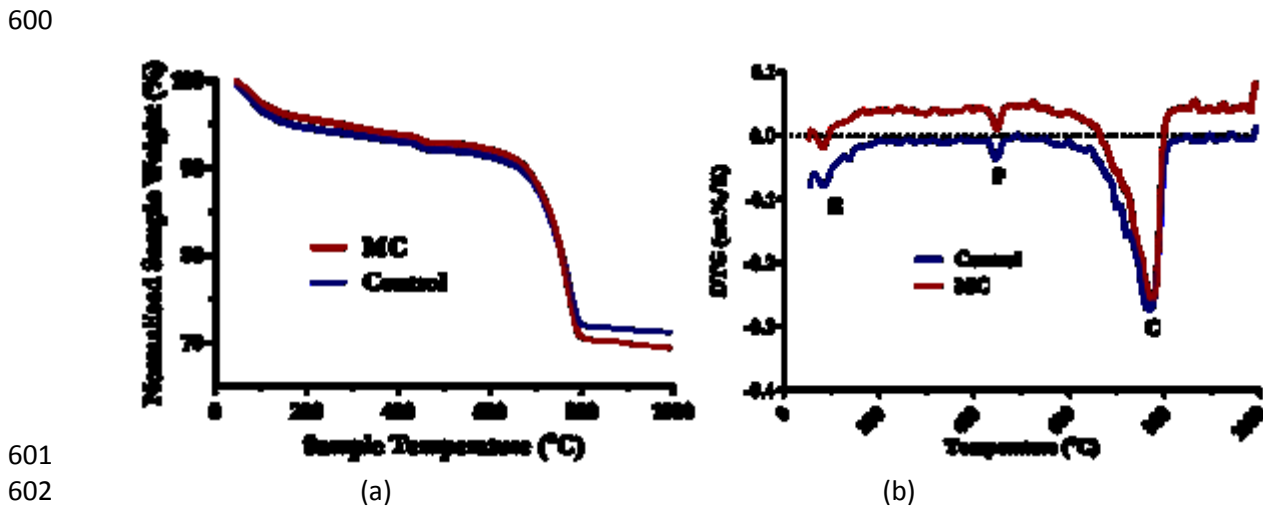
601
 602 (a) (b)
 603 Figure 19 Representative TGA/DTG graphs of powder extracted from crack faces of MC and control
 604 walls (a) TGA weight loss, (b) DTG curves where E: ettringite, P: portlandite and C: calcite

605 It is worth noting that it is difficult to distinguish between a reduction in portlandite due to reaction
 606 with the sodium silicate or carbonation to form calcite. However, these cumulative measurements
 607 support the hypothesis that a greater portlandite content existed in the microcapsule wall prior to
 608 cracking and has either been converted to calcite or reacted with the healing agent to form C-S-H.
 609 Furthermore, the increased quantity of calcite measured in the microcapsule wall sample is
 610 consistent with the increased visual healing that was observed at the crack mouth.
