NEBRASKA GROUT TASK FORCE

In-Situ Study of Grout Materials 2001-2006 and 2007 Dye Tests

Educational Circular EC-20
Conservation and Survey Division, School of Natural Resources
Institute of Agriculture and Natural Resources
University of Nebraska–Lincoln

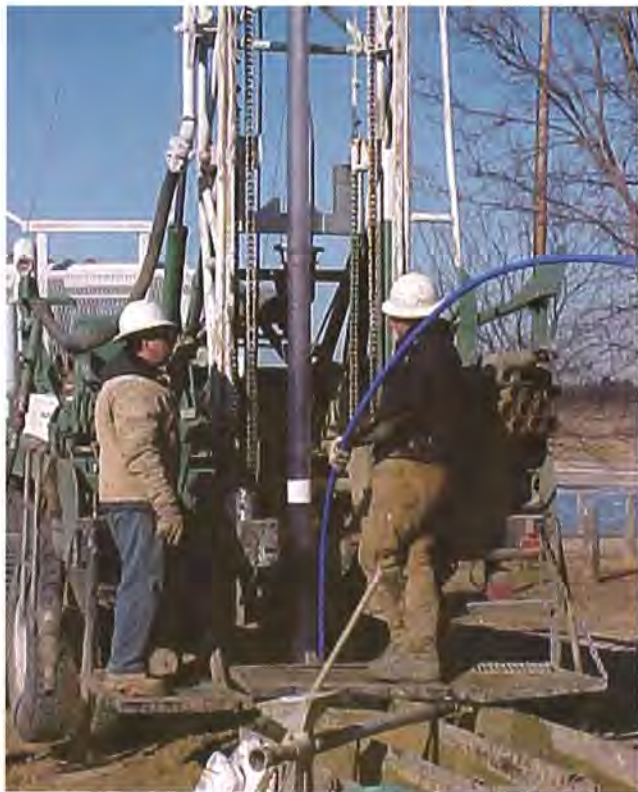
Figure 3. Installation of clear PVC casing with tremie pipe.

For all installations except heat loops, the 4.5-inch outside diameter (OD) Schedule 40 clear casing and slotted screen were installed in the boreholes at the target depths (Fig. 3). Centralizers were set every 20 feet. Gravel pack was poured or tremied into the annulus from the bottom of the borehole to about 2 feet above the top of the screen. The top of the filter pack was tagged with a weighted tape to ensure proper placement. A 2- to 3 feet, $\frac{3}{8}$ " chip bentonite seal was placed above the filter pack. Then the specified grout was placed above the seal according to NGTF's specifications.

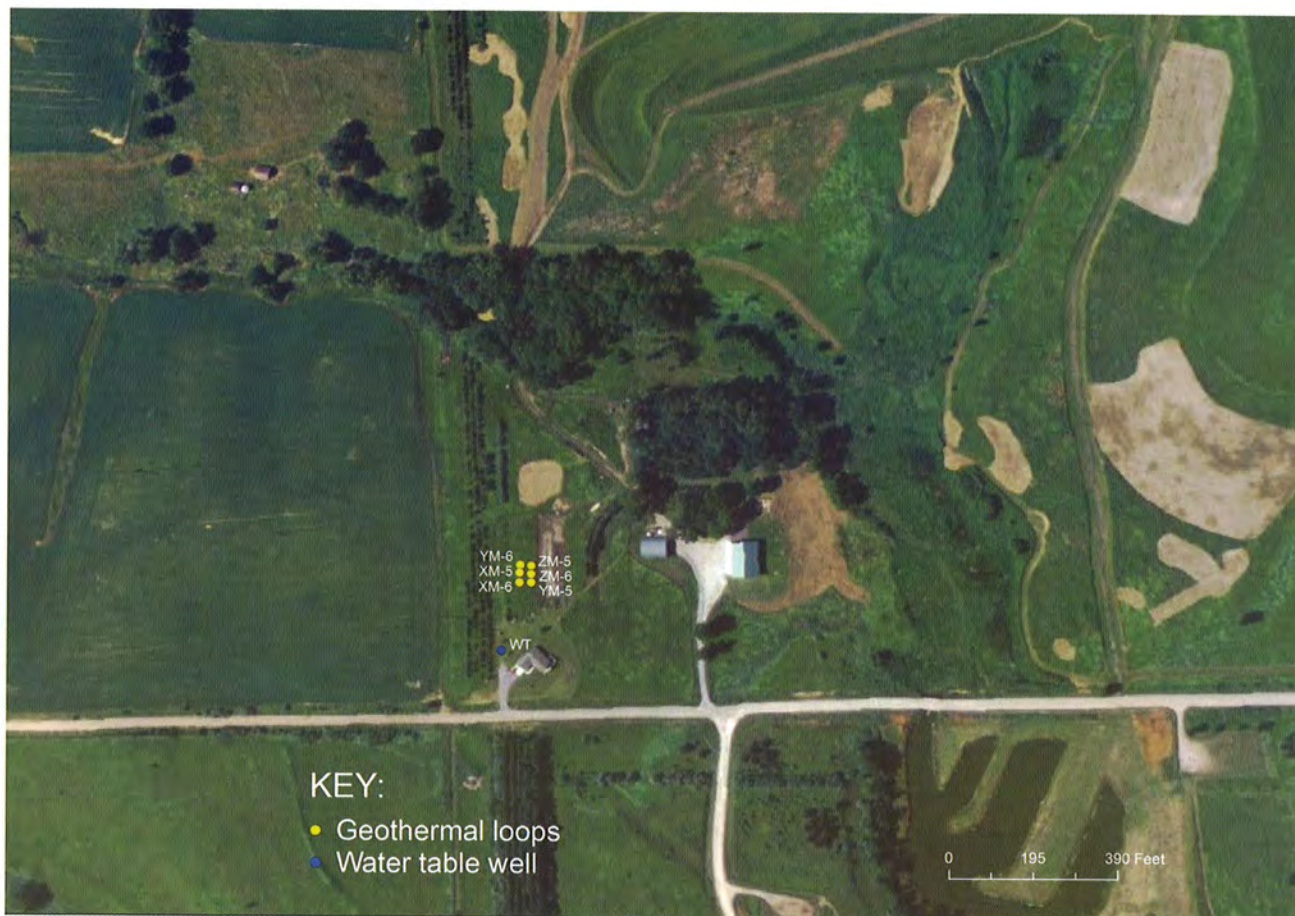
Figure 6. Well and loop locations at the Maskenthine study site.
 Aerial photography: USDA Farm Service Agency, 2003.

TABLE 2
 CONSTRUCTION DETAILS OF GROUT OBSERVATION LOOPS
 AT THE MASKENTHINE SITE

Well ID	Date installed	Bit size	Grout interval	Grout type	Specified grout
		In	Ft bgs		
XM-5	10/17/03	9.5	0 - 180	Geothermal-sand	60%
XM-6	10/18/03	9.5	0 - 180	Geothermal	20%
YM-5	10/15/03	9.5	0 - 180	Geothermal-sand	60%
YM-6	10/16/03	9.5	0 - 180	Geothermal	20%
ZM-5	10/13/03	9.5	0 - 180	Geothermal-sand	60%
ZM-6	10/14/03	9.5	0 - 180	Geothermal	20%

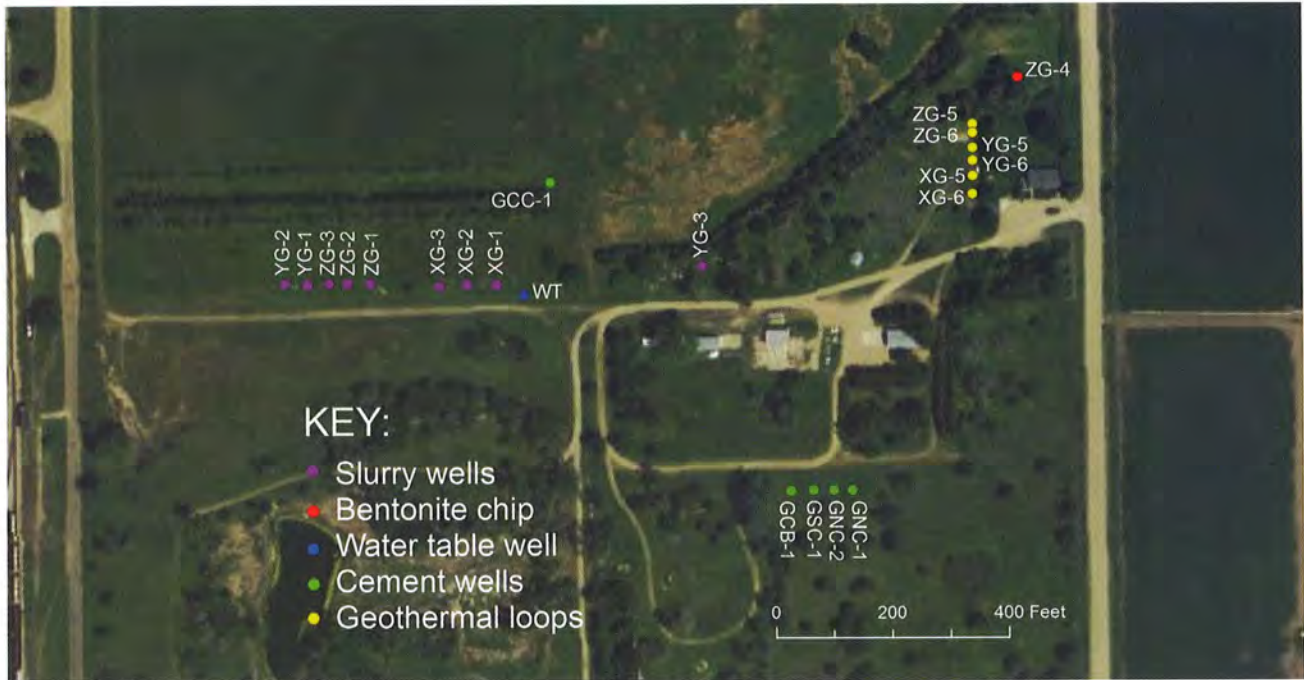
Figure 7. Well and loop locations at the Grand Island study site.
Aerial photography: USDA Farm Service Agency, 2003.

TABLE 3
CONSTRUCTION DETAILS OF GROUT OBSERVATION INSTALLATIONS
AT THE GRAND ISLAND SITE

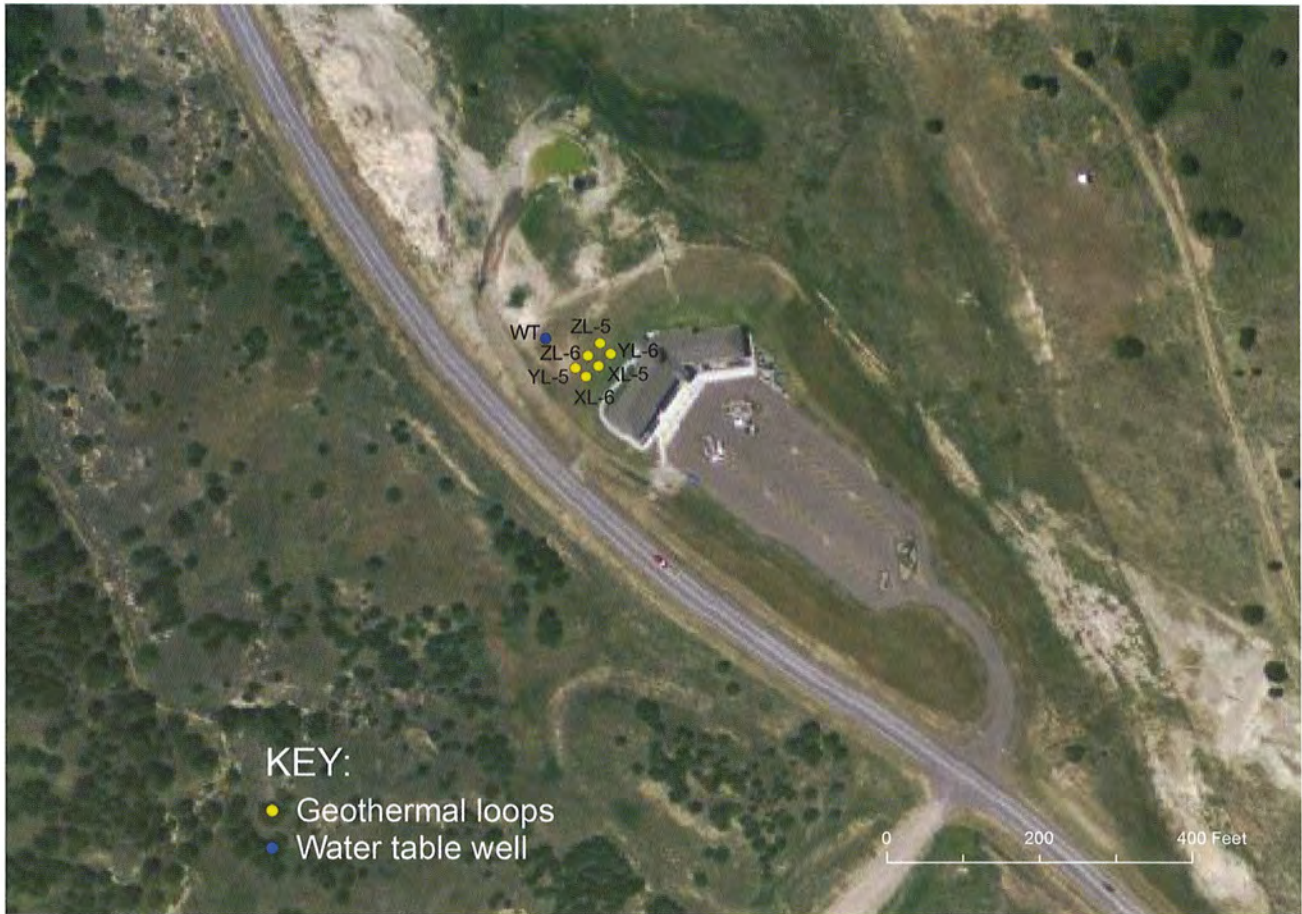
Figure 9. Well and loop locations at the Lake McConaughy study site.
Aerial photography: USDA Farm Service Agency, 2003.

TABLE 5
CONSTRUCTION DETAILS OF GROUT OBSERVATION LOOPS
AT THE LAKE McCONAUGHY SITE

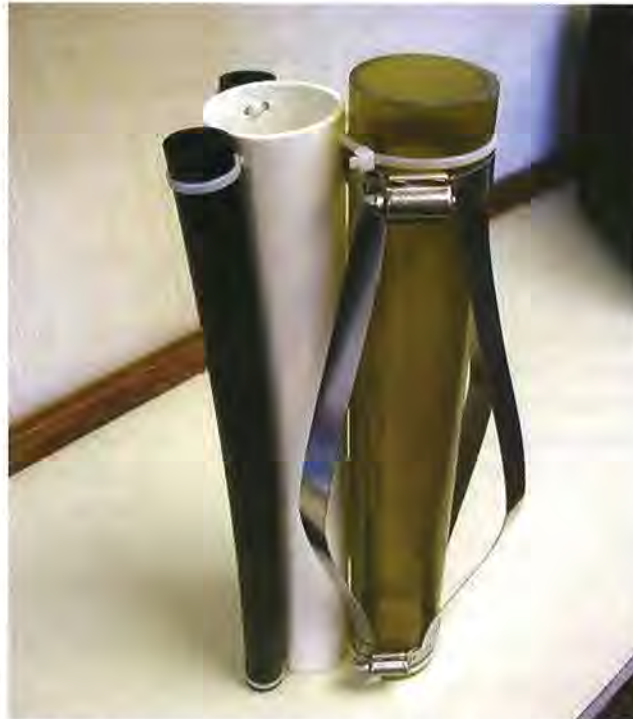
Figure 10. Example of geothermal loop installation.

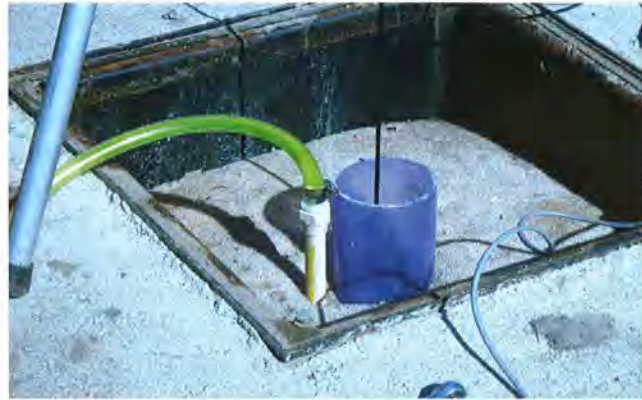
Figure 14. Dye testing.

The NGTF Technical Team adapted the dye test techniques used by the Ohio Department of Health (May 2000). Surface completion diagrams (Figs. 11 and 12) show the configuration of the dye reservoirs. The dye was non-toxic food grade quality. In dye tests performed between 2004 and 2006, we used a yellow-green fluorescein dye. NDHHS personnel swabbed the dye tubes to eliminate the possibility of any obstructions in the tube that could alter the results of the dye test. Then a clear hose was attached to the dye tube and connected it to the 220-gallon dye tank (Fig. 14).

Field personnel placed the tank in the bed of a pickup truck to aid in maintaining a positive artificial head. NDHHS personnel then lowered the camera into the well and opened the valve from the tank. The movement of the camera depended on detection of the dye. Near the end of the 1-hour test, the camera was lowered to the bottom of the well and then slowly raised to detect the maximum depth of penetration of the dye after approximately one hour. In 2006 the technical team decided to also video each of the wells twenty-four hours later to assess longer term dye movement. NDHHS personnel recorded the results of the dye tests on a dye test form provided by the NGTF.

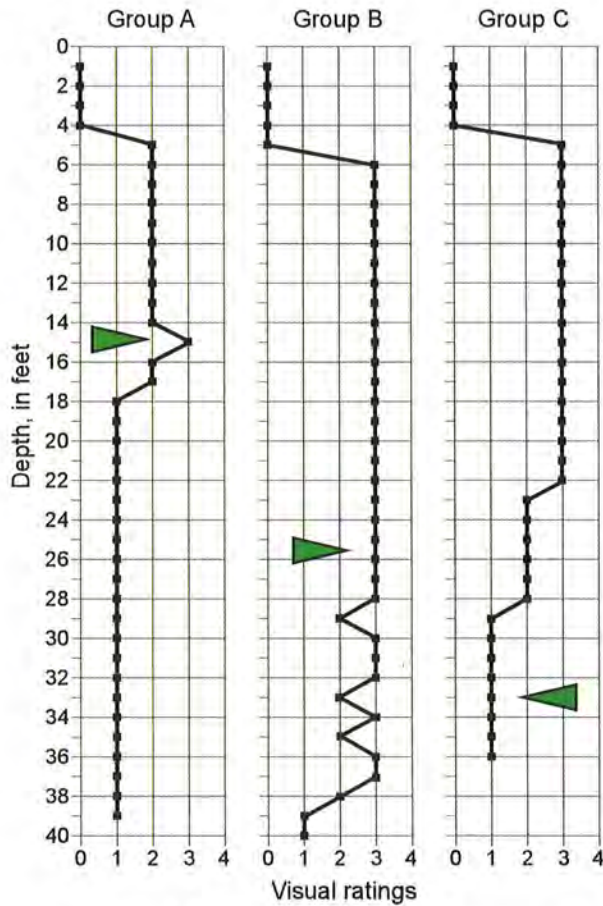
Figure 15. Comparison of visual assessment and dye test results. Arrow indicates maximum depth dye was detected.

dye was detected was within 3 feet of the lower visual ratings. Group B included cases where the dye was shallower than expected. The dye did not penetrate all sections of grout that were identified as cracks or cracks and voids. Group C included instances where the dye penetrated deeper than expected. In this group the dye penetrated areas of the grout that showed no inconsistencies. Figure 15 shows an example from each group.

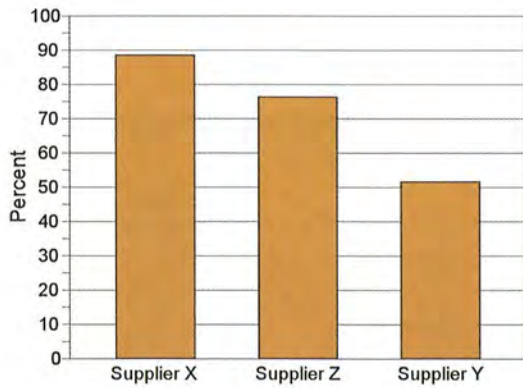
Figure 21. Percentage of the unsaturated zone penetrated by dye.

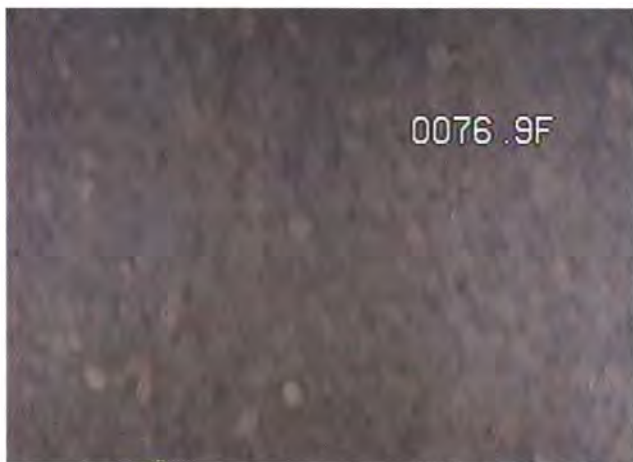
Figure 22. Infiltration of cement grout into the filter pack. (Numbers indicate depth of camera in feet.)

In April 2009, the Technical Team noted that the cement grout infiltrated through the bentonite chip seal and into the filter pack (Fig. 22). Industry personnel indicated that this occurs when the water phase of the cement slurry grout is given off due to the hydrostatic head caused by the density of the grout column itself.

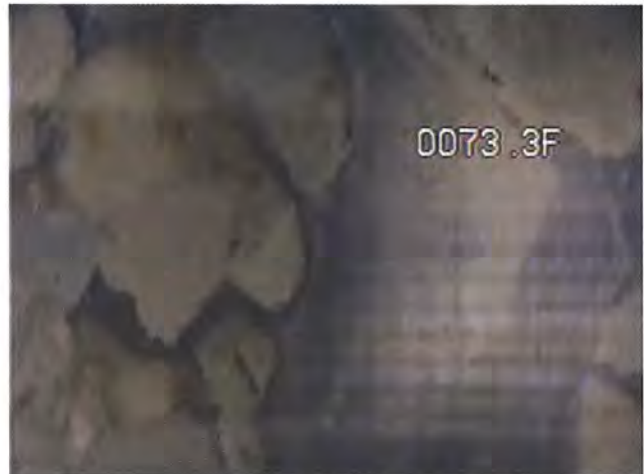
Figure 23. Failure of bentonite chip seal caused by cement grout.

This water is acidic and contains high concentrations of calcium that breakdown the chip seal when cement is in direct contact with it as shown in Figure 23. Cement industry representatives recommend placing at least 2 feet of blotter sand between the cement and bentonite chip to prevent the breakdown of the seal.

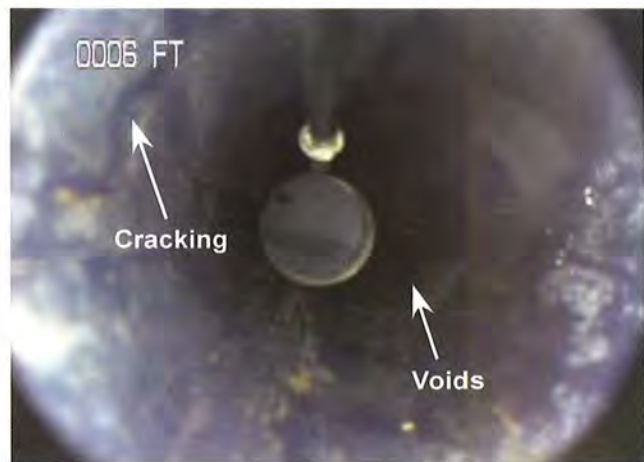
Figure 24. Cracking and voids in the Trenton bentonite slurry.

The Technical Team observed inconsistencies in slurry wells ranging from small areas of spiral cracking to large open voids in the annular space. At least some form of visual inconsistency was observed in the slurry grouts throughout much of the unsaturated zone in all of the wells assessed. The grout ratings for the Pilger and Trenton observation wells were generally more comparable with rating code assignments of 2 and 3 for the majority of the unsaturated zone depth intervals as shown in Figure 24. The grout nature of

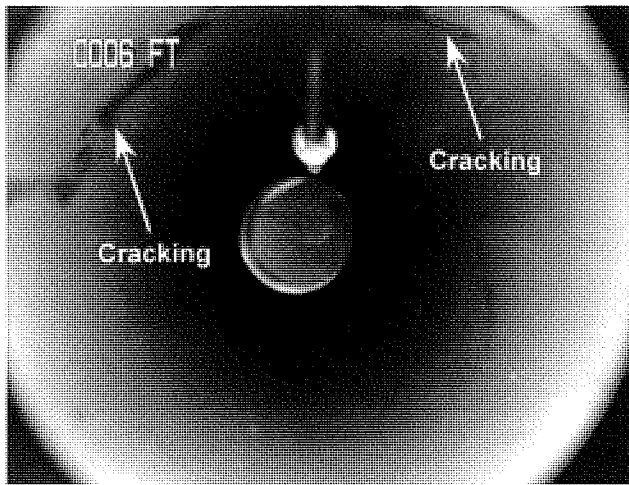
Figure 25. Small cracks in Grand Island bentonite slurry.

the Grand Island wells was more typically rated 1 and 2 (Fig. 25).

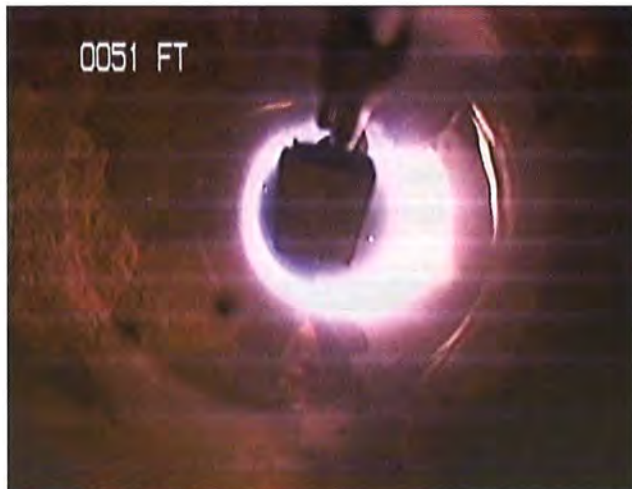
Figure 27. Geothermal grout containing 20 percent solids.

The geothermal bentonite grouts exhibited predominate cracking and voided areas throughout much of the unsaturated zone, as shown in Figure 27. In general, many of the grout seal conditions

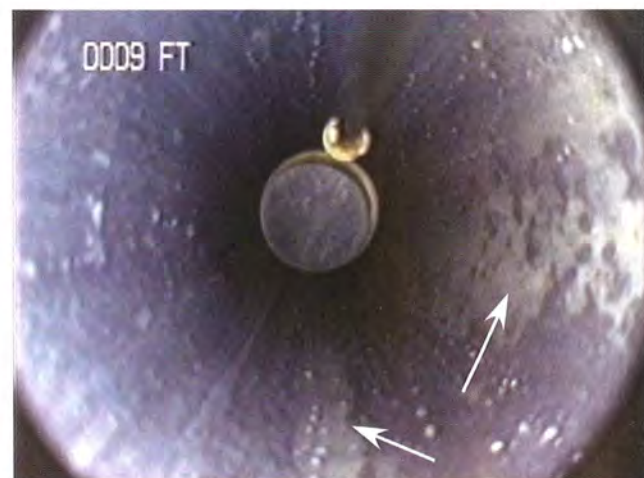
Figure 30. Neat cement appears detached from casing.

Overall the cement wells appeared to show some inconsistencies through most of the unsaturated zone. However, it was difficult to consistently rate the occurrence of these due to the obstacles noted in Section 1 of Chapter 3. The detachment of the grout from the casing was one of the most difficult challenges to assess visually in the cement wells. Detachment may have occurred in many of the wells assessed with this grout type, but may not have been accounted for completely in all of the visual assessments. Figures 28 through 30 show examples of the nature of cement-based grouts.

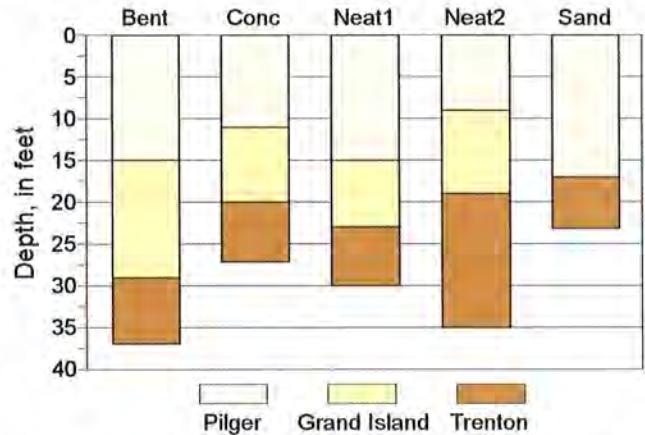
Figure 33. Accumulative maximum depth of detection for cement grouts.

The cement sand grout performed the best overall and the cement bentonite grout was the worst overall. However, all the cement-based grouts have similar performances when the accumulated depths of each recipe are compared (Fig. 33).
