## Two Test Level 4 Bridge Railing and Transition Systems for Transverse Timber Deck Bridges

Ronald K. Faller, Michael A. Ritter, Barry T. Rosson, Michael D. Fowler, and Sheila R. Duwadi

The Midwest Roadside Safety Facility, in cooperation with the Forest Products Laboratory, which is part of the U.S. Department of Agriculture's Forest Service, and FHWA, designed two bridge railing and approach guardrail transition systems for use on bridges with transverse glue-laminated timber decks. The bridge railing and transition systems were developed and crash tested for use on higher-service-level roadways and evaluated according to the Test Level 4 safety performance criteria presented in *NCHRP Report 350: Recommended Procedures for the Safety Performance Evaluation of Highway Features*. The first railing system was constructed with glulam timber components, whereas the second railing system was configured with steel hardware. Eight full-scale crash tests were performed, and the bridge railing and transition systems were acceptable according to current safety standards.

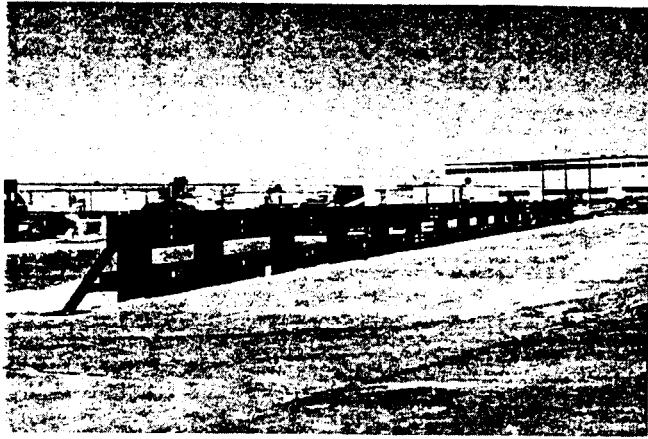
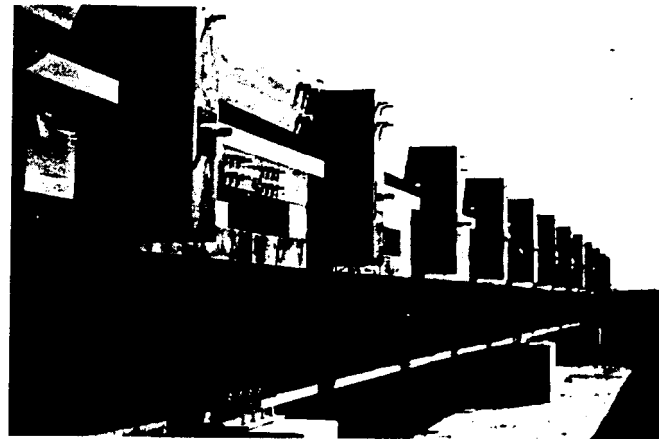
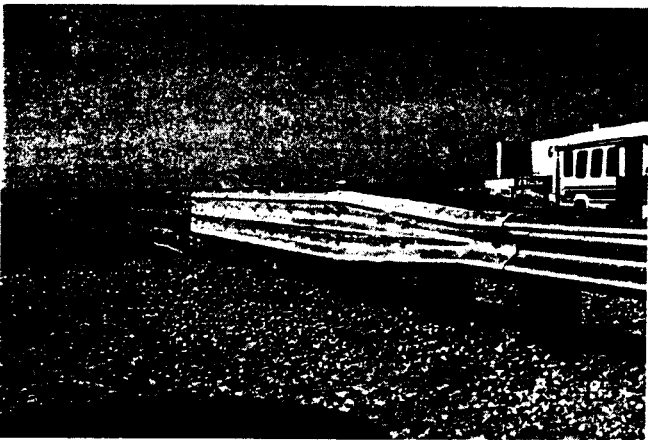
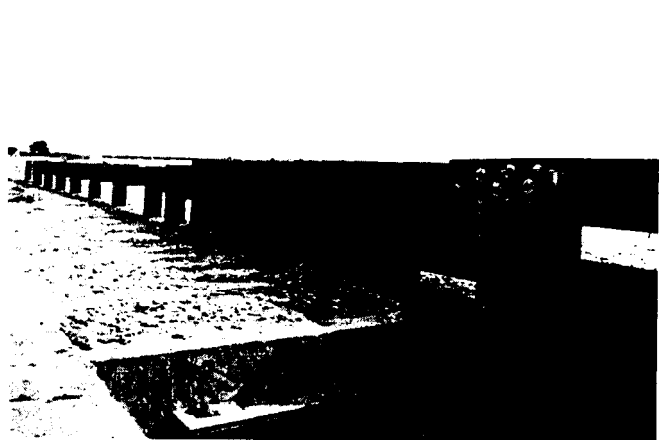
FIGURE 1 System No. 1: glulam rail with curb bridge railing [*top*] and thrie beam with curb transition [*bottom*].

The first bridge railing, referred to as System No. 1, was a wood system that was constructed with an upper rail, a lower curb rail, scupper blocks, posts, and blockouts, all of which were manufactured from glulam timber. Photographs of the railing system of the wood bridge and the attached approach guardrail transition are shown in Figure 1. The second bridge railing, referred to as System No. 2, was a steel system that was constructed with a three-beam rail, an upper structural tube rail, and wide flange posts and blockouts. Photographs of the steel bridge railing system and the attached approach guardrail transition are provided in Figure 2.

constructed with an upper rail, a lower curb rail, scupper blocks, bridge posts, and rail blockouts. Specific details of the system are provided in Figure 3. For the wood system, glulam timber for the upper rail and post members was Combination No. 48 SYP, as specified in *AASHTO LRFD Bridge Design Specifications* (7), and was treated with pentachlorophenol in heavy oil according to AWP Standard C 14 requirements (23). Glulam timber for the curbs, scuppers, and spacer blocks were fabricated with Combination No. 47 SYP, as specified by AASHTO, and treated in the same manner as described previously according to AWP Standard C14.

A transition system using a TL-4 approach guardrail was designed for attachment to each end of the bridge railing system. The system was constructed with a steel thrie-beam upper rail, a lower curb rail, guardrail posts, rail blockouts, and special transition blocks and connectors. Specific details of the approach guardrail transition that is used with System No. 1 are provided in Figure 4.

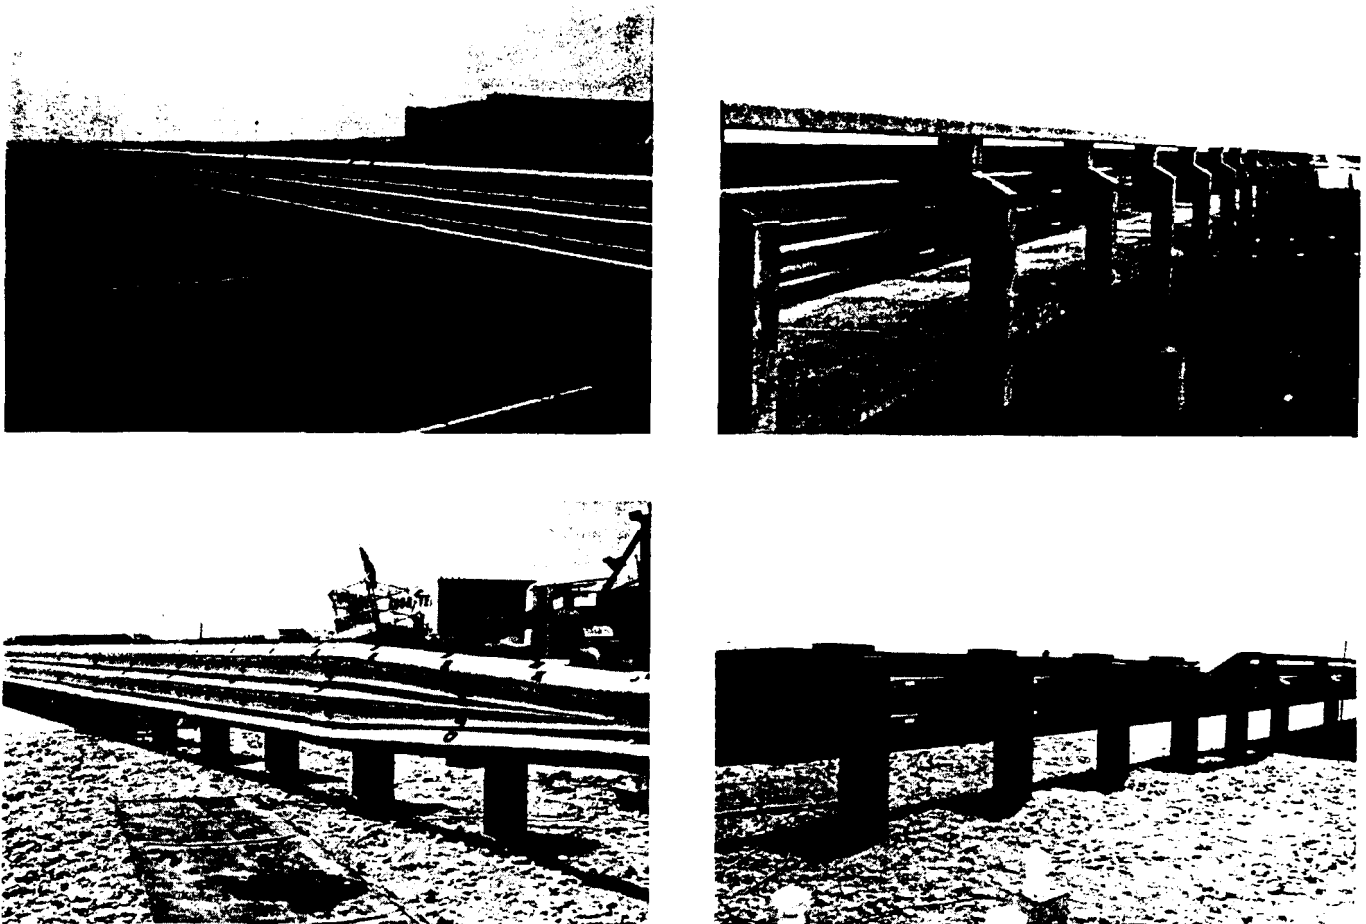
FIGURE 2 System No. 2: steel thrie beam with tube bridge railing [top] and thrie beam with tube transition [bottom].

The second bridge railing system was designed as an all-steel system. This system was constructed with a thrie-beam rail, an upper structural tube rail, wide flange bridge posts and rail blockouts, and deck-mounting plates. Specific details of this system are provided in Figure 9. For the steel system, a 10-gauge, thrie-beam rail was blocked from the wide flange posts with wide flange spacers. A structural tube rail was then attached to the top of the spacer blocks. The lower end of each post was bolted to two steel plates that were connected to the top and bottom surfaces of the bridge deck with vertical bolts.

A transition system that uses a TL-4 approach guardrail was designed for attachment to each end of the bridge railing system. The system was constructed with a steel thrie-beam rail, a sloped structural tube end rail, guardrail posts, and rail blockouts. Specific details of the approach guardrail transition that is used with System No. 2 are provided in Figure 10.

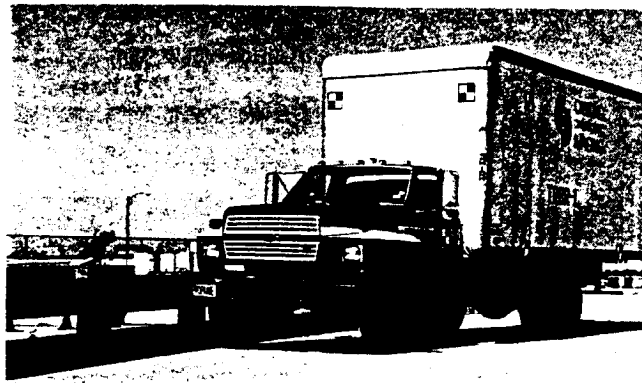
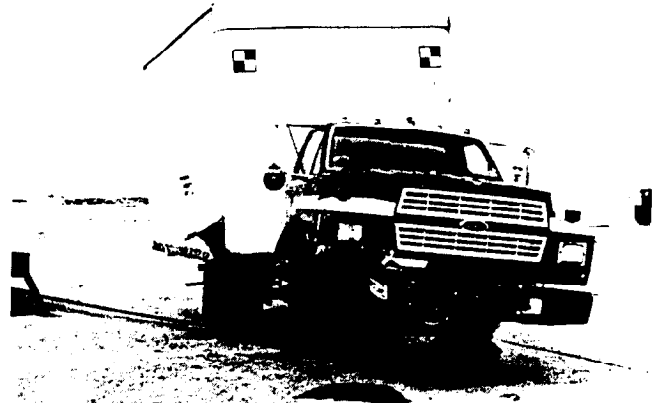
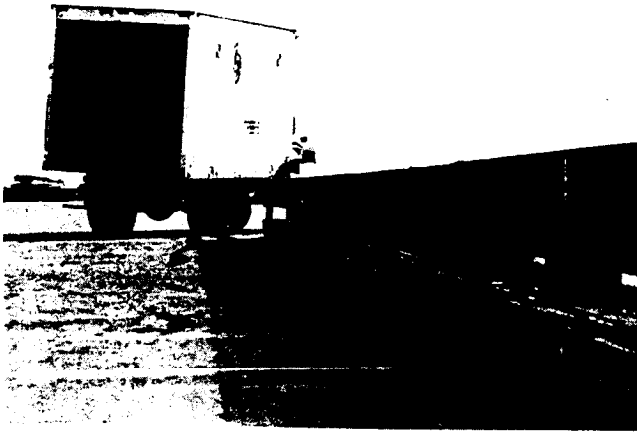
FIGURE 5 Test TRBR-1: (a) impact location, (b) vehicle damage, and (c) bridge railing damage,

The first crash test, Test TRBR-1, was successfully performed with a 1986 Ford F-800 Series, single-unit truck with a test inertial mass of 8000 kg and at impact conditions of 74.8 km/h and at an angle of 16 degrees. During impact, the vehicle exited the railing system at a speed of 47.3 km/h and at an angle of 0 degrees. The maximum lateral permanent set deflection and the dynamic rail deflection were observed to be 10 and 84 mm, respectively. The location of vehicle impact with the bridge railing, vehicle damage, and barrier damage are shown in Figure 5.

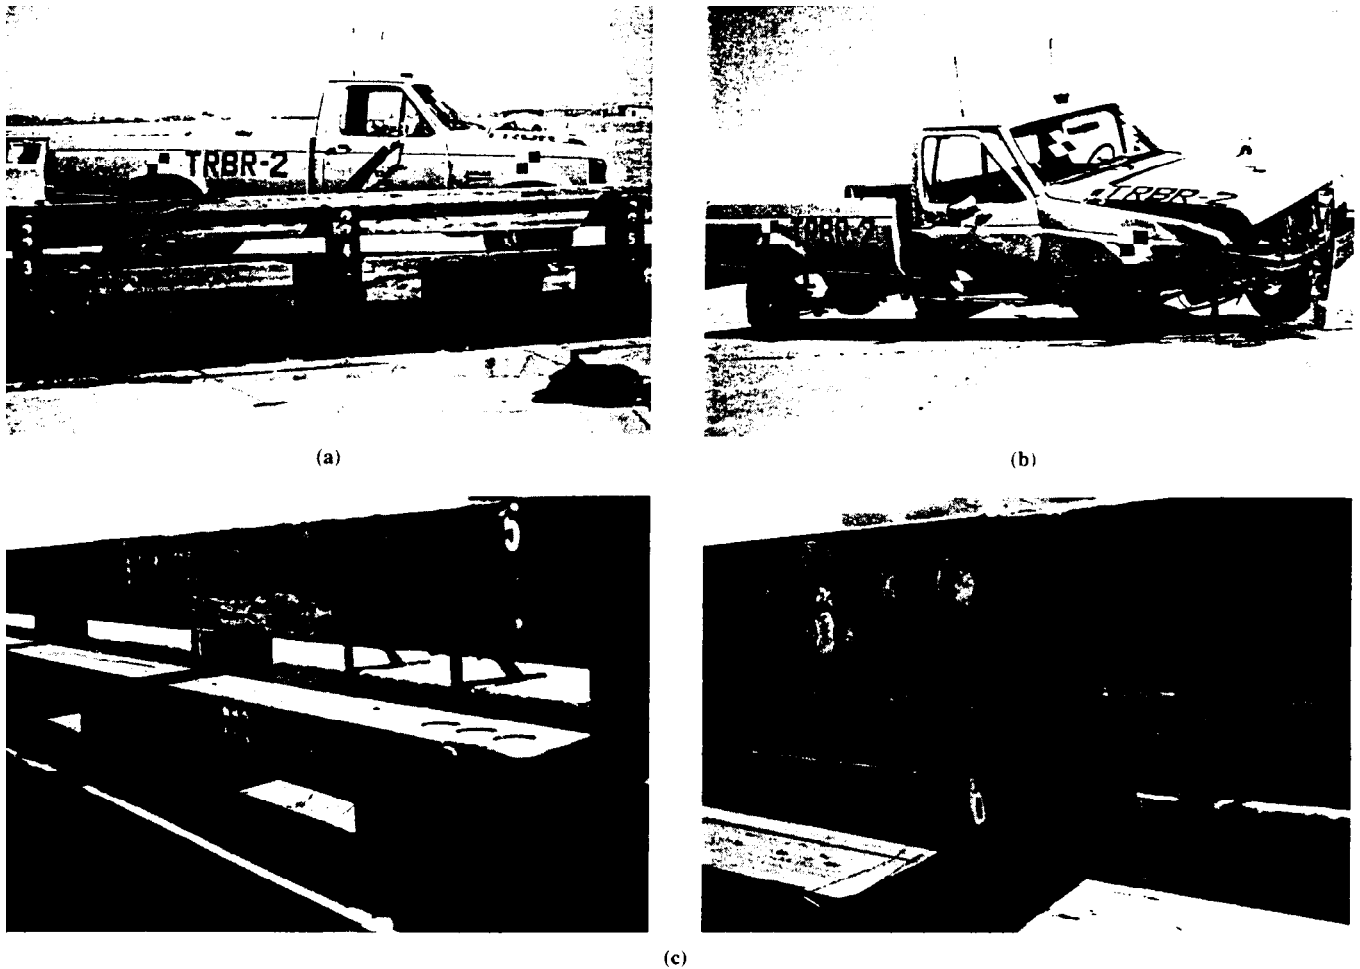
FIGURE 6 Test TRBR-2: (a) impact location, (b) vehicle damage, and (c) bridge railing damage.

The second crash test, Test TRBR-2, was successfully performed with a 1988 Ford F-250, ¾-ton pickup truck with a test inertial mass of 1993 kg and at impact conditions of 99.2 km/h and at an angle of 27.4 degrees. During impact, the vehicle exited the railing system at a speed of 62.3 km/h and at an angle of 2.1 degrees. The maximum lateral permanent set deflection and the dynamic rail deflection were observed to be 29 and 203 mm, respectively. The location of the vehicle impact with the bridge railing, vehicle damage, and barrier damage are shown in Figure 6.

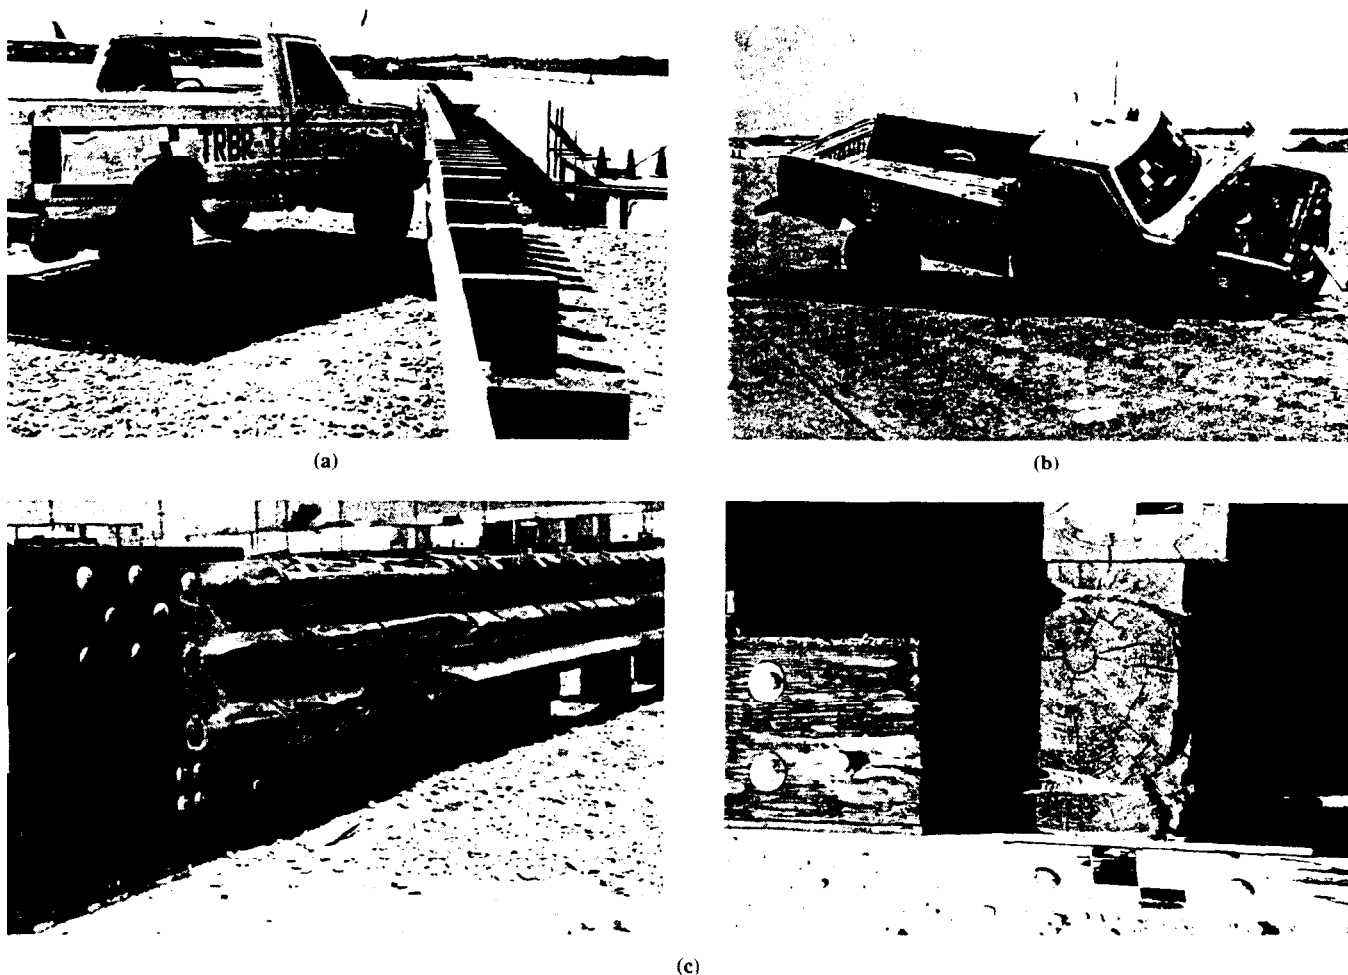
FIGURE 7 Test TRBR-3: (a) impact location, (b) vehicle damage, and (c) approach guardrail transition damage.

The first crash test, Test TRBR-3, was successfully performed with a 1987 Ford F-250, ¾-ton pickup truck with a test inertial mass of 2029 kg and at impact conditions of 104.9 km/h and at an angle of 26.4 degrees. During impact, the vehicle exited the transition system at a speed of 71.1 km/h and at an angle of 11.9 degrees. The maximum lateral permanent set deflection and the dynamic rail deflection were observed to be 35 and 163 mm, respectively. The location of vehicle impact with the approach guardrail transition, vehicle damage, and barrier damage are shown in Figure 7.

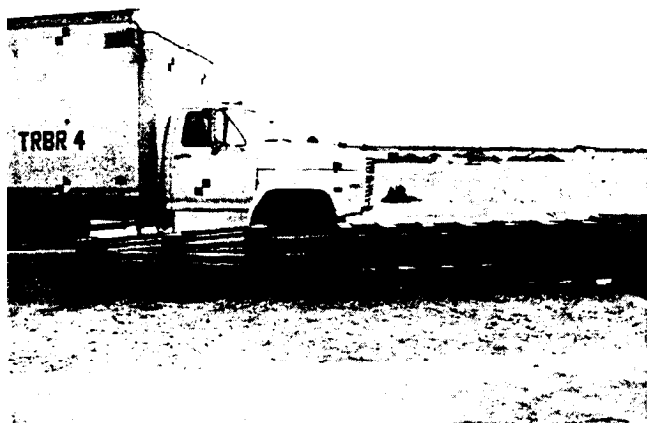
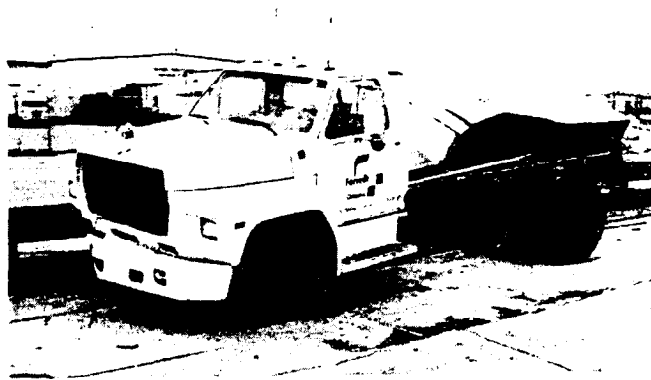
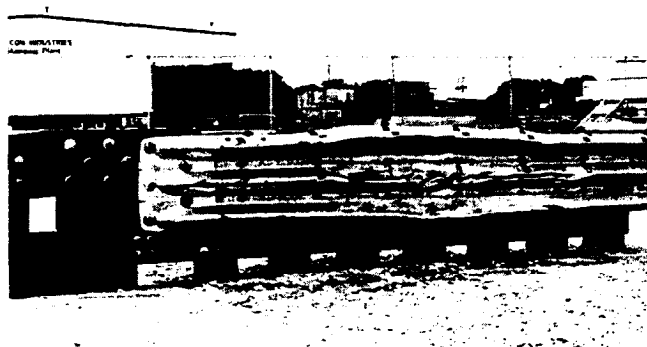
FIGURE 8 Test TRBR-4: (a) impact location, (b) vehicle damage, and (c) approach guardrail transition damage.

The second crash test, Test TRBR-4, was successfully performed with a 1988 Ford F-700 Series, single-unit truck with a test inertial mass of 8003 kg and at impact conditions of 82.5 km/h and at an angle of 13.7 degrees. During impact, the vehicle exited the transition system at a speed of 25.3 km/h and at an angle of less than 1 degree. The maximum lateral permanent set deflection and the dynamic rail deflection were observed to be 49 and 124 mm, respectively. The location of vehicle impact with the approach guardrail transition, vehicle damage, and barrier damage are shown in Figure 8.

During the impact event, a failure occurred in the connection hardware between the truck box and the steel frame that caused the box to release from the frame and travel over the bridge railing. From an analysis of the high-speed photographs, it was evident that this failure occurred after the truck had reached the bridge railing region and was not a result from any specific contact with components of the approach guardrail transition. Because a single-unit truck had successfully performed on the bridge railing system and no vehicle snagging had occurred in the transition region, the researchers determined that a retest was not required. Further investigation revealed that the release of the truck box resulted from an inadequate number and size of steel connection hardware.

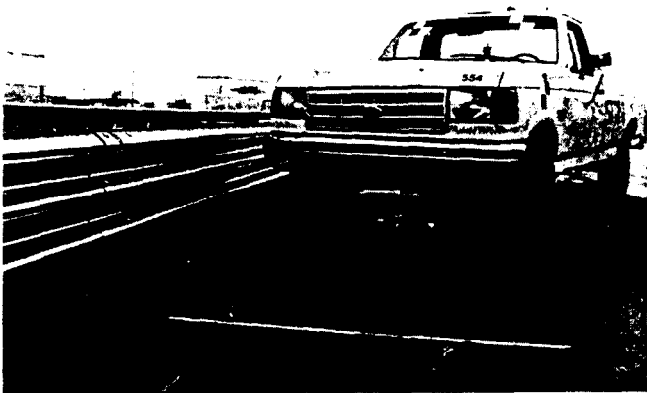
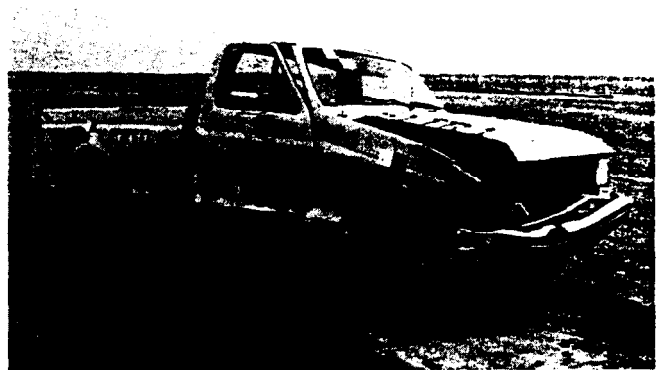
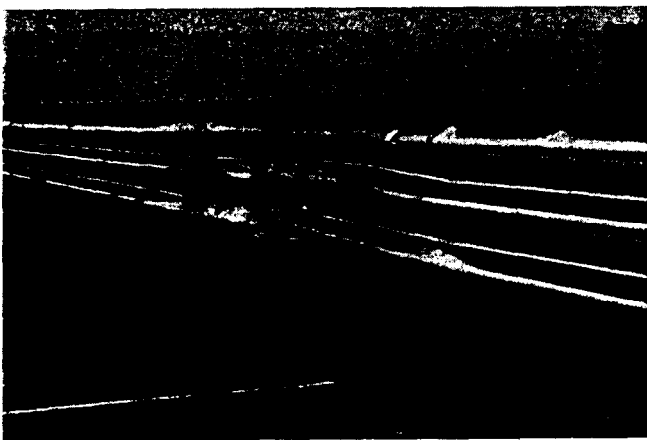
FIGURE 11 Test STTR-1: (a) impact location, (b) vehicle damage, and (c) bridge railing damage.

The first crash test, Test STTR-1, was successfully performed with a 1990 Ford F-250, ¾-ton pickup truck with a test inertial mass of 1994 kg and at impact conditions of 93.7 km/h and at an angle of 25.5 degrees. During impact, the vehicle exited the railing system at a speed of 62.3 km/h and at an angle of 1.5 degrees. The maximum lateral permanent set deflection and the dynamic rail deflection were observed to be 92 and 137 mm, respectively. The location of vehicle impact with the bridge railing, vehicle damage, and barrier damage are shown in Figure 11.

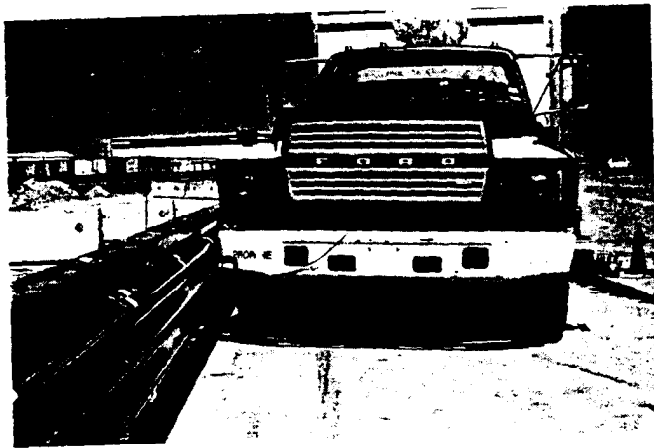
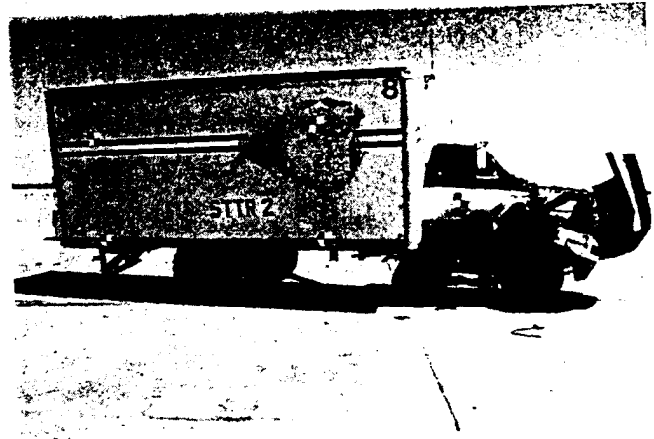
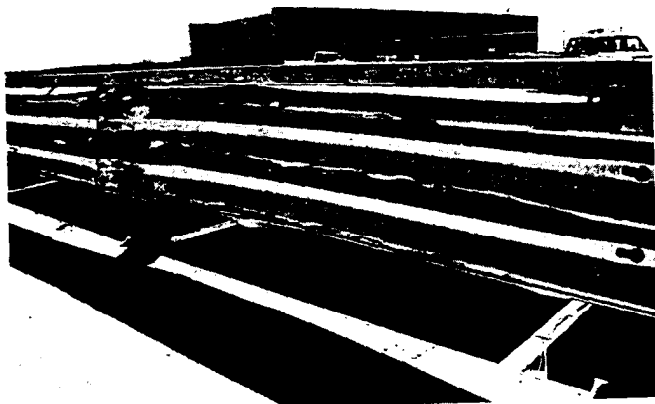
FIGURE 12 Test STTR-2: (a) impact location. (b) vehicle damage, and (c) bridge railing damage

The second crash test, Test STTR-2, was successfully performed with a 1985 Ford F-800 Series, single-unit truck with a test inertial mass of 8067 kg and at impact conditions of 76.1 km/h and at angle of 14.6 degrees. During the impact, the vehicle exited the railing system at a speed of 63.6 km/h and at an angle of less than 1 degree. The deflection of the maximum lateral permanent set rail was observed to be 136 mm. The location of the vehicle impact with the bridge railing, vehicle damage, and barrier damage are shown in Figure 12

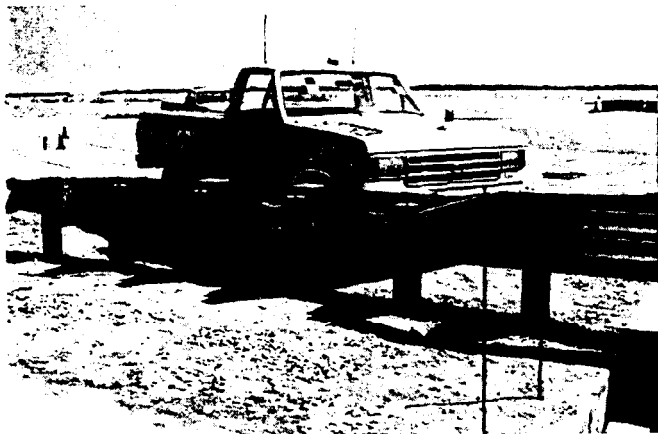
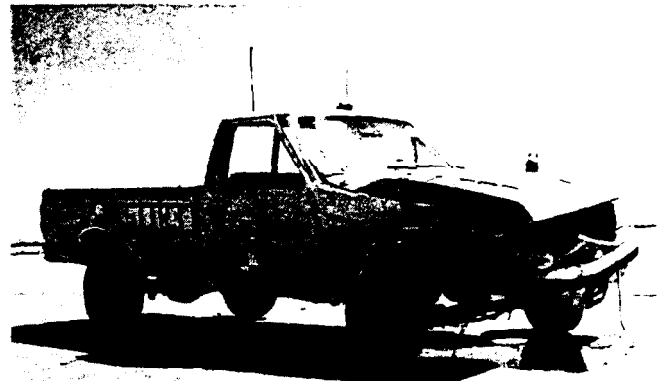
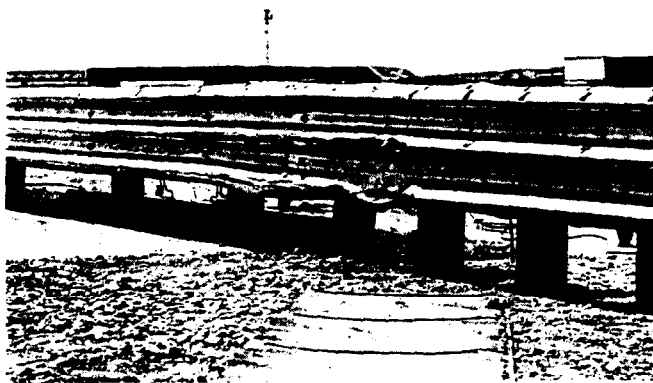
FIGURE 13 Test STTR-3: (a) impact location, (b) vehicle damage, and (c) approach guardrail transition damage.

The first crash test, Test STTR-3, was successfully performed with a 1985 Ford F-250,  $\frac{3}{4}$ -ton pickup truck with a test inertial mass of 1997 kg and at impact conditions of 101 km/h and at an angle of 25.6 degrees. During impact, the vehicle exited the transition system at a speed of 73.5 km/h and at an angle of 4.9 degrees. The maximum lateral permanent set deflection and the dynamic rail deflection were observed to be 67 and 143 mm, respectively. The location of vehicle impact with the approach guardrail transition, vehicle damage, and barrier damage are shown in Figure 13.

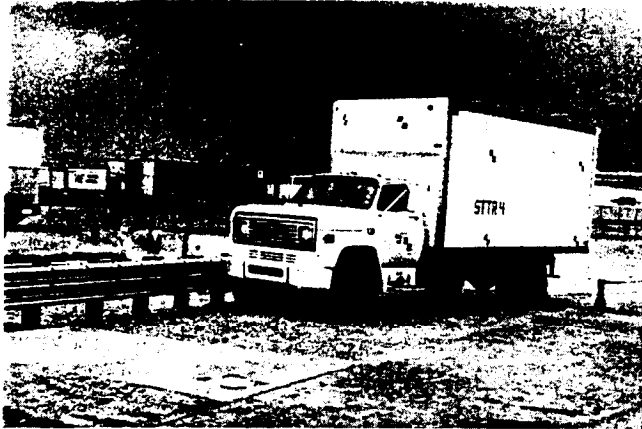
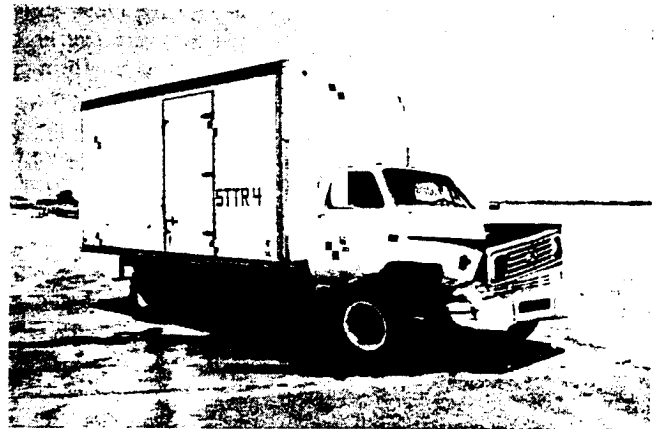
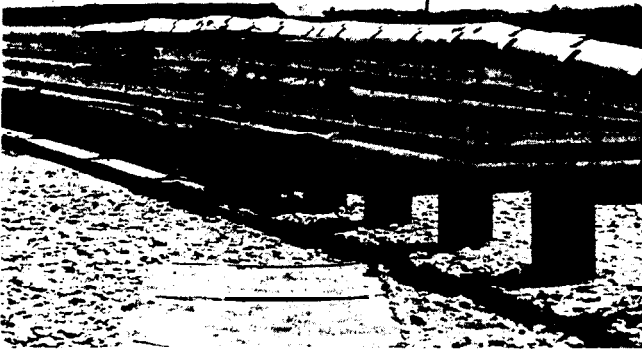
FIGURE 14 Test STTR-4: (a) impact location, (b) vehicle damage, and (c) approach guardrail transition damage.

The second crash test, Test STTR-4, was successfully performed with a 1988 Chevrolet C60, single-unit truck with a test inertial mass of 8006 kg and at impact conditions of 81.8 km/h and at an angle of 15.2 degrees. During impact, the vehicle exited the transition system at a speed of 65.2 km/h and at an angle of 7.8 degrees. The maximum

lateral permanent set deflection and the dynamic rail deflection were observed to be 38 and 93 mm, respectively. The location of vehicle impact with the approach guardrail transition, vehicle damage, and barrier damage are shown in Figure 14.
