[Proceedings of the 7<sup>th</sup> International Conference on HydroScience and Engineering  
Philadelphia, USA September 10-13, 2006 \(ICHE 2006\)](#)

## EVALUATION OF THE LONG TERM IMPACTS OF AN INFILTRATION BMP

Andrea L. Welker<sup>1</sup>, Matthew Gore<sup>2</sup>, and Robert Traver<sup>3</sup>

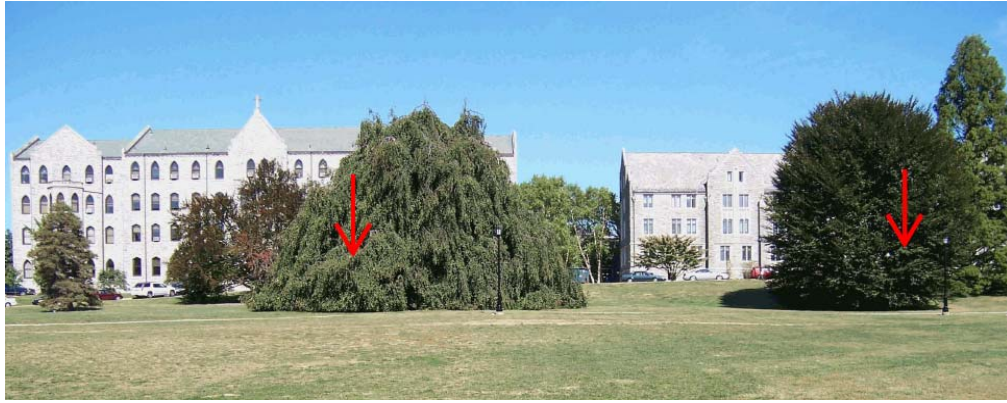
Figure 1 Photograph of the Site Facing North from Lancaster Avenue

Originally, four pits existed in the area to collect and infiltrate storm water off of Tolentine Hall (building to the left in Figure 1) and St. Thomas Monastery (building to the right in Figure 1). We found through our investigations that two of the pits had been replaced by large box culverts and no longer function as seepage pits. Currently, all stormwater is being routed to these two box culverts. The locations of the two remaining pits are indicated by arrows on Figure 1. To facilitate our discussion, the pits have been named based on their proximity to the Monastery and Tolentine and will here in after be referred to as either the Monastery or Tolentine pits.

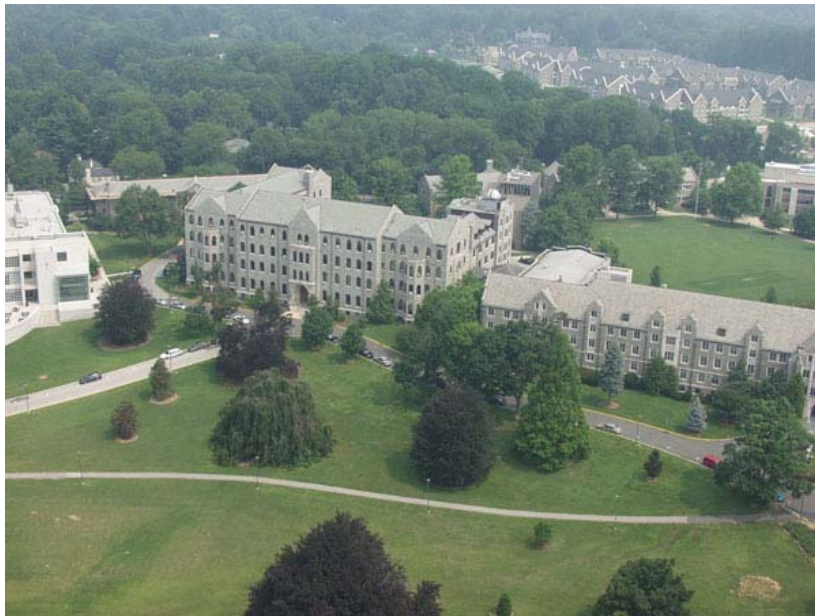
Figure 2 Top View of Site

The pits are below ground located on the hill side that descends off the driveway in front of Tolentine Hall and the Monastery and onto the open field between the aforementioned buildings and Lancaster Avenue (US. 30). Figure 2 shows a top view of the site.
