Study of effectiveness of experimental marking and signs in speed management

Abstract. The paper presents the evaluation of effectiveness of non-standard road marking and signs (ES) in speed management. Transverse strips, speed limit signs dedicated to selected lanes, non-standard sign, which inform about slippery pavement at motorway curve during the rain. were analysed. Based on survey, degree of understanding of the content of analysed marking and signs by road users was assessed. Empirical studies allowed for evaluation of change in speed caused by non-standard marking and signs implementation. Results show that non-standard marking and signs can be effective speed management measures. The paper also point out problems in evaluation of ES implementation.

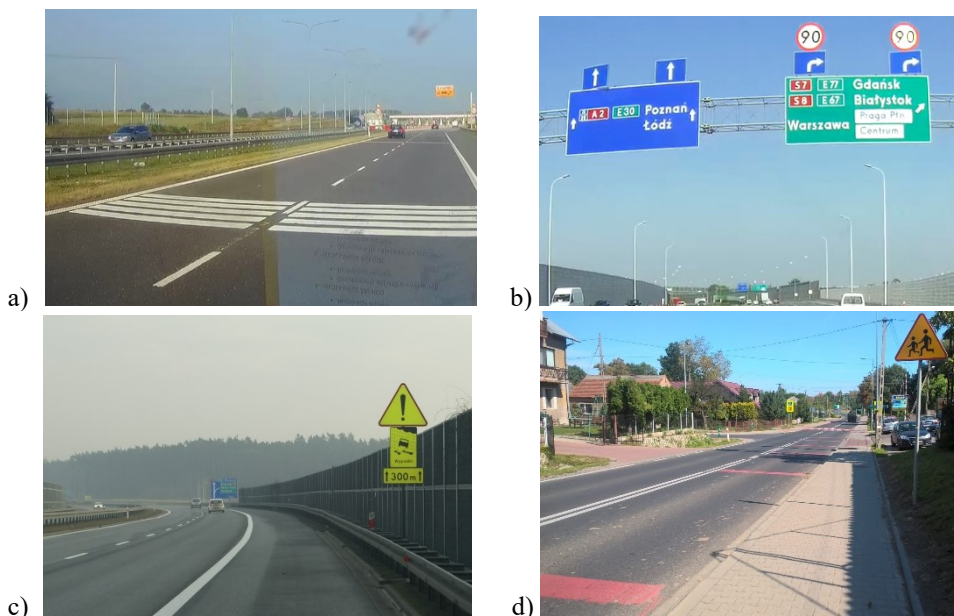
Fig. 1. Analysed non-standard road marking and signs: a) transverse strips on approach to toll plaza; b) speed limit signs dedicated to selected lanes (located above the lanes); c) non-standard sign of hazardous curve; d) red transverse strips on approach to crosswalk.

- transverse strips located on approaches to two toll plazas “Strykow” and “Zdzary” on A2 motorway (marking is located on the pavement in the approach to toll plaza, Fig. 1a);
- transverse strips combined with speed limit signs dedicated to selected lanes (located above the lanes) in the approach to interchange ramp on A1 motorway (Fig. 1b);
- non-standard sign of hazardous curve on A4 motorway (Fig. 1c);
- red transverse strips on approach to crosswalk in Biorkow Maly and Poskwitow villages (Fig. 1d).

Non-standard sign of hazardous curve consists of a few standard signs. Only the background of the sign is changed, therefore that sign was not the subject of the survey. It was assumed that sign shown in Fig. 1c should be understood by the drivers.

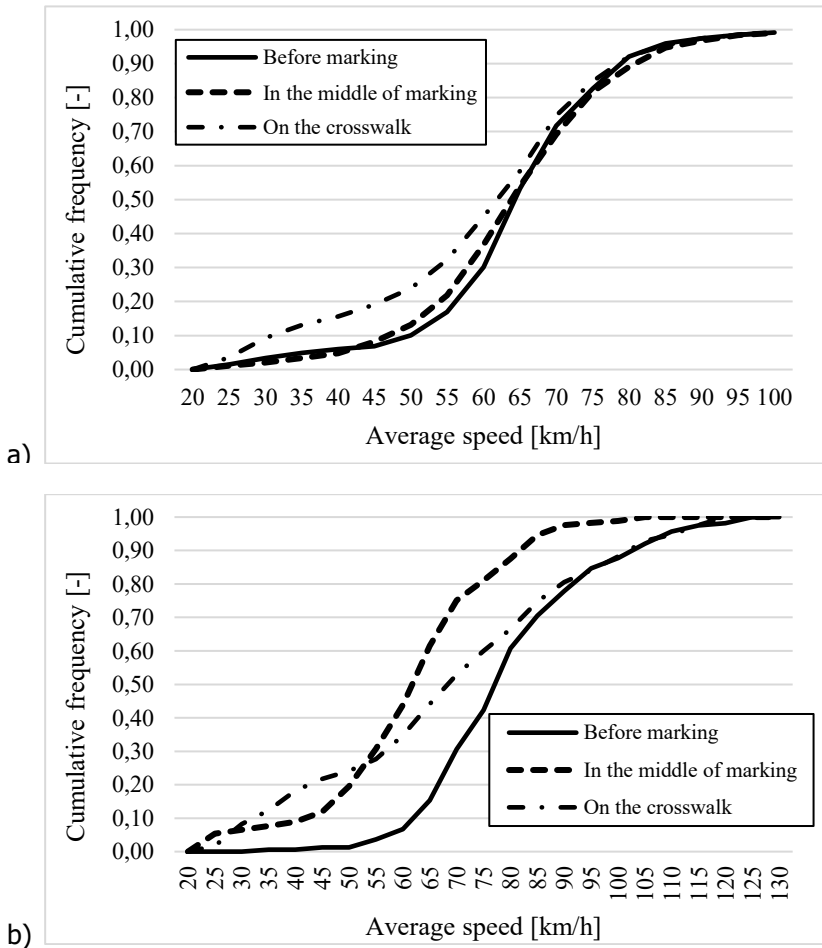
Fig. 2. Speed distributions on approaches to crosswalks with red transverse strip: a) Biorkow Maly city; b) Poskwitow villages.

The impact of red transverse strip on approaches to crosswalks was analyzed based on free flow speed distributions at the following sections: "before" transverse strips; "in the middle" of transverse strips; at crosswalk (Fig. 2).

Results show a statistically significant difference in average speed at crosswalks in comparison to the average speed "before" transverse strips. Average speed decreased by 15,5-27,5km/h (29-43%). At control crosswalks speed increased by 3,5km/h (6%) [10]. Despite the reduction of the average speed, the share of drivers exceeding the speed limit (50km/h) is 87-99% in section "before" transverse strips and 76% at crosswalks. Described results
