**FLEXURAL BEHAVIOR OF INTERLOCKING COMPRESSED EARTH BLOCK  
SHEAR WALLS SUBJECTED TO IN-PLANE LOADING**

A Thesis  
Presented to the Faculty of  
California Polytechnic State University,  
San Luis Obispo

In Partial Fulfillment  
of the Requirements for the Degree of  
Master of Science in Civil and Environmental Engineering

by  
Bradley James Stirling  
July 2011

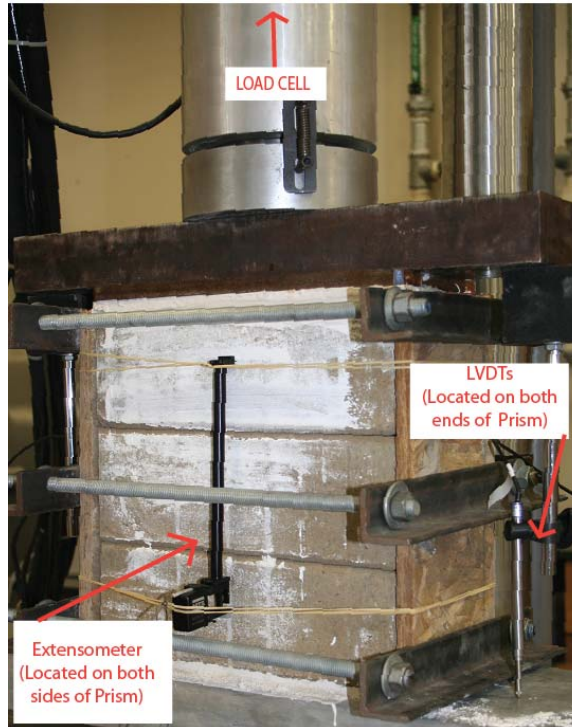
**Figure 3-3: Masonry prism test setup**

The compressive strengths of the tested prisms are summarized in Table 3-4 and the corresponding strain-stress curves are included in Figure 3-4. The cross-sectional area associated each fully grouted prism is 45,000 mm<sup>2</sup>. All of the tested prisms experienced a similar failure mode of to that of an ungrouted ICEB blocks. At the beginning of each test diagonal compression cracking was observed in the prism, followed by conical spalling on the unconfined sides of the prism, followed by the vertical crushing of the prism.

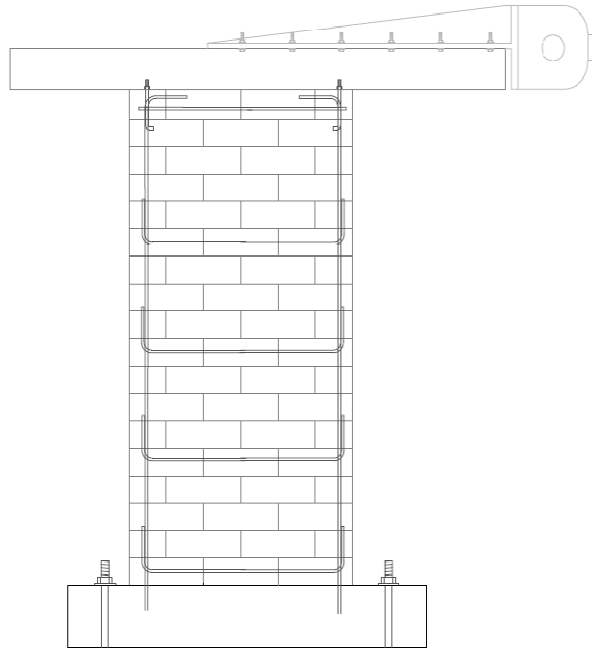
W4 is a 1.8 meter tall and 0.9 meter long wall with a 2:1 height-to-width aspect ratio designed to investigate the effect of aspect ratio on ICEB walls. To focus on the impact of wall aspect ratio on its seismic behavior, the only variable changed from W3 (tested in the companion thesis) to W4 was the aspect ratio, done by essentially building half of W3. The procedure presented in Section 4.2 outlines and explains the steps taken to build W4 and the rationale behind the manner in which the wall was constructed, while the overall reinforcing pattern is shown in Figure 4-1.

**Figure 4-1: W4 reinforcing pattern**

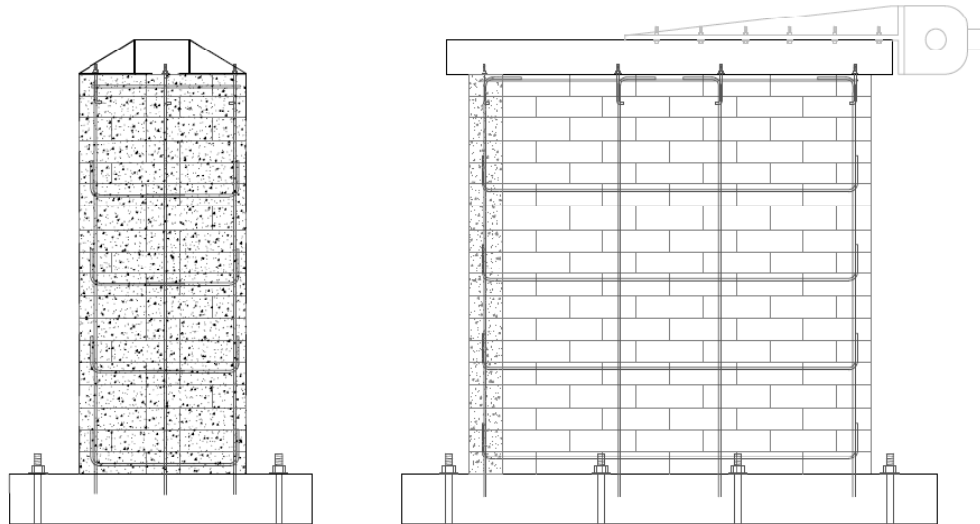
design decision in which the wall was constructed, while the overall reinforcing pattern is shown in Figure 4-2.

**Figure 4-2: W5 reinforcing pattern**

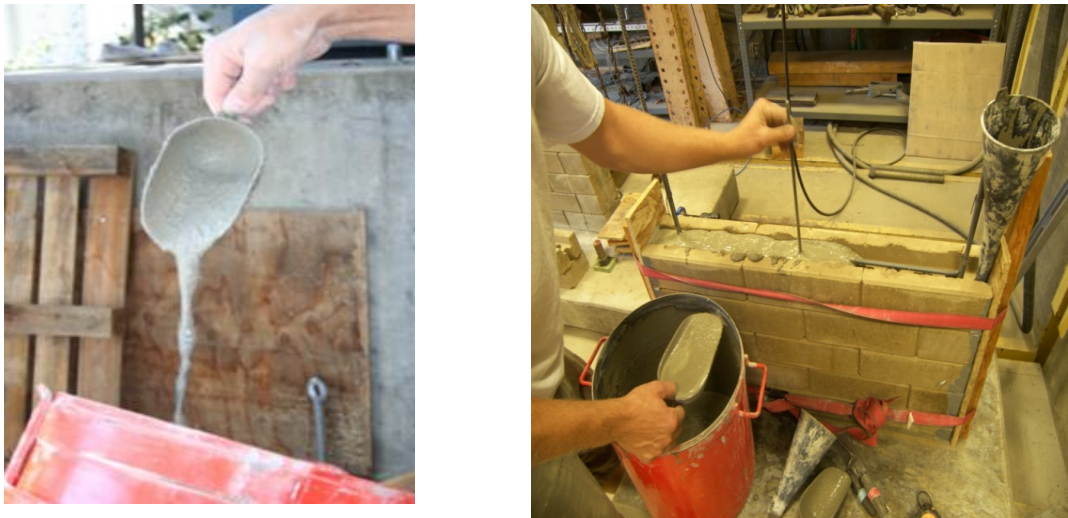
**Figure 4-5: Grout used in specimen construction**

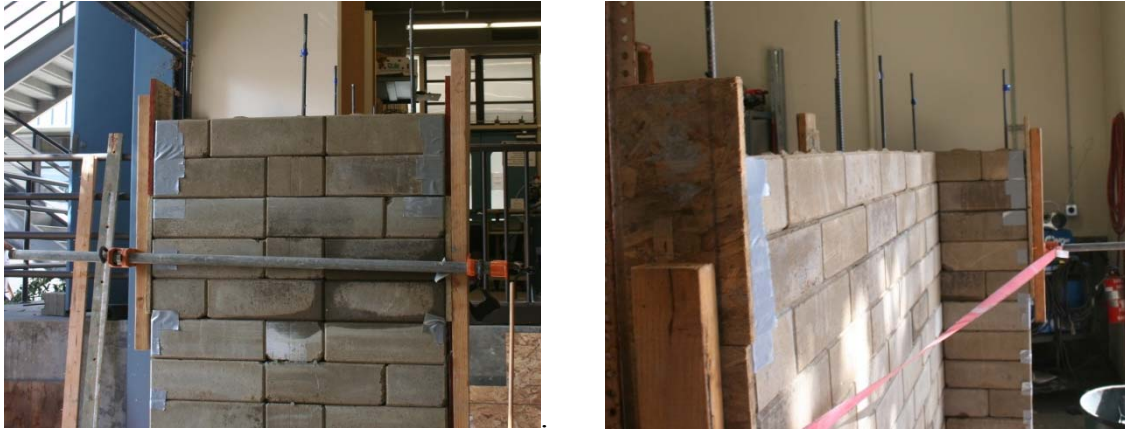
outsides had the form built up around the outside grout channel. The top channel was left open to provide a layer of reinforcement and the mortar which would be used to fill the channel of the eighteenth course and bond the steel loading beam to the wall.

**Figure 4-14: Courses 17 and 18 in the flange (left) and web (right) of W5**

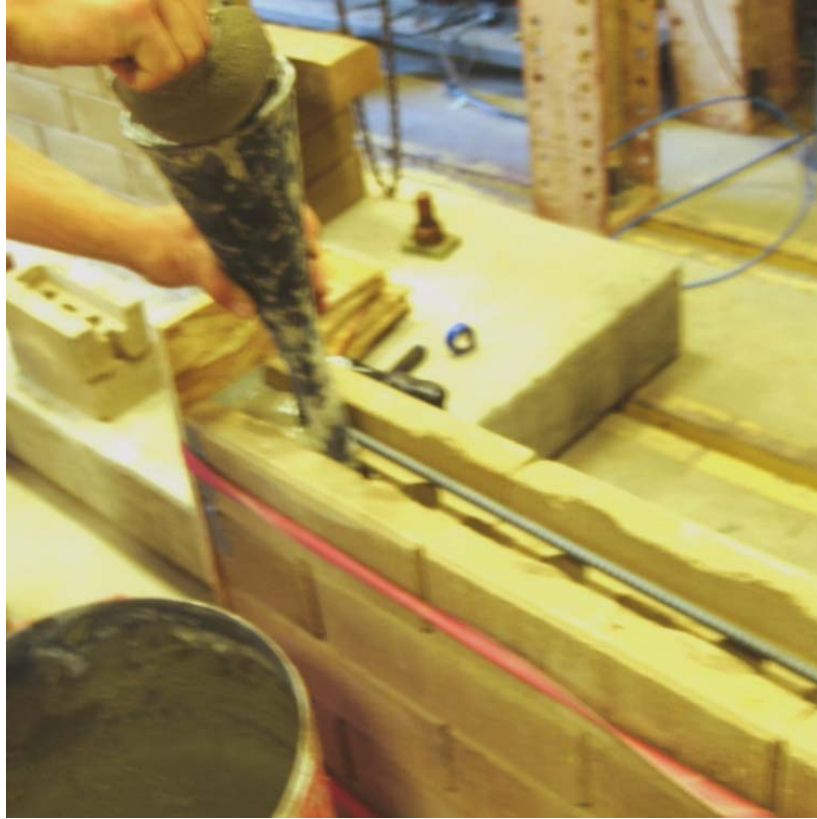
Courses 2 and 3 of the wall were dry stacked using the running bond pattern, making the second course all full block and the third course having half blocks on either end of the wall, similar to the first course. The fourth course consisted of all channel blocks and would become the bottom layer of the window. These blocks were laid in a pattern similar to that of course 2 and the transverse reinforcement was again hooked around the two outside bars (rebar A and D) using 180 degree hooks with 150 mm tails. Duct tape was taped to the end of the blocks of the wall, and plywood boards cut to the width of the ICEB were butted against either end of the wall. Ratchet-straps were then strapped around the length of the specimen to prevent the grout from pouring out on either end. Fluid grout was then poured into each hole and rodded 3 to 5 times to prevent any air voids which can be seen in Figure 4-19. The wet mortar which filled the channel was then smoothed using a trowel for esthetic purposes.

**Figure 4-19: Courses 1-4 of W6 being grouted**

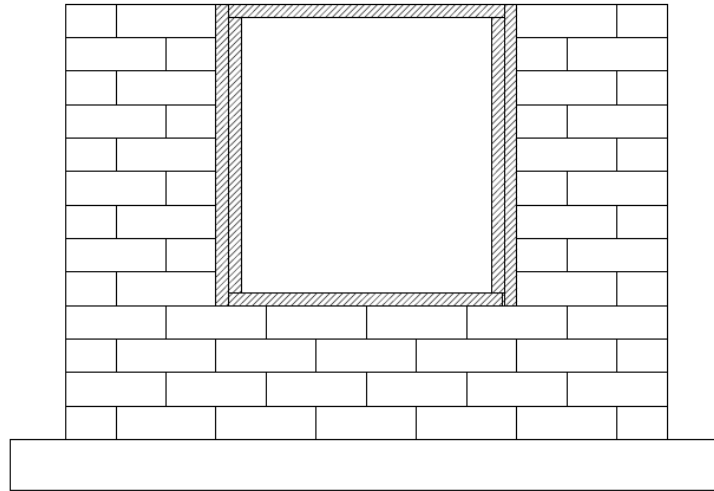
were nailed to the outer pieces supporting the top and bottom pieces of the frame, allowing a flat bridge across the top of the window to keep the header level.

**Figure 4-20: Schematic of the timber frame for the window**

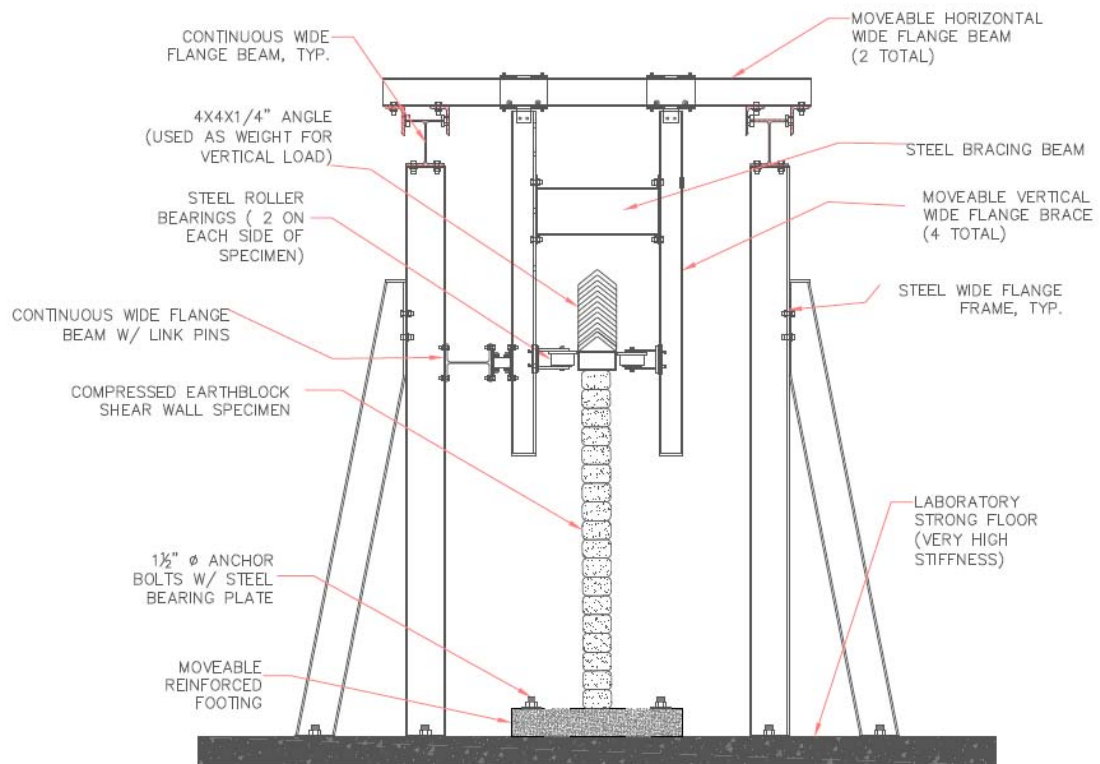
5-2. Rollers attached to the wide flange vertical members restrained the wall in the out-of-plane direction at either end, but allowed the wall to translate in plane. W4 and W6 used two sets of vertical bracing beams, one at each end of the wall, as shown by Figure 5-2. The addition of the flange to W5 negated the need for the second set of braces at the flange end of the wall; as the flange was assumed to prevent the wall web from rotating out of plane. During the testing of W5 only one set of vertical braces were used as shown in Figure 5-3.

**Figure 5-2: Test set-up for testing of W4 and W6 (Out-of-plane)**

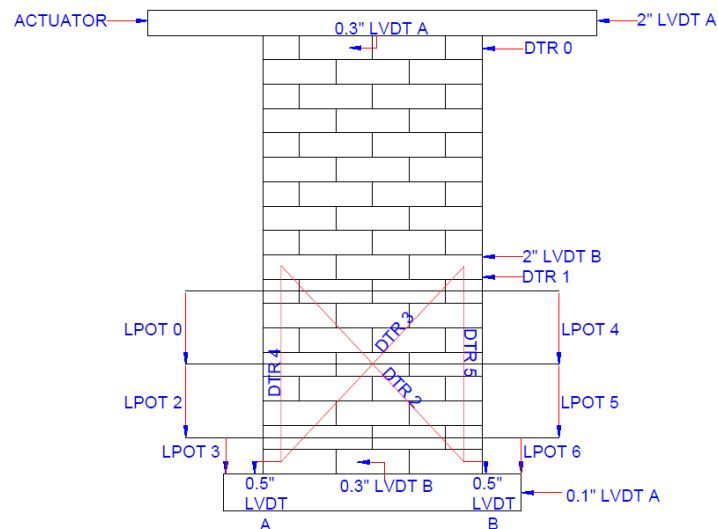
Specimen W4 was expected to exhibit flexure dominant behavior for which the majority of the damage would occur in the bottom half of the wall. As such, the instrumentation was focused on the bottom half of the wall. DTRs 2 through 5 were configured to measure the shear deformation on the bottom half of the wall by mounting the instruments to studs epoxyed into the wall. Two 0.5" LVDTs (0.5" LVDTs A and B shown in Figure 5-5), set at either toe of the wall, measured the uplift at each corner of the wall. Lateral deflections were captured by DTRs 0 and 1 which measured displacements at the top (below the loading beam) and midpoint of the wall respectively. To capture flexural displacements at the bottom half of the wall the six LPOTs were attached to angle irons, which extended on either side of the wall to increase the resolution of the instruments. All six LPOTs were attached to the 1550 mm long angle irons which were bolted to the studs epoxyed in the wall. Figure 5-5 shows the configuration of the instruments arranged on W4.

**Figure 5-5: Instrumentation configuration of W4**

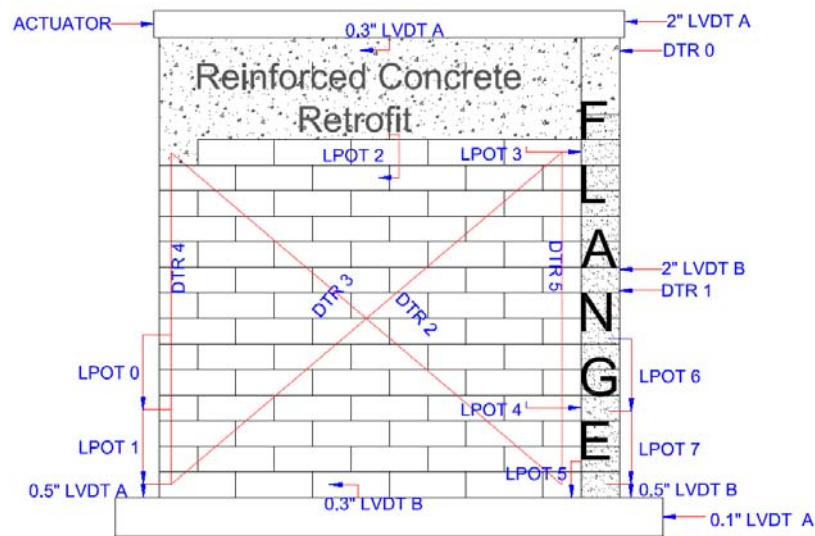
As described in detail in Chapter 6, an unexpected mechanical failure occurred at the initial stage of the testing of W5. The specimen was then repaired and subjected to retests. The configurations of some of the instruments were modified slightly in the repaired specimen due to the change in geometry of the wall. DTRs 2 through 5 were moved four courses down, below the reinforced concrete segment shown in Figure 5-7 to capture the behavior of the masonry. In order to determine whether movement occurred between concrete retrofit and the masonry wall, LPOT 3 was moved from measuring vertical movement of the flange to measuring slip between the reinforced concrete segment and the rest of the wall. Figure 5-7 shows the configuration of which the instruments were arranged on W5 after the retrofit.

**Figure 5-7: Instrumentation configuration of W5 after reinforced concrete retrofit**

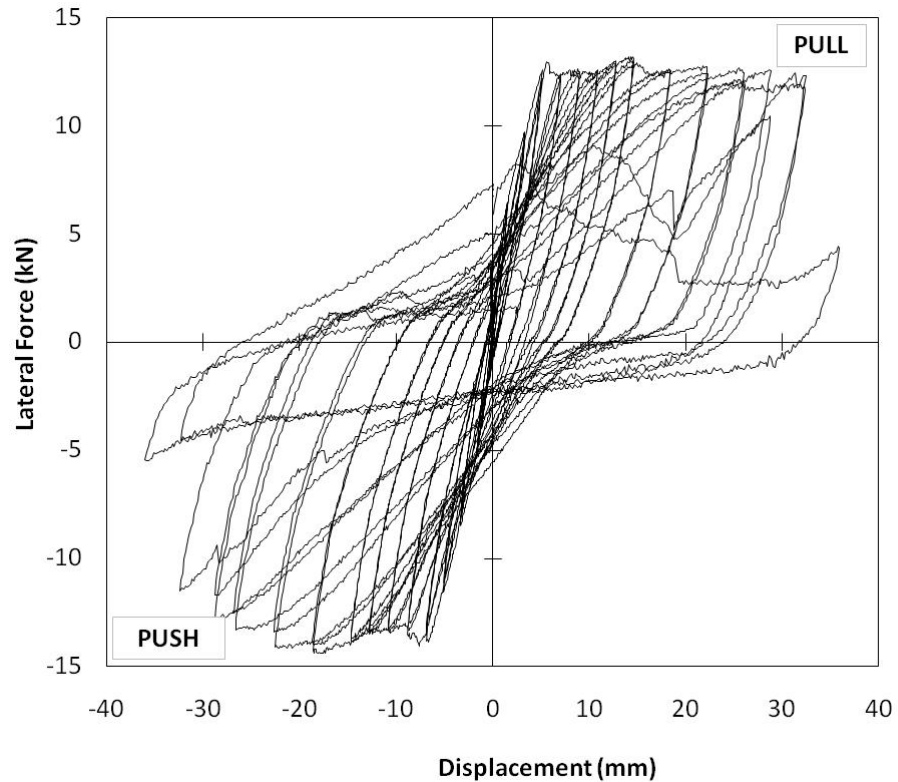
The wall resisted 9% more force in the push direction than in the pull direction as described by the force and displacement relationship depicted in Figure 6-2. It is noted that there are many reasons which may have contribution to this observation (e.g. horizontal slip deformation at footing, initial imperfection of construction, non-uniform property of the construction materials; and possible premature failure at wall base resulting in slight uplift deformation of the wall at the tension side). However, to further quantify their impacts is beyond the scope of this thesis given that the resistance difference is within the acceptable range from the perspective of engineering design. The following sections describe in detail the observed behavior of W4 at different deformation levels.

**Figure 6-2: Hysteresis of W4**

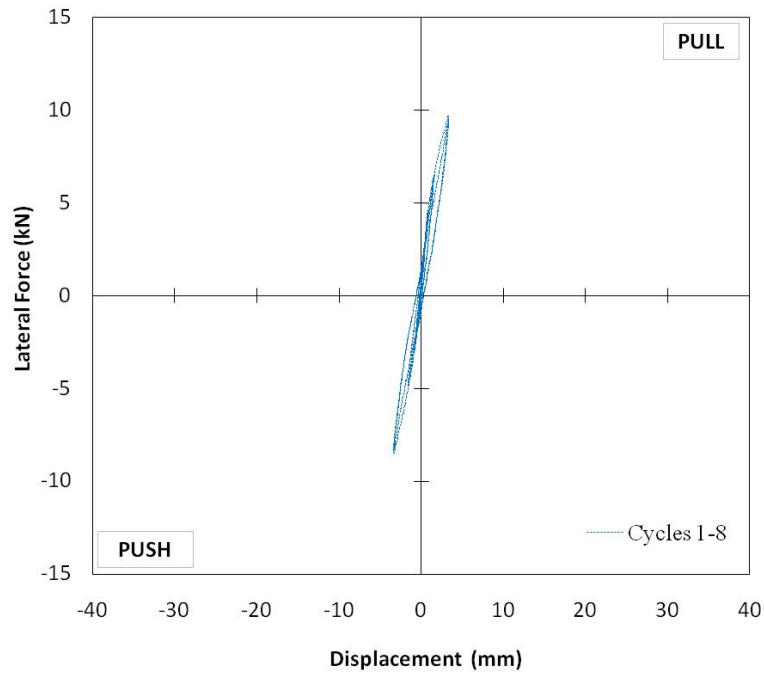
where two distinct paths can be seen. These two distinct paths, making the loops appear thicker, indicated that energy dissipation was beginning to occur. Although, the start of energy dissipation was observed in Cycle 8, the wall is primarily in the elastic region based on the almost linear relationship of the force displacement curve.

**Figure 6-3: Hysteresis of W4 Cycles 1 through 8**

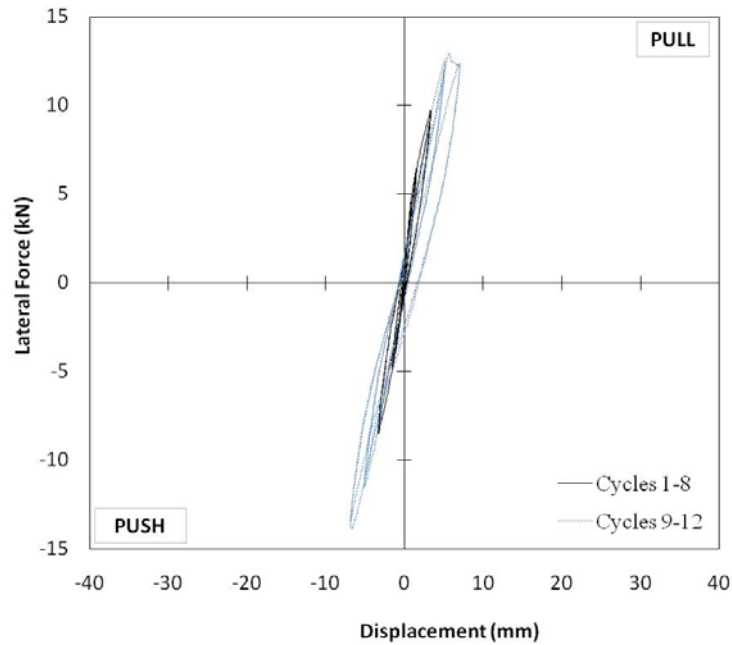
**Figure 6-4: Hysteresis of W4: Cycles 1 through 12**

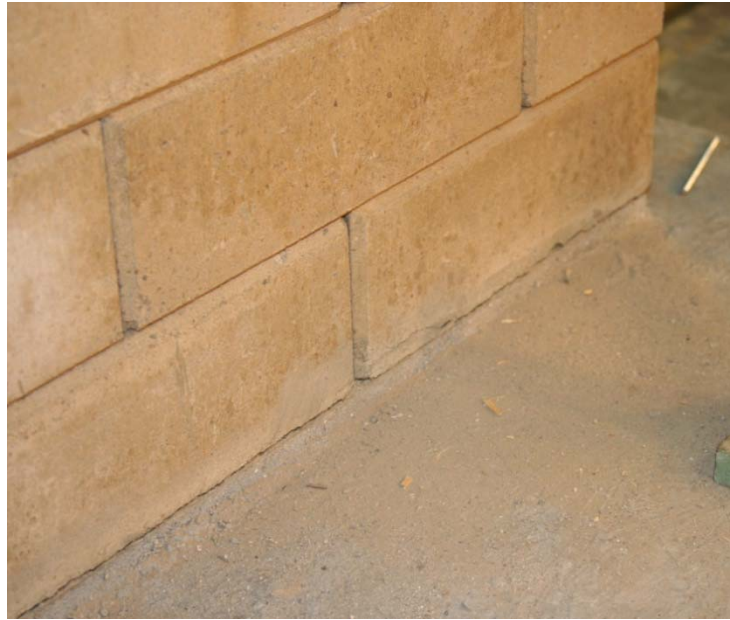
around the base of the wall. The cracking of the toe, in addition to the yielding of the rebar, resulted in the first considerable energy dissipation observed in the test.

**Figure 6-5: Cracking at the base of W4 during Cycle 10**

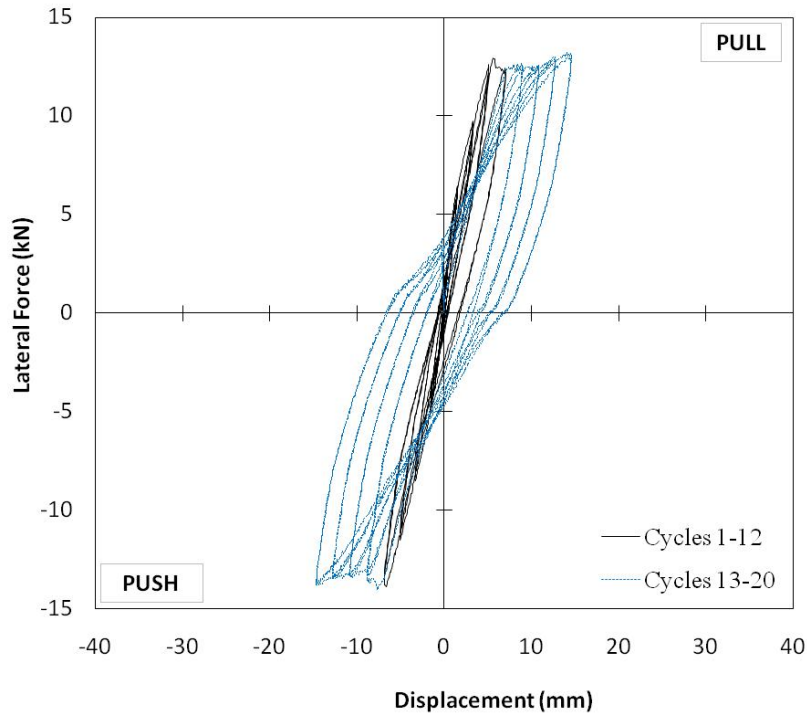
In Cycles 13 through 20, corresponding to displacements of 10mm through 16mm, the maximum horizontal resisting force observed in each cycle was about 13.2 kN ( $\pm 0.5$  kN) in the pull direction and 14.2 kN ( $\pm 0.5$  kN) in the push direction, demonstrating the stable resistance of the wall. Each successive cycle dissipated more energy than the preceding cycle, increasing at a proportional amount to the displacement. This trend can be observed in Figure 6-6 showing the hysteric loops of each of the cycles. It was also observed that with each progressive cycle, the zero force moves further from zero displacement.

**Figure 6-6: Hysteresis of W4: Cycles 1 through 20**

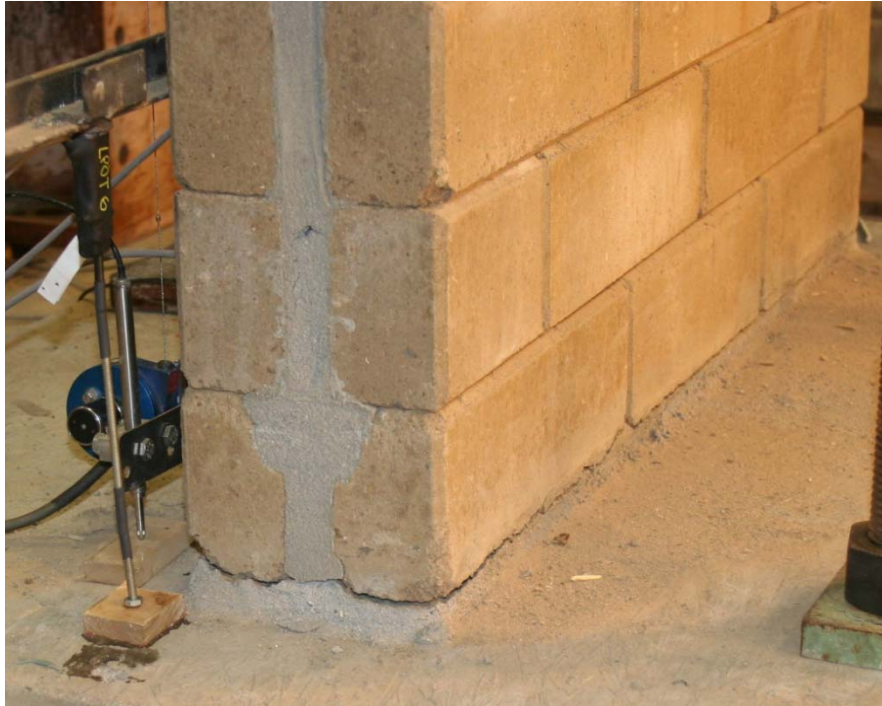
**Figure 6-7: Cracking around the base of W4**

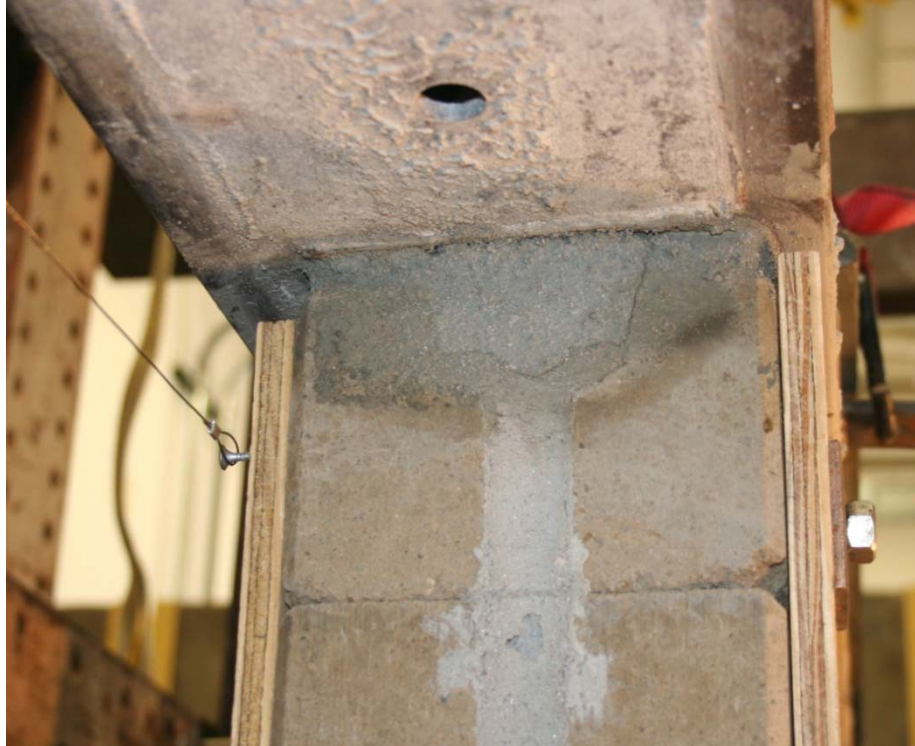
6-8. The cracking was first observed after the completion of Cycle 14 and became more pronounced after the completion of Cycle 16; however, there were no more changes throughout the rest of the wall testing. This crack, though prevalent to visual observation, appeared to have very little impact on the strength of the wall.

**Figure 6-8: W4 cracking around the grout channel and the loading beam**

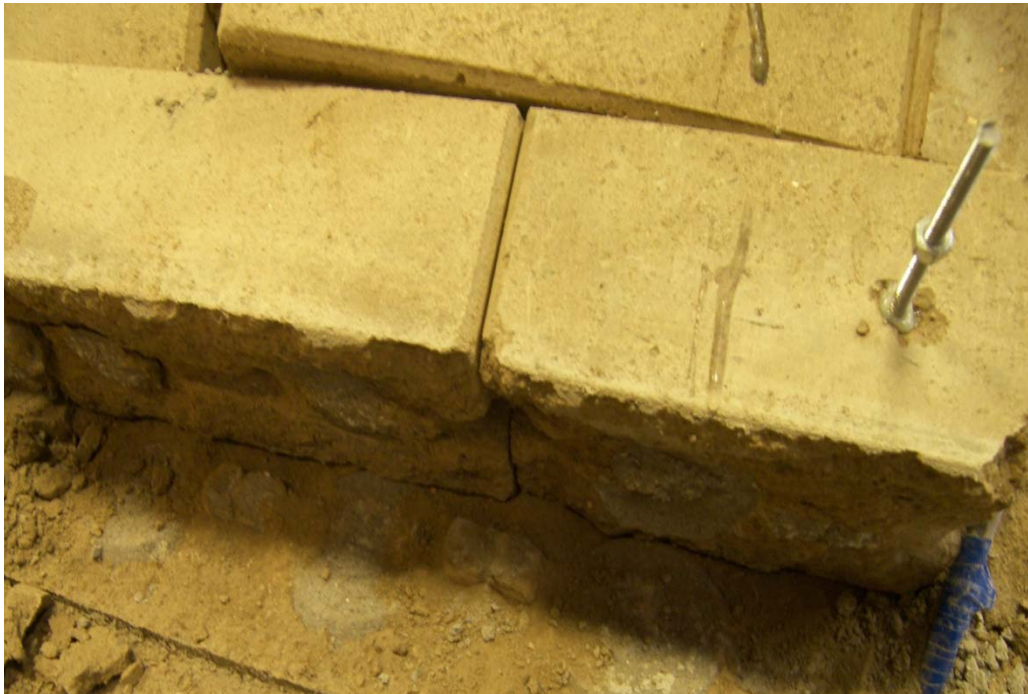
**Figure 6-9: Shearing between the bottom courses of W4 and the mortar in the footing**

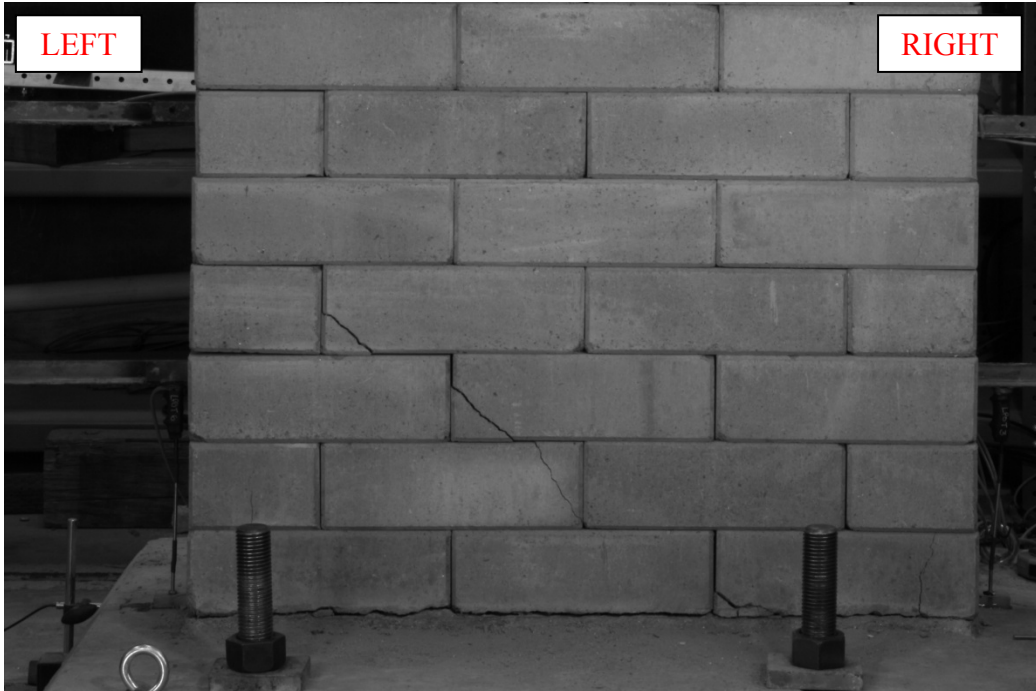
propagated from the vertical rebar on the left side of the wall to the shear rebar in the bottom course of the wall as shown in Figure 6-10. The shear cracks opened as the displacement increased and closed when the displacement returned to zero. It was observed that all the shear cracking took place in the bottom half of the wall. There was no sign of damage taking place above the midpoint of the wall.

**Figure 6-10: Shear cracking along the bottom of W4**

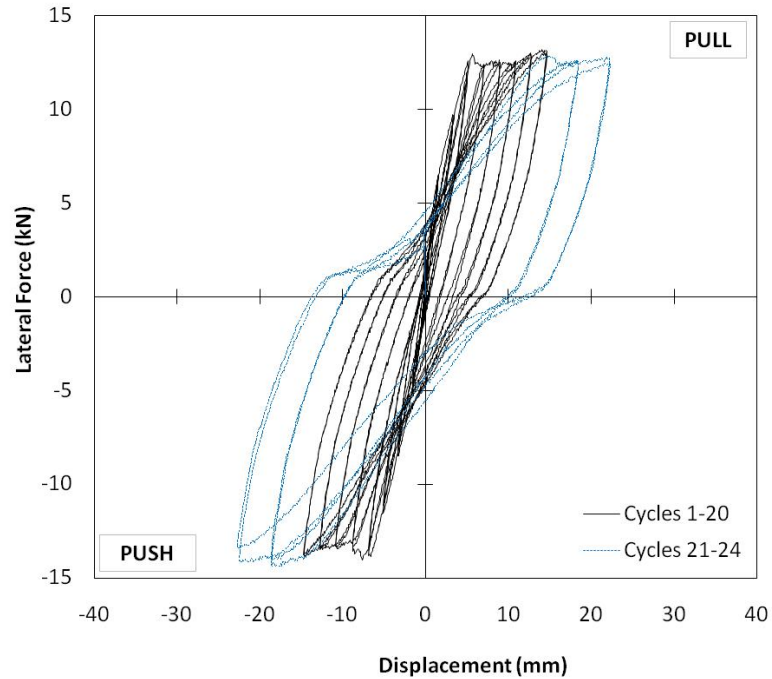
From the hysteresis shown in Figure 6-11, it can be observed that the shear cracking does not appear to have a significant impact on the strength of the wall. A small amount of strength degradation was observed in the pull excursion of Cycle 21, but the strength increased slightly in the push direction. When the wall was subjected to the push cycle, no shear cracking in the other direction was observed.

**Figure 6-11: Hysteresis of W4: Cycles 1 through 24**

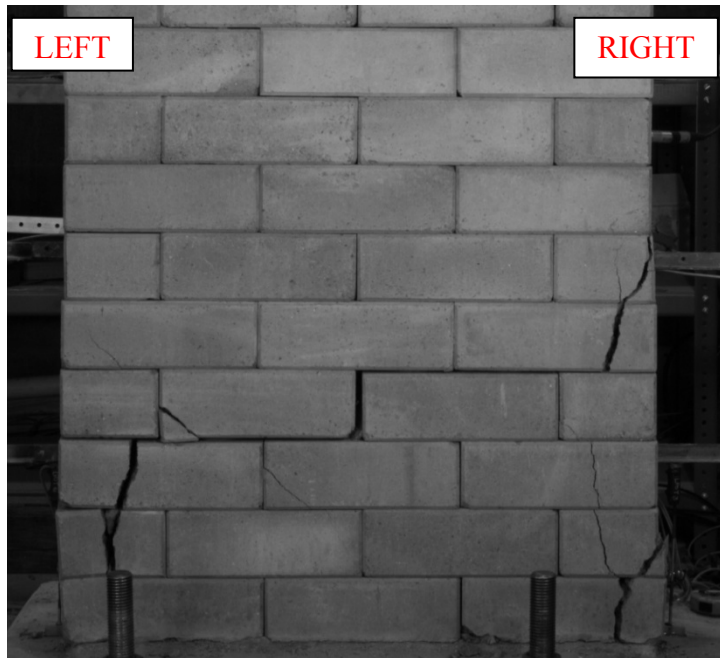
As shown in Figure 6-12, two other types of failure were also observed: sliding shear failure and progressive vertical cracking at the toe of the wall. The more notable of the two was the horizontal cracking. The horizontal cracking began to propagate from the base of the wall upwards almost immediately following the beginning of Cycle 21, and grew wider throughout the following cycles. The toe cracking, at either end of the wall, formed on both sides of the wall (back and front) and began to separate the toe from the rest of the wall as shown in Figure 6-13.

**Figure 6-12: Cracks in W4 in Cycles 21 through 24**

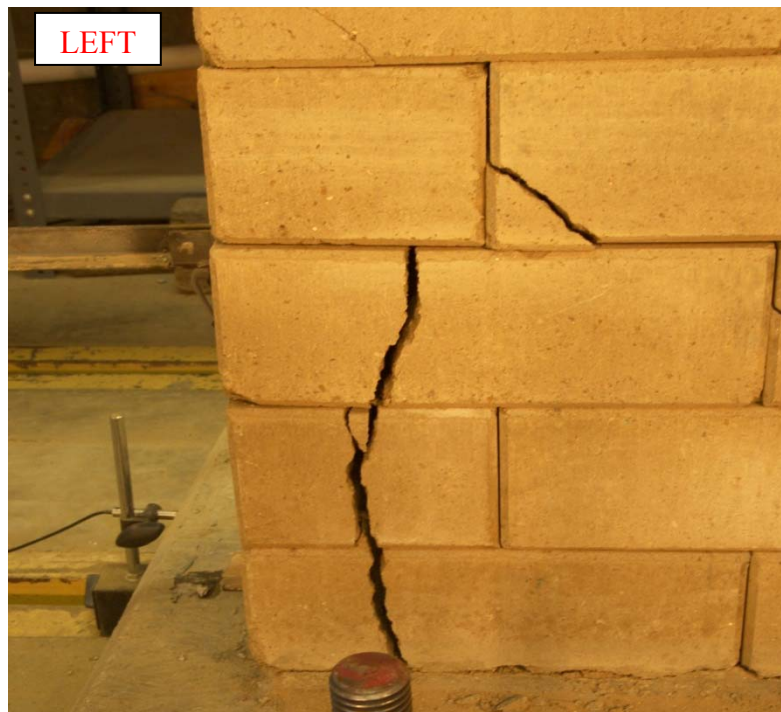
**Figure 6-13: Toe cracking of W4 in Cycle 24**

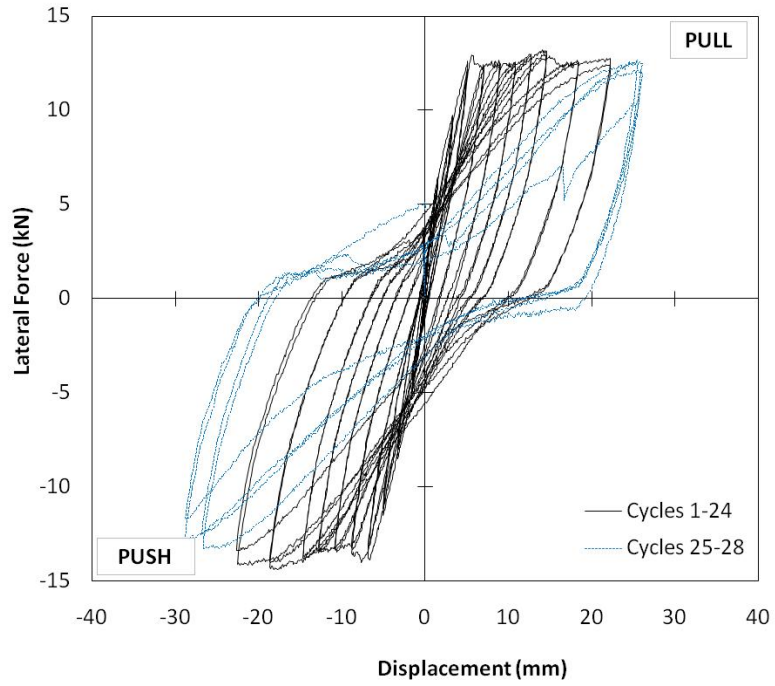
A significant dip in the hysteresis can be observed in the last push excursion of Cycle 28. The wall suddenly lost 1.85 kN of strength. This sudden loss in the strength was the result of the lower part of the toe suddenly opening up around the rebar. It is clear that prior to the fracture, little strength was provided by the toe, only stability. From the hysteresis shown in Figure 6-14, it can be observed that the stiffness had the similar slope before and after the strength reduction, indicating no significant change in stiffness.

**Figure 6-14: Hysteresis of W4: Cycles 1 through 28**

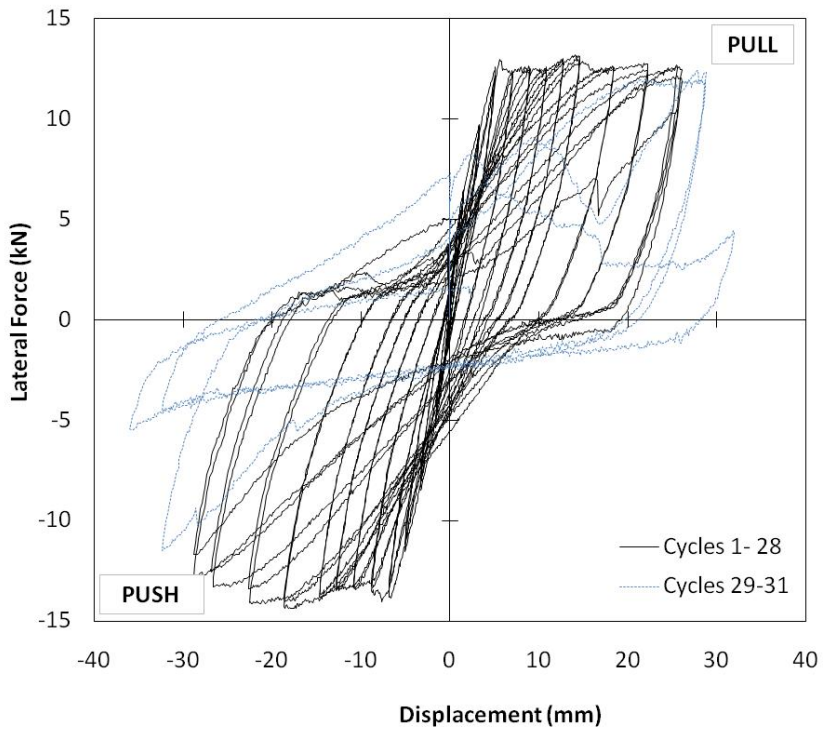
**Figure 6-15: Hysteresis of W4: Cycles 1 through 31**

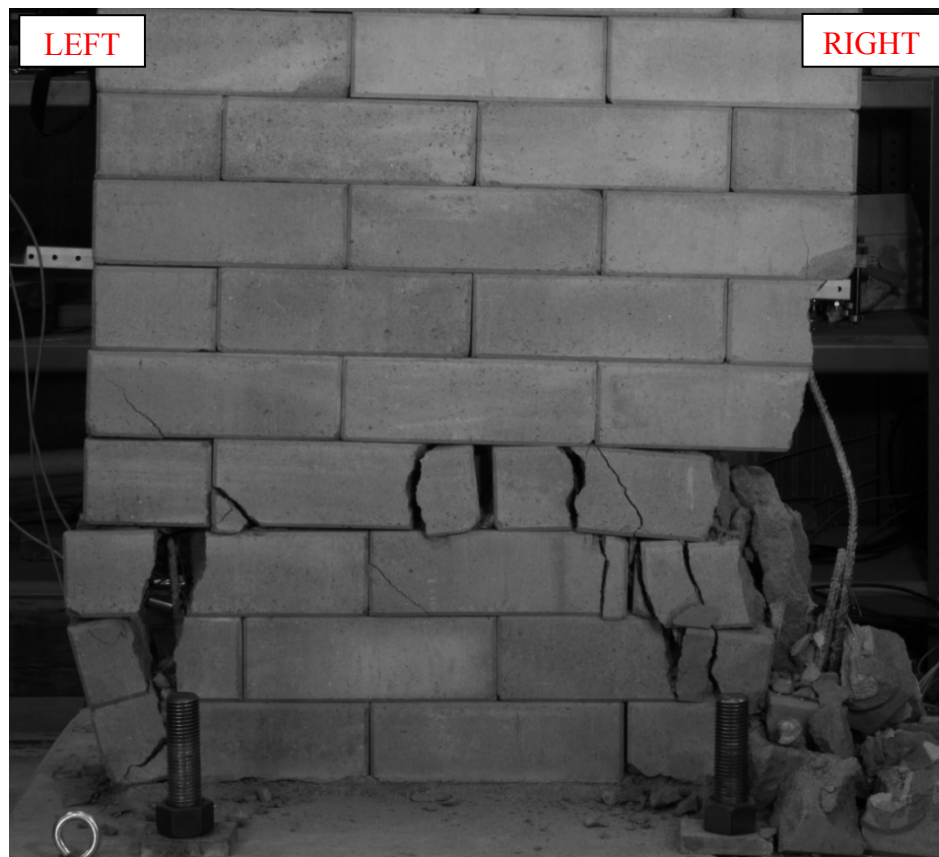
Due to the toe failure at the end of the Cycle 28, it was necessary to remove all external instruments before proceeding with Cycles 29 and 30. Although in excess of 20% strength loss was observed during Cycle 28, Cycles 29 through 32 were deemed necessary to investigate the ultimate behavior of the specimen. Cycle 29 caused the complete deterioration of the toe on both sides of the wall. Although the hysteresis shows similar strength degradation on either direction, the right side of the wall provides a more visible example of the failure mode as shown in Figure 6-16. Upon completion of Cycle 31, the trend of decreasing strength was clearly shown in Figure 6-15 and the test was concluded due to the instability of the wall.

**Figure 6-16: Complete degradation of toe due to Cycle 31**

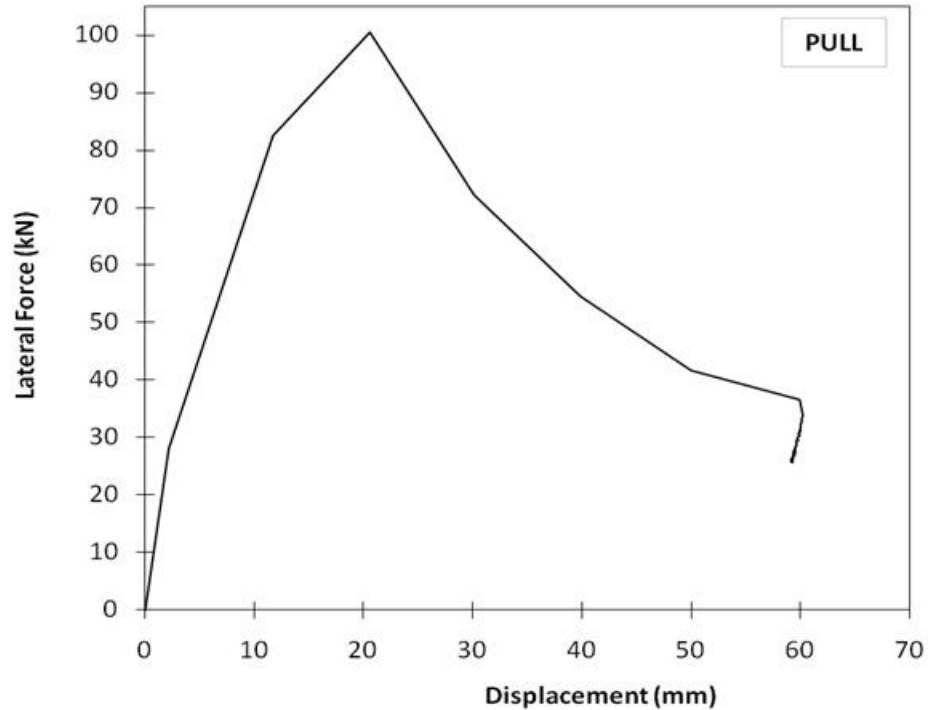
W5 was scheduled to be tested 24 days after construction. Following the test setup, a mechanical failure occurred while zeroing the instruments for testing. The actuator moved at rate of approximately 24 mm per second and was stopped at a displacement of 60.25 mm, corresponding to a 3.34 percent drift. The loading rate that the actuator moved at did not correspond to any prescribed loading protocol. Although data acquisition was running at a speed of four hertz at the time of loading, only ten data points were recorded before the actuator was stopped. The force-displacement graph, shown in Figure 6-17, shows the data recording over the course of the movement of the actuator. Due to the high speed of loading, very little useful data could be salvaged for analysis, but it provided useful information regarding the new state of the specimen after retrofitting took place for retesting.

**Figure 6-17: Force vs. Displacement of W5-Phase I**

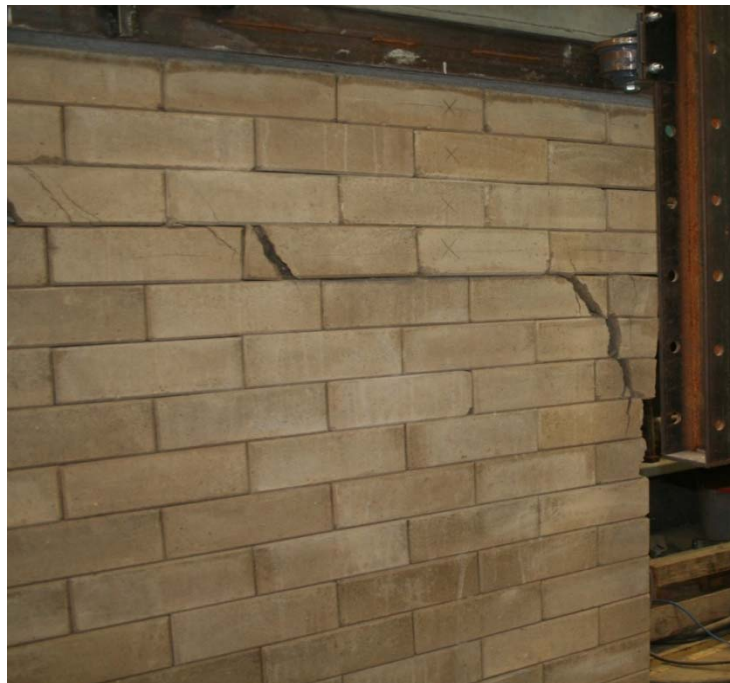
was shifted 9.67 mm relative to the web. Although the damage to the web was mostly concentrated in the top four courses, two places where considerable damage took place were at the web toe and the intersection between the web and the flange, as shown in Figure 6-18 and Figure 6-19. The compressive failure at the toe of the web caused spalling around the top of the toe due to the increased force from the overturning moment. The web is designed to take most of the in-plane shear, while the flange simulates an intersecting wall, making the web relatively stiff compared to the flange. The majority of the damage found in the web was the result of shear failure and was predominant in the top four courses of the web. The crack shown in Figure 6-19 shows the characteristic shear crack. Other characteristics of a shear failure were seen in the vertical and horizontal extensions between blocks as well as spalling in high tension regions of the wall.

**Figure 6-18: Damages in W5 Web resulting from mechanical failure of actuator**

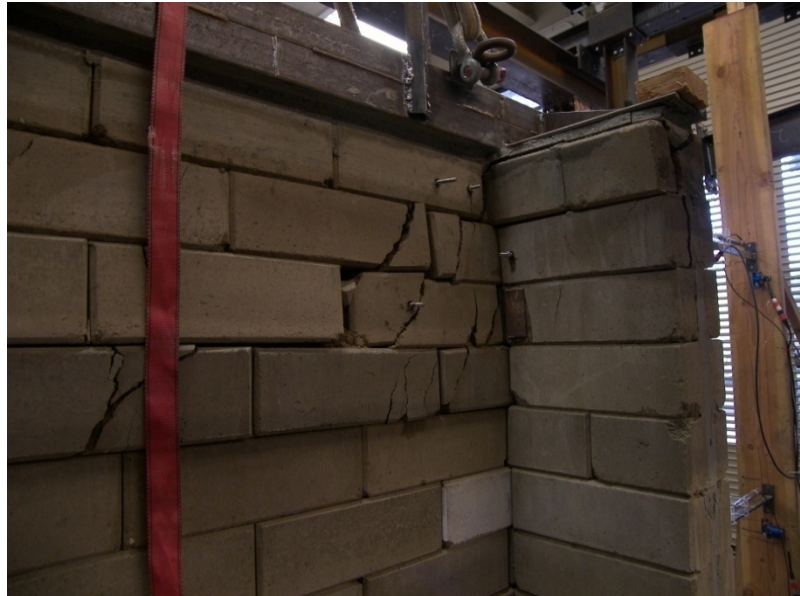
**Figure 6-19: Compression failure at the intersection of the web and flange**

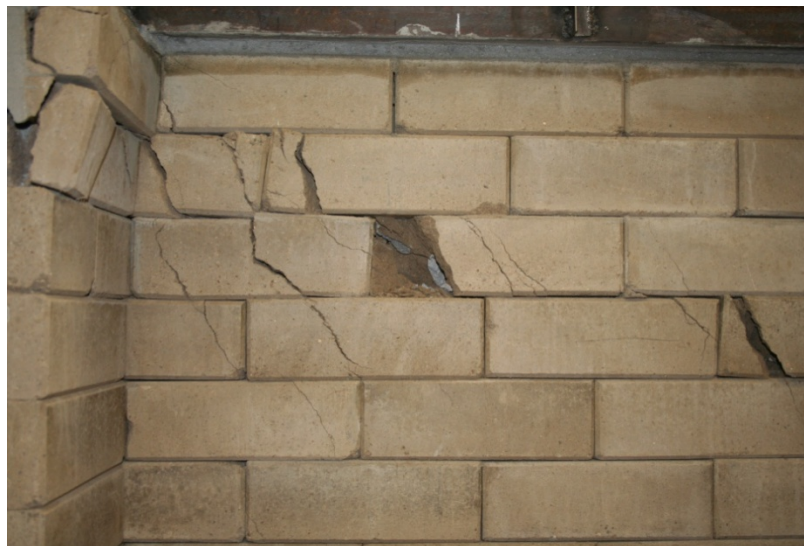
**Figure 6-20: Shear Failure of the web and flange.**

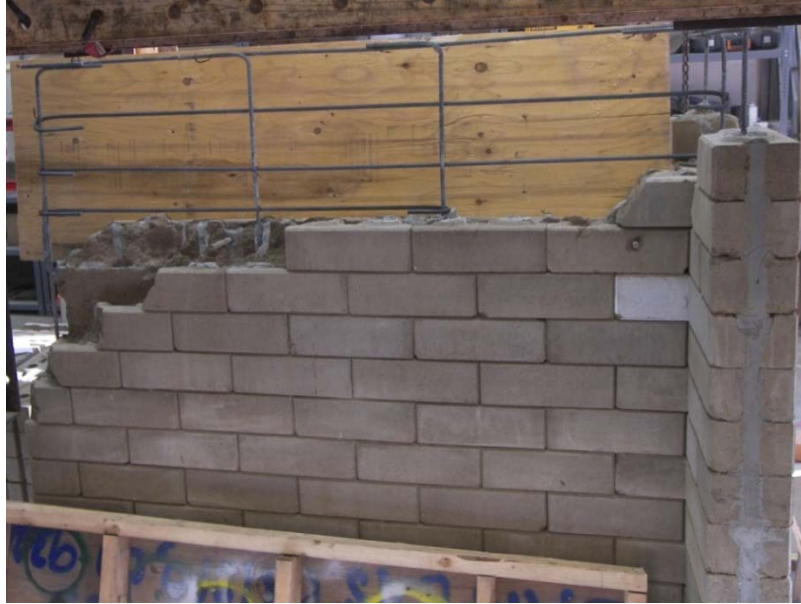
The reinforced concrete for the repair purpose was designed to be a high strength, fast curing, fluid mix, which would provide load transfer from the actuator to the remaining fourteen courses in the wall. In order to accomplish this, extra horizontal reinforcing was added as shown in Figure 6-21 and Figure 6-22. Formwork was then built around the areas where the blocks had been removed in both the web and flange. Areas surrounding the toe where significant spalling occurred were formed up to maintain the original shape of the wall. Reinforced concrete was then mixed and poured into the wall. After each batch of the concrete was poured, it was then vibrated to prevent any air voids.

**Figure 6-21: Repair of the web of W5 before reinforced concrete was cast**

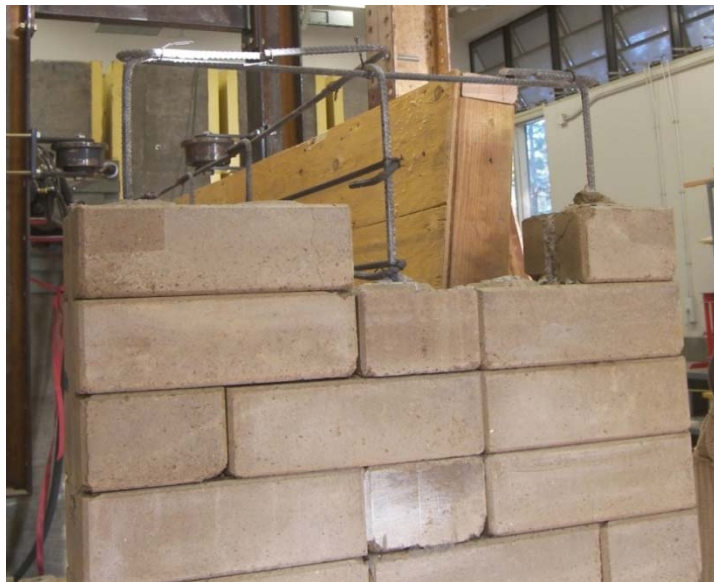
**Figure 6-22: Repair of the flange of W5 before reinforced concrete was cast**

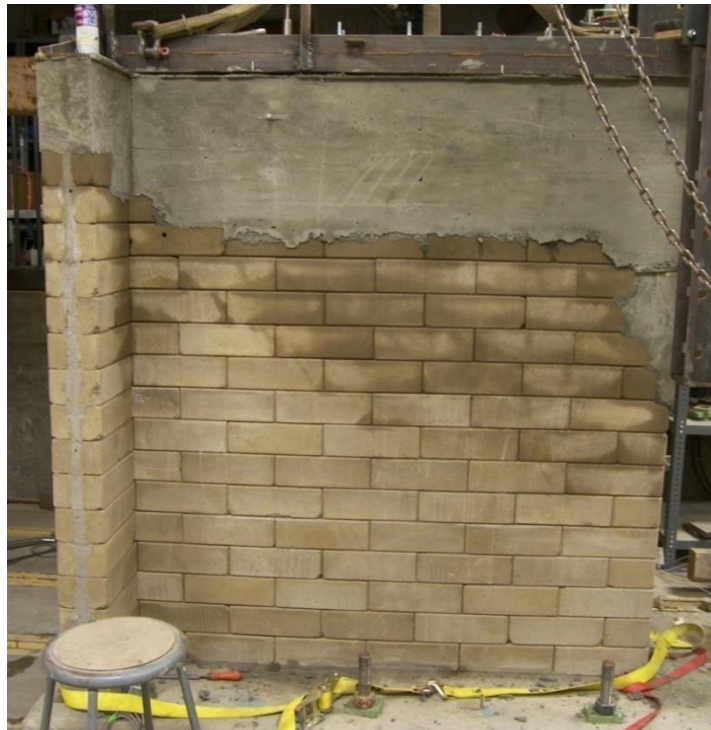
Twelve hours after the reinforced concrete section was poured, the formwork was removed for re-instrumentation and visual inspection. The repaired specimen is shown in Figure 6-23 and Figure 6-24. The visual inspection detected two bonding defects in the reinforced concrete section. The first was between the steel loading beam and the concrete top, and the other near the bottom of the concrete where the formwork bulged. Hydrostone was dry packed in these areas to close any visible gaps but provided little structural benefit.

**Figure 6-23: Web of W5 after removal of the reinforced concrete formwork**

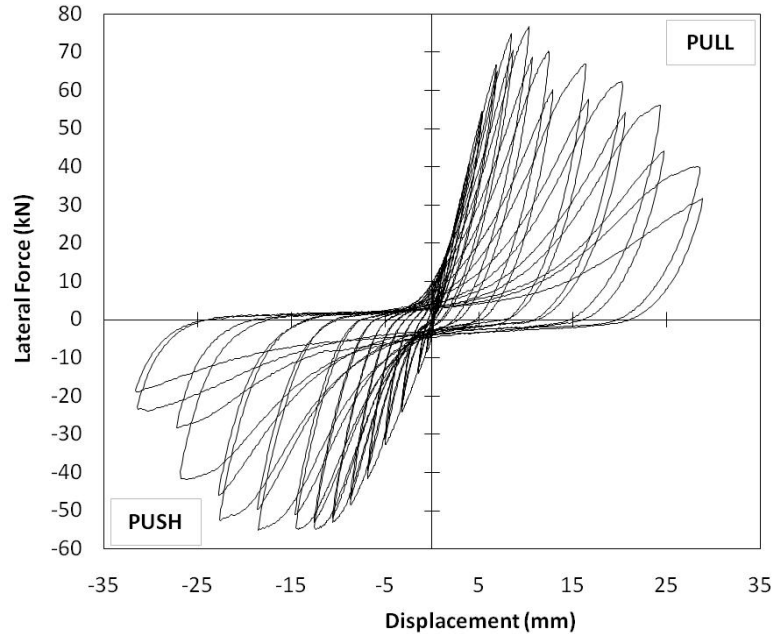
W5 was retested 31 days after the original construction was completed and 7 days following the repair using reinforced concrete. Through the duration of the experiment, 28 cycles of the loading protocol, found in Chapter 5, were used. W5 was tested to a maximum displacement of 32 mm, corresponding to 1.77 percent drift, which was roughly half of the maximum displacement from W5-Phase I test. A maximum resisting force from the wall was recorded as 76.71 kN at a displacement of 14 mm in the pull direction, and 55.1 kN at the same displacement in the push direction as shown in Figure 6-25.

**Figure 6-25: Hysteresis of W5-Phase II**
