**FLEXURAL BEHAVIOR OF INTERLOCKING COMPRESSED EARTH BLOCK  
SHEAR WALLS SUBJECTED TO IN-PLANE LOADING**

A Thesis  
Presented to the Faculty of  
California Polytechnic State University,  
San Luis Obispo

In Partial Fulfillment  
of the Requirements for the Degree of  
Master of Science in Civil and Environmental Engineering

by  
Bradley James Stirling  
July 2011

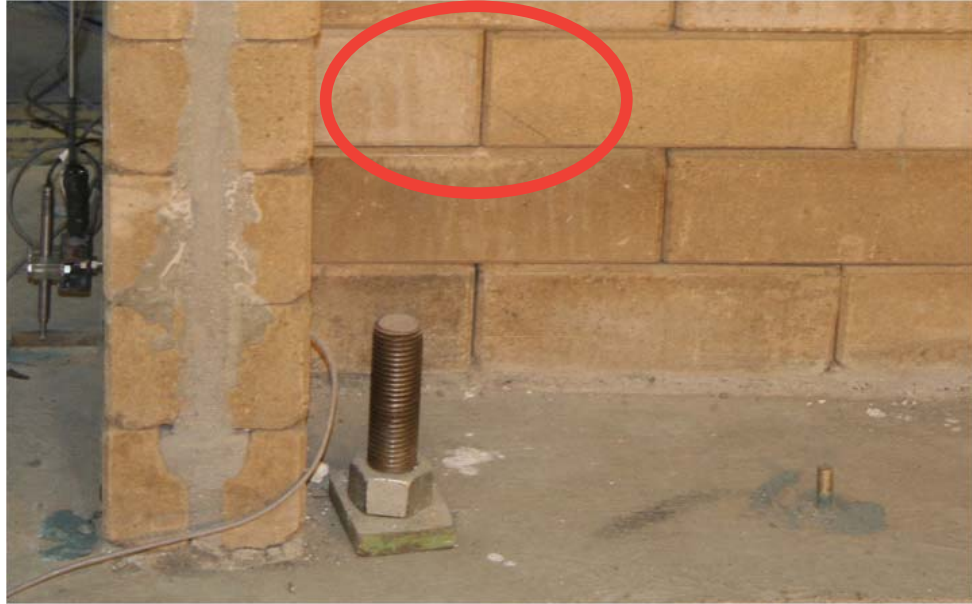
Throughout the duration of the first eight cycles very little noticeable damage took place with respect to the deformation of the wall. Close inspection of the web of the wall showed cracks, created from the initial 60.25 mm shift of Phase I test, opening and closing with the displacement of the wall. This opening and closing action can be seen by comparing the closed crack at zero displacement, and the open crack at maximum displacement shown in Figure 6-26 and Figure 6-27, respectively. It was clear from the observations that the wall remained elastic throughout the first eight cycles based on the small amount of cracking observed. The hysteric loops produced during testing further confirmed these observations. A closer observation of the hysteric loops, seen in Figure 6-28, shows the loops enclose negligible area indicating that very little energy has been dissipated by the wall.

**Figure 6-26: Crack in W5 at zero displacement**

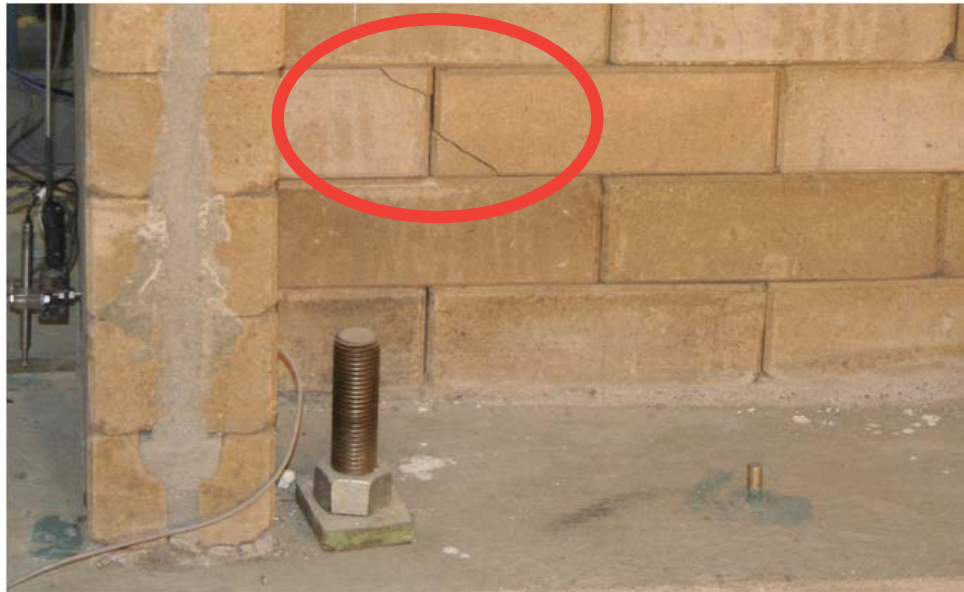
**Figure 6-27: Crack in the W5 at maximum displacement of cycle 8**

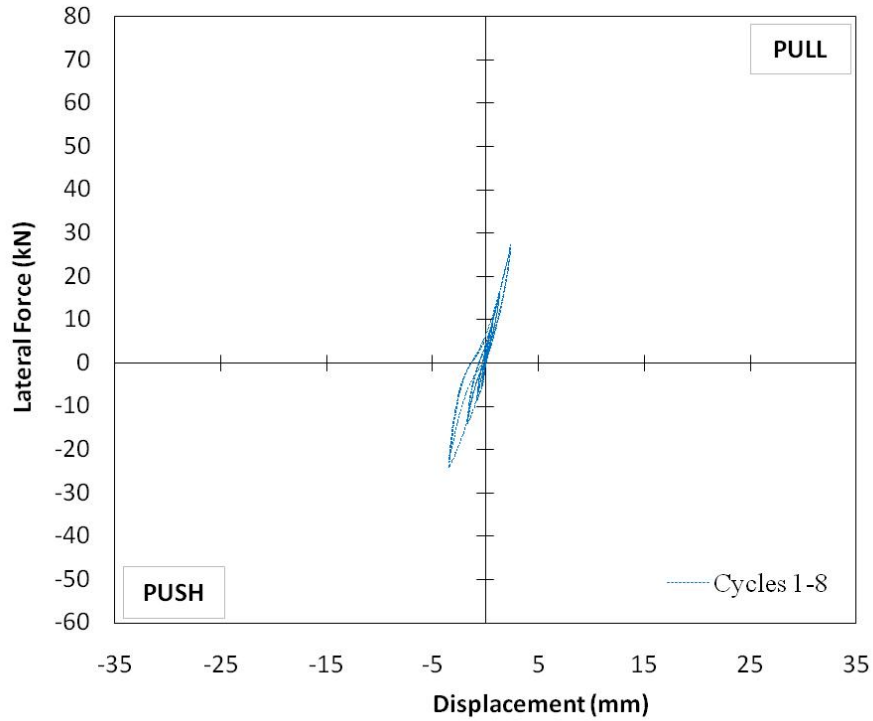
**Figure 6-28: Hysteresis of W5- Phase II: Cycles 1 through 8**

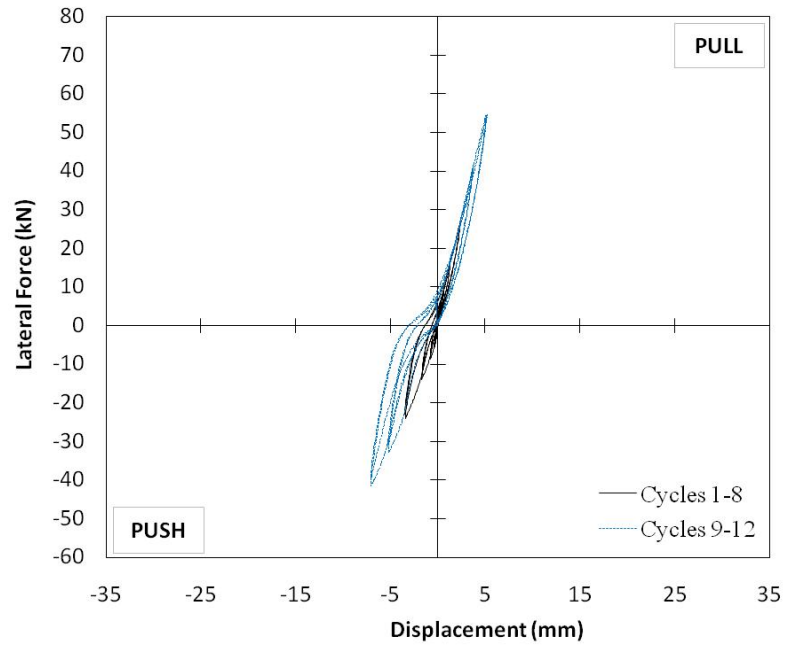
As shown in Figure 6-29, at the peak displacements of Cycles 10 and 12 (i.e., at 6 mm and 8 mm respectively), that the strength of the wall continues to grow with very little energy dissipated. The beginning of significant energy dissipation could be seen in the push excursion of Cycle 11, primarily due to the horizontal cracking between blocks at the toe of the web which is shown in Figure 6-30. The hysteresis, shown in Figure 6-29, clearly shows that the zero force line being crossed at two separate displacements, neither of which are zero, indicating a residual shift in the wall from a previous displacement.

**Figure 6-29: Hysteresis of W5: Phase II Cycles 1 through 12**

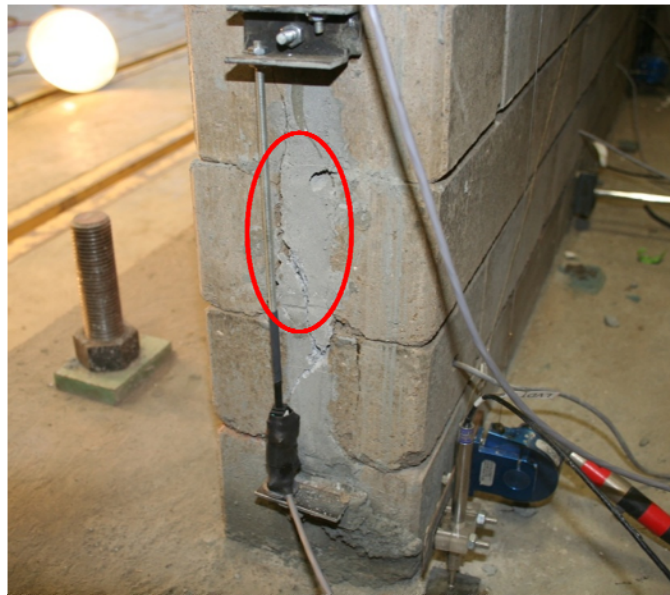
**Figure 6-30: Tension cracks at the base of the toe of W5 web**

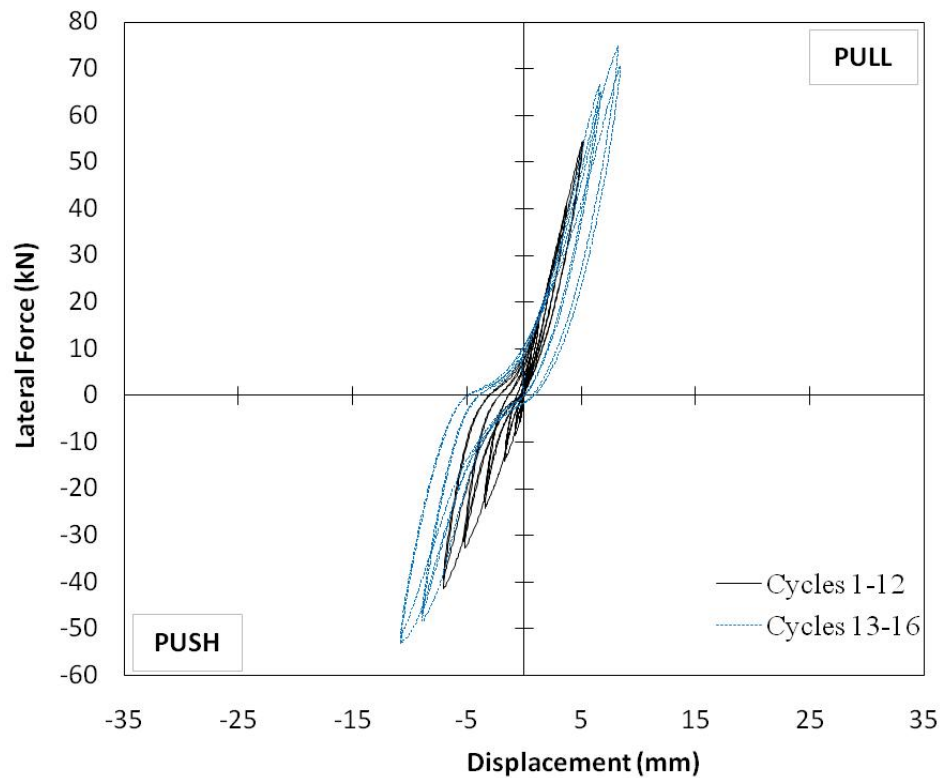
**Figure 6-31: Hysteresis of W5-Phase II: Cycles 1 through 16**

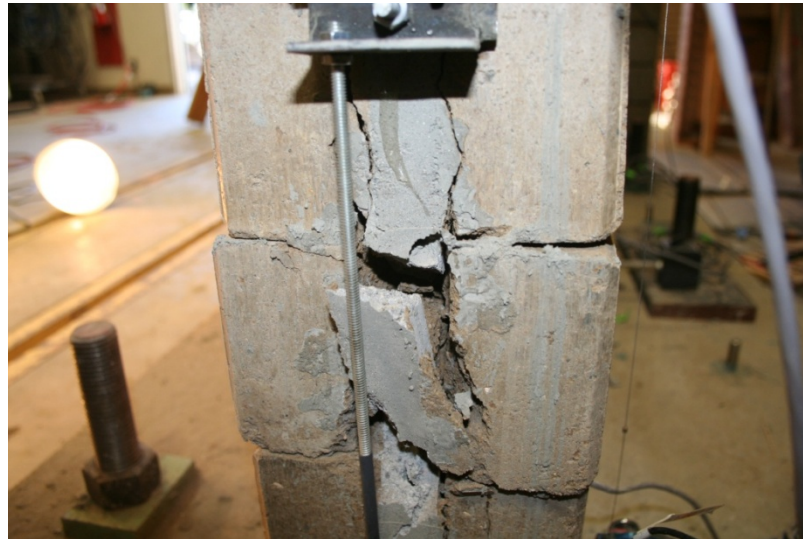
**Figure 6-32: Spalling of the outer grout channel of the W5 web during Cycle 16**

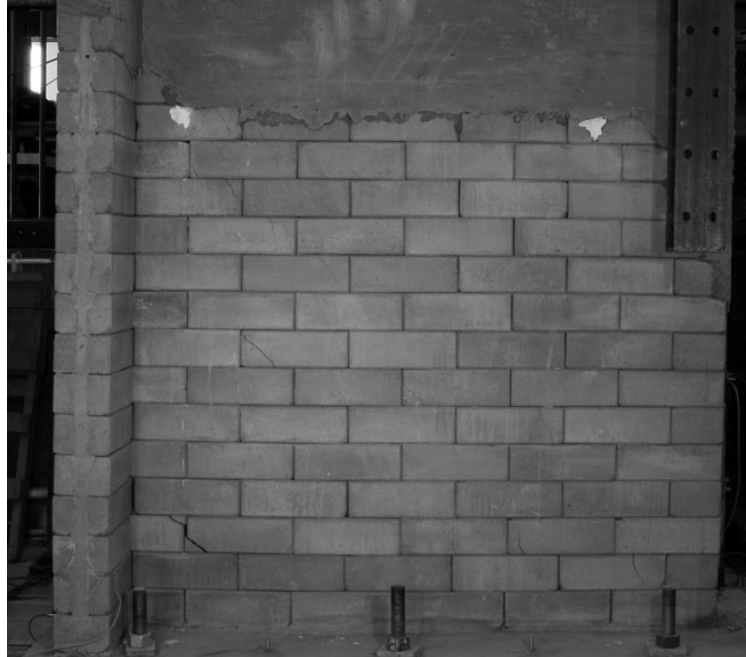
**Figure 6-33: Cracking of W5 web at zero displacement after Cycle 16**

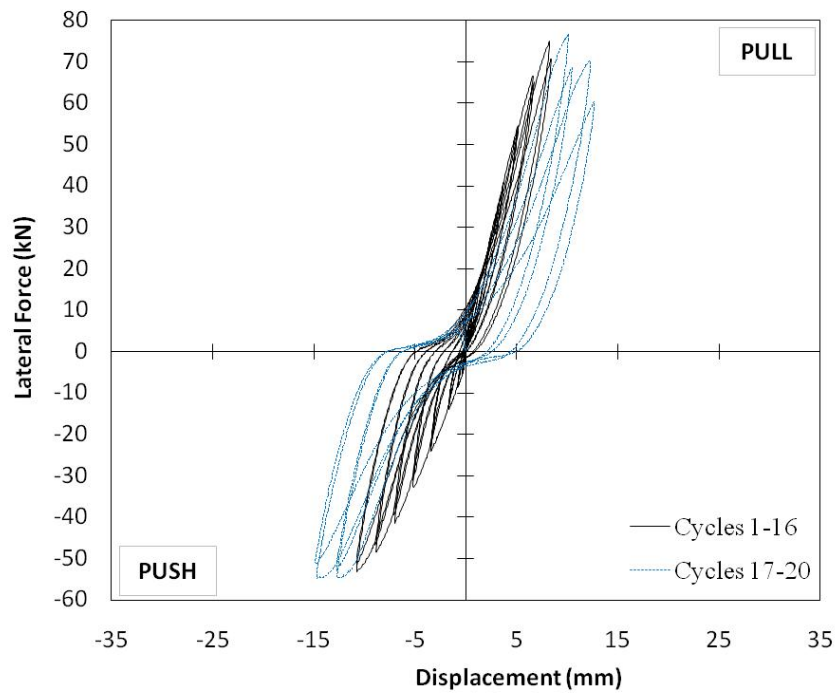
**Figure 6-34: Hysteresis of W5-Phase II: Cycles 1 through 20**

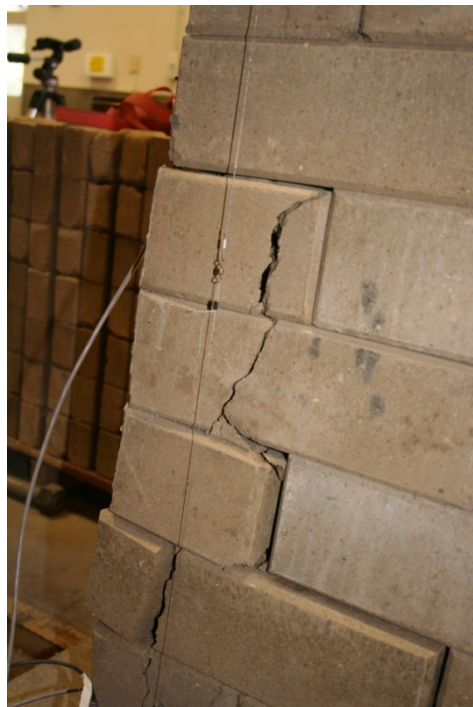
**Figure 6-35: W5 cracking around the bottom toe of the web**

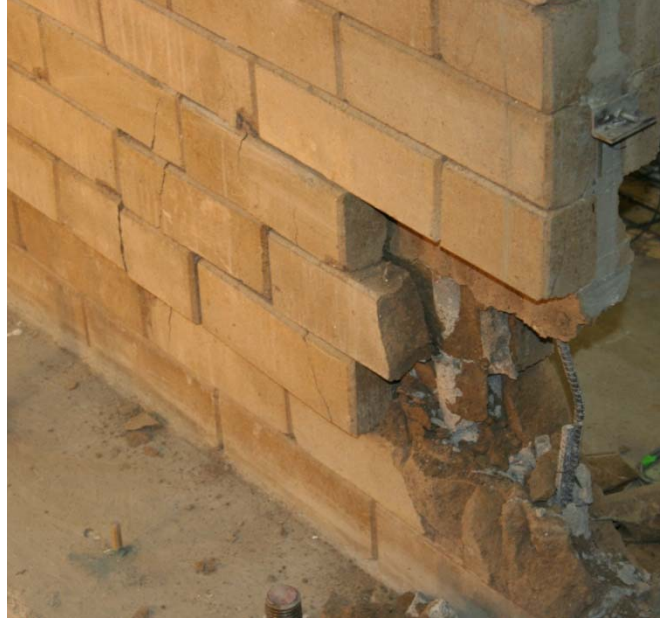
**Figure 6-39: External spalling of ICEBs at the web toe of W5.**

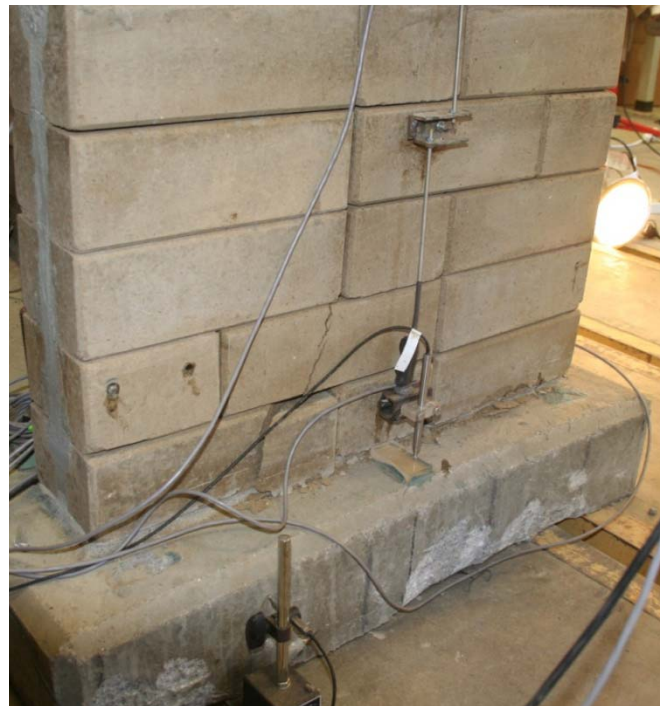
**Figure 6-40: Cracking at the base of the flange of W5**

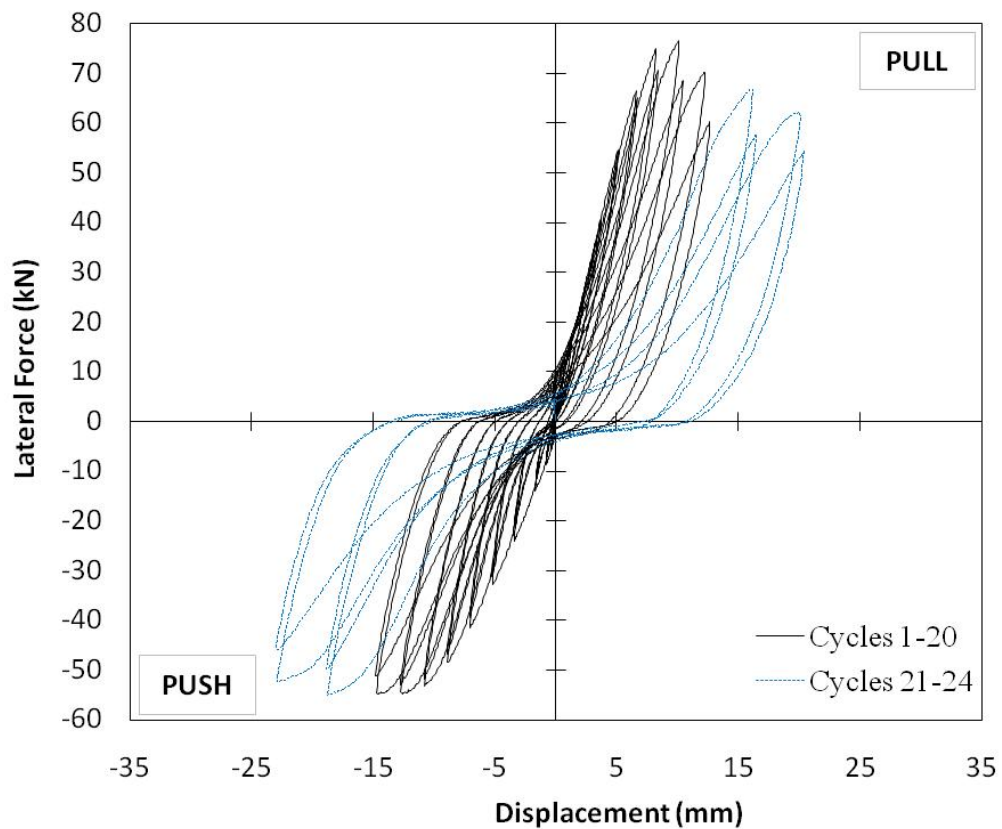
**Figure 6-41: Hysteresis of W5-Phase II: Cycles 1 through 24**

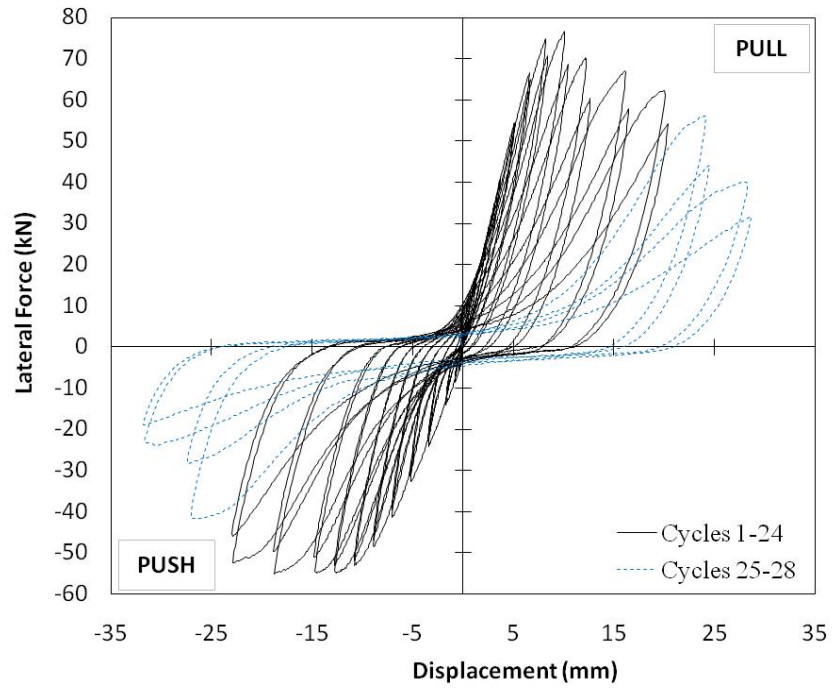
**Figure 6-42: Hysteresis of W5-Phase II: Cycles 1 through 28**

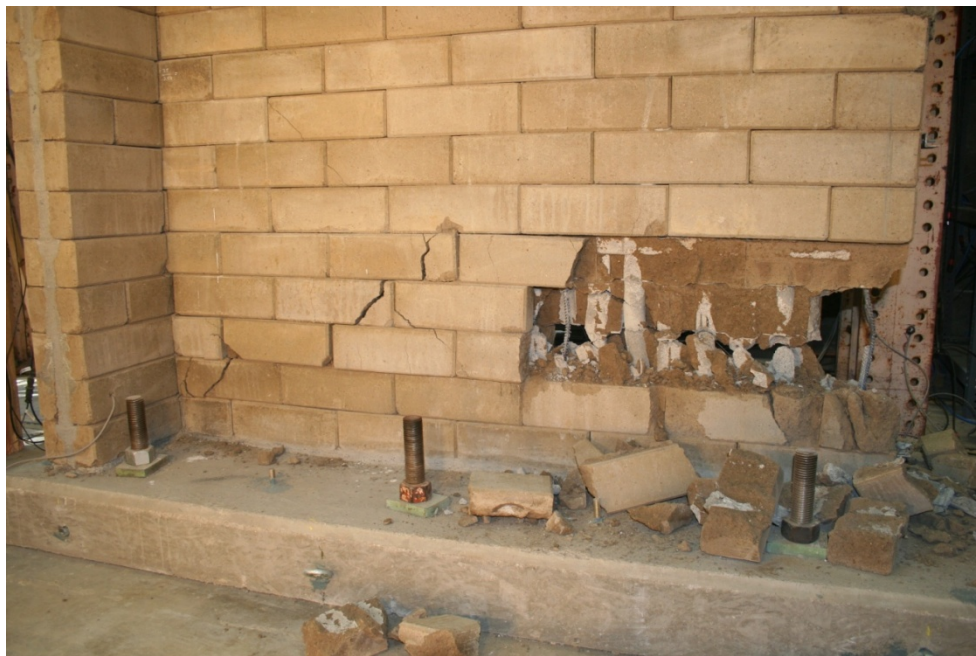
**Figure 6-43: Degradation of W5 web**

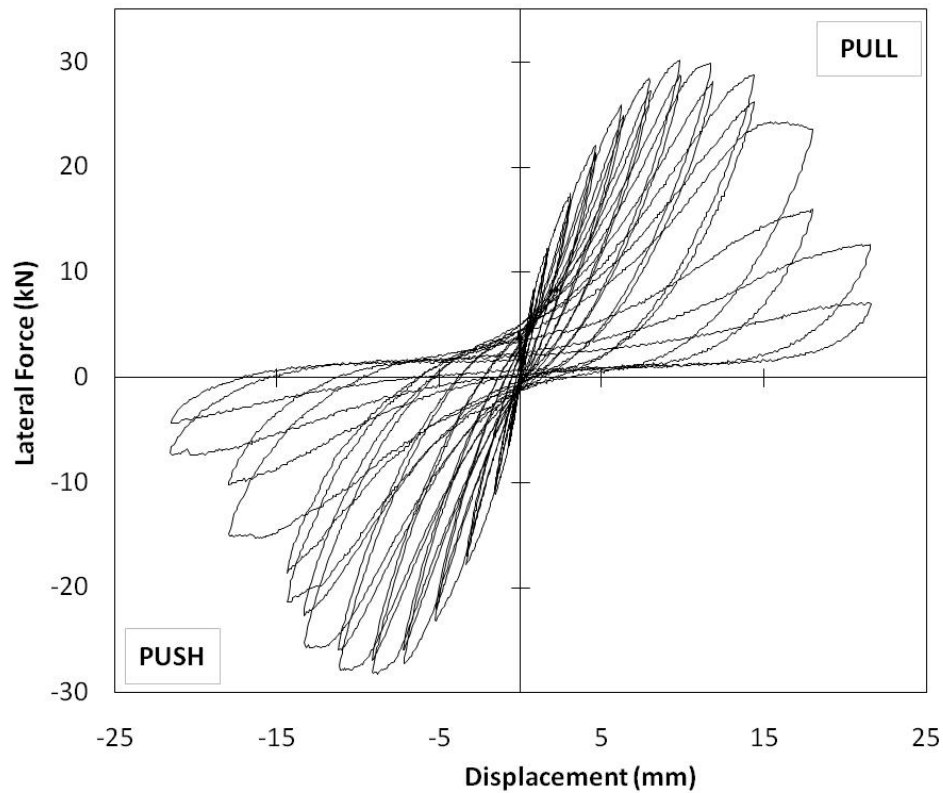
**Figure 6-44: Hysteresis of W6**

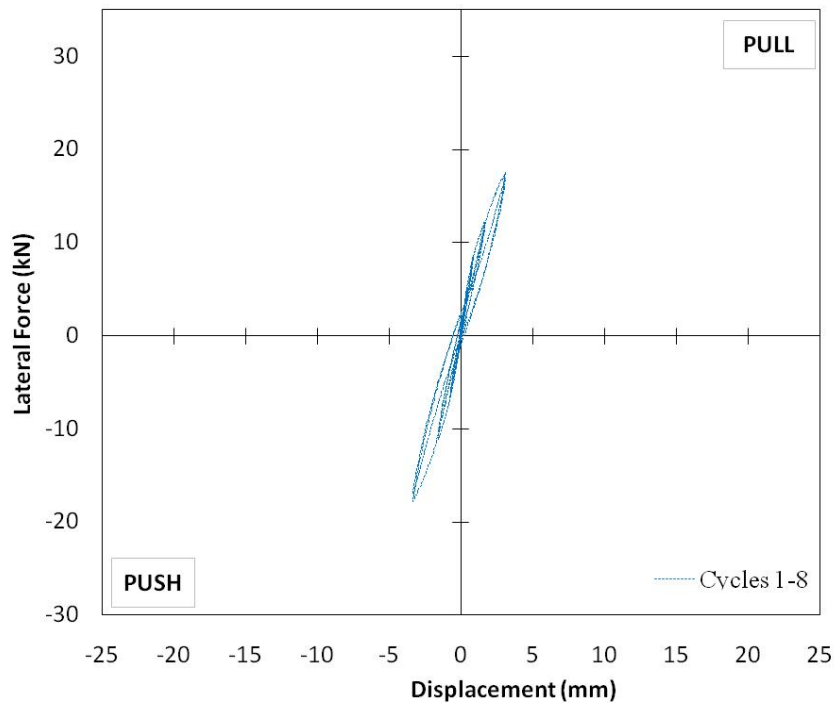
**Figure 6-45: Hysteresis of W6: Cycles 1 to 8**

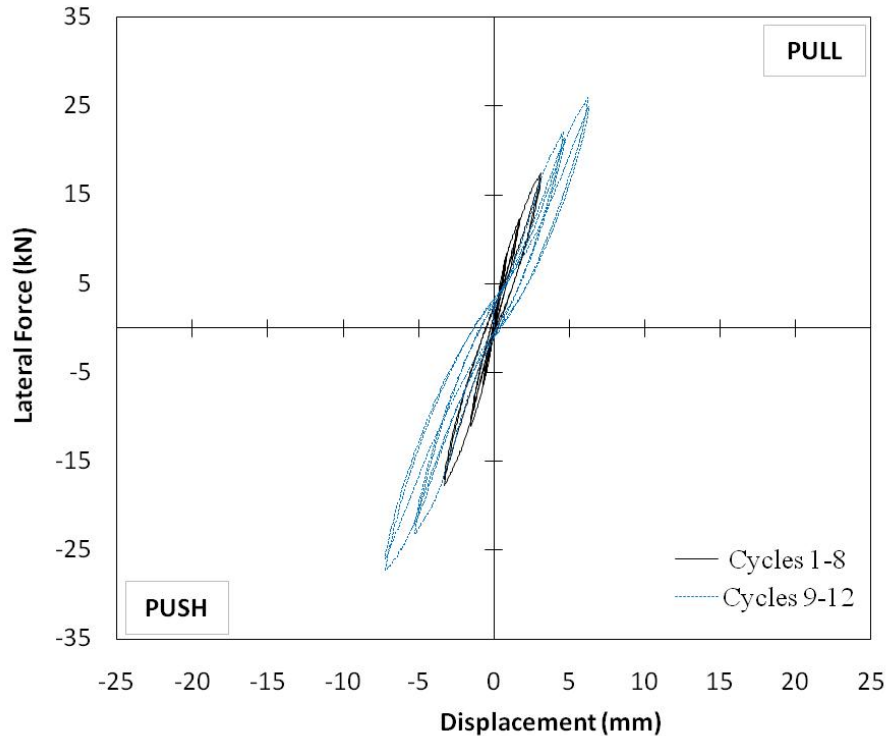
**Figure 6-46: Hysteresis of W6: Cycles 1 through 12**

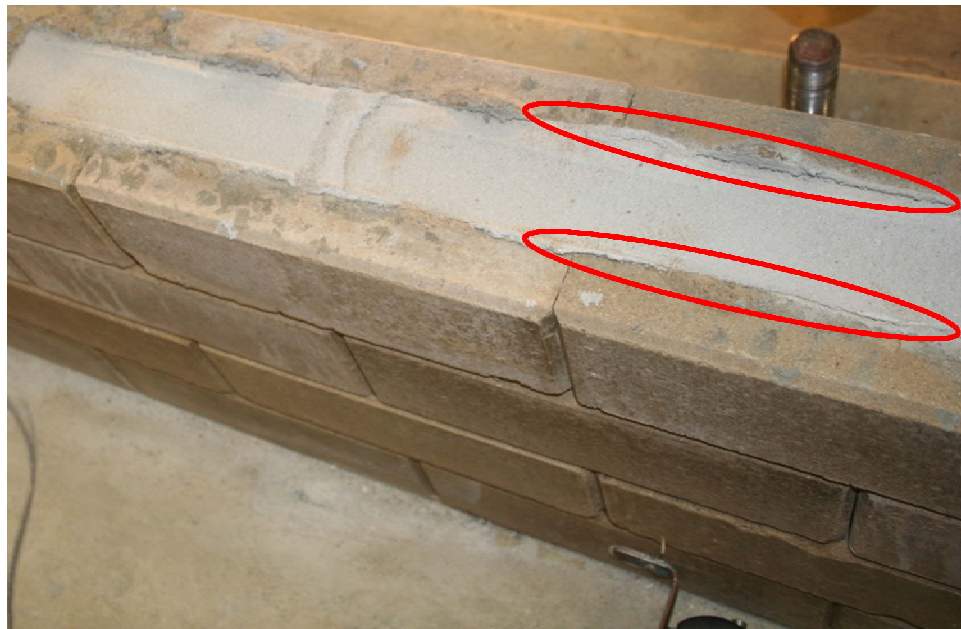
**Figure 6-47: W6 cracking around the sill of the windows following Cycle 14**

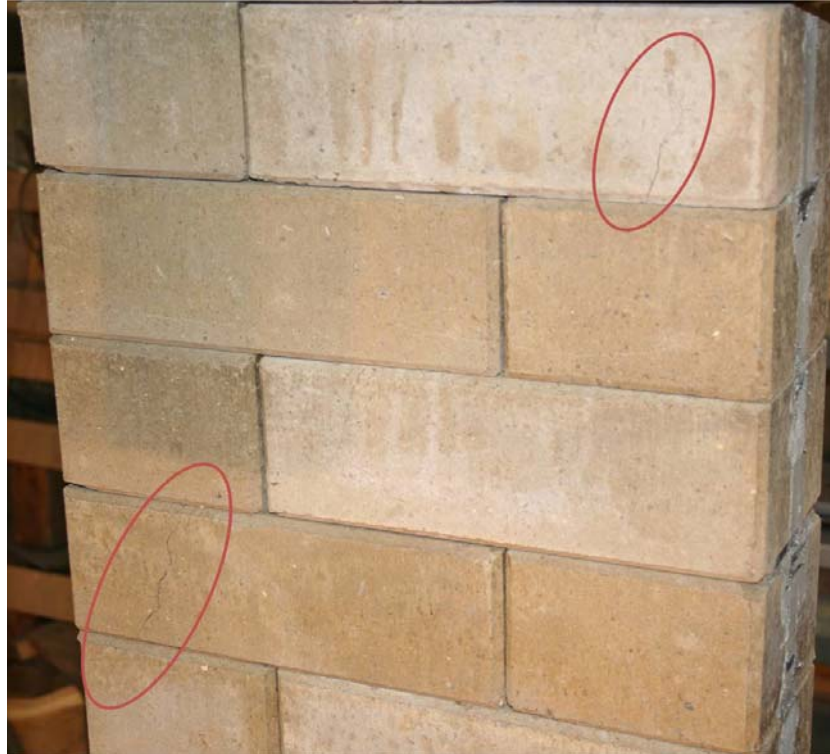
**Figure 6-48: W6 diagonal cracking observed in the left pier after Cycle 16**

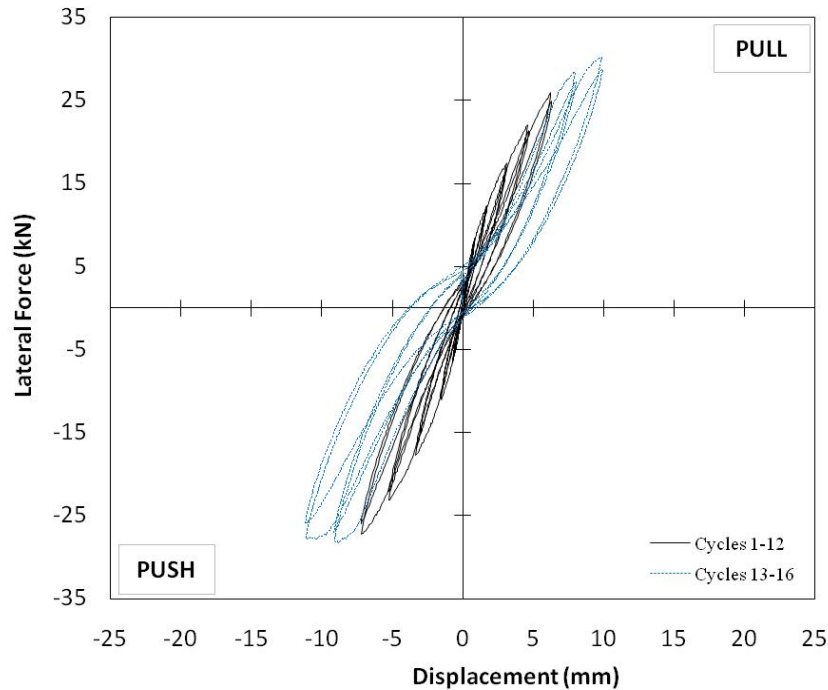
**Figure 6-49: Hysteresis of W6: Cycles 1 through 16**

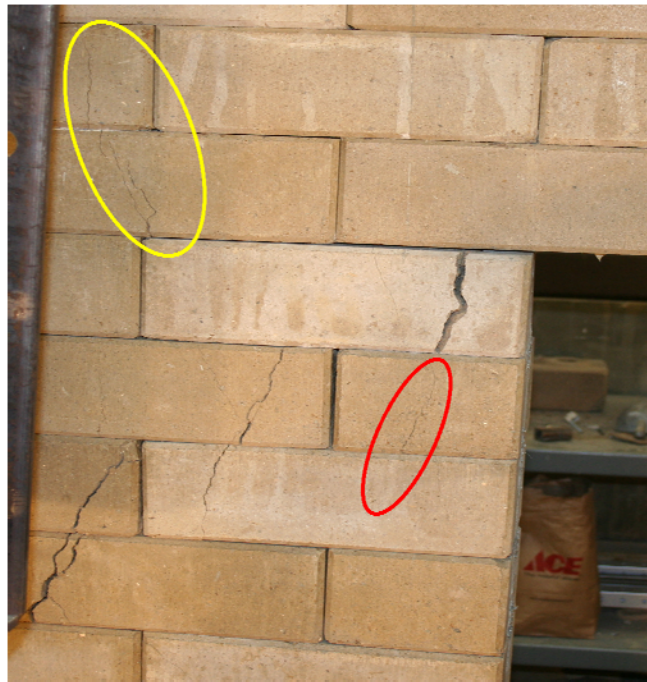
develop on the right pier in a manner similar to what was seen in the left pier during Cycle 17. These diagonal cracks began on the outer face of the pier and propagated towards the vertical reinforcement.

**Figure 6-50: New cracks observed in W6 during Cycles 9 and 10**

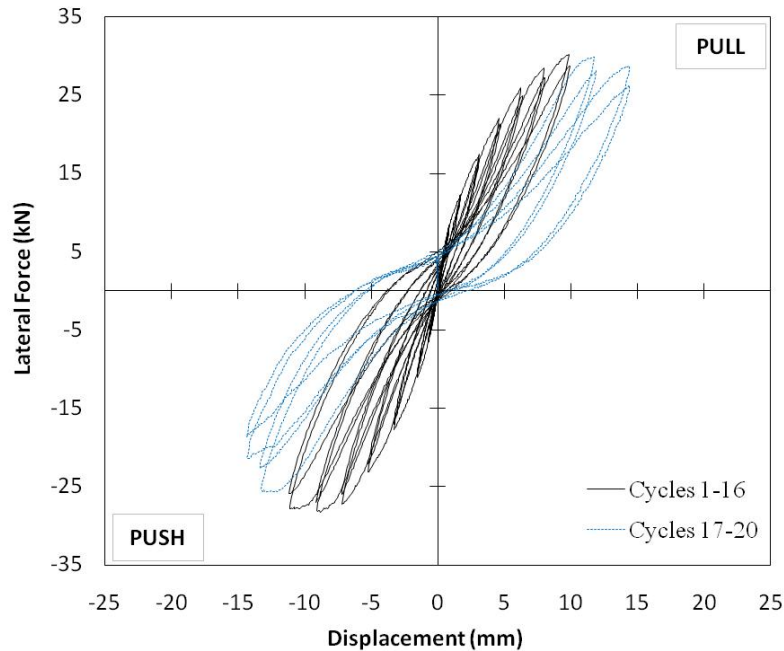
**Figure 6-51: Hysteresis of W6: Cycles 1 through 20**

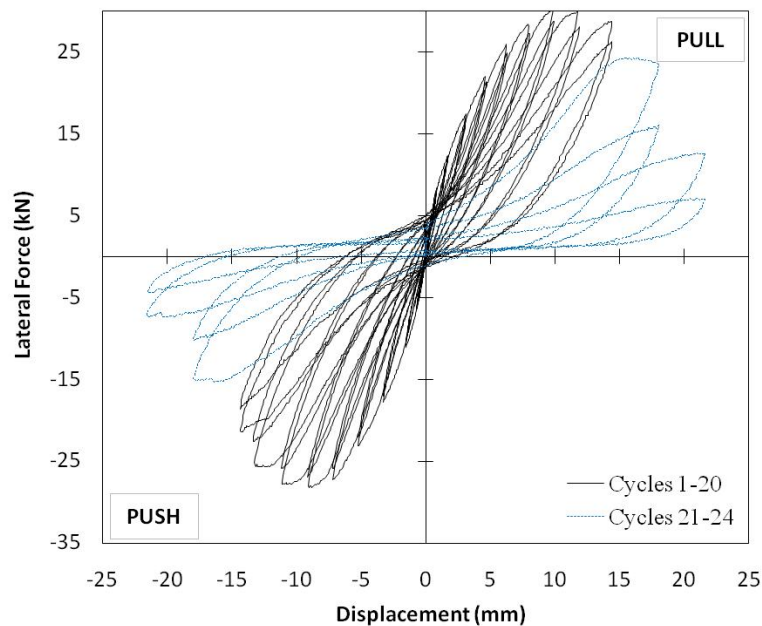
**Figure 6-52: Hysteresis of W6: Cycles 1 through 24**

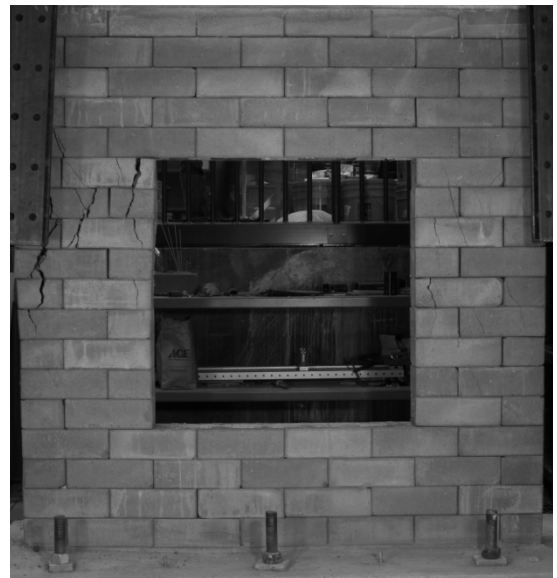
**Figure 6-54: Cracking pattern of W6 following Cycle 22**

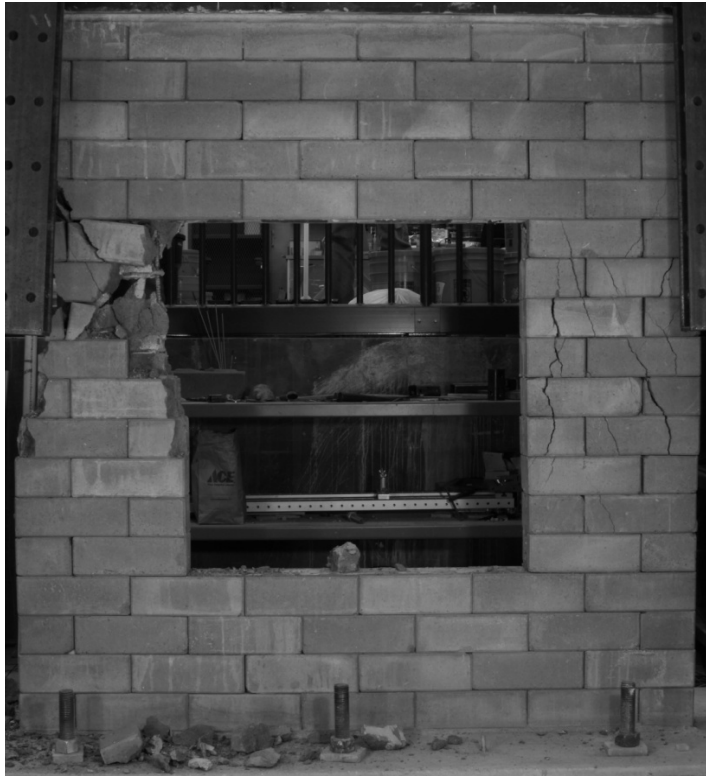
**Figure 6-55: Damage in W6 following Cycle 24**

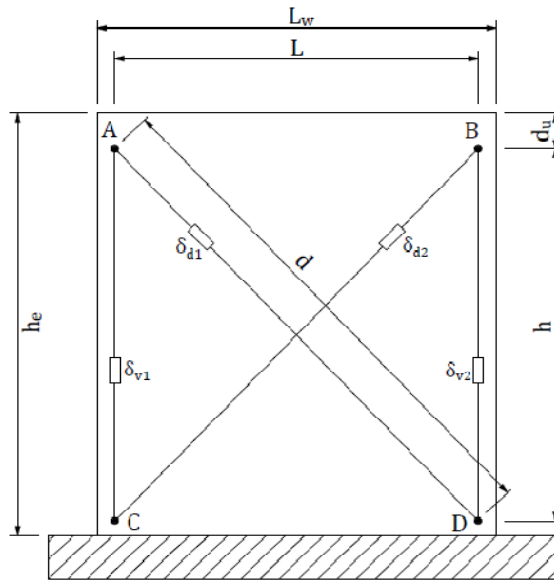
**Figure 7-7: Arrangement for shear deformation instruments (from Voon, 2007)**

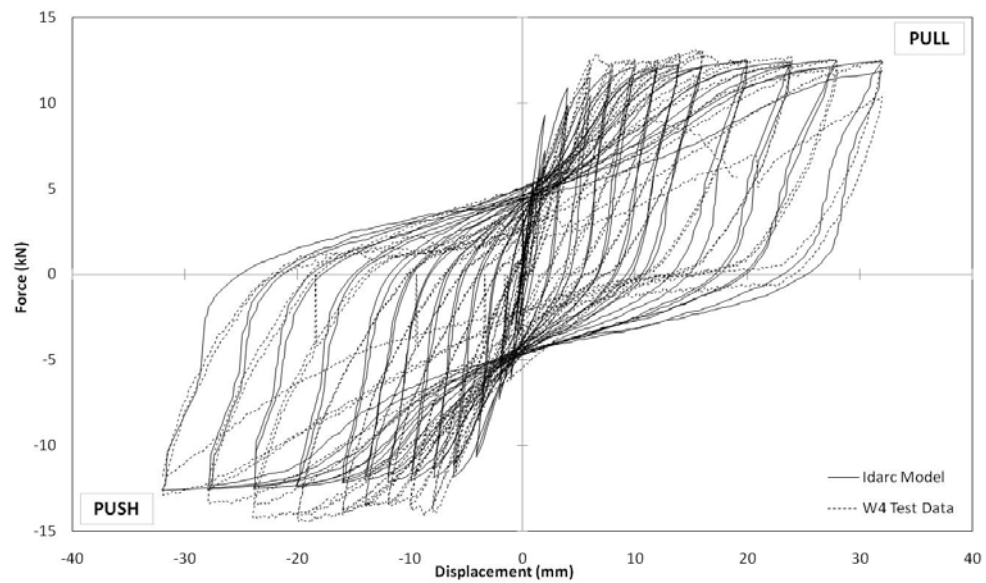
**Figure 8-1: Comparison of results from test and IDARC**

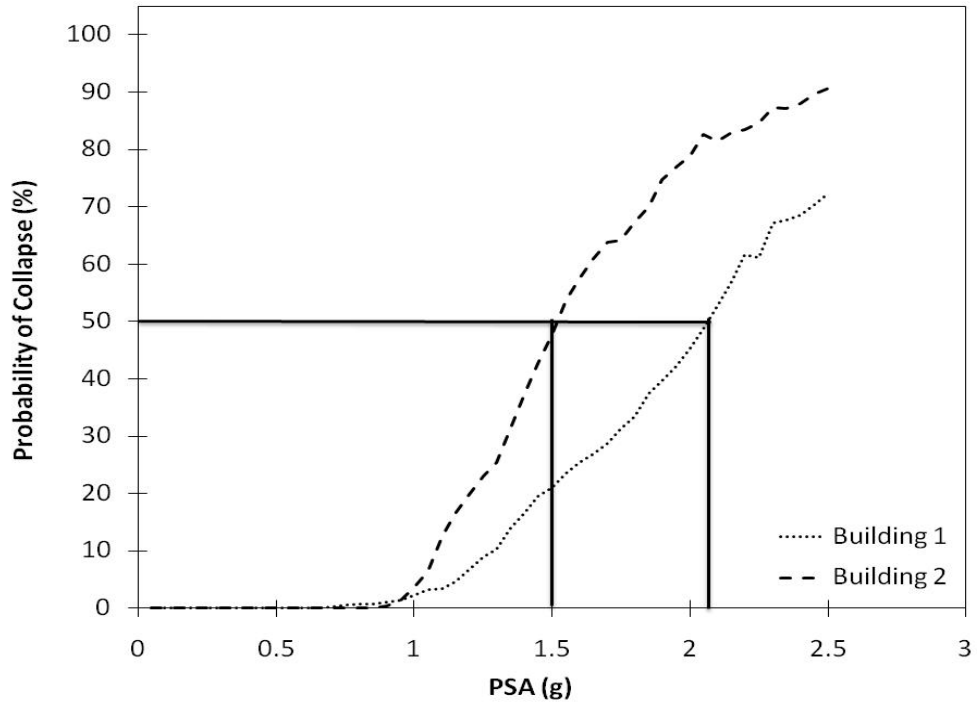
**Figure 8-5: Fragility curves of demonstration buildings under near field ground motions**

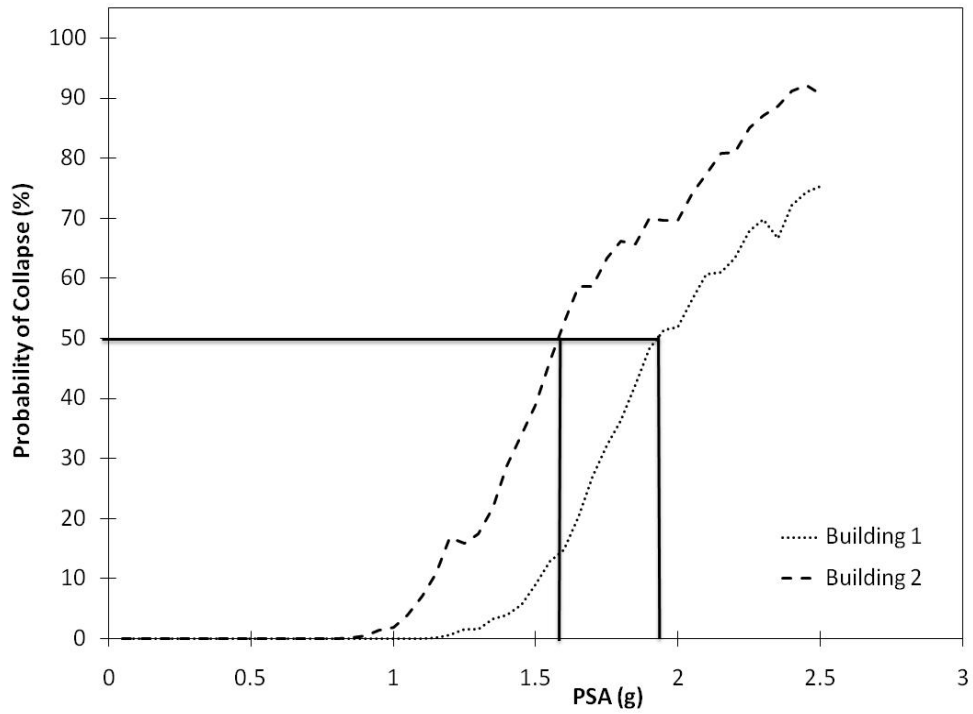
**Figure 8-6: Fragility curves of demonstration buildings under far field ground motions**

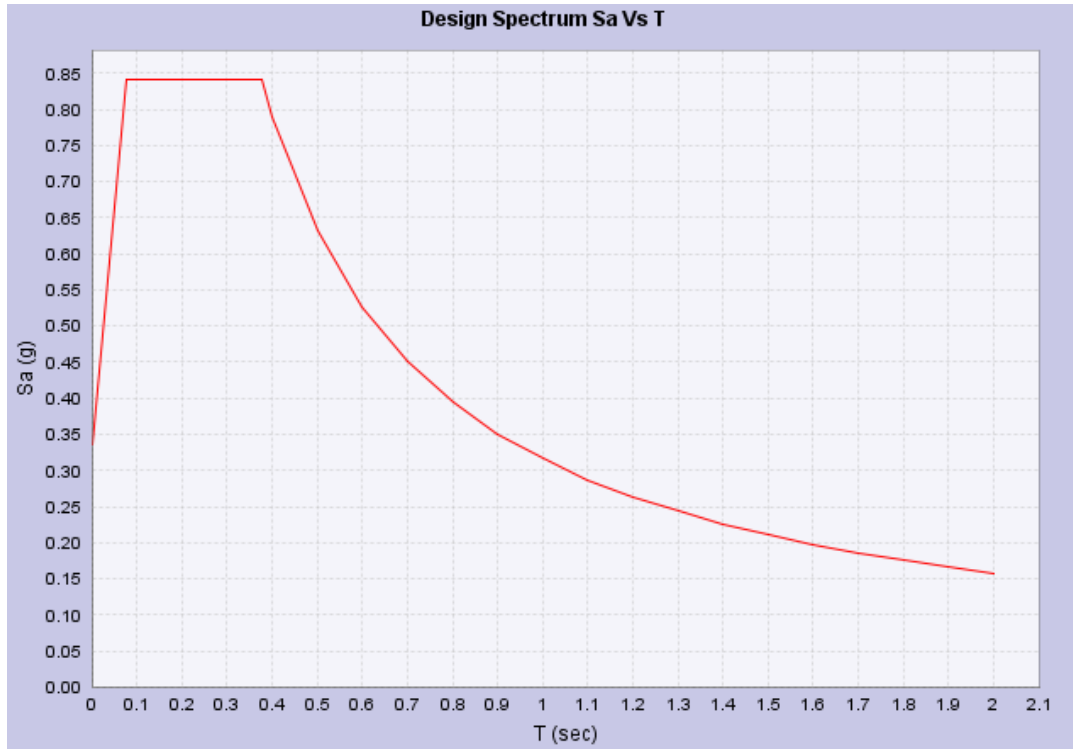
**Figure C-4: Design Spectra for Cal Poly assuming site class B**
