Development of a Laboratory Experiment to Simulate Upper-Stage Rocket Explosions

A Senior Project

California Polytechnic State University, San Luis Obispo

May 17, 2011

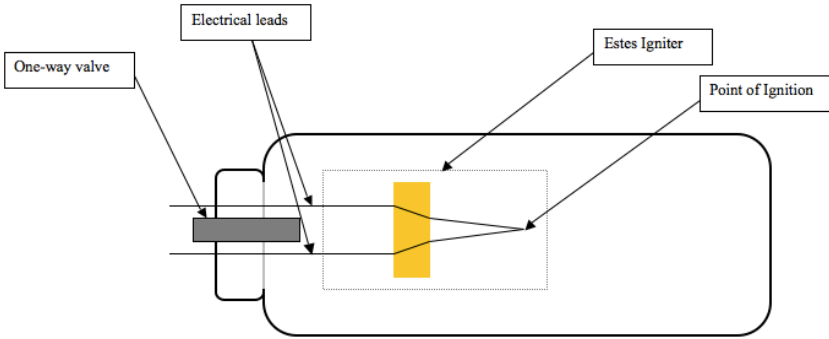
Figure 1. Schematic showing a cut away view of the can test apparatus. Note that the redundant igniter is not shown.

The final apparatus and procedure used in the Spacecraft Environments laboratory was derived from the fourth series of tests. A list of materials needed to prepare and test the cans can be found in Appendix A. The cans were constructed by taking an empty Rockstar energy drink can and drilling a hole in the center of the cap. The hole is sized to match the one-way Presta or Schrader valve from a bicycle inner tube, because of the adapter, either type of valve can be used. The hole should be sized so that the valve fits tightly. Four small holes are then drilled in the top of the cap, these holes allow the ignition wires to be fed through the top of the cap.

valve are in place, a generous amount of epoxy must be applied to the inside of the cap. Care should be taken to cover each hole and the edges of the cap with epoxy as this will insure an airtight seal. After the cap is sufficiently epoxied, the cap should be placed on top of the can and tightened down with care taken to make sure the cap is tightened down around the threads. The can should then be allowed to sit upside down for a period of 24 hours. This allows the epoxy to fully harden and form its seal. The existence of an airtight seal can be verified using a bicycle pump. Each can was colored into five longitudinal strips with a permanent marker, this allows for the origin of each fragment to be compared to its final location after the explosion. Once the can has been constructed and the epoxy has been allowed to dry, the mass was taken. This will be used later to determine what percent of the can was collected after the explosion. Figures 1-3 all depict the test can described above. Figure 1 is a cutaway view schematic of the test can. Figure 2 is a photograph of a completed can fitted with a Schrader valve and Fig. 3 is a photograph showing the internal wiring of the can, the redundant Estes igniters can be seen.

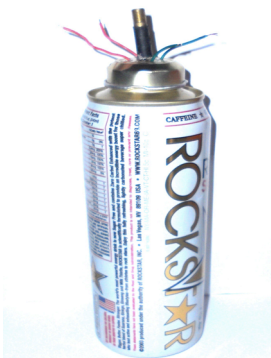
Figure 2. Photograph showing a completed test can.

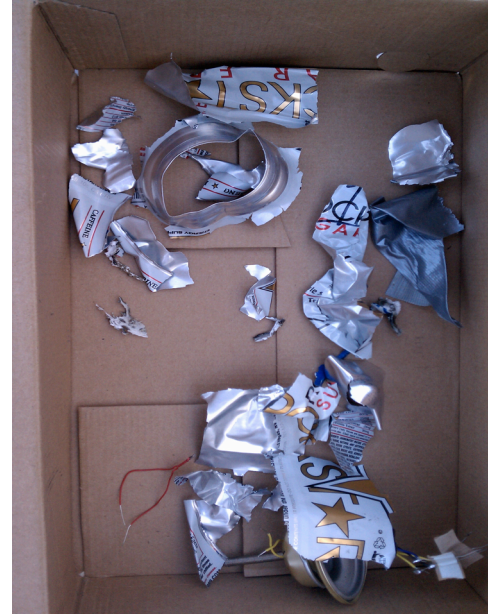
Figure 2. This photograph shows the debris collected after the first successful test.

The final apparatus and procedure implemented in the laboratory experiment successfully created the desired explosion and aluminum fragmentation. The debris formed in large fragments and were propelled outward from the center of the can. This pattern is consistent with the predicted debris formation from an internal explosion.¹ Figure 2 is a photograph showing the debris collected from the first successful test. During the laboratory class the students were able to build and explode the cans and collect the debris, measure the mass and calculate the cross sectional area of each fragment and draw conclusions about the behavior of debris formation.

One concern with debris testing is that the testing environment affects the formation of the debris. This effects of the testing location and environment were clearly seen during these tests. The fragments created from the can near the ground were flattened by the explosion while the other fragments formed irregular shapes similar to those seen in Fig. 2. There were also several instances where the debris impacted an obstacle in the testing area causing it to change direction. Wind also affected the final location of the debris as several fragments were blown around before they could be collected. There are several possible solutions to mitigate these testing environment effects. Suspending the can prior to ignition, possible hanging it from the valve at the top of the can, would eliminate the flattening effects caused by the cans close proximity to the ground. A containment mechanism which could withstand the pressure change from the blast and allow the debris to imbed itself in the walls of the container would prevent any obstacles or wind from affecting the trajectories of the fragments. The container however would likely cause the debris to deform differently than if left in the open. A soft layer, possibly made out of aerogel, ballistics gel, or Styrofoam, backed by a solid casing capable of withstanding the blast could possible collect the debris and minimize the impact effects.
