# ANALYSIS OF FAILED FORGING SADDLING MANDRELS AND PROCESS IMPROVEMENTS FOR INCREASED MANDREL LIFESPAN

Materials Engineering Department Senior Project

Industry Sponsor: Schlosser Forge Co.

6/1/2012

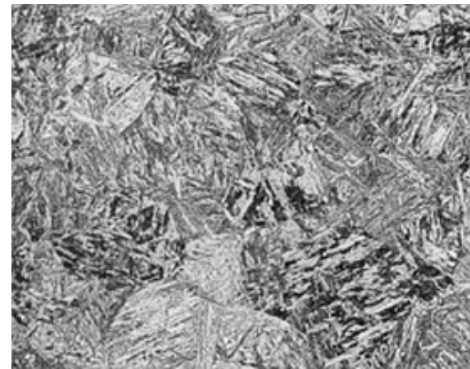
**Figure 7:** This micrograph is a mix of plate and lath martensite at 1000x magnification<sup>10</sup>.

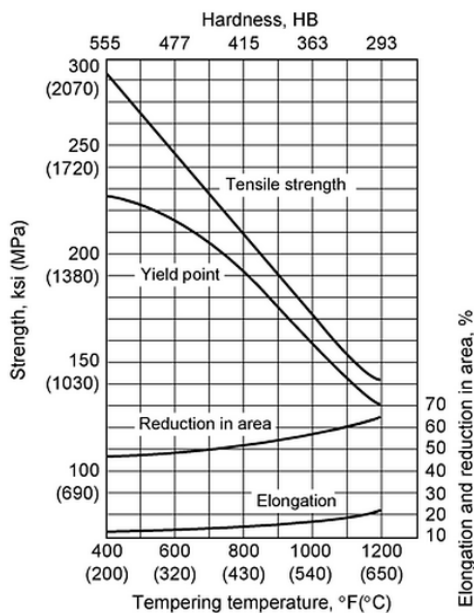
**Figure 9:** Tempering temperature has an effect on all of the mechanical properties of steel. This diagram shows a linear trend between the tensile strength and tempering temperature of 4340 steel<sup>10</sup>.

austenite to martensite, the resulting microstructure will not contain any proeutectoid ferrite, pearlite, or bainite formed during cooling; where the martensite used to be, a fine distribution of carbides in a ferrite matrix will be found. This microstructural constituent is called tempered martensite (Figure 8). This transformation reduces the strength and hardness inherent in martensite, but restores some toughness and ductility (Figure 9).

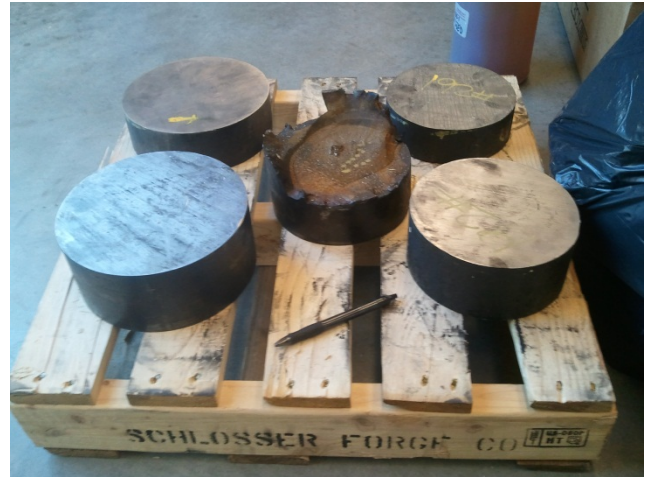
**Figure 11:** The five mandrel samples provided a total of 220 pounds of steel for further analysis. Fracture surface of a mandrel is in the center.

Several samples were taken from used 4340 steel mandrels at the Schlosser Forge facility. The samples were cut by a large band saw from either 7" or 8" diameter mandrels. A total of five mandrel slices, shown in Figure 11, varying in thickness from 2.5" to 4" were prepared. The five samples covered the following mandrel conditions: complete fracture of a 7" diameter mandrel, mid-mandrel sample of an 8" diameter mandrel, a section of an 8" mandrel containing initial cracking, and a piece from the end of both an 8" and a 7" mandrel. All of the sample sections were confirmed to be 4340 steel through use of a portable x-ray fluorescence spectrometer. Due to the high hardness of 38 – 42 HRC and the large diameter-to-thickness ratio of the sample disks, locating a machine shop capable of dividing the disks into smaller samples was difficult because it was not possible for a band saw to grip the disk. Ultimately, smaller samples were cut from the disks by a water jet cutter. The water jet only allowed cuts from the face of the disks, meaning that it was not possible to slice disks of lesser

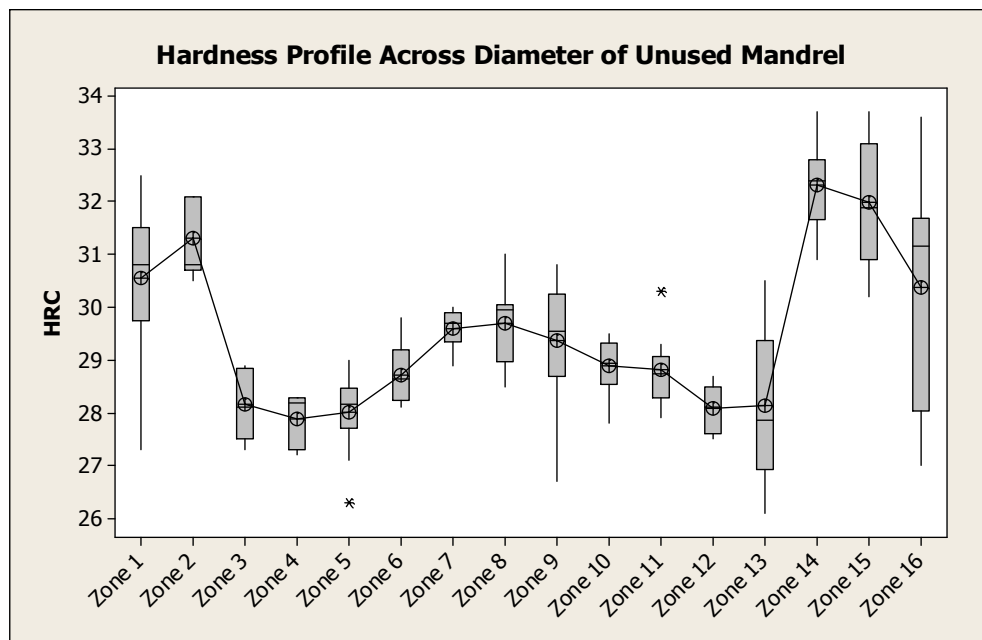
Figure 16 depicts hardness measurements from across the diameter of the unused mandrel end piece. Even at its hardest point, this section of the mandrel is still considerably softer than the specified hardness value of 38-42 HRC.

**Figure 16:** This representation of the hardness data for the unused mandrel shows a profile of hardness versus location while also providing an idea of the deviation of the data.

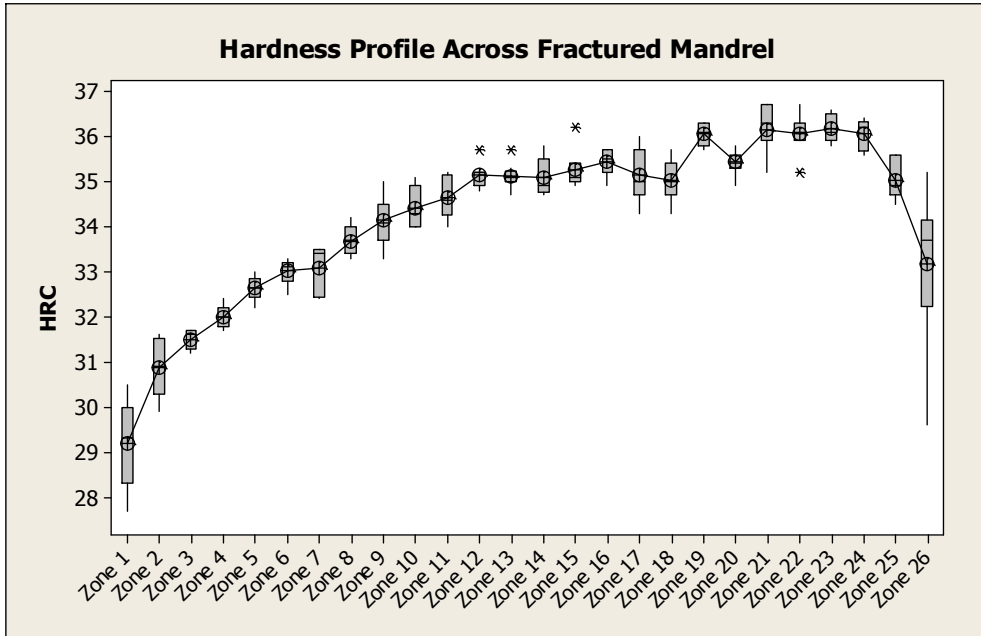
Figures 17 and 18 are both hardness profiles from the fractured mandrel sample. The profile in Figure 17 is from nearer the fracture surface than the hardness measurements in Figure 18. It is apparent in both graphs that the hardness decreases from the right side of the graph to the left side. The left side of the graph corresponds to the identified origin of the fracture that eventually led to the mandrel's failure. This means that mandrel failure may be facilitated by a softening of the steel near the surface of the mandrel.

**Figure 17:** Since the mandrel rotates and the workpiece does not necessarily contact each point of the circumference of the mandrel evenly, hardness may be different at multiple points around the mandrel.

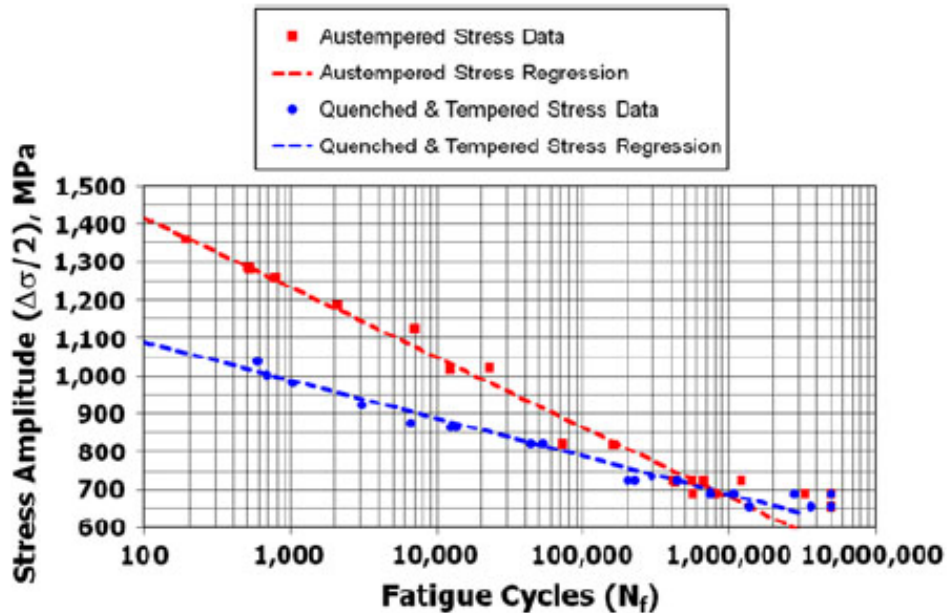
Figure 25: Comparison of fatigue life of Q&T steel and austempered steel based on stress amplitude. High cycle fatigue life seems to be similar for the two treatments, but in the low cycle regime, austempered steel shows a promising increase in fatigue life<sup>18</sup>.

High toughness will enable the mandrel to absorb much of the impact of the upper die without the localized plastic deformation that leads to the cracks that eventually cause the mandrel to fracture. Table III shows that it is difficult to obtain a combination of high hardness and toughness with quenched and tempered steel. The austempering process results in a material with less residual stresses and a lower dislocation density because the quench to the austempering temperature is less severe than the quench to room temperature for transforming austenite to martensite. The data in Figure 25 is from a study in which the fatigue life of 4340 was analyzed in both the quenched and tempered and austempered conditions. At high stress amplitude, austempered steel shows increased fatigue life.
