Updating reliability of steel miter gates on locks and dams using visual inspection results

Allen C. Estes^{a,*}, Dan M. Frangopol^b, Stuart D. Foltz^c

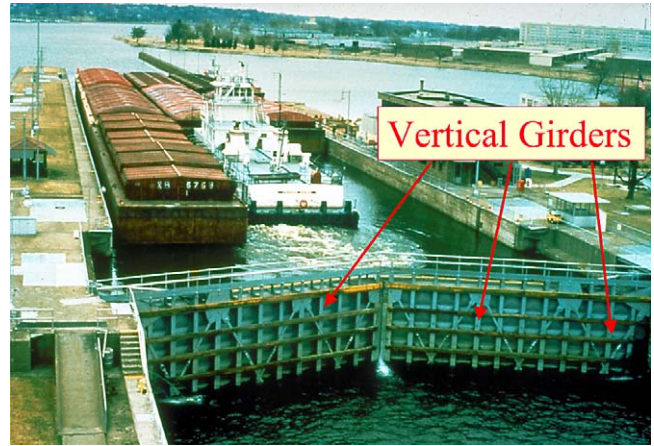
Fig. 3. Typical vertically framed miter gate [4,27].

The Rock Island District of the USACE prepared a time-dependent reliability analysis of Lock and Dam 12 (Fig. 2) on the Mississippi River near Dubuque, IA, to predict how this structure will perform over its useful life [24]. This gate comprises vertically framed girders similar to those shown in Fig. 3. The reliability

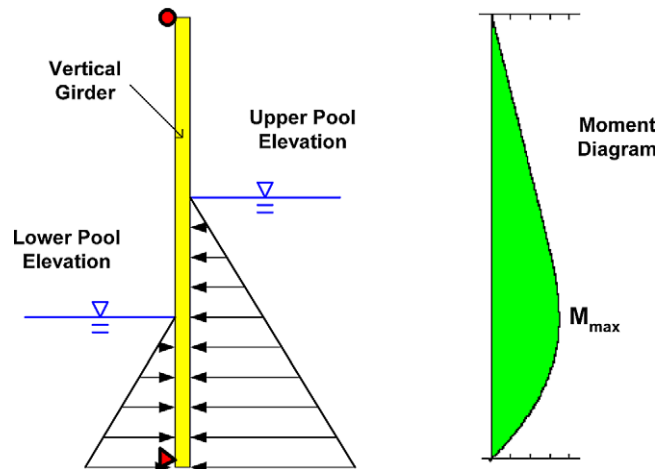
Fig. 4. Hydrostatic forces and resulting moment diagram on a vertically framed miter gate girder.

analysis was based on the bending failure limit state of a typical vertical girder. The hydrostatic forces on the girder from the upstream and downstream water levels and the resulting moment diagram are shown in Fig. 4. The maximum moment (M_{max}) varies as the level of water in the lock chamber rises and falls. All interior girders experience the same hydrostatic loading.

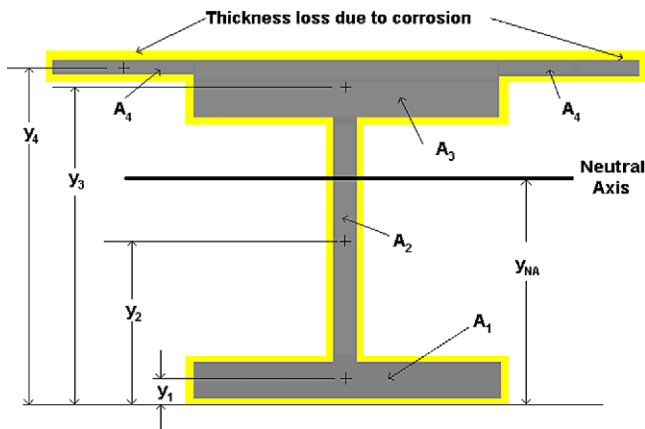
Fig. 5. Thickness loss due to corrosion on composite cross-section of the vertical girder.

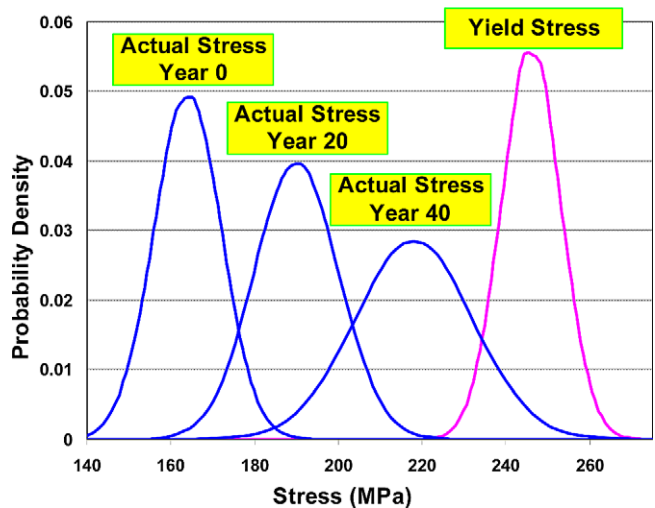
Fig. 6. Decrease in reliability over time as reduced section loss causes an increase in the bending stress on the girders.

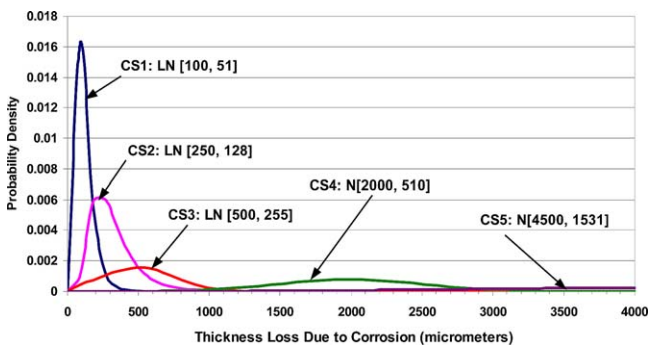
Fig. 7. Condition state distribution for section loss due to corrosion (very experienced inspector).

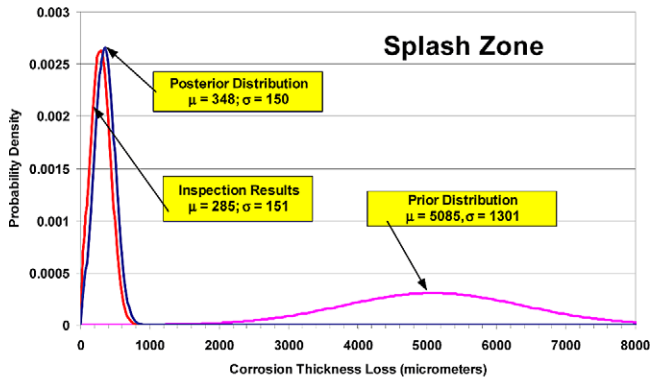
Fig. 8. Bayesian updating based on inspection results for the atmospheric and splash zones.

where μ , μ' and μ'' represent the mean values of the inspection results, the prior distribution, and the posterior distribution, respectively. The values σ , σ' , and σ'' represent the standard deviations of those same distributions. Fig. 8 shows the prior, inspection, and posterior distributions for the inspection results shown in Table 4 for both the splash zone and atmospheric zone. Because of the high degree of corrosion expected in the splash zone in 1998 and its associated uncertainty, the effect of the inspection results dominated the posterior distribution. The projected deterioration and its uncertainty were much less in the atmospheric zone. The deterioration model and the inspection results received about equal weight in computing the posterior distribution.

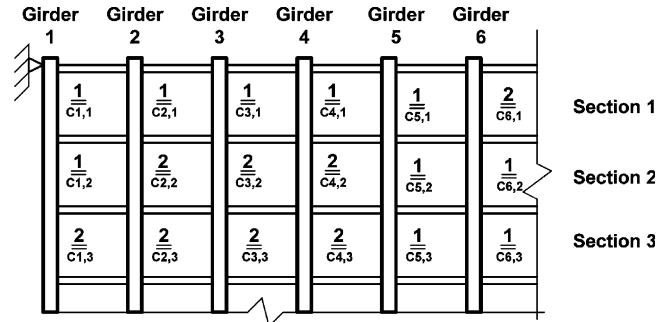
Fig. 9. Segment-based inspection for corrosion deterioration.

A segment-based inspection requires additional work in the preparatory phase, but does not take longer to conduct. Even when inspection results are based on a worst-case rating, every member must still be examined. It does not require much additional effort to record that rating. Since a miter gate is naturally divided into identifiable segments by the girders and intercostals, it lends itself well to a segment-based inspection. Hypothetical segment-based inspection results for a portion of upstream gate for Lock and Dam 12 are shown in Fig. 9 where the miter gate rating is recorded

on a picture and the miter gate is subdivided and evaluated by specific numbered sections. An alternative and simpler format is illustrated in Table 5 for the entire gate structure where the evaluation is tabular and sections are represented by the environmental zones.

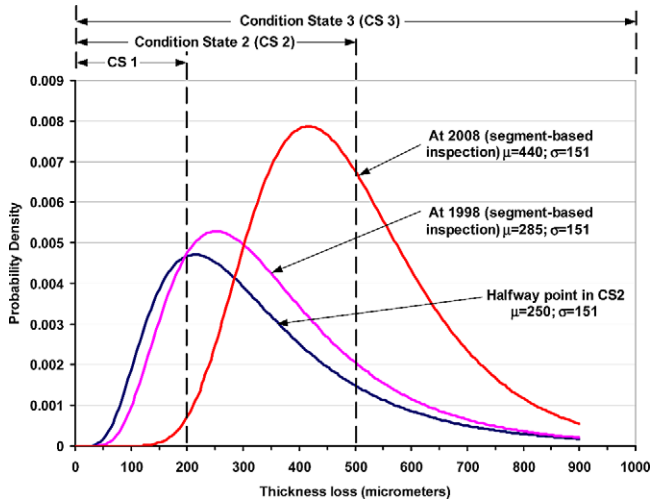
Fig. 10. Progression of miter gate through condition state 2 for corrosion based on inspection results.

Using method D which requires both a segment-based inspection and Bayesian updating, the deterioration model was updated based on a hypothetical segment-based inspection in the year 2008. Fig. 10 shows the distribution of the thickness loss for condition state 2 (from Table 3) based on the results of the segment-based inspections. The graphs show the computed distribution when the structure first enters the condition state 2 (it is conservatively assumed that the condition state is entered at the half-way point; i.e., $\mu = 250 \mu\text{m}$), at the year 1998, and at the year 2008. The mean value could go as high as $500 \mu\text{m}$ where it would remain until an inspector classified the damage as condition state 3 [3]. After the inspections in 1998 and 2008, the deterioration model was updated based on the prior and new information. The new models, as shown in Fig. 11, are expressed as $C = 10.23t^{0.903}$ and $C =$

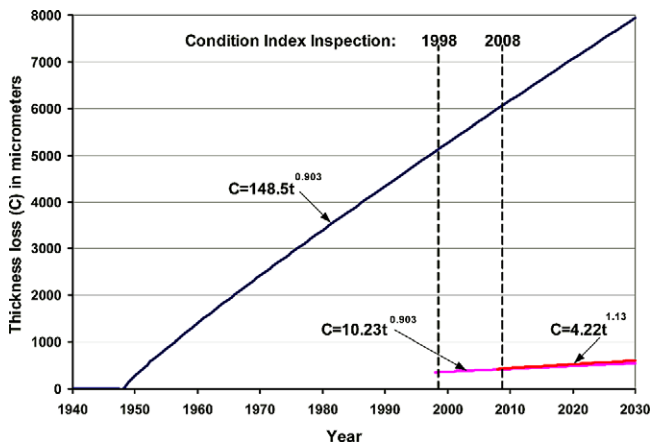
Fig. 11. Updated deterioration models based on condition index inspections in 1998 and 2008 [3].

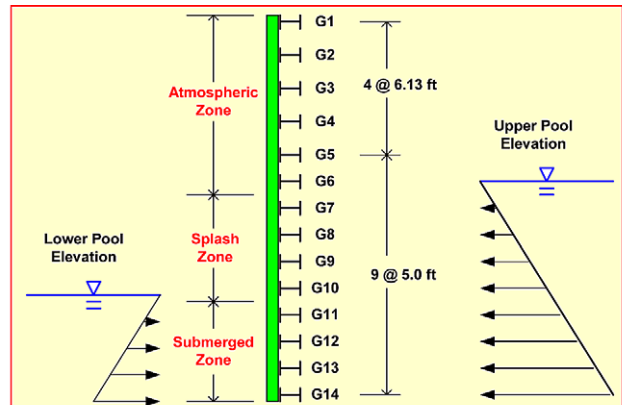
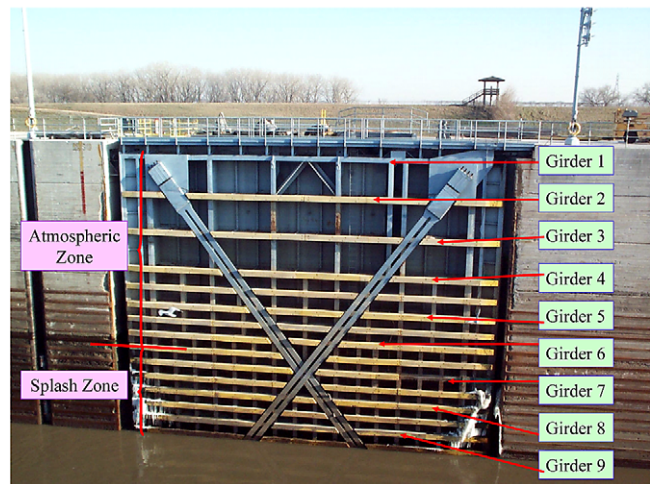
Fig. 13. Location of horizontal girders and environmental zones of the miter gate on Lock and Dam 27 [8].

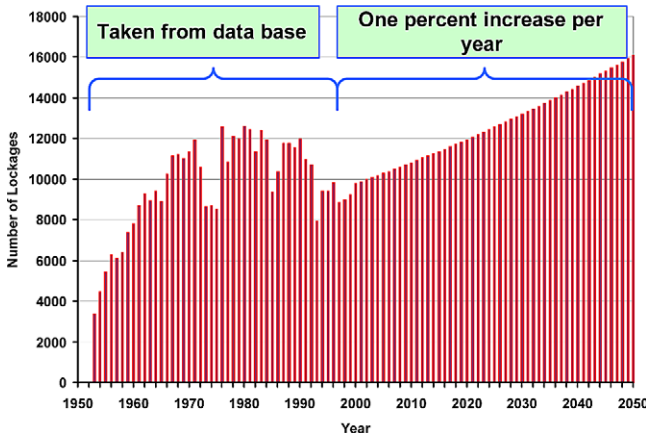
Fig. 14. Number of lockages on Lock and Dam 27; the future projection is 1% per year [4].

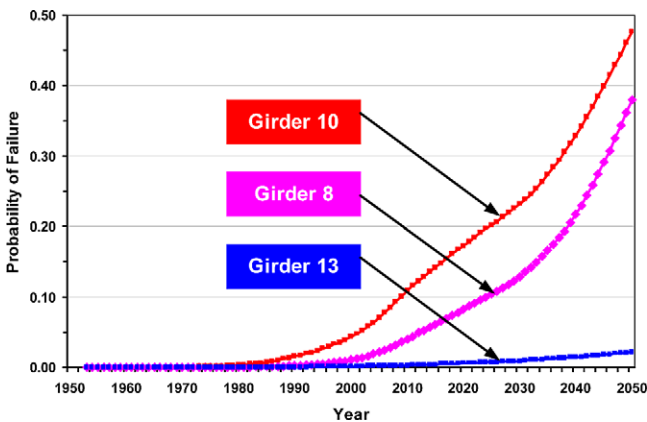
Fig. 15. Probability of failure of girders 8, 10, and 13 on Lock and Dam 27 based on fatigue damage.

The graph for girder 10 (Fig. 15) represents the cumulative probability of failure, $P_f(t)$. The reliability function $R(t)$ is equal to $1 - P_f(t)$. The PDF for the failure of the structure can be computed as

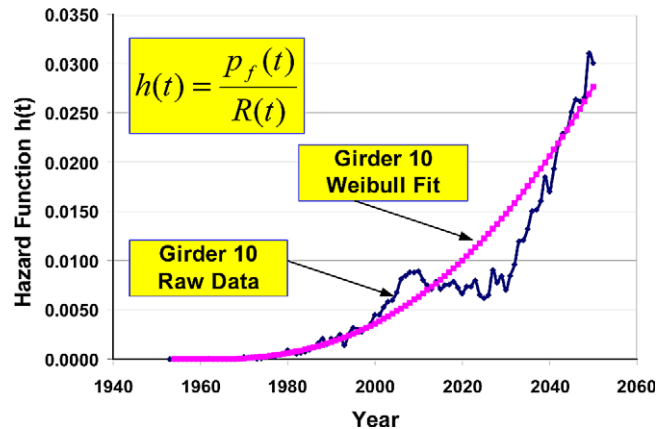
Fig. 16. Hazard function for girder 10 on Lock and Dam 27 based on fatigue damage.

Fig. 16 shows the hazard function $h(t)$ for girder 10. The hazard function using raw data is obtained by numerically differentiating $p_f(t)$ and provides a very jagged hazard curve. The data can be fitted to a Weibull distribution [16] to produce a smooth, constantly increasing hazard curve as shown in Fig. 16.

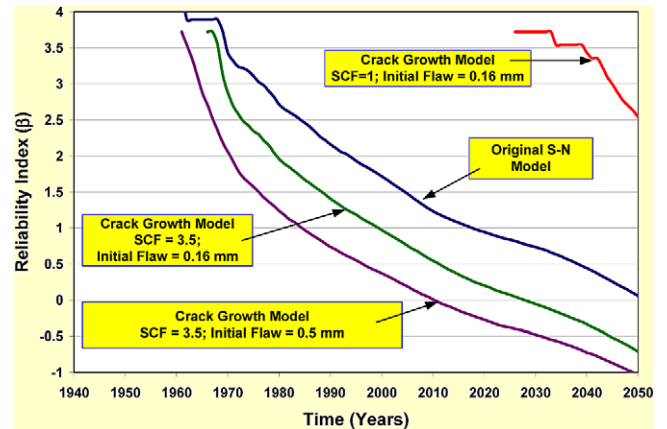
Fig. 17. Reliability index (β) for girder 10 fatigue deterioration using the characteristic $S-N$ model and several crack growth models.

There is not a necessarily good correlation between the $S-N$ deterioration model and the crack growth model despite some common parameters such as the stress field and the number of cycles. Fig. 17 compares the reliability index β over time for the miter gate on Lock and Dam 27 using the original $S-N$ model and the crack growth model varying both the stress concentration factor and the initial flaw size. The simulation package @RISK [14] was used for the reliability analysis. An individual analyst must choose the most appropriate models for initial analysis and design, but any of these models can be updated once a crack is observed.

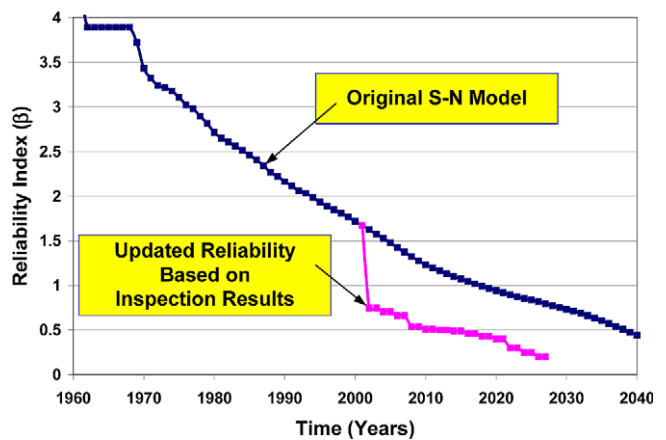
Fig. 18. Updated reliability index (β) for girder 10 fatigue deterioration using inspection results and a crack growth model for observed cracks.

on Lock and Dam 27. The first visible crack appears in 2004, which is earlier than the deterioration model predicted. Fig. 18 shows the reliability index, β , over time for both the original characteristic $S-N$ fatigue deterioration model and the updated crack growth deterioration model based on the CI inspection results. Once a crack appears, the crack growth model with stress concentration factor of 3.5 was used for the updating. The reliability is updated after every inspection, which is assumed to be conducted every 2 years. If the crack had been on a fracture critical member, it would never have been allowed to progress so far.

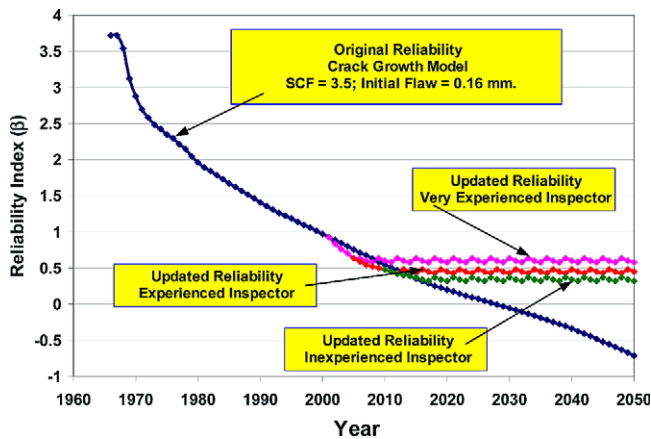
Fig. 19. Updated reliability index (β) for girder 10 fatigue deterioration using inspection results when no cracks were found.

The more delicate situation is when the fatigue performance is better than the deterioration model predicts and no visible cracks ever appear. The CI rating for fatigue never changes from a condition state rating of 1. It is also possible that a crack exists, but the inspector has not detected it. Fig. 19 shows the updated reliability for the miter gate when the inspectors are classified as very experienced, experienced, and inexperienced. The analysis is based on the assumption that a surface crack of 6, 12, and 25 mm (1/4, 1/2, and 1 in.), respectively, would not go undetected by the inspector. The crack growth model using a stress

concentration factor of 3.5 and initial flaw size of 0.16 mm (0.0064 in.) was used for the initial model. The reliability curves flatten out as the original deterioration model has been invalidated. The reliability continues to deteriorate until a new inspection reveals that no cracks have appeared, but no new information is available to update the model and the analysis is based on the detection capability of the inspector. Still the absence of cracks when they were clearly expected provides some new information and it should be used to the extent possible.
