## Research Article

# Water Content Influence on Properties of Red-Layers in Guangzhou Metro Line, China

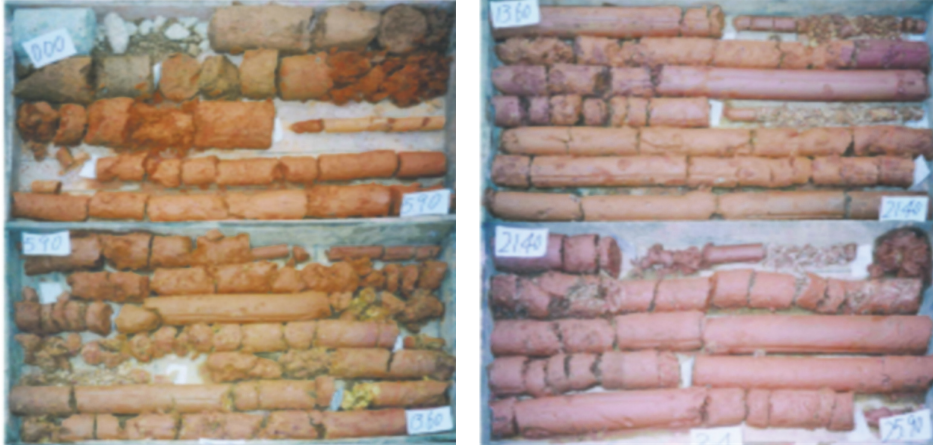
FIGURE 1: Typical borehole rock or soil cores.

The typical red-layers specimens were sampled at Tiyu West Road Station, Zhujiang New Town Station, Wushan Road Station, Kecun Road Station, and Tianhe Road Station of Guangzhou Metro Line, separately. The details of specimens were shown in Table 1. The sampled depth of red-layers specimens were from 8.2 m to 31.3 m. The specimens consisted of 102 groups with intact and disturbed soil or rock samples, which had different shapes, such as lumpy soil, cylindrical soil, drilling core rock, and shield tunnel excavated soil. The lithologies of the samples were red clay, moderately weathered red clay, moderately to strongly weathered red clay, sandstone, red sandstone, weathered granite, and shield tunnel excavated soil, respectively (Figure 1).

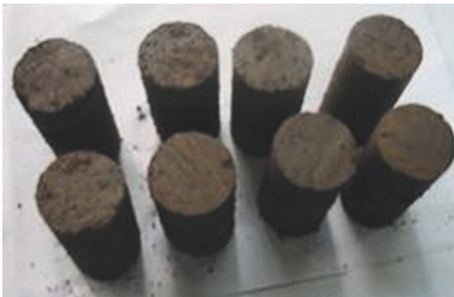
FIGURE 2: Part reconstituted soil specimens for automatic triaxial shear test.

The automatic triaxial test specimens were made with different water contents by the reconstituted Zhujiang New Town Metro Station red-layers, and the Unconsolidated-Undrained (UU) triaxial test was adopted. The specimens were remolded as a cylinder with 39.1 mm in diameter and 80 mm in height with different water contents (Figure 2).

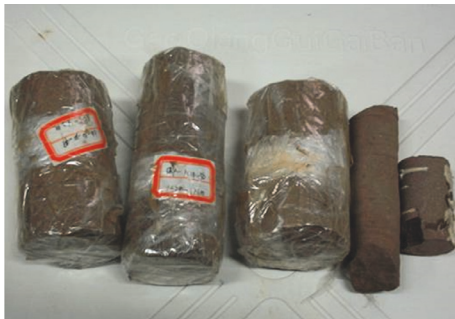
FIGURE 4: Part specimens of creep test.

Typical red sandstone specimens with dry and saturated state of Zhujiang New Town Metro Station were chosen for creep test, and the specimens' sampled depths were 17.8 m~20.0 m (Figure 4). The samples were processed into a cylinder with 61.8 mm in diameter and 130 mm in height.

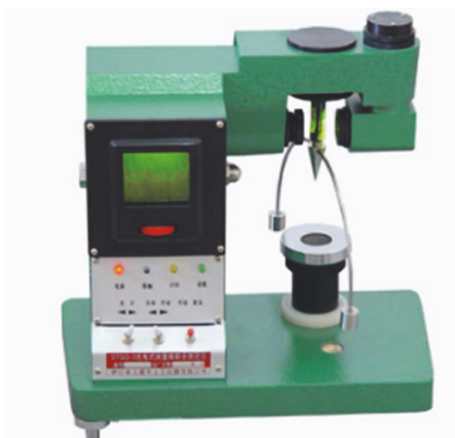
FIGURE 5: STGD-3 type photoelectric liquid-plastic limit tester.

The STGD-3 type photoelectric liquid-plastic limit tester was used to measure the water content of reconstituted soil specimen (Figure 5); the ZJ type direct shear apparatus was chosen to test the cohesion  $c$  and internal friction angle  $\phi$  of different water content soil specimens (Figure 6).

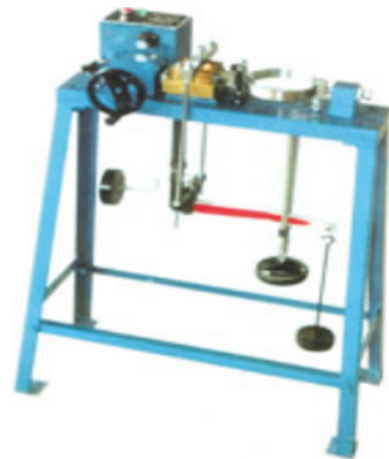
FIGURE 6: ZJ type direct shear apparatus.

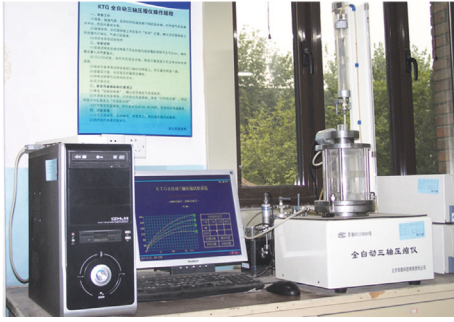
FIGURE 7: KTG automatic triaxial shear test apparatus.

The KTG automatic triaxial test apparatus was used for shear strength test (Figure 7). Three specimens in each group settled the same confining pressure; that is,  $P_1$ ,  $P_2$ , and  $P_3$  were 100 kPa, 200 kPa, and 400 kPa, respectively, to be tested.

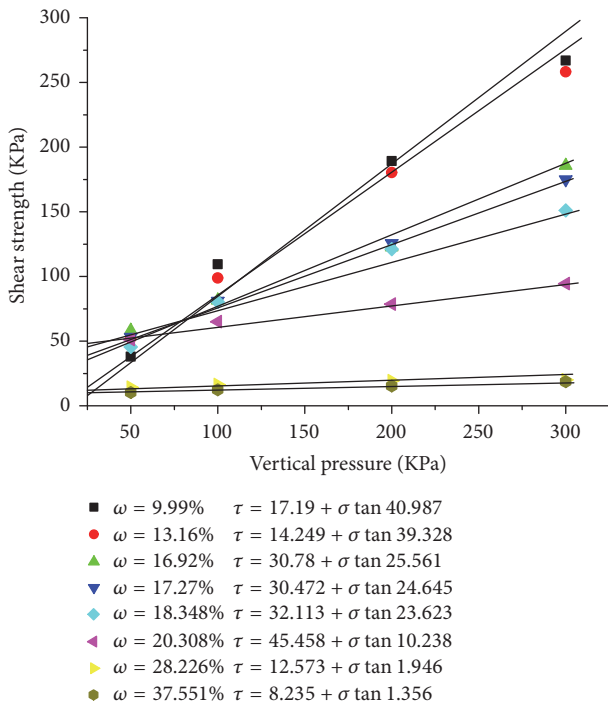
FIGURE 8: Shear strength and vertical load relationship curves.

**4.1. Direct Shear Test Results.** The shear strength envelopes of the remolded soil specimens were shown in Figure 8; the values of cohesion  $c$  and internal friction angle  $\phi$  of the soil specimens with different water contents were shown in Table 2. The following two points can be noticed from Figure 8 and Table 2.

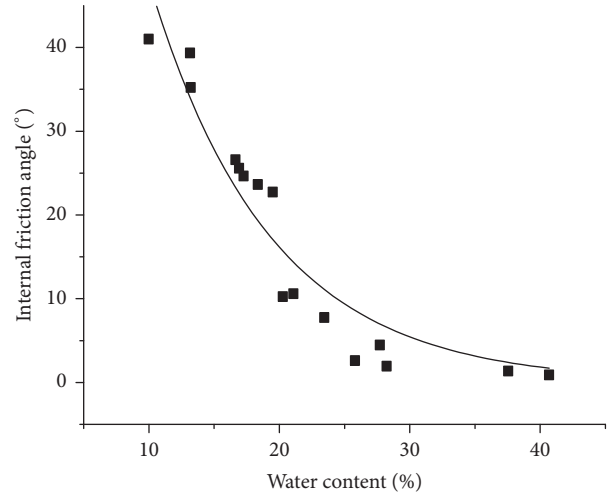
FIGURE 9: Fitting curve of water content and internal friction angle.

(1) Internal friction angle  $\phi$  decreased with the increase of water content  $w$ ; the exponential decay function could be

chosen to present the relationship of internal friction angle  $\phi$  and water content  $w$ . The fitting curve of internal friction angle  $\phi$  and water contents  $w$  was shown in Figure 9, and the fitting equation was presented as (1).

$$\phi = 142.157e^{-w/9.197}, \quad (1)$$

After careful investigation of Figures 9 and 10, one can understand that the experimental data are well in accordance with the corresponding equation curve. It was illustrated that the water content was one of the important parameters which strongly affected the shear strength of typical Guangzhou Metro red-layers; therefore, the water-weakening mechanism of the red-layers should be further studied for the safety and efficiency of Guangzhou Metro Line construction. The shear strength and water contents relationship of the red-layers established by direct shear test could provide reference for

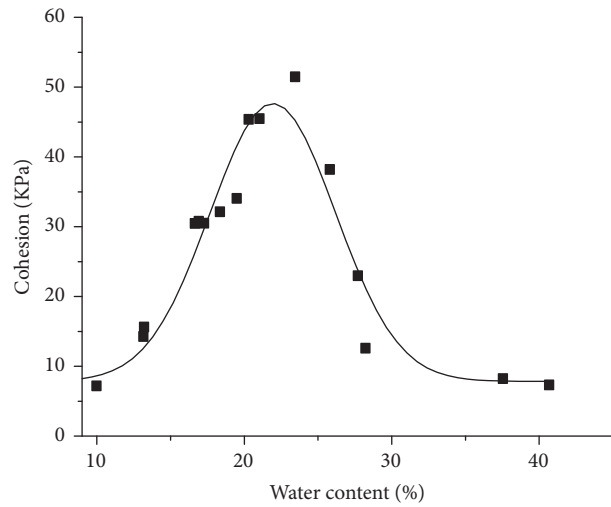
FIGURE 10: Fitting curve of water content and cohesion.

(2) Cohesion  $c$  increased with the increase of water content  $w$  when  $w$  was less than 21.938% and decreased with the increase of water content  $w$  when  $w$  was higher than 21.938%; that is, the inflection point occurred at  $w = 21.938\%$ . The Gaussian function could be chosen to fit the results. The

fitting curve of cohesion  $c$  and water contents  $w$  was shown in Figure 10, and the curve expression was shown as

$$c = 7.834 + \frac{424.715}{8.509 \times \sqrt{\pi/2}} e^{-2(w-21.938)^2/8.509^2}. \quad (2)$$

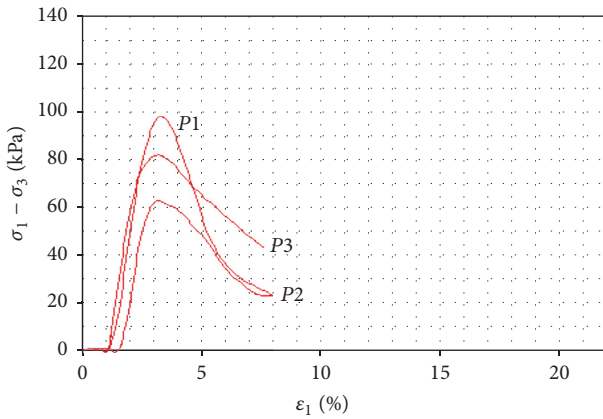
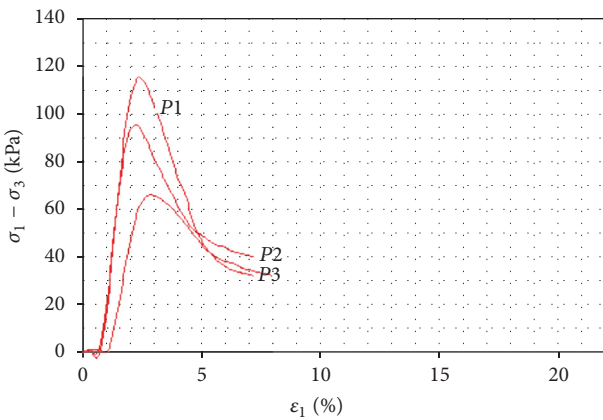
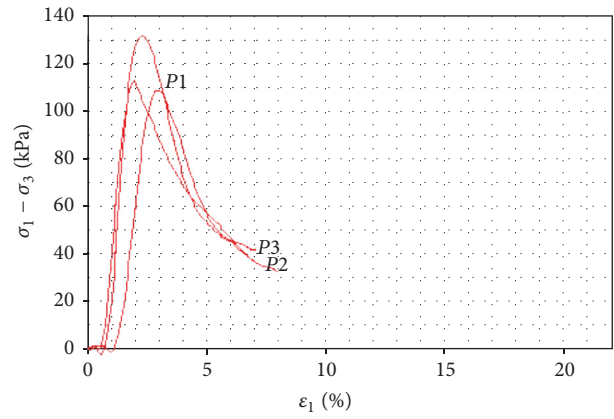
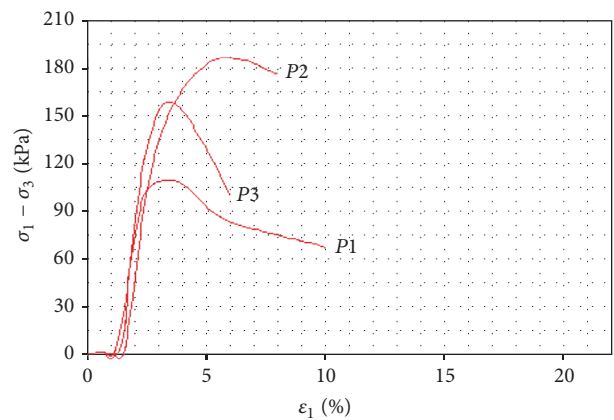
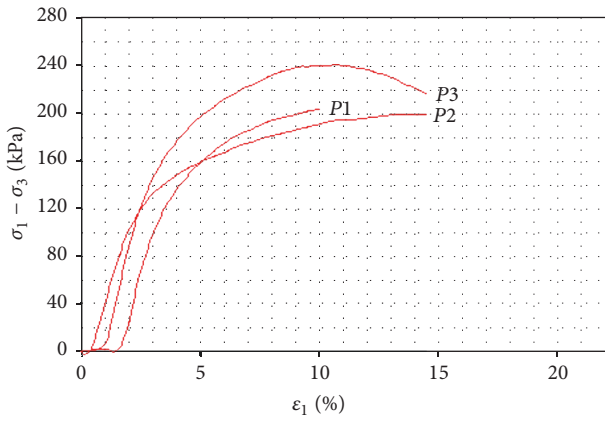
FIGURE 11: Principal stress difference and axial strain with 13.61% water content.

FIGURE 13: Principal stress difference and axial strain with 15.00% water content.

FIGURE 12: Principal stress difference and axial strain with 14.04% water content.

FIGURE 14: Principal stress difference and axial strain with 15.81% water content.

FIGURE 15: Principal stress difference and axial strain with 18.5% water content.

4.2. *Triaxial Test (UU) Results.* The main stress difference and the axial strain curves and other valuable results were obtained after the test, as shown in Figures 11–17. The water contents and cohesion values were presented in Table 3.

(2) With the same confining pressure, the specimens with different water contents had different peak strength and axial deformation. In general, the peak strength increased with the increase of water content. When the water content was no more than 18.5%, the peak strength firstly increased and then decreased with increase of the  $(\sigma_1 - \sigma_3)$  while  $P1 = 100$  kPa but simply increased with the increase of the  $(\sigma_1 - \sigma_3)$  while confining pressures  $P2 = 200$  kPa and  $P3 = 400$  kPa.

(4) When the water content was 18.5%, the peak strength reached the maximum value under different confining pressure, and the strain was 1%~1.5%, which was more than that of 0.2%~0.56%, when water content was less than 18.5%.

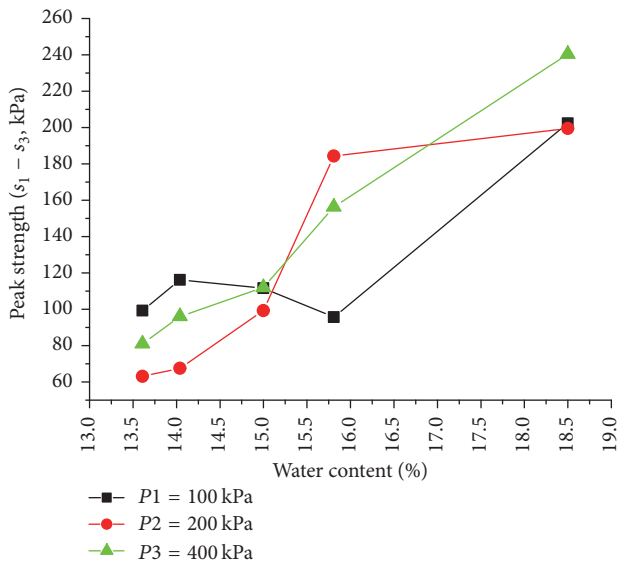
FIGURE 16: Relationship of water content and peak strength.

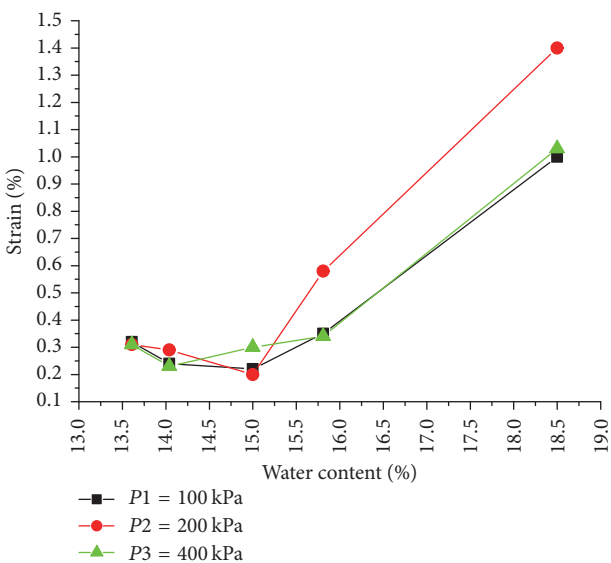
FIGURE 17: Relationship of water content and strain.

(3) Generally, the strain slightly decreased and then sharply increased with increase of water content; the inflection point occurred at  $w = 15\%$ .

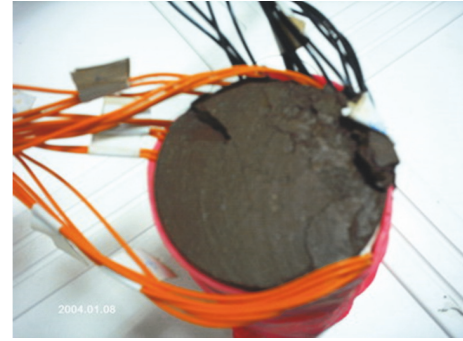
FIGURE 18: Typical specimen upper face after 10 minutes in water.

**4.3. Swelling Test Results.** The intact and disturbed typical red sandstone specimens of Wushan Road Metro Station were used for unconfined swelling test. After being immersed in water, the air-drying red sandstone specimen rapidly expanded with numerous cracks occurring and debris falling,

which indicated that red sandstone had strong swelling and disintegration potential. The swelling damage mode of red sandstone specimen was shown in Figure 18, the test results were shown in Figure 19, and the time-strain curves were shown in Figures 20 and 21. The following valuable points could be made from Figures 18–21.

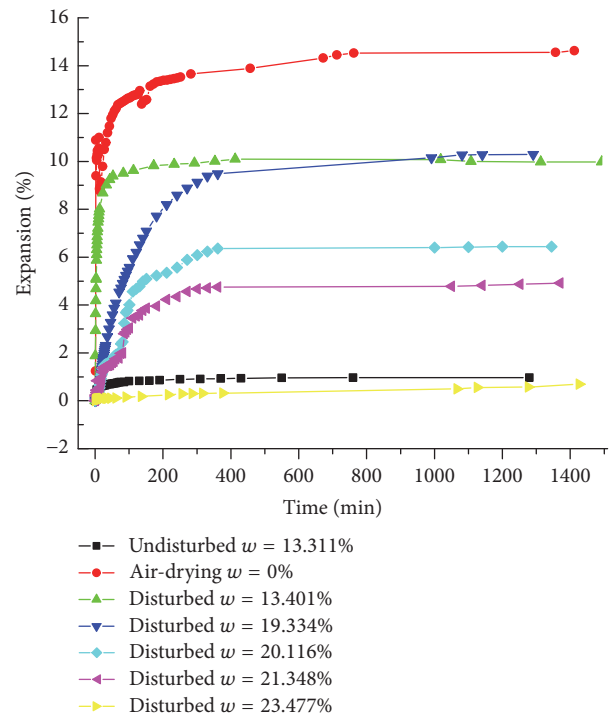
FIGURE 19: Swelling rate versus time curves of red-layers specimens.

(1) Water contents had the strong influence on the expansion of the disturbed specimens; generally, the expansion decreased with increase of water content, which illustrated that the water may weaken the mineral compositions or microstructures to reduce the sample expansion.

(2) There was very different swelling between the different water content samples. The smallest expansion of the highest

water content sample was about 0.65%, while the biggest swelling of the air-drying samples was about 14.3%; the expansion has very big difference between the two specimen.

(3) The microstructures had big influence on the expansion, too. With the similar water content, that is, 13.311% of intact sample and 13.401% of disturbed specimen, the expansion was about 1% and 9.8%, respectively, almost ten times difference in swelling with different microstructures.

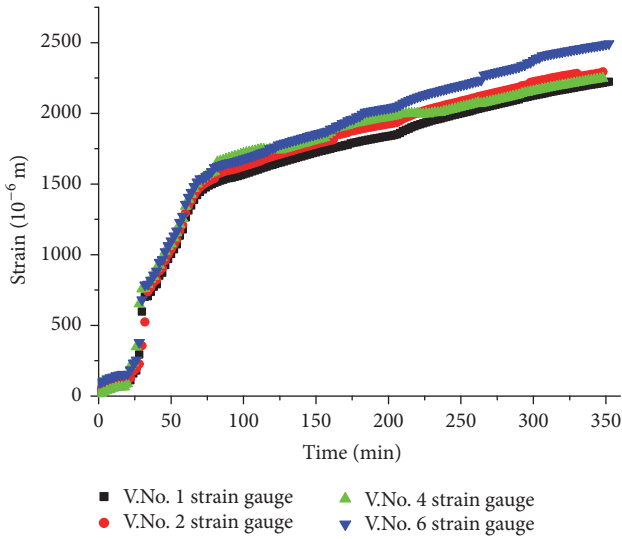
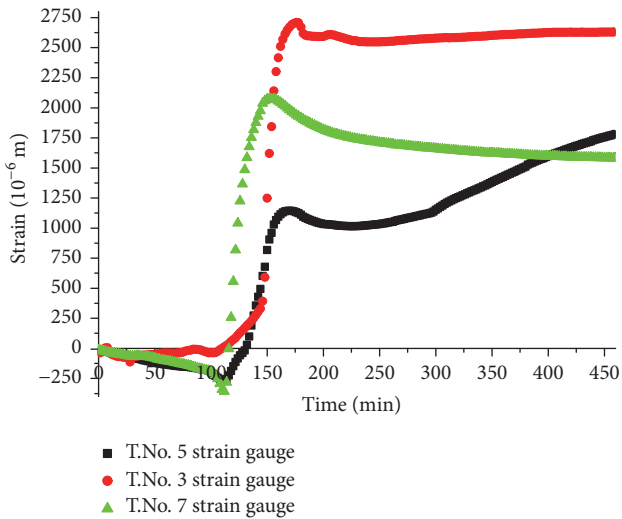
FIGURE 20: Vertical strain and time curves of No. 3 specimen.

FIGURE 21: Transverse strain and time curves of No. 3 specimen.

(4) In general, there were similar vertical stains in different parts of samples, and comparatively, there were different transverse strains in different parts of samples. The lower part of sample had bigger transverse strain, that is, about 2.75 mm, while the upper and middle part of specimen had smaller strain, that is, about 2.15 mm and 1.75 mm, respectively.

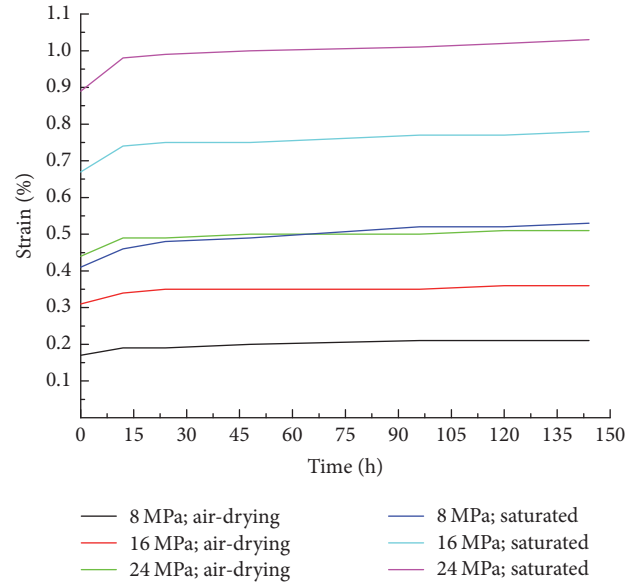
FIGURE 22: Time-strain curves of the typical red sandstone.

were conducted using equipment under uniaxial compression. Based on the tested results as shown in Figure 22, the influence of water content on the creep strain could be presented as follows.

(1) All of the time-strain curves exhibited three typical stages, that is, accelerated, dumped, and steady-state stages. The deformation at accelerated stage was significant. Generally, the accelerated stage spent short period of time. In contrast, the dumped and steady-state states took long period of time.

(2) The strain of different deformation stages all increased with the increase of the loading stress; that is, the higher the loading stress, the higher the strain of different deformation stages.

(3) Water content has very significant effect on the creep properties of red sandstone; in the same loading level, the strain of air-drying samples was only 40.1 to 49.3 percent of

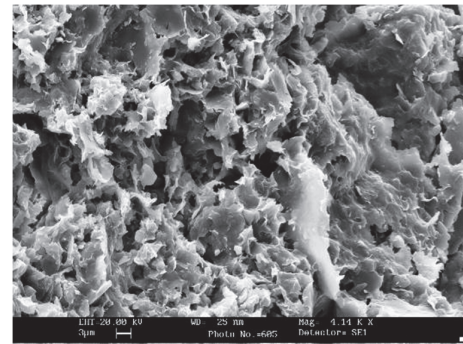
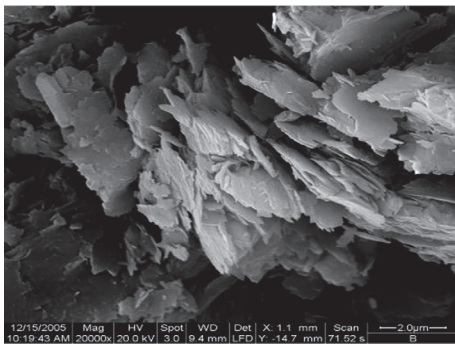
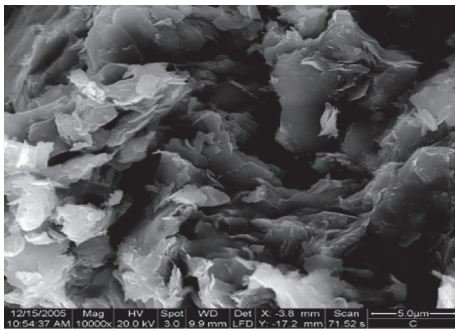
FIGURE 23: SEM picture of Tiyu West Road Station red clay sample,  $\times 4140$  Honeycomb I/S with a small amount of needle-like C.

FIGURE 24: SEM picture of Zhujiang New Town Station sample,  $\times 20000$  leaf shaped and laminated C.

FIGURE 25: SEM picture of Wushan Road Station sample,  $\times 10000$  filament I/S.

(1) The microstructures of samples were relatively loose; the larger pores of the different samples were about 30–200  $\mu\text{m}$  between the particles, with the good connectivity. The samples contained numerous needle-like chlorite, flake-flocculent chlorite, honeycomb and flaky illite, and smectite mixed layer and chlorite and smectite mixed layer, with the authigenic polyhedral quartz and strip albite crystal existing in particles.

(1) The typical red-layers samples had layered or honeycomb microstructures and easily water swelling or weakening minerals such as chlorite and smectite, and the pores had good connectivity between the particles which provided the water invasion tunnels.

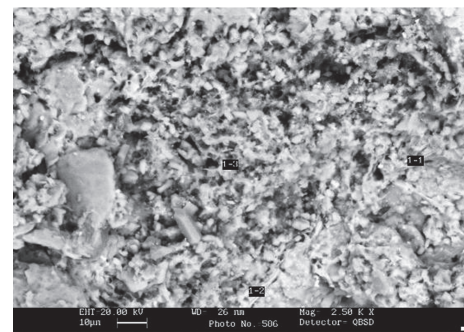
FIGURE 26: Energy spectrum picture of red clay sample in Tiyu West Road Station,  $\times 2500$  1-1 I/S; 1-2 I/S; 1-3 C/S.

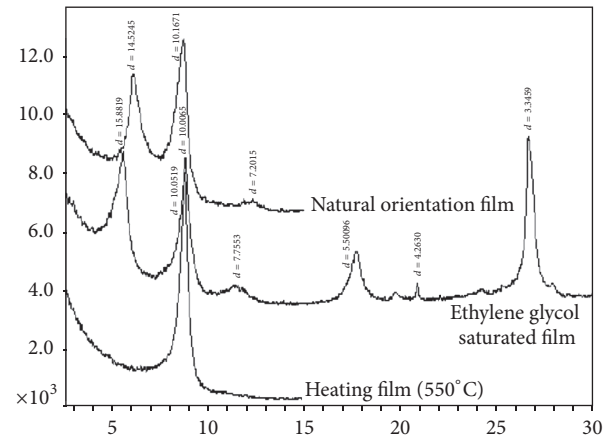
FIGURE 27: X-ray diffraction pattern of red clay in Tiyu West Road Station.

(2) Tiyu West Road Station sample mainly contained 54% smectite and 46% illite. Zhujiang New Town Metro Station

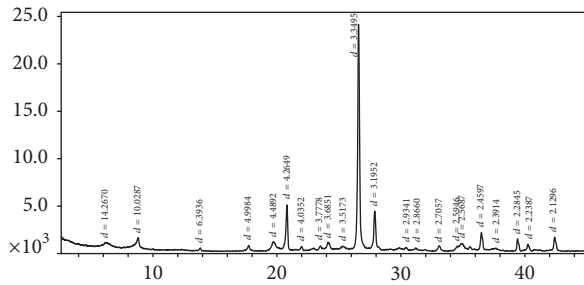
FIGURE 28: Total minerals from X-ray diffraction pattern of red clay samples in Zhujiang New Town Station.

sample relative contents were 39.9% clay minerals, 45.7% quartz, 10.9% plagioclase, and 3.5% hematite.
