Research Article

Use of Reclaimed Asphalt Pavement in Conjunction with Ground Improvement: A Case History

Kevin C. Foye

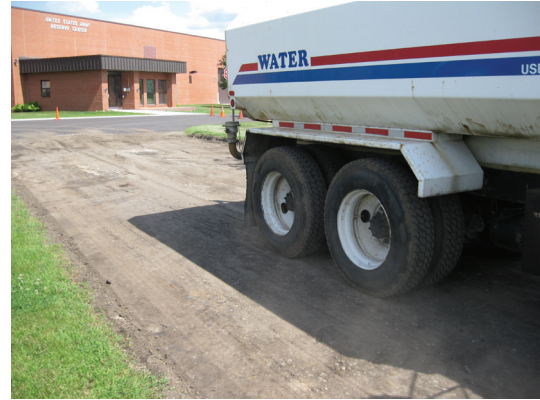
FIGURE 2: Photo showing typical proof rolling test.

Suitability of the subgrade to support the pavement system was assessed by means of a proof rolling test, whereby a loaded rubber-tired water truck is driven over the subgrade and a quality control technician observes the subgrade for signs of deflection, pumping, and/or rutting under the action of the tires (Figure 2). Observed pumping and rutting disqualifies the subgrade. Areas of disqualified subgrade required either compaction or replacement to meet design requirements. In cases where compaction is ineffective in achieving an acceptable subgrade, the contract required the undercutting of the subgrade to a depth of 1 m below top of subgrade elevation and replacement with compacted imported fill.

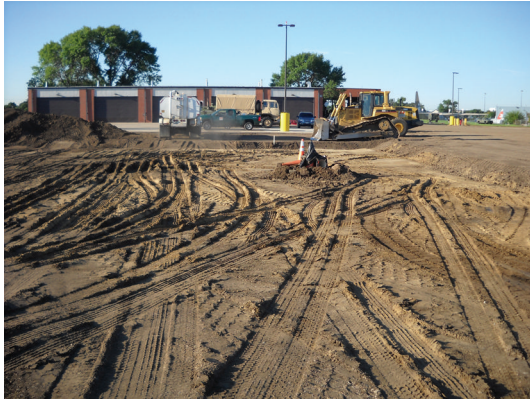
FIGURE 3: Photo showing typical rutting observed following proof rolling of the existing subgrade.

Following milling of the existing pavement and removal of the existing base material, the paving subcontractor proof rolled the existing subgrade. The quality control technician noted significant deflection, pumping, and rutting of the subgrade during proof rolling, suggesting that the subgrade may be unsuitable to depths greater than 300 to 1000 mm. Consequently, the subgrade was deemed unsuitable for placement of the pavement base. The extent of the permanent rutting, partially shown in Figure 3, indicated that nearly all of the 1.95 ha parking lot subgrade would require improvement.

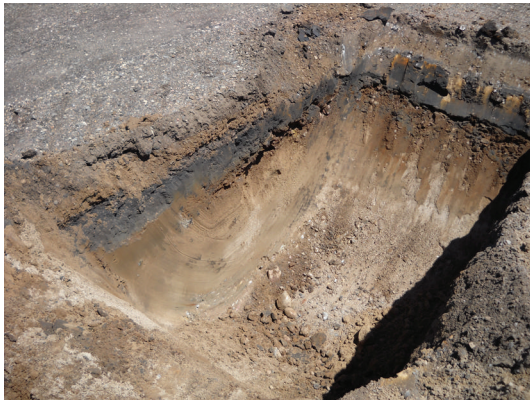
FIGURE 4: Example test pit showing, from top to bottom, typical soil profile: residual gray base aggregate, brown silty sand, black organic silt, brown silty sand.

To further investigate the subsurface profile following the failed proof-roll tests, the prime contractor excavated several test pits into the parking lot subgrade. These test pits revealed the consistent expression of a wet organic silt layer throughout the parking lot footprint. Figure 4 presents a photo of a typical test pit showing the organic silt layer. The organic silt varied in thickness over the site from 300 to 600 mm. A layer of wet, silty sand immediately below the organic silt also appeared to contribute to the poor condition of the subgrade and may also be responsible for the observed pumping during proof-roll testing. The typical depth to the bottom of the wet silt is 1 m below the top of subgrade.

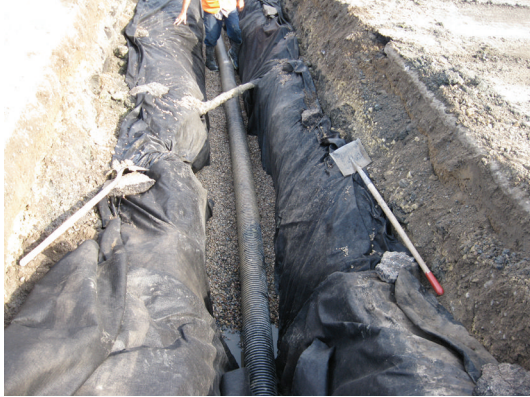
FIGURE 5: Photo showing installation of underdrains.

As part of the original design, the prime contractor installed a number of underdrains extending from the recently installed catch basins. These underdrains consisted of a perforated high-density polyethylene (HDPE) pipe embedded in a stone aggregate-filled trench wrapped in a filter geotextile (Figure 5). The trenches were excavated about 700 mm deep into the subgrade. The effective area drained by these underdrains was limited to less than 10% of the total parking lot. However, their placement at the low points of the regraded parking lot subgrade may facilitate effective drainage of a much larger fraction of the total area. These drains became significant to the improvement of the subgrade due to concerns about the discovery of water trapped within the silty sand above the organic silt layer. The quality control technician noted that visible flow through the installed drains stopped within 4 to 5 hours of installation. Anecdotal accounts of improved subgrade conditions 2 months after

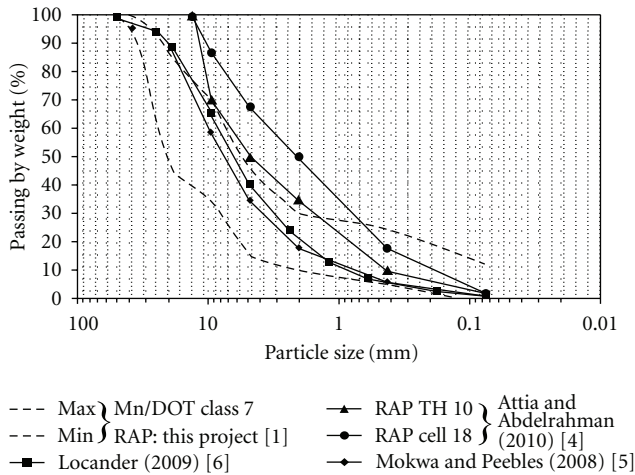
FIGURE 6: Comparison of Minnesota Department of Transportation (Mn/DOT) class 7 Particle Size Gradation Specification (RAP Used in This project) with Tested RAP Gradations from Selected Studies.

Attia and Abdelrahman [4], Mokwa and Peebles [5], and Locander [6] investigated the strength and stiffness properties of RAP and RAP/stone aggregate blends in the laboratory to assess their suitability as pavement base layers. Since gradation is expected to have a significant effect on the behavior of RAP, it is useful to consider if the gradation of the RAP used in this project is comparable to these laboratory studies. The RAP used in this project met the criteria for Mn/DOT class 7 aggregate. Figure 6 plots the particle size gradation bounds for class 7 aggregate together with the gradation curves for the 100% RAP aggregate tested by Attia and Abdelrahman [4], Mokwa and Peebles [5], and Locander [6]. The gradation for RAP investigated by Attia and Abdelrahman [4] is similar to the gradation for Mn/DOT class 5 aggregate—the same specification as the original base design for this project. As seen in Figure 6, the gradations for Mokwa and Peebles [5] and Locander [6] fall within the Mn/DOT class 7 bounds while the RAP studied by Attia and Abdelrahman [4] is finer than Mn/DOT class 7 aggregate. Based on this comparison, the Mn/DOT class 7 RAP used in this project is expected to have properties similar to those tested by the selected

studies. Since Mn/DOT class 7 is apparently coarser than RAP studied by Attia and Abdelrahman [4], it is expected to have slightly more favorable properties as a base material, although this relationship is not studied in this paper.
