Research Article

Research on Fire Resistance of Ultra-High-Performance Concrete

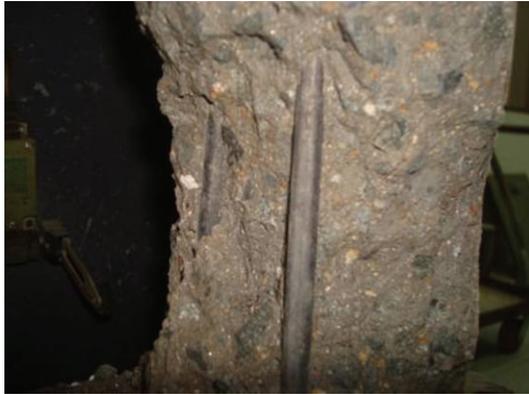
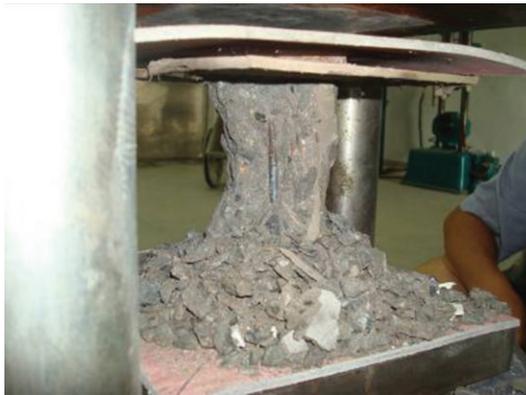
At present, the research on the fire resistance of ultra-high-performance concrete equal to or greater than C100 has yet prevailed. However, concrete buildings usually get badly damaged in fire (Figures 1 and 2), causing high life and property losses, let alone environmental pollution [1].

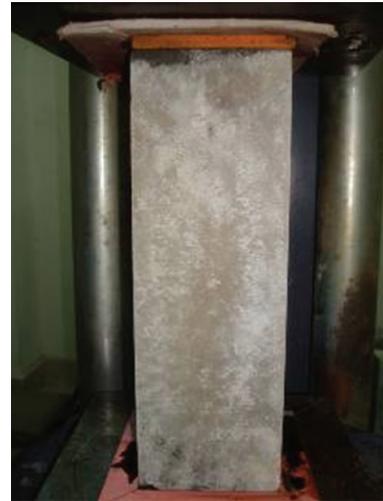
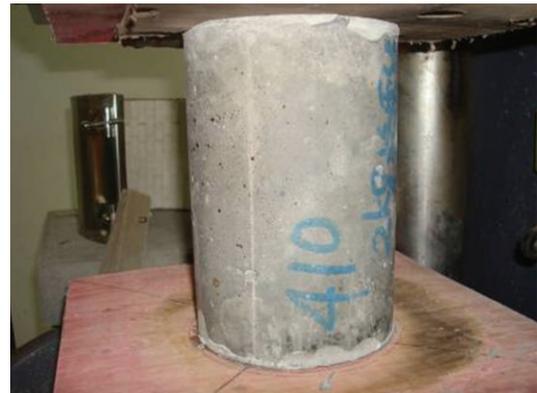
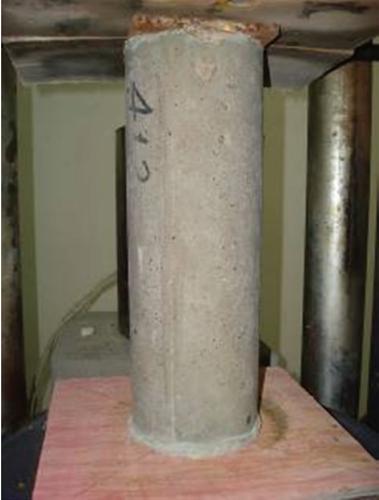
Finished test pieces were in 3 sizes: 100 × 100 × 300 mm, $\Phi 100 \times 150$ mm, and $\Phi 100 \times 300$ mm, as in Figures 3, 4, and 5.

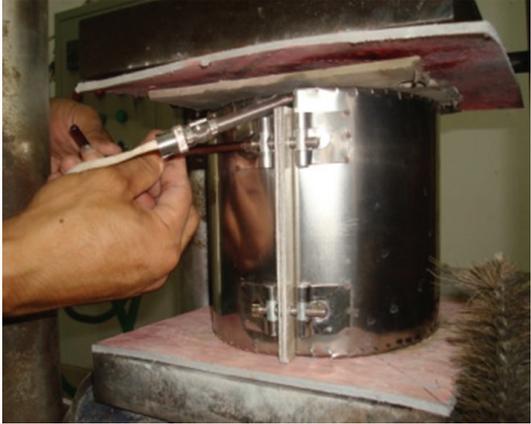
FIGURE 8: Cylindrical heating jacket.

- (1) Heating: we designed 3 heating apparatus and assigned a workshop to manufacture them for us. They came out as in Figures 6, 7, and 8.
- (2) Loading: 2000 KN digital press machine.

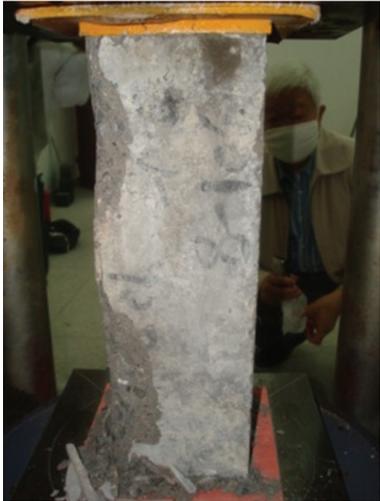
FIGURE 9

- (1) Figure 9 features basic test-pieces condition after undergoing constant loading pressure and being heated to 200°C. We could see from the figure that the concrete on the surface, especially the corners, was flaking away; there were minor cracks everywhere, suggesting cracking was the main reason why the concrete flaked away under the influence of pressure and heat.

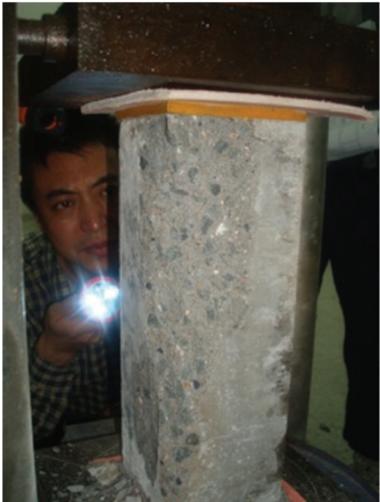
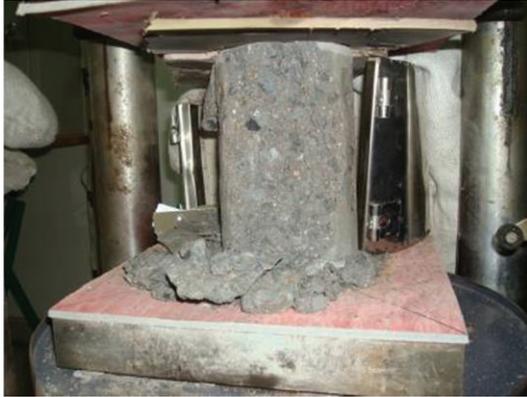
- (2) Figures 10 and 11 feature basic test-pieces condition after undergoing constant loading pressure and being heated to 300°C. During the process, the test piece endured dozens of crackings, which led to massive concrete flaking away on the surface; cylindrical test piece even exploded while pressure mounted and got more seriously damaged.

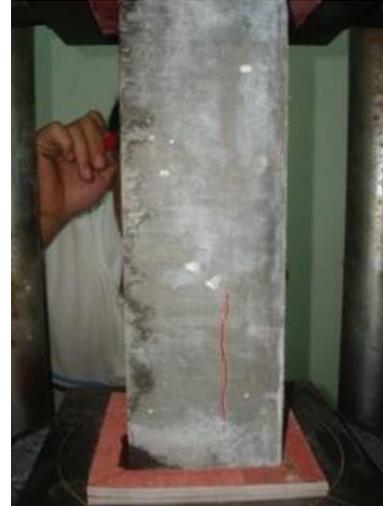
FIGURE 13

- (1) Figure 13 features the condition of test piece with 1 Kg/m³ polypropylene fiber after undergoing loading pressure and being heated to 200°C. It looks quite intact, only few minor cracks can be seen in the figure.
- (2) Figures 14 and 15 feature the condition of test piece with 1 Kg/m³ polypropylene fiber after undergoing loading pressure and being heated to 300°C. Cracks seen in the figures were caused by sudden temperature change after the heating jacket was removed; during heating and loading processes, the test piece

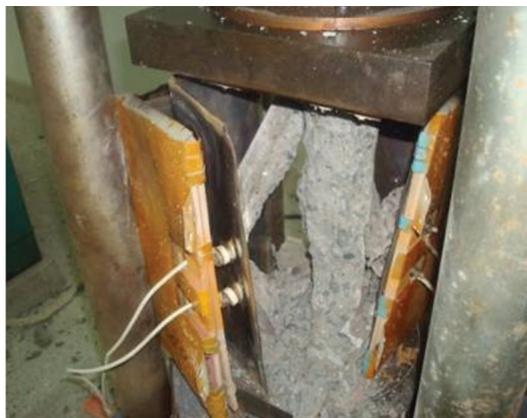
FIGURE 12

- (3) Figure 12 features basic test-pieces condition after undergoing constant loading pressure and being heated to 400°C. Test piece cracked numerous times during the process of heating, and it exploded while the warmth was being maintained. After all these

ordeal, the test piece was too wrecked to undertake any pressure.

cracked many times and more severely at 300°C than at 200°C and eventually exploded at 400°C , forcing the test to get aborted.

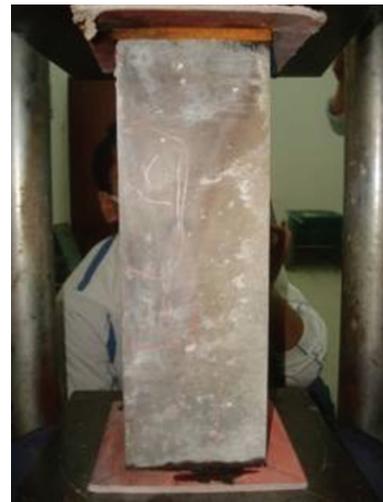
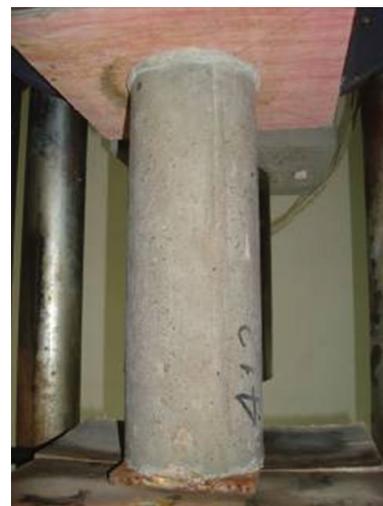
was largely intact. Prismatic and cylindrical test pieces showed no difference in this test.

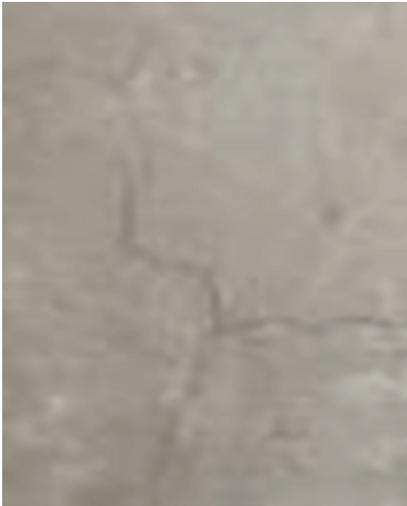
FIGURE 16

- (3) Figure 16 features the condition of test piece with 1 Kg/m³ polypropylene fiber after undergoing loading pressure and being heated to 400°C. We saw no major cracks but minor ones on the surface of the test piece. In addition, a great number of shallow cracks were also found.

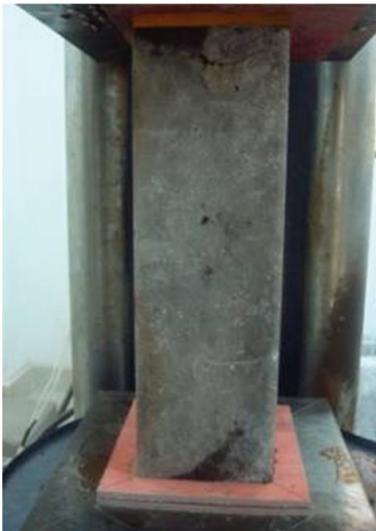
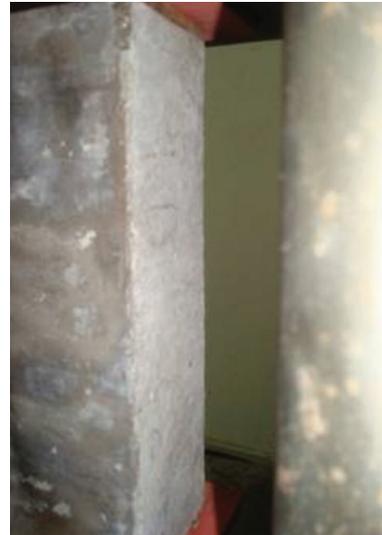
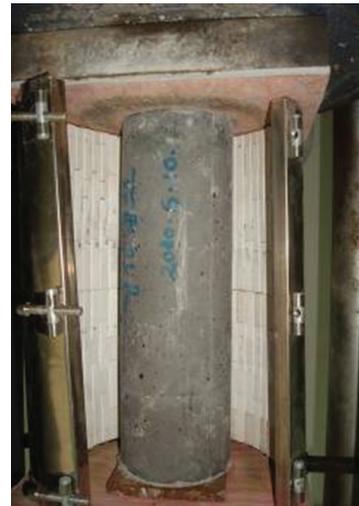
- (1) Figures 17, 18, and 19 feature the condition of test piece with 2 Kg/m³ polypropylene fiber after undergoing loading pressure and being heated to 200°C and 300°C. After the tests, it appeared nice and sound.

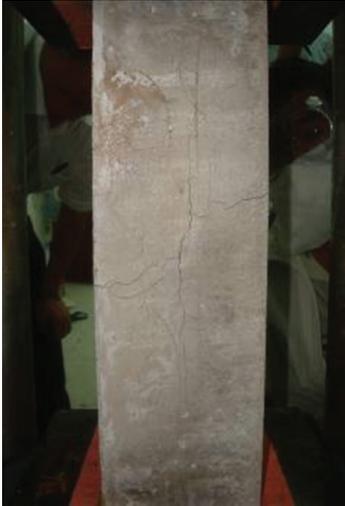
FIGURE 20

- (2) Figure 20 features the condition of test piece with 2 Kg/m^3 polypropylene fiber after undergoing loading pressure and being heated to 400°C . It did not explode in such temperature, but minor cracks still appeared.

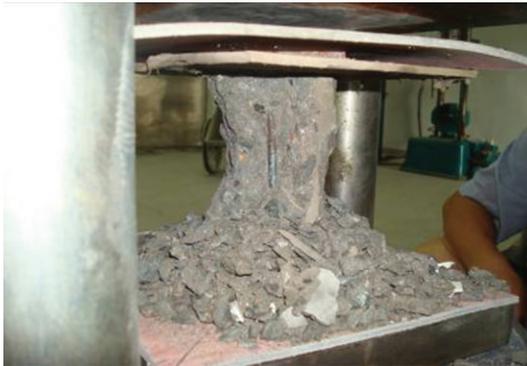
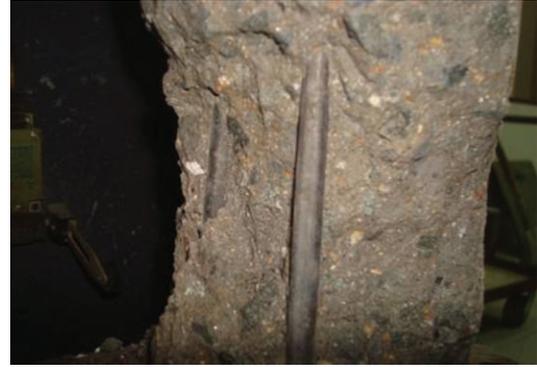
6.4. Reinforced Concrete Specimen Observations. Put steel bars into C120 concrete and observe how it changes during the test. Figures 21 and 22 feature the condition of reinforced concrete test-pieces sized $\Phi 100 \times 150 \text{ mm}$ and $\Phi 100 \times 300 \text{ mm}$ after undergoing loading pressure and being heated to 300°C . Test pieces exploded during test, not only the concrete fell off into pieces, but also the steel bars were partly exposed in the air.

(2) At 300°C , reinforced concrete test pieces were more vulnerable to heat than others. Basic test pieces suffered moderate flake-away while reinforced concrete ones broke into pieces, revealing steel bars.

This phenomenon resulted from the fact that steel bars swelled when heated. For basic test pieces, the crackings were caused by the stress released from their own thermal expansion; for reinforced concrete test pieces, they underwent not only stress from its own thermal expansion but also the thermal expansion of the steel bars. It is not hard to explain why the latter broke from the inside out [6].
