# Landslide damage along Araniko highway and Pasang Lhamu highway and regional assessment of landslide hazard related to the Gorkha, Nepal earthquake of 25 April 2015

**Background:** The Gorkha, Nepal Mw 7.8 earthquake of 25 April 2015 triggered a large number of coseismic landslides in a broad area. Two highways, Araniko Highway and Pasang Lhamu Highway, that connect Tibet of China and Nepal, were affected seriously by these landslides. The purpose of this study was to investigate the landslide damage along the two highways, construct a detailed and complete inventory of coseismic landslides in the 5-km buffer area of the Araniko Highway, and perform a regional assessment of landslide hazard in the affected area.

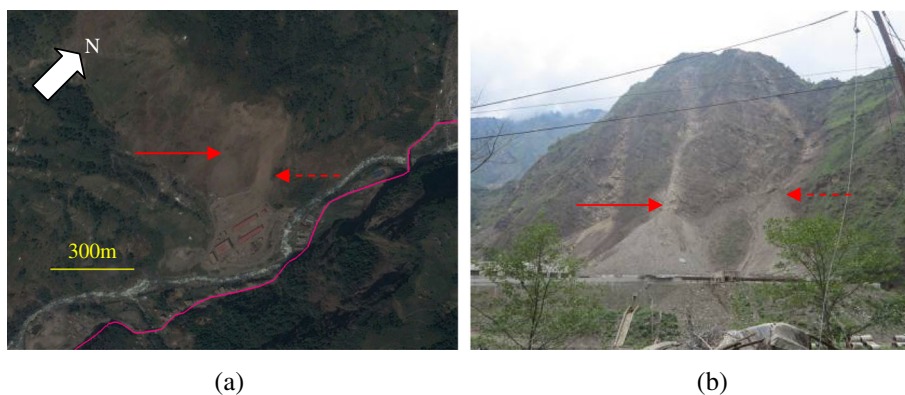
**Fig. 4** Rockfalls on the upper slope of an inspection station of Nepal. **a** Satellite image of 4 May 2015. **b** Field photo of 14 June 2015 (by Chong Xu, view to northwest). The solid and dotted arrows in (a) and (b) indicate the same places, respectively

Figure 4 shows two rockfalls (27.927°N, 85.932°E) occurred on the upper slope at an inspection station of Nepal, which originated from nearby the ridge of the reverse slope and accumulated into two conical heaps with two narrow runout paths. The broken accumulate

materials are dangerous for the structures on the toe of the slope. Despite different expressions of the rockfalls on the image and field photos due to the image stretching caused by steep topography, the rockfalls can be easily identified on the satellite image with the aid of field investigations. They have short runout distances on the image, whereas the actual runout distances of them are likely longer. This is because the slope of the rockfalls occurrence is

almost vertical. Small rockfalls or falling stones are more susceptible than large deep-seated landslides on such a reverse slope.

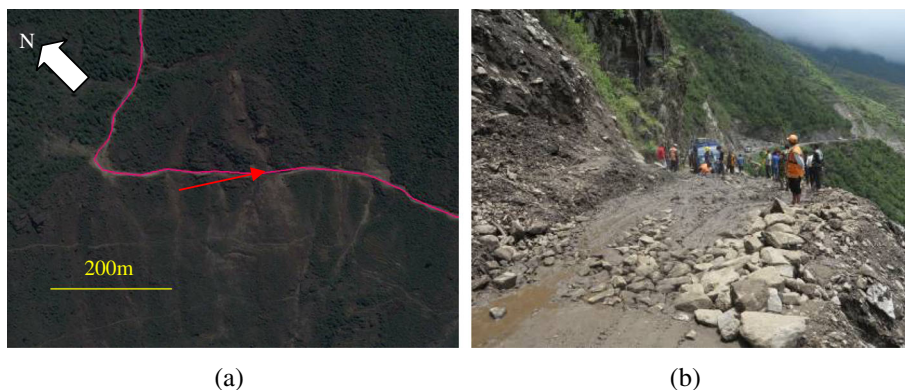
**Fig. 5** A series of shallow, disrupted landslides blocking the Pasang Lhamu Highway. **a** Satellite image of 3 May 2015. **b** Field photo of 15 June 2015 (by Chong Xu, view to southeast) showing the road was blocked by a secondary landslide caused by a heavy rainfall. The red solid arrow in (a) shows the location of field photo in (b)

After the main shock, a series of aftershocks and rain-falls struck the affected area and caused more landslides. For example, the satellite image of 3 May 2015 (Fig. 5a) shows quite a few shallow, disrupted landslides (located at 28.064°N, 85.225°W) that occurred in weathering layers

and blocked the Pasang Lhamu Highway. Fig. 5b shows the road was blocked by a secondary landslide caused by a heavy rainfall in the area. Information from local residents suggests that the landslide accumulation material that blocked the road was not triggered by the main shock, but by a strong rainfall a few days before. All the landslide

materials related to the main shock and subsequent triggers blocking the roads have been cleared up or were being cleared away in time to keep the traffic flowing.

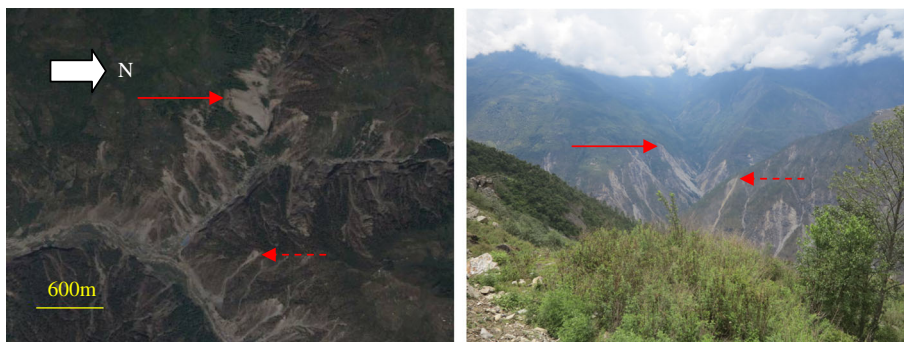
(a) (b)

**Fig. 6** An area characterized by high density of coseismic landslides. **a** Satellite image taken on 3 May 2015. **b** Field photo taken on 15 June 2015 (by Chong Xu, view to west). The solid and dotted arrows denote the same places, respectively

The satellite image (Fig. 6a) shows an area with high density of coseismic landslides, dominated by shallow, disrupted landslides. The red solid arrows wherein

indicate a large rock slide located at 28.079°N, 85.194°W. It occurred at the lower part of the slope and blocked the valley. However, they did not create a lake because of the small area of the catchment upstream. The red dotted arrows show a shallow, disrupted landslide originated from a ridge (located at 28.08°N, 85.208°W). Most of the landslides shown in Fig. 6a are distributed along the rivers, likely associated with river incision or loose deluvium with high landslide susceptibility.

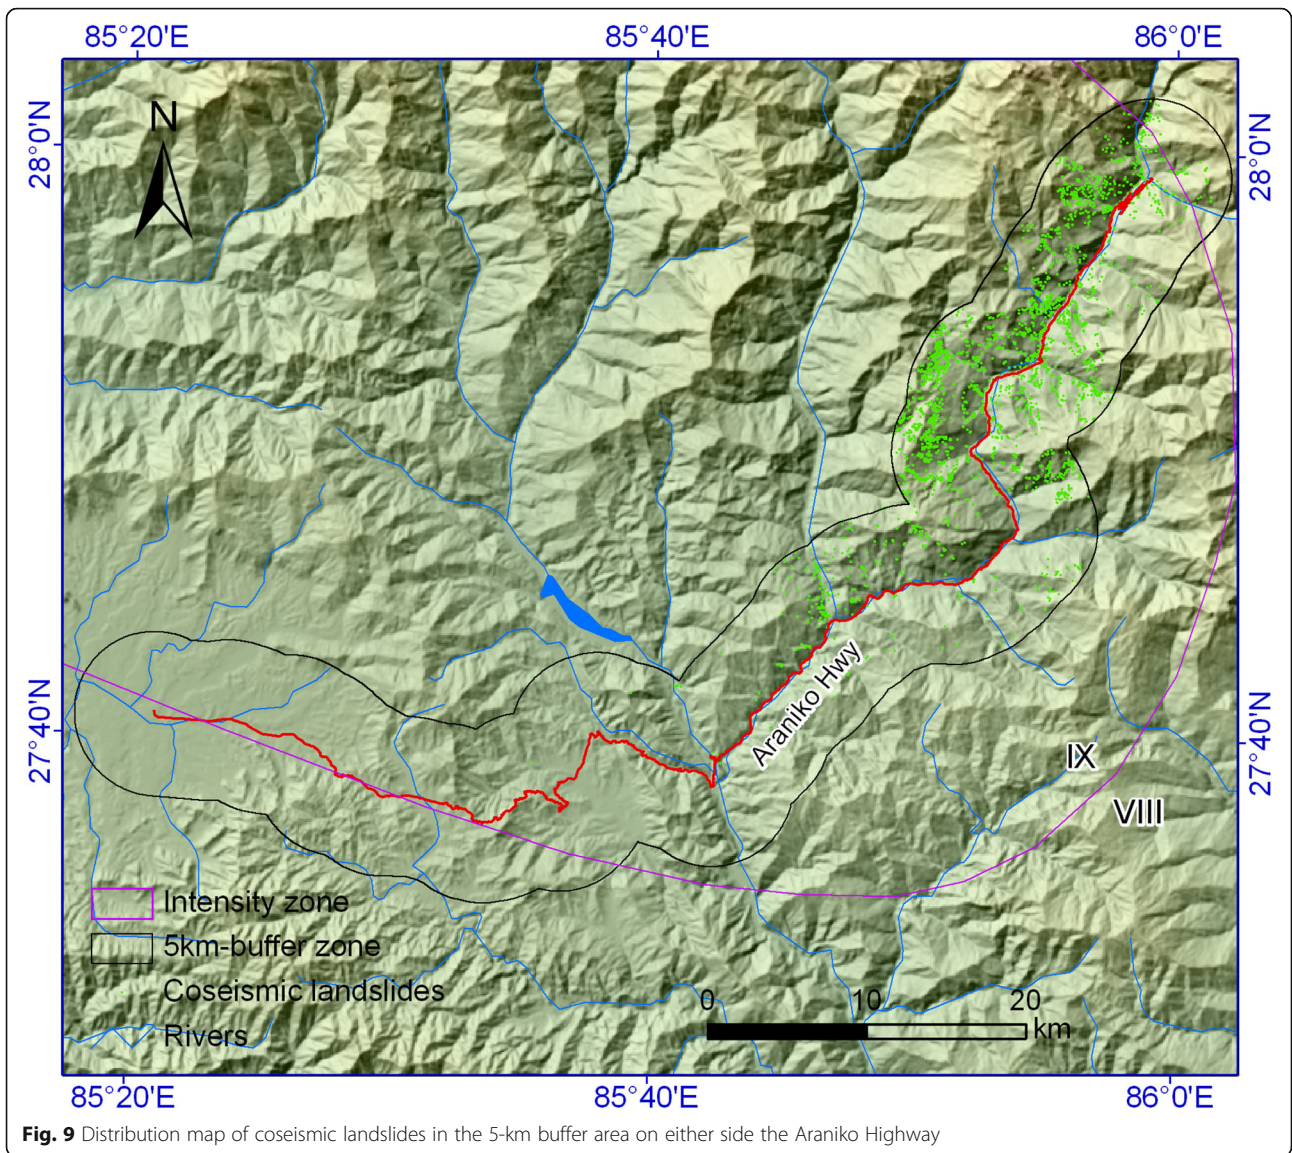
As a common index to reflect landslide abundance, landslide number density was employed as the index to measure spatial distribution of the 3,005 landslides in the 5-km buffer area of the Araniko Highway. In this study, five controlling factors including elevation, slope angle, slope aspect, lithology, and seismic intensity were selected to analyze their correlations with the landslides (Figs. 10, 11, 12, 13 and 14). The DEM of the area was derived from SRTM in 3 arc-second, which permitted to determine the elevations of the buffer area vary from 610 m to 4,750 m. The study area was divided into six classes based on 500 m of elevation intervals, i.e. 610–1000 m, 1000–1500 m, 1500–2000 m, 2000–2500 m, 2500–3000 m, and 3000–4750 m (Fig. 10). The

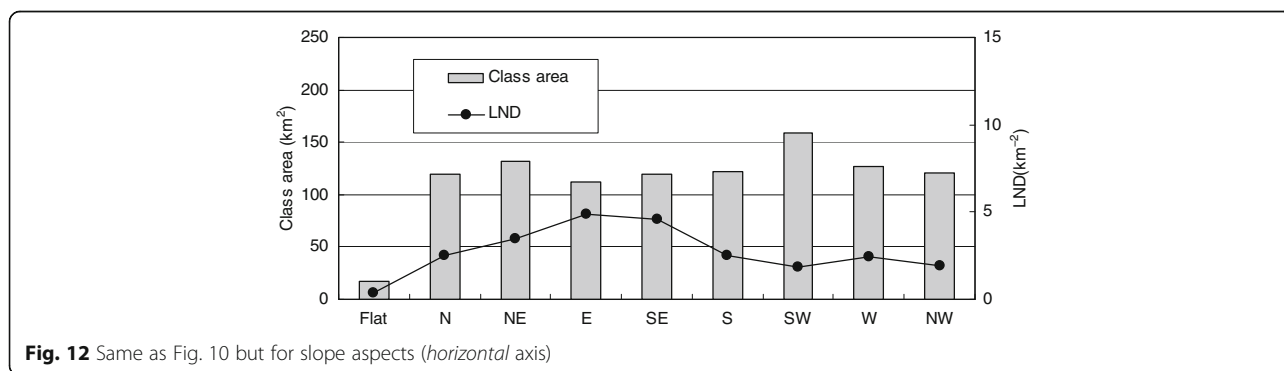
**Fig. 12** Same as Fig. 10 but for slope aspects (*horizontal axis*)

northwest (NW). Fig. 12 shows the correlations between the slope aspect, area of its classes and landslide number density. It is clear that the slope aspects E and SE correspond to the two largest LND values, which are 4.87 km<sup>-2</sup> and 4.58 km<sup>-2</sup>, respectively. This is perhaps related to the movement direction of the hanging wall of the seismogenic fault or the propagation direction of seismic wave (Shen et al. 2016). The study area is located east of the epicenter of the Gorkha main shock, and thus the propagating direction of seismic waves is eastward. During the Gorkha earthquake, the hanging wall of the fault, where the buffer area is located, moved toward south and probably generated inertia effect to the south. In addition, the slopes of southward aspect in the area are easily exposed to sunlight and rainfall, thus leading to widespread weathering layers and high susceptibility to seismic landslides.

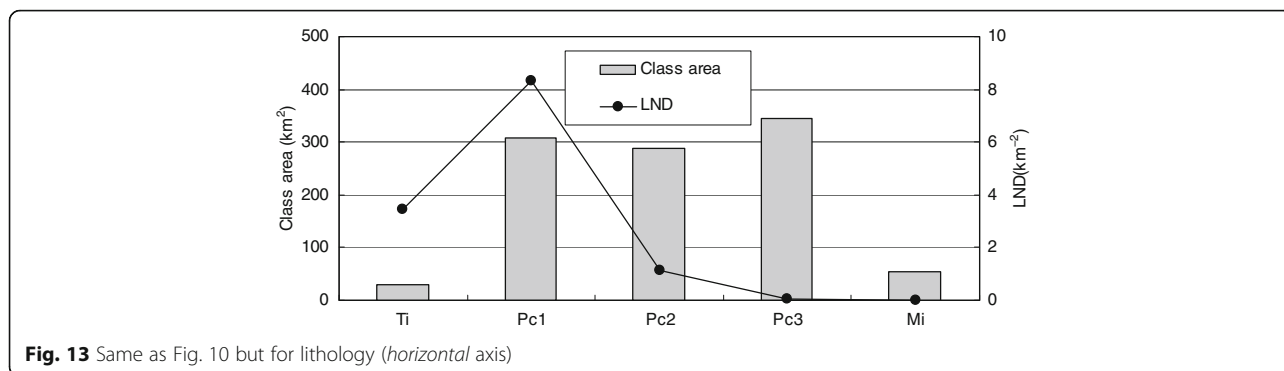
**Fig. 13** Same as Fig. 10 but for lithology (horizontal axis)

class area and landslide number density. The three groups of Precambrian rocks cover most of the area, which is 942.8 km<sup>2</sup>, occupying 91.8% of the total. The lithology class Pc1 registered the largest landslide number density, which is 8.32 km<sup>-2</sup>.

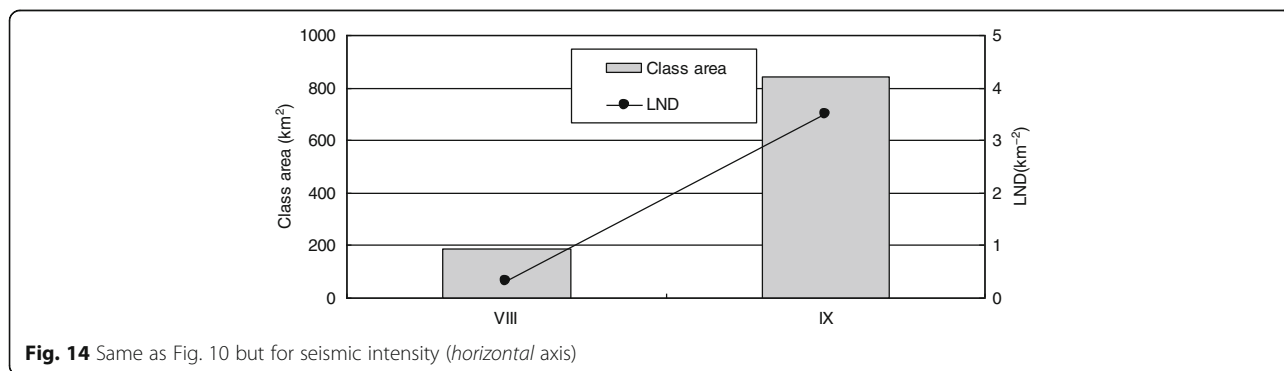
**Fig. 14** Same as Fig. 10 but for seismic intensity (horizontal axis)

Seismic intensity and peak ground accumulation (PGA) are two common proxies representing the degree of seismic energy and often used to explore the effect of earthquakes on landslides. The PGA distribution map released by USGS ([www.usgs.gov](http://www.usgs.gov)) is rather irregular in the 5-km buffer area of the Araniko Highway because the buffer area is relatively small and there are perhaps significant errors generated by numerical simulation and limited stations. Therefore, we preferred to analyze the correlation between coseismic landslides and seismic intensity in this study. The seismic intensity map of the Gorkha earthquake was produced by China Earthquake Administration (CEA) (Fig. 1). Only VIII and IX intensity zones appear in the study area, which have the landslide number density values 0.32 km<sup>-2</sup> and 3.5 km<sup>-2</sup>, respectively (Fig. 14). Despite merely two data points, these data show a positive correlation with the coseismic landslides, i.e. the place with larger seismic intensity has a higher landslide number density.

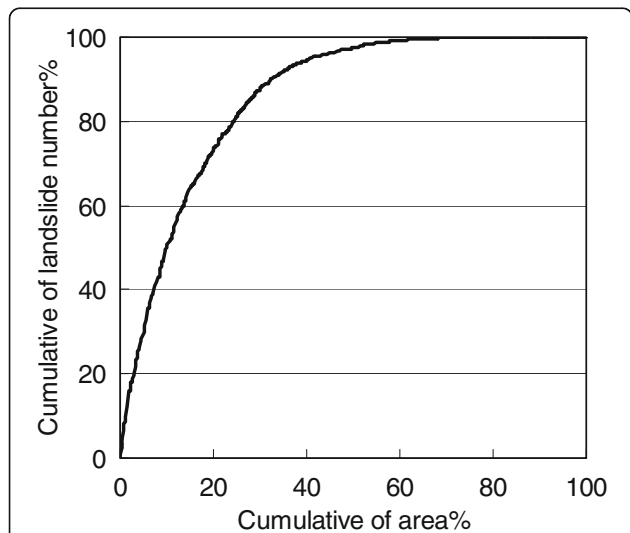
**Fig. 15** The area under the curve representing the success ratio of the landslide hazard assessment. Area % means the percentage of area to the study area for each factor class. Landslide number % means the percentage of landslide number in a factor class to the total landslide number

whereas negative WI values represent the opposite. WI values close to zero mean moderate probabilities of occurrence of coseismic landslides. Results show the LHI of the area is in the range from -23.546 to 4.48. In order to examine the validity of the model, the 3,005 coseismic landslides aforementioned were employed to compare the known landslides with the landslide hazard index map. By referring to a common method, the regional area was categorized into 100 classes with a same area by the LHI value and the percentages of landslide number in each class were calculated. Then, a correlation curve between cumulative area percentages and cumulative percentage of landslide number from high to low LHI in a descending order was drawn (Fig. 15). It shows the area under the curve (AUC) is as much as 85.9%, i.e. a quite satisfactory success ratio. The curve also reveals

that 10% of the area with the highest landslide hazard index could cover 1,514 landslides, about 50.4% of the total. Likewise, 20 and 30% of the area with the highest landslide hazard index can account for 2,207 and 2,645 landslides, about 73.4 and 88% of the total, respectively.
