Environ Earth Sci (2017) 76:99 DOI 10.1007/s12665-016-6347-1

# Diversification of the hydromorphological state and the habitat quality of streams in the Negev Desert (Israel)

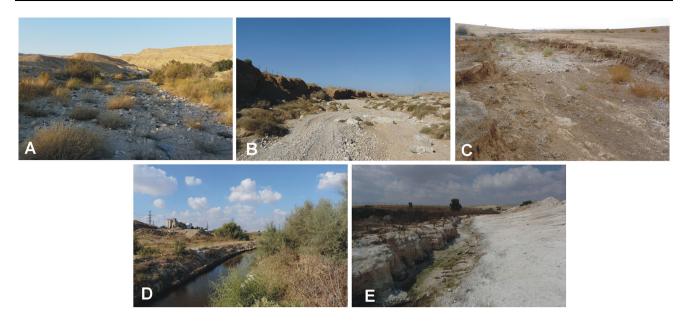
Fig. 2 Channel of selected stream in Negev Desert (a Nahal Hatira; b Nahal Yatir; c Nahal Sansana; d Nahal Be'er Sheva; e Nahal Hebron)
