UAV AND COMPUTER VISION, DETECTION OF INFRASTRUCTURE LOSSES AND 3D MODELING

KEY WORDS: 3D modeling, Structure from Motion, Infrastructures, Civil buildings, Degradation of buildings, Monitoring, UAV

This paper deals with the creation of 3D models based on the capture of digital images, through autopilot flight UAV, for civil buildings situated on the area of Reggio Calabria. The following elaboration is done thanks to the use of commercial software, based on specific algorithms of the Structure from Motion (SfM) technique. SfM represents an important progress in the aerial and terrestrial survey field obtaining results, in terms of time and quality, comparable to those achievable through more traditional data capture methodologies.

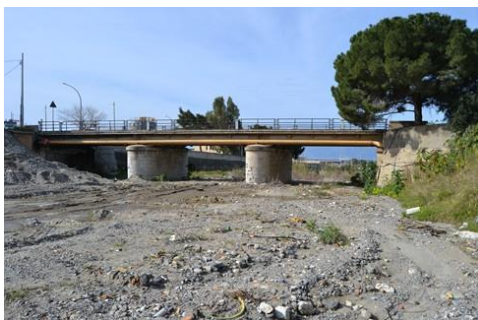
Figure 2. Detail of the San Gregorio Bridge

For this contribute three distinct works have been acquired by nature and complexity. First, was surveyed a bridge in reinforced concrete located in San Gregorio in the town of Reggio Calabria. It consists of three spans in reinforced concrete, each of which consists of five longitudinal beams of 13.75 m long, with a section of 0.40 mx 0.70 m, of 1.40 m which are connected by traversers having a section of 0.15 mx 0.30 m spaced at a distance of 2.75 m (Figures 1 and 2). The artefact has several problems both with regard to metal reinforcements, in advanced oxidation state and in concrete, characterized by important and diffused areas affected by the separation of the concrete cover. It is therefore evident that there is a need for interventions aimed at the restoration and consolidation of all structural elements of the bridge (beams, traversers and slats), which cannot ignore the knowledge of the geometry of the various structural elements and the determination of the position, number and the section of the metal armatures.

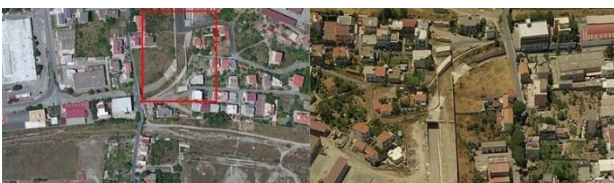
Figure 3. Position of the second work surveyed

Always in San Gregorio, in the city of Reggio Calabria, a box-shaped road tunnel (Figures 3 and 4) was found, with a length of 100 m and a width of 11.80 m, shoulders have a width of 1.30 m and a height of 5.50 m, the concrete slab thickness is 1.30 m. The work has not yet been completed and there are signs of efflorescence, moisture spots, due to bad or non-existent waterproofing (Bae, Golparvar-Fard, White, 2013).

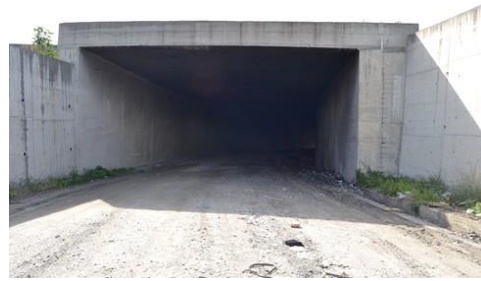
Figure 4. Detail of the tunnel entrance

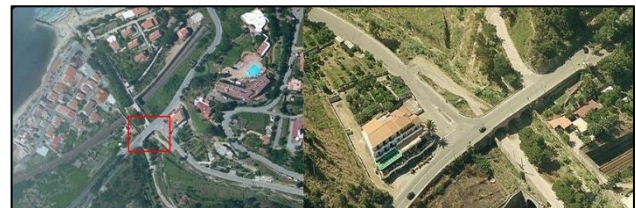
Figure 5. Bridge framing in Villa San Giovanni

The third surveyed work is a bridge located at km 517.20 of the SS 18 in the Villa San Giovanni municipality in the province of Reggio Calabria (Figure 5 and 6). The work was chosen in view of its particular design; in fact, it is made up of an original masonry structure consisting of three spans with 6.60 m light and two 1.50 m wide poles with a length and a width of 27 m each 6.30 m. This structure, following the adjustment and extension of the road section, was alongside a new in reinforced concrete, always at three lanes with lights of 7.20 m, a width of 4.20 m, also, length of 27 m. They are commonly found in masonry work, missing or broken elements, efflorescence traces and a general degradation due to time spent and poor maintenance. The part in reinforced concrete has traits with concrete dilution, efflorescence, expulsion of the cover, spraying of the casting, losers, these, from a misalignment of the work.

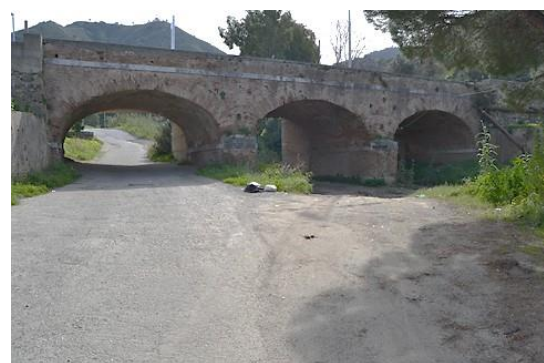
Figure 6. Detail of the bridge of Villa San Giovanni

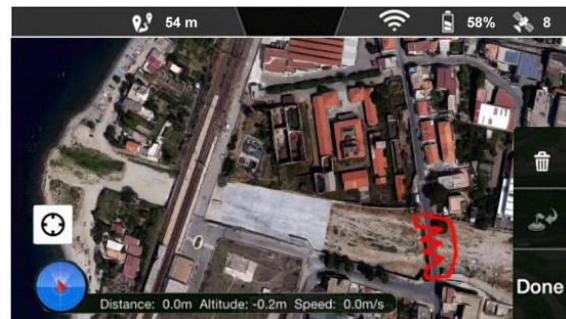
Figure 7. Ground station screen with flight plane

the various surveys were set in automatic mode by the formulation of flight planes, set by the input of track points with known coordinates of ground-based landmarks with RTK kinematics rover GNSS implemented in previous phases (also useful in Processing phase for model scaling). The possibility of real-time control of the drone through a ground station has allowed detailed and accurate shooting of the works investigated, monitoring the position, the quota and the state of the device (Figure 7).

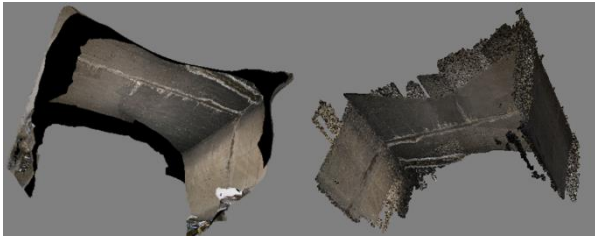
Figure 10. Texture of the San Gregorio tunnel with highlighted losers

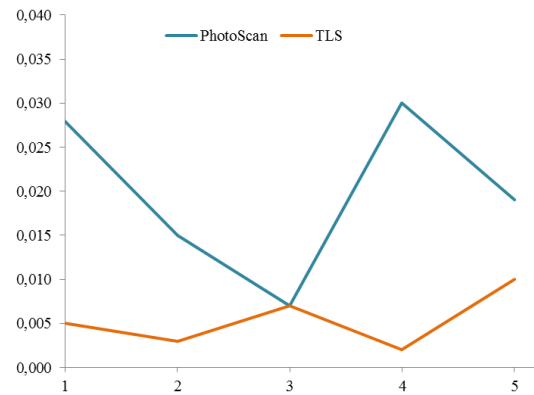
Figure 15. Error comparison (cm) in the two systems

The evaluation of the precisions was based on the 5 survey target placed on the deck facades and on the comparison of the results obtained with a traditional topographic survey with the Leica TCRA 1201 high precision automated station (Figure 15) (Barrile, Meduri, Bilotta, 2014a), (Barrile, Meduri, Bilotta, 2014b).
