**ASSESSING THE CONDITION OF
BURIED PIPE USING GROUND
PENETRATING RADAR**

A Thesis submitted to
The University of Birmingham
For the degree of
MASTER OF PHILOSOPHY (MPhil)

School of Civil Engineering
College of Engineering and Physical Science
The University of Birmingham
August 2013

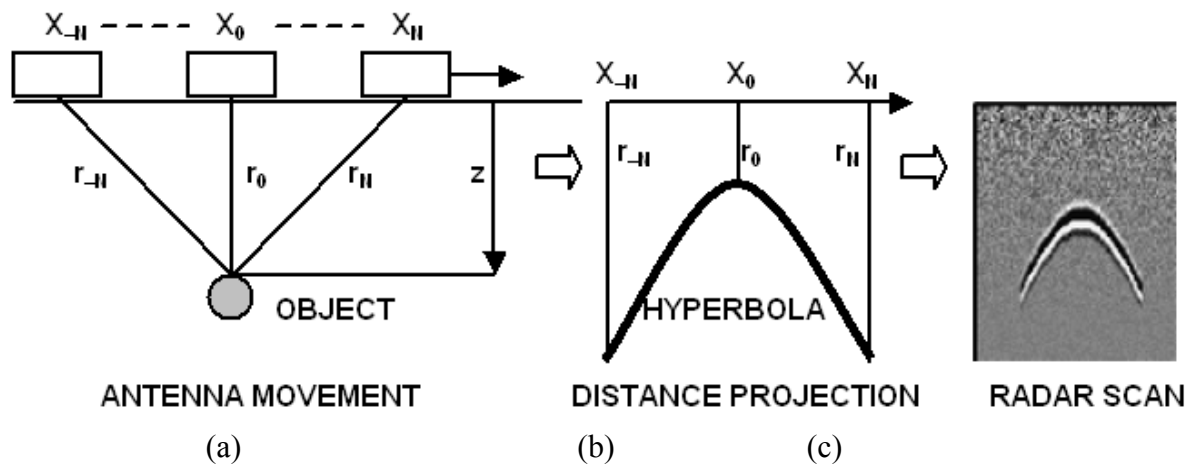
Figure 2.3: Radar scan generation (Dusan & Aleksandar, 2007)

All points on the scan include the reflected wave amplitude data. Points on top of the segments have the peak amplitude value. The peak on the shortest segment r_0 the antenna centre is above the pipe axis is the highest (positive or negative). This value is the criteria for scan searching and determination of the location and the depth of the underground utility.

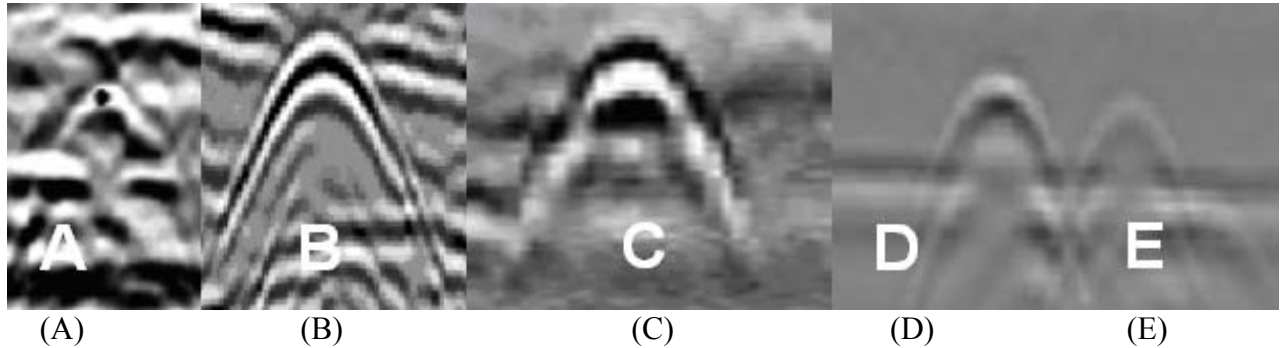
Figure 2.6: Type and material detection of utilities (Paniagua et al., 2004)

It can be seen, that the electric cables (Figure 2.6A) differ from empty PVC pipe the most, and also that it can be difficult to differentiate reflections of concrete and PVC pipes (Figure 2.6). It is also shown, that metal utilities have better reflections than those made of non-metallic (concrete, PVC) (Paniagua et al., 2004). This difference is caused by various reflective capabilities of metals and non-metals. Metals reflect most of the EM waves, while PVC is transparent to EM waves. A study by Paniagua et al. (2004) found that GPR is able to detect metal cables in PVC cladding. Figure 2.7 shows a processed scan of an optic cable in PVC cladding with a diameter of 110mm.

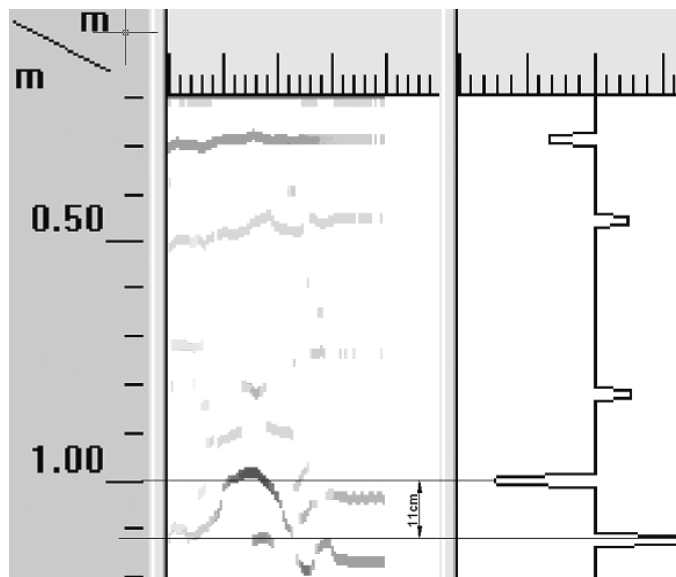
Figure 2.7: Optical cable in a PVC pipe with diameter of 110mm (Paniagua et al., 2004)

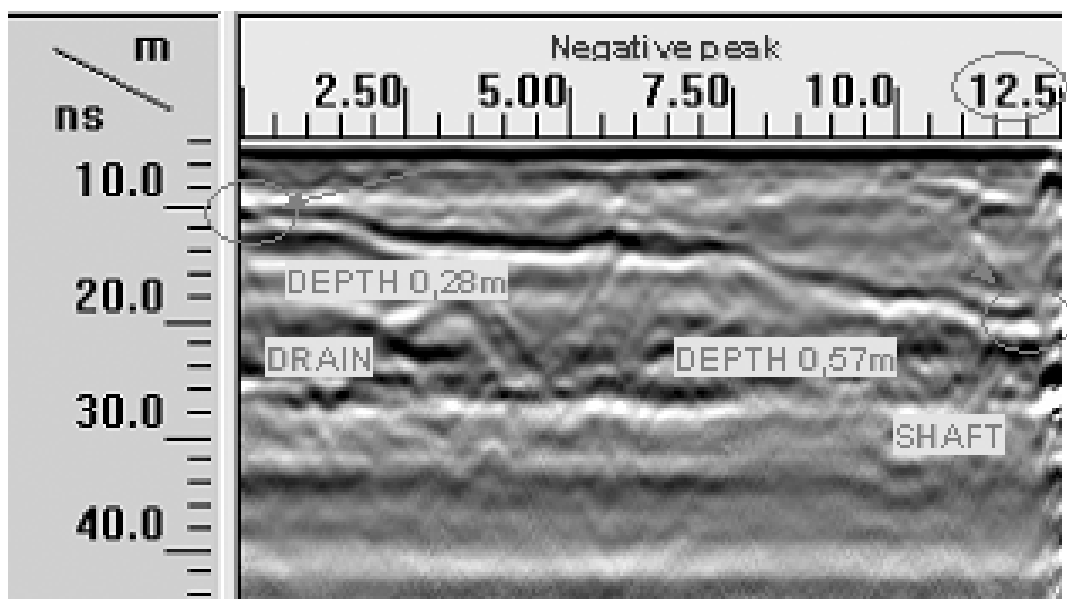
Figure 2.8: Scan along PVC pipe (Dusan & Aleksandar, 2007)

Another study by Dusan & Aleksandar (2007) indicated that if the antenna moves along the pipeline axis – the longitudinal scan transforms the hyperbola into a straight line. They also stated that the metal objects have weak reflections caused by the minimal radar cross-section of the longitudinal scans. Empty non-metal pipes (concrete, PVC, ceramics) have opposite polarisation, which cause negative peaks and good quality of longitudinal scans. Figure 2.8 shows the longitudinal scan of a PVC pipe with a length of 12 metres (diameter 200 mm) taken in Novi Sad. It also illustrates the parameters which can be estimated: pipe, for examples inclination, length, junctions, and reductions.

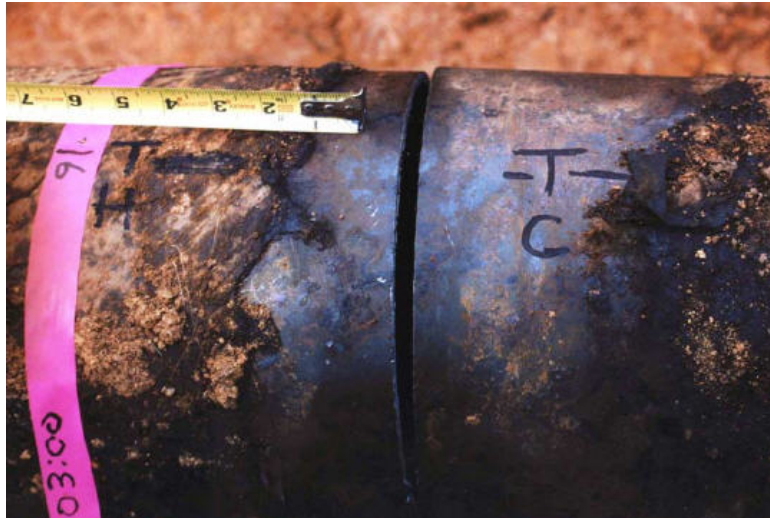
Figure 2.9: Broken metal pipe with 160mm diameter

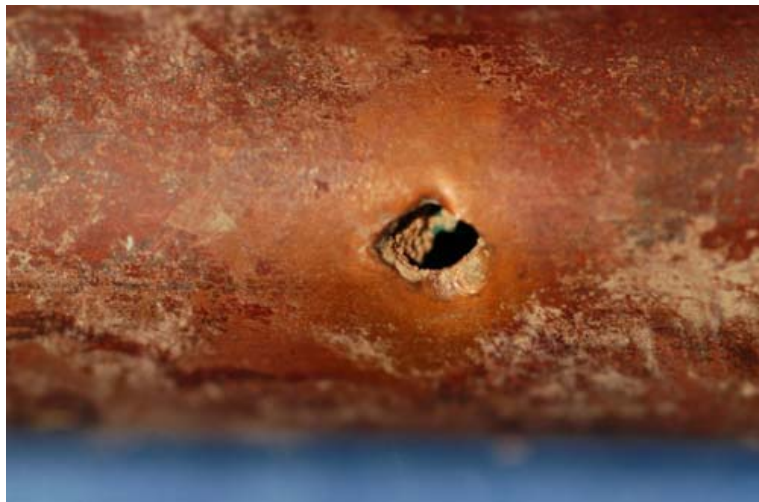
Figure 2.10: 10mm hole in metal pipe with 180 mm diameter

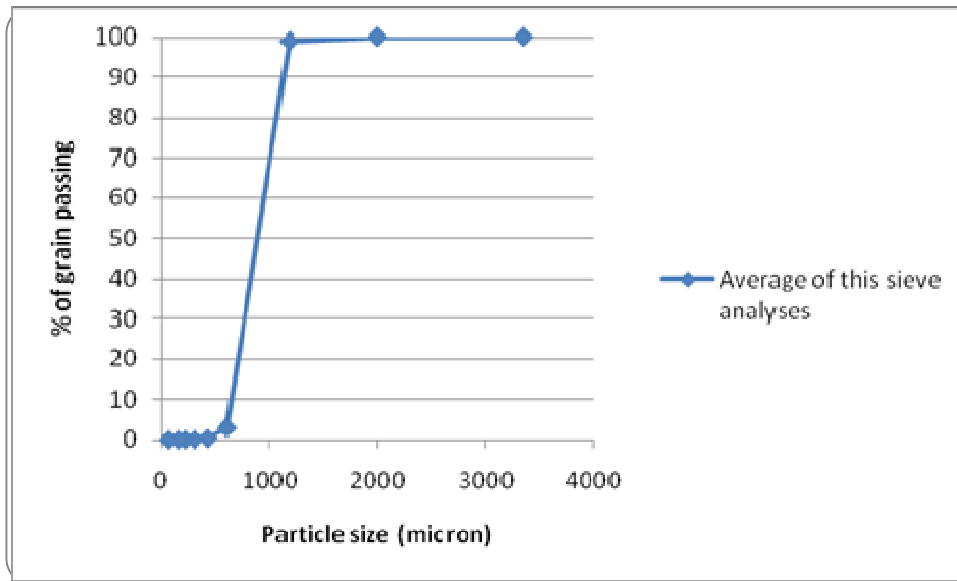
Figure 3.4: Particle size distribution for the Leighton Buzzard Sand

Hence for these experiments, a Leighton Buzzard sand was selected as the soil medium. A sieve analysis was conducted in order to classify the soil particle size distribution. Three measurements were carried out and Figure 3.4 shows the average of the sieve analysis results. The material is classified as a uniform coarse grained sand with particle sizes ranging from 0.6mm to 2.0mm. These sand particles were identified through sieve analyses as low-electrical-loss materials.

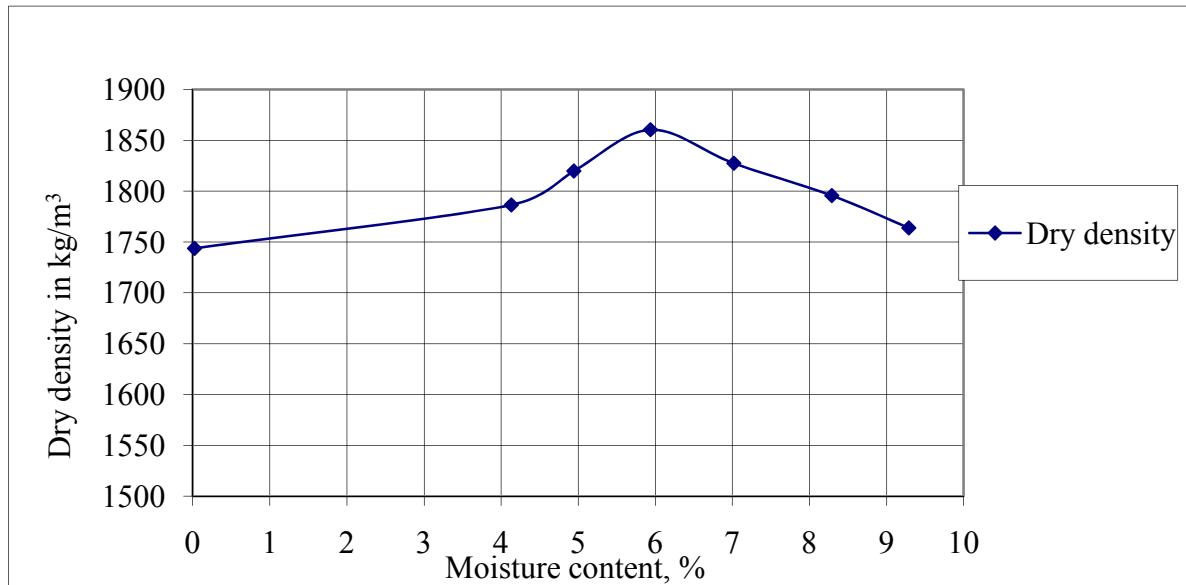
Figure 3.5: The compaction test results for the sand

As mentioned, the strength of electromagnetic waves depends on the medium they are passing through and the GPR signal can travel further in ‘low-electrical-loss materials. That means the GPR signal is weaker in wet materials compared with dry materials. Materials containing appreciable amounts of moisture will behave as conducting dielectrics, especially if the water contains ions (Daniels, 2004). The attenuation of GPR signal rises in wet materials. Therefore, a compaction test was carried out to identify the behaviour of the material. Three measurements were taken at each moisture content and Figure 3.5 shows the average results for the compaction test. The optimum moisture content for this sand was determined as 5.9% with an achieved maximum dry density of 1861kg/m³.

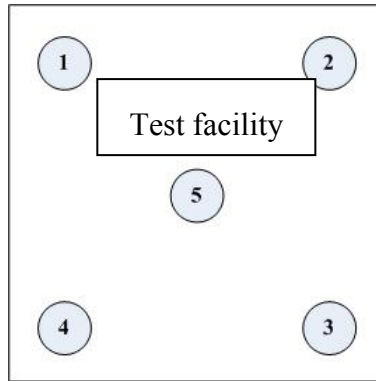
Figure 3.6: Moisture content measurements were taken at five different positions within the test facility

In these experiments, the optimum moisture content was not chosen for a number of reasons, e.g. reducing signal attenuation as the water content increases, therefore the minimum moisture content was preferred in these tests, and also the difficulty of maintaining the optimum moisture content during the tests (data acquisition). The sand was therefore placed as dry as possible (a small amount of water was needed to keep the dust to a minimum during placement for health and safety reasons). Measurements of soil moisture content were taken at five different positions within the test facility (Figure 3.6) and the average of soil moisture content was 0.02% with a standard deviation (σ) of 0.007.

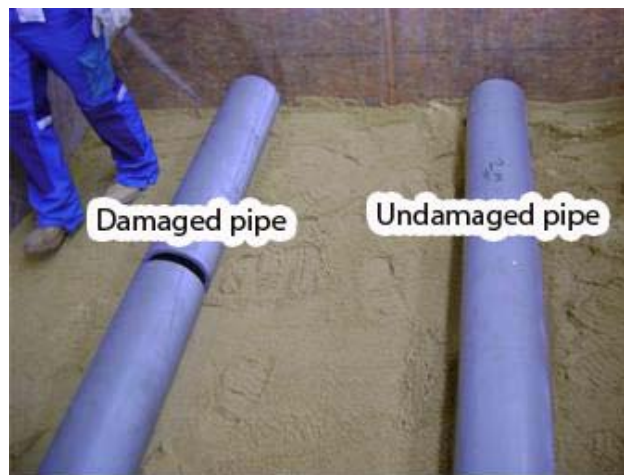
Figure 3.7: Arrangement of the two plastic pipes in the test box prior to burial

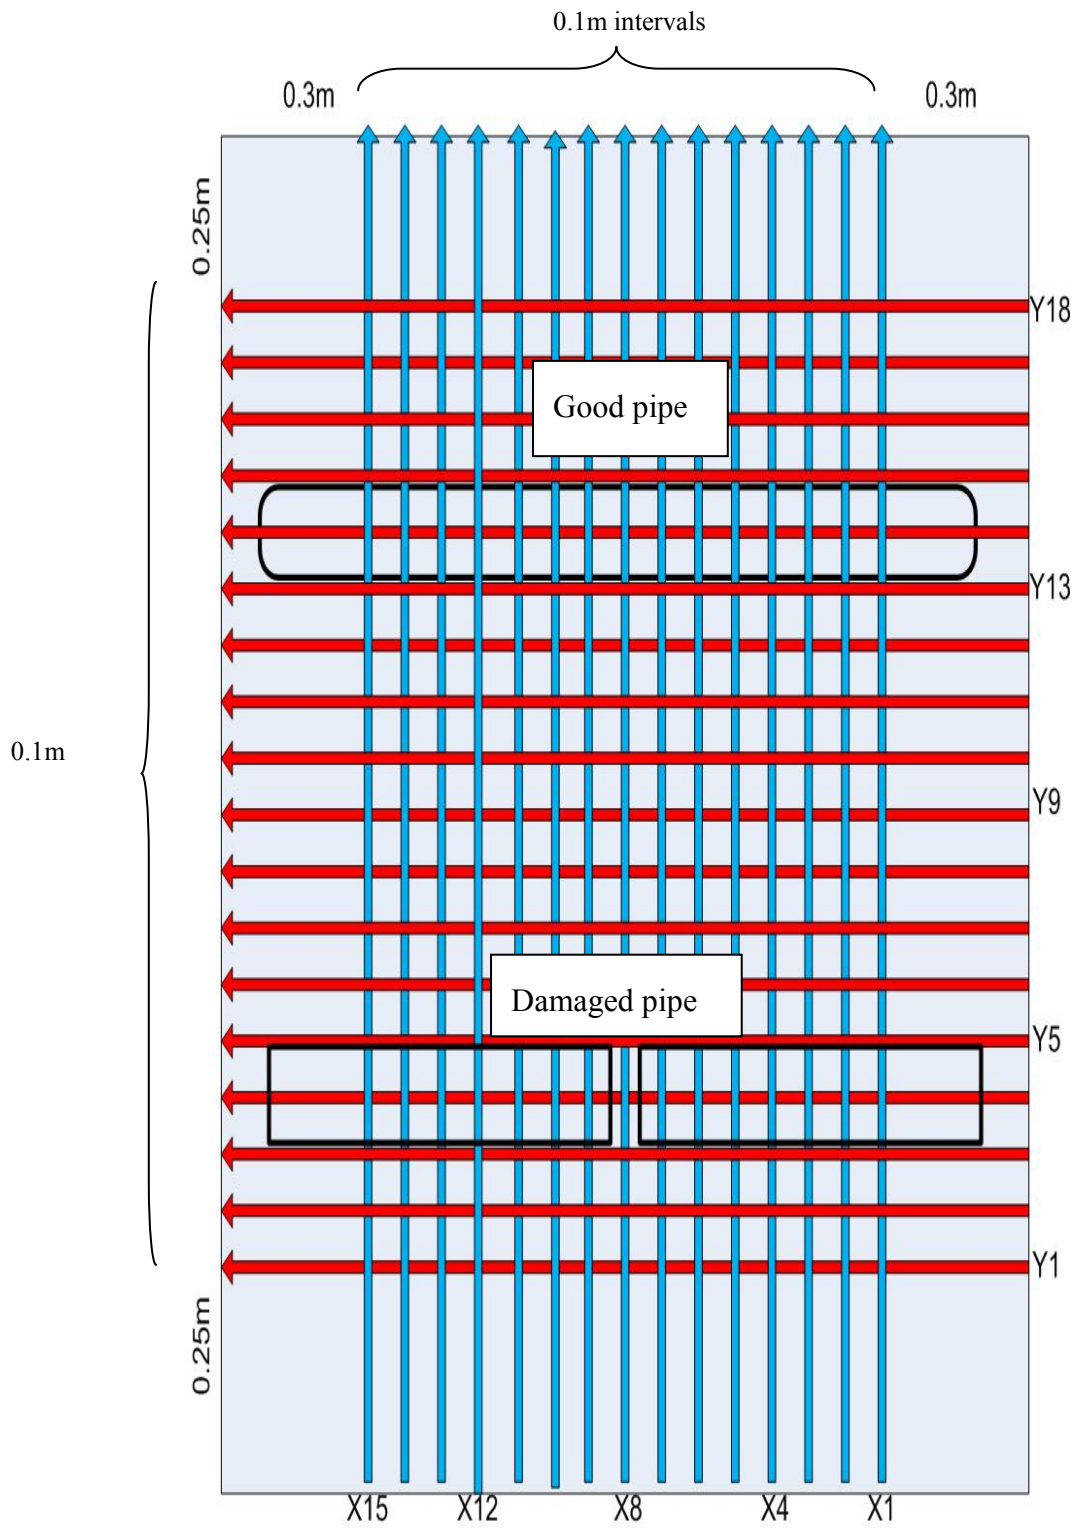
Figure 3.11: Survey grid lines used for each experiment

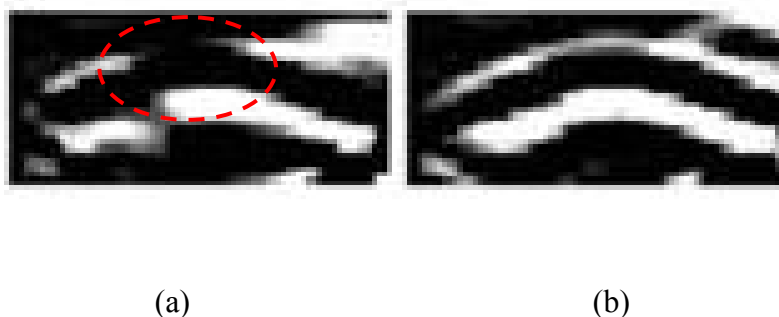
Figure 3.13: Signal contrast between (a) a damaged pipe and (b) an undamaged pipe.

The analyses have concentrated on the amplitude changes of a particular area of the GPR data obtained from the undamaged and damaged pipe. An example of the signal contrast between a damaged pipe and an undamaged pipe when the GPR crosses perpendicular to the pipe direction is shown in Figure 3.13.

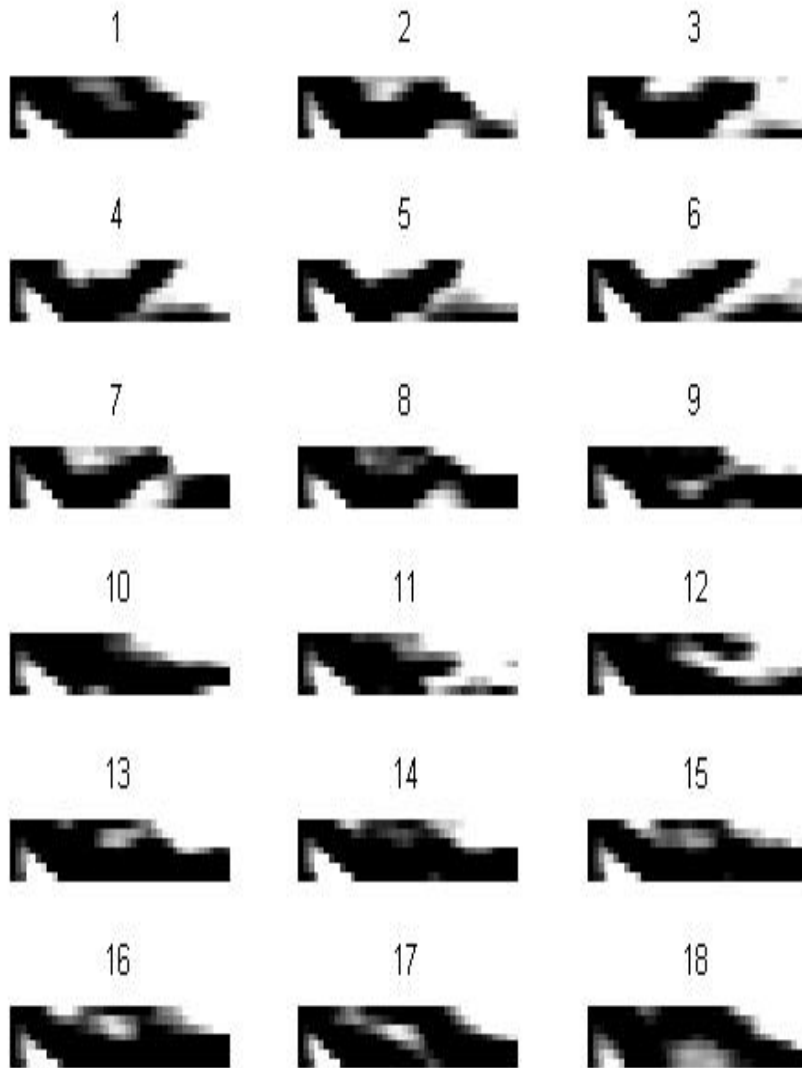
Figure 3.15: 18 radar images relating to 18 crossing points on the survey grid along the damaged pipe (position 14 is where the break in the pipe occurs in this example (Test 1)).

Meanwhile, the 18 radar images for the Y direction are represented in Figure 3.15.

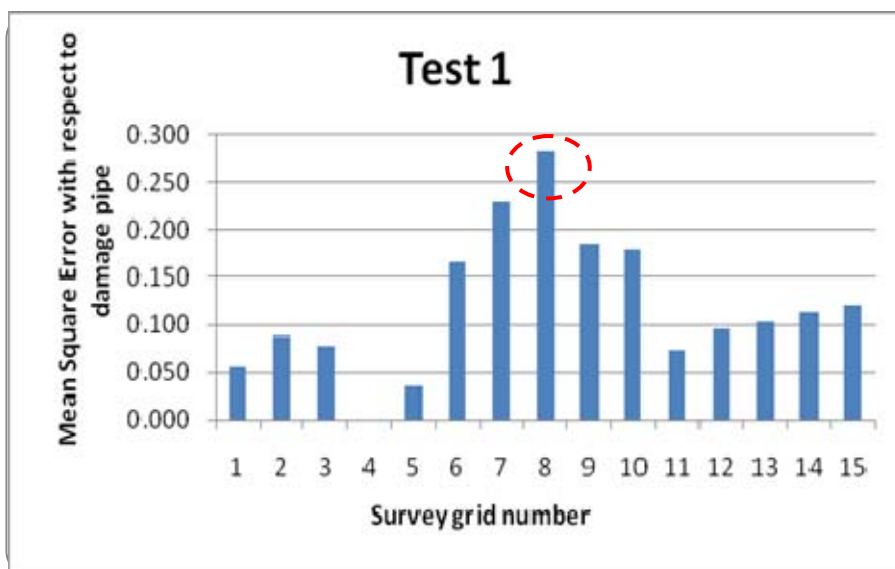
Figure 3.16: Example Mean Square Error (MSE) analysis for a pipe where there is damage in the region of survey grid number 8 (Test 1, frequency 250MHz, as described in Table 3.2) (The red dotted circle indicates that the greatest MSE occurs at grid number 8.)

From the analysis of these images using the Mean Square Error (MSE), it is possible to quantify the signal amplitude changes between the undamaged and the damaged pipe section. In this case, grid position 4 is the reference as it contained the undamaged pipe, while grid position 8 has the highest MSE value as compared to the scan at grid 4. This indicates that the scan at position 8 has the largest anomaly. Figure 3.16 shows the results of the analysis, and for the particular example shown in Figure 3.11, it is known *a priori* that point 4 is where the pipe is undamaged and grid point 8 is where the damage occurred on the pipe.

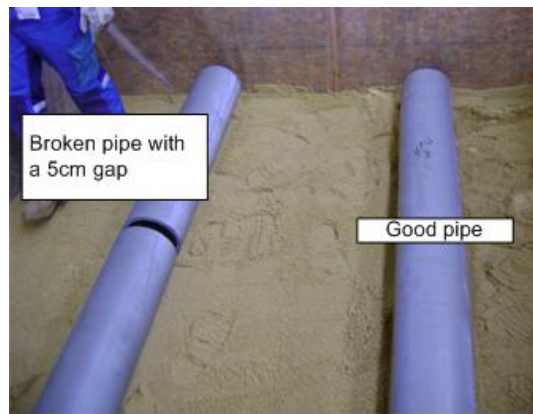
Figure 3.18: Test 1 during filling of the test facility

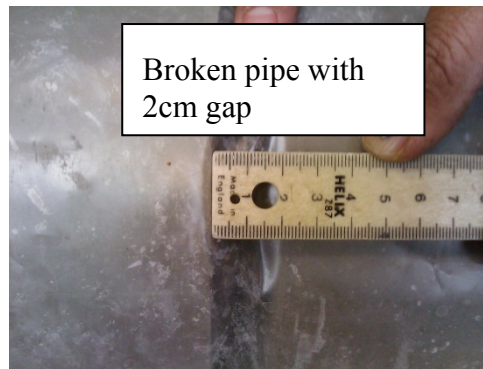
Figure 3.19: Broken pipe with a 2cm gap under a plastic cover

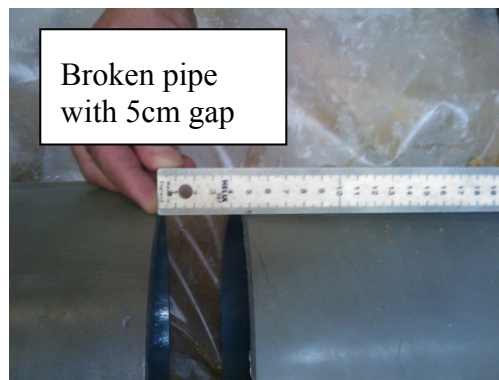
Figure 3.20: Broken pipe with a 5cm gap under a plastic cover

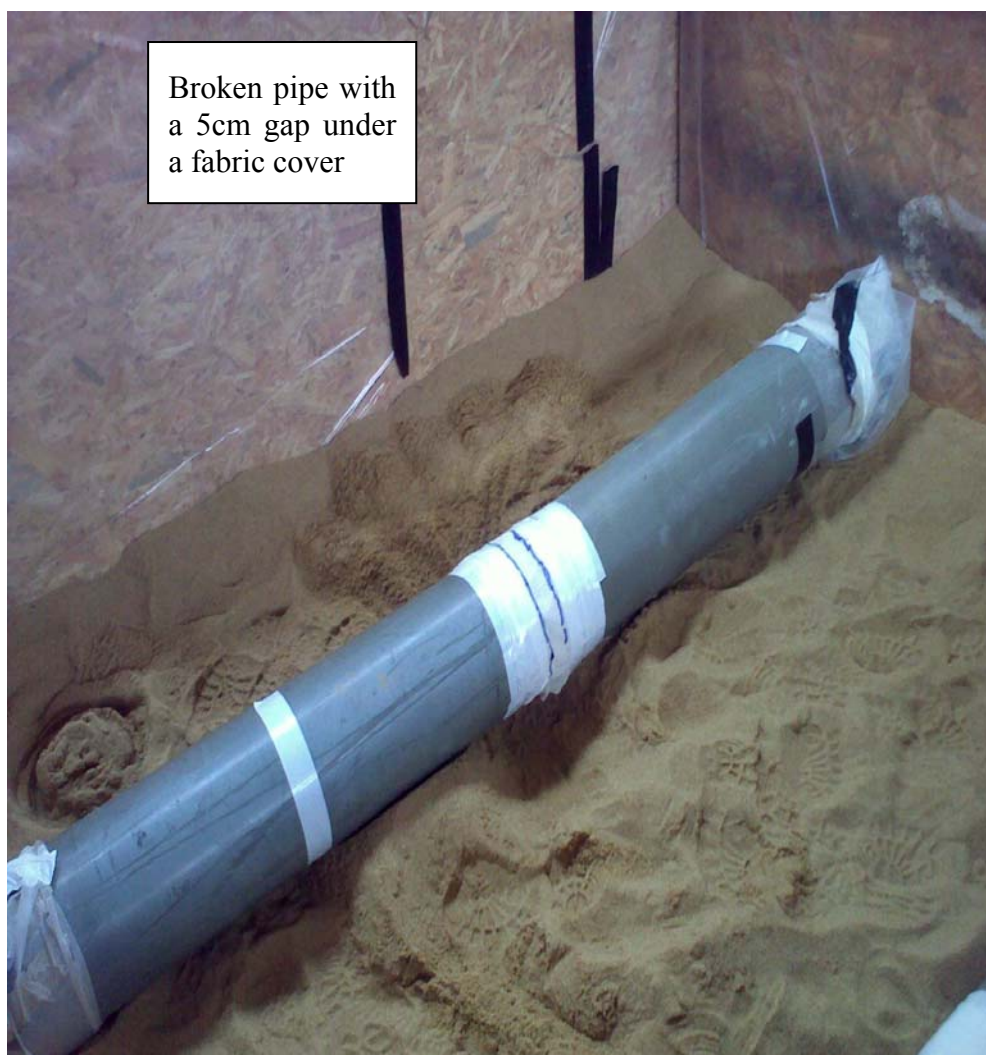
Figure 3.24: Broken pipe with a 5cm gap under a fabric cover

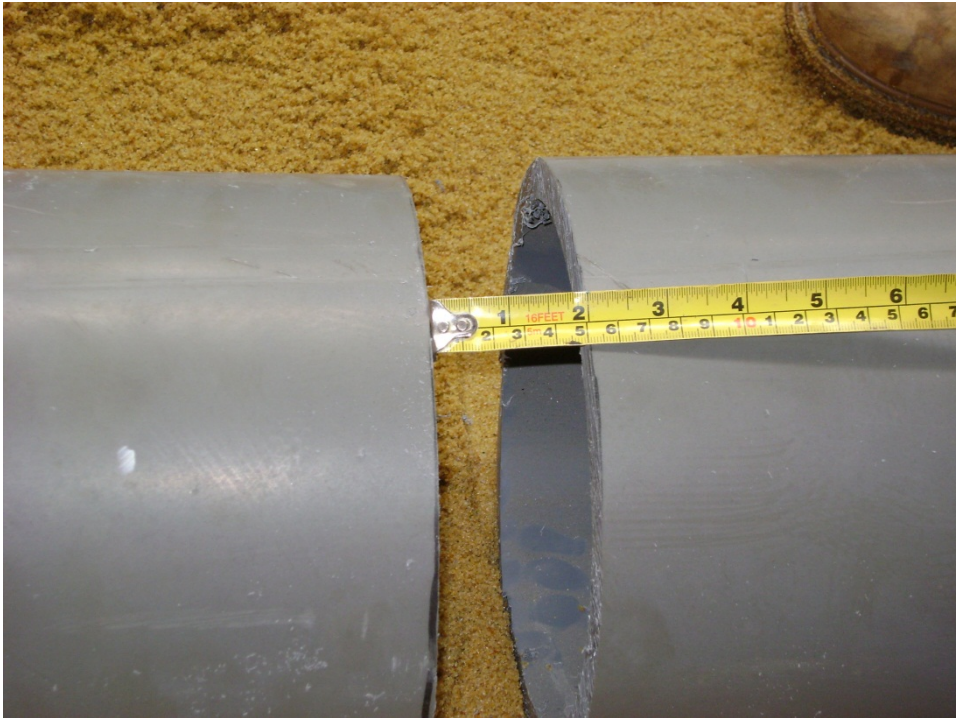
Figure 4.1. Broken pipe split into two sections with a 5cm gap without plastic cover

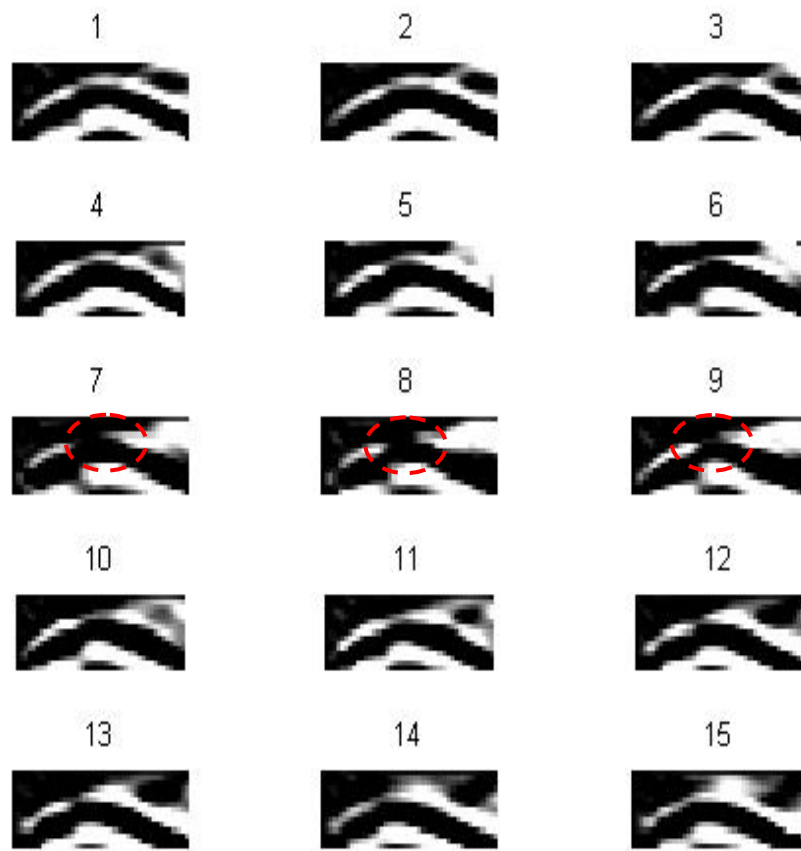
Figure 4.3. Test 1 - 15 radar images (perpendicular to the pipes) using the 250MHz antenna with 10 integrations.(The red dotted circles indicate areas where visual differences are evident in the scans associated with damaged pipe section.)

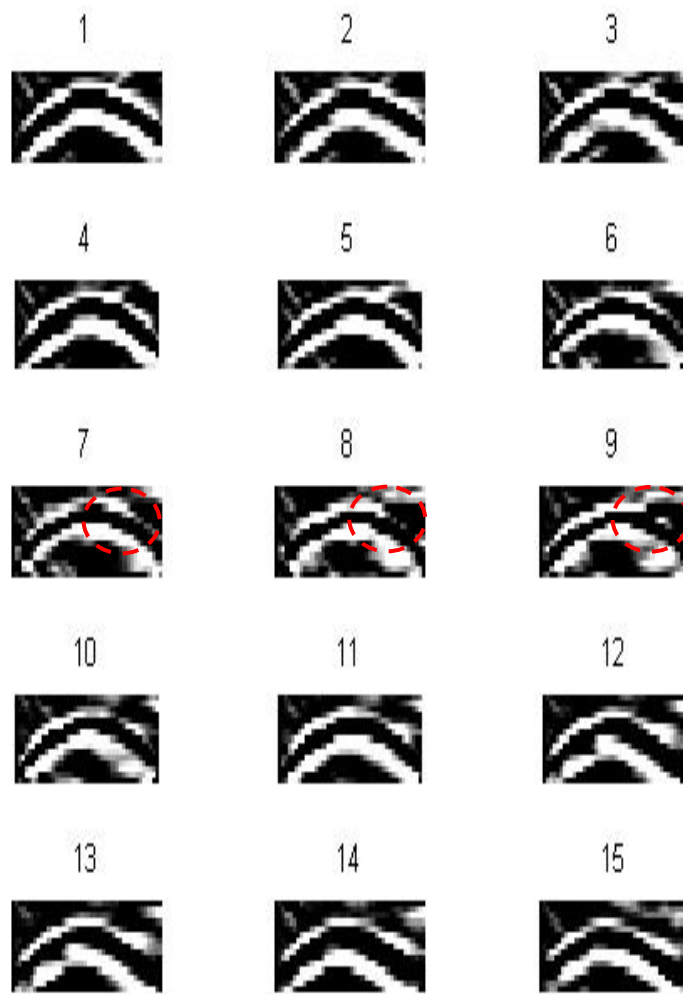
Figure 4.4. Test 1 - 15 radar images (perpendicular to the pipes) using the 700MHz antenna with 10 integrations. (The red dotted circles indicate areas where visual differences are evident in the scans associated with damaged pipe section.)

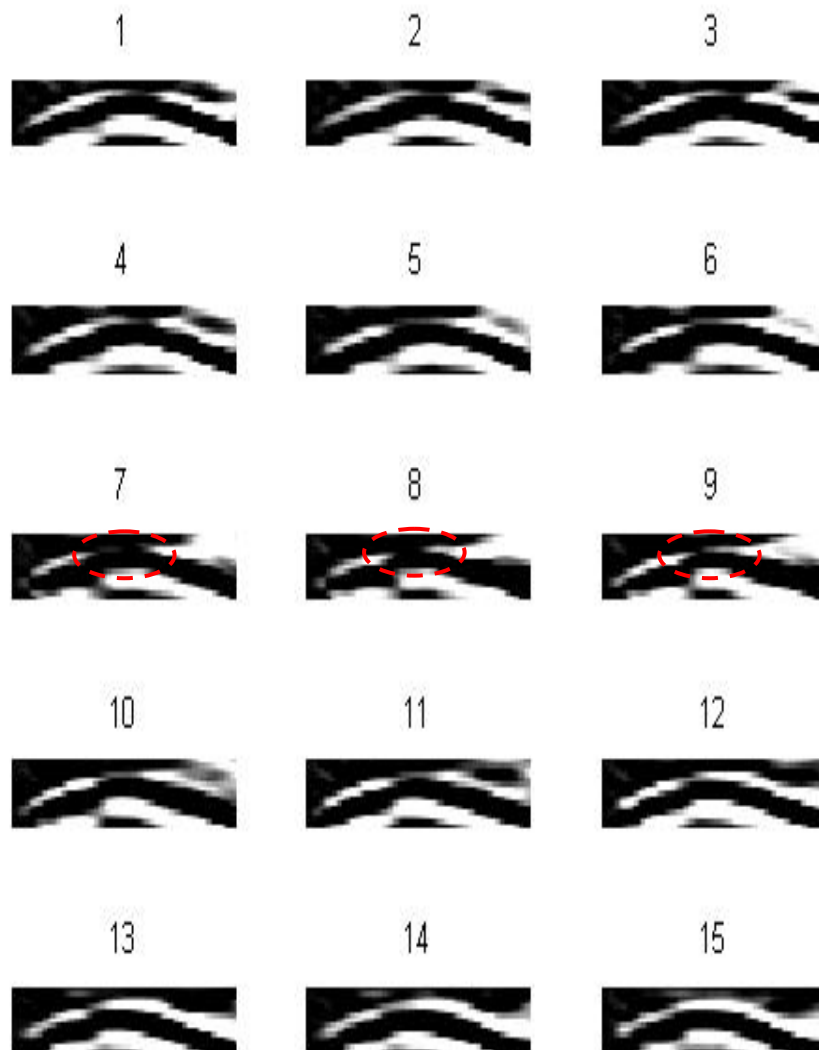
Figure 4.5. Test 1 - 15 radar images (perpendicular to the pipes) using the 250MHz antenna with 5 integrations. (The red dotted circles indicate areas where visual differences are evident in the scans associated with damaged pipe section.)

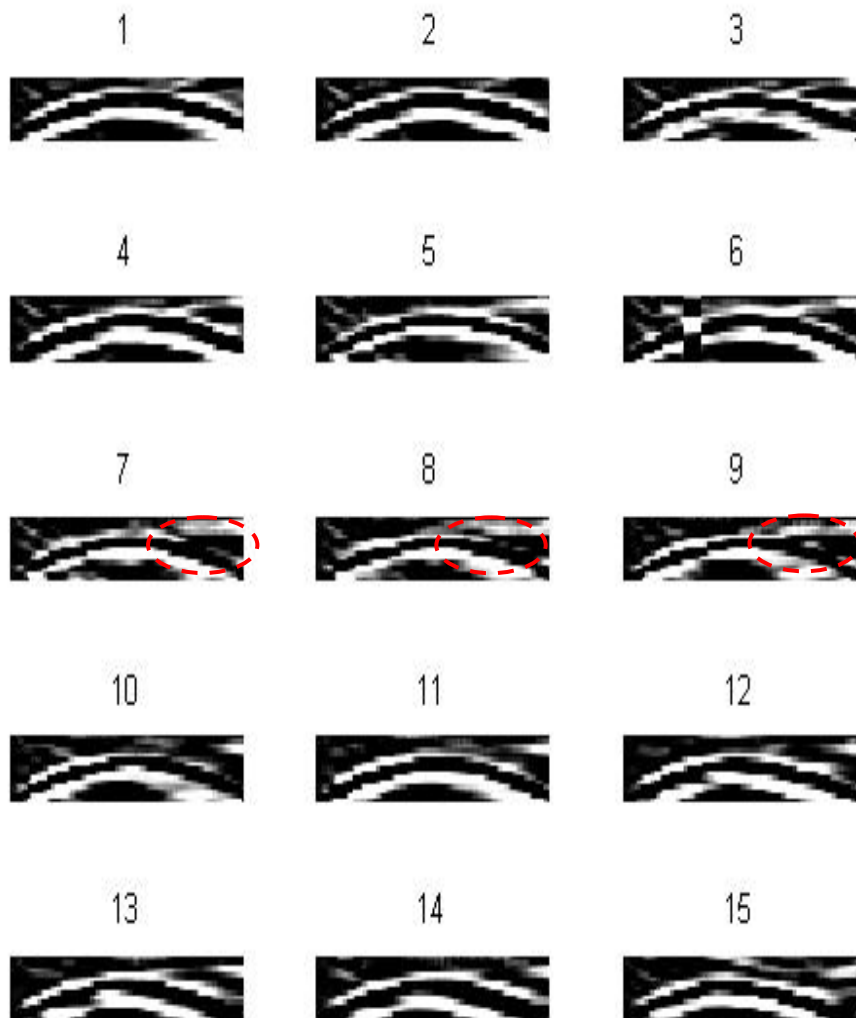
Figure 4.6. Test 1 - 15 radar images (perpendicular to the pipes) using the 700MHz antenna with 5 integrations. (The red dotted circles indicate areas where visual differences are evident in the scans associated with damaged pipe section.)

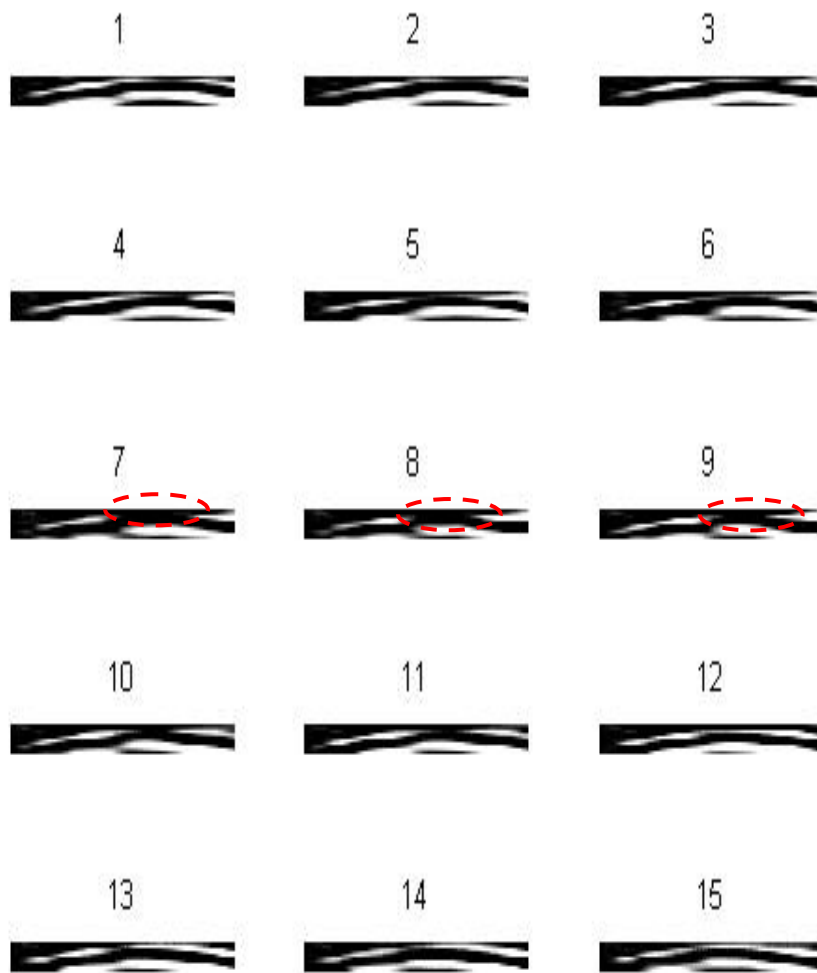
Figure 4.7. Test - 15 radar images perpendicular to the pipes using the 250MHz antenna with 2 integrations. (The red dotted circles indicate areas where visual differences are evident in the scans associated with damaged pipe section.)

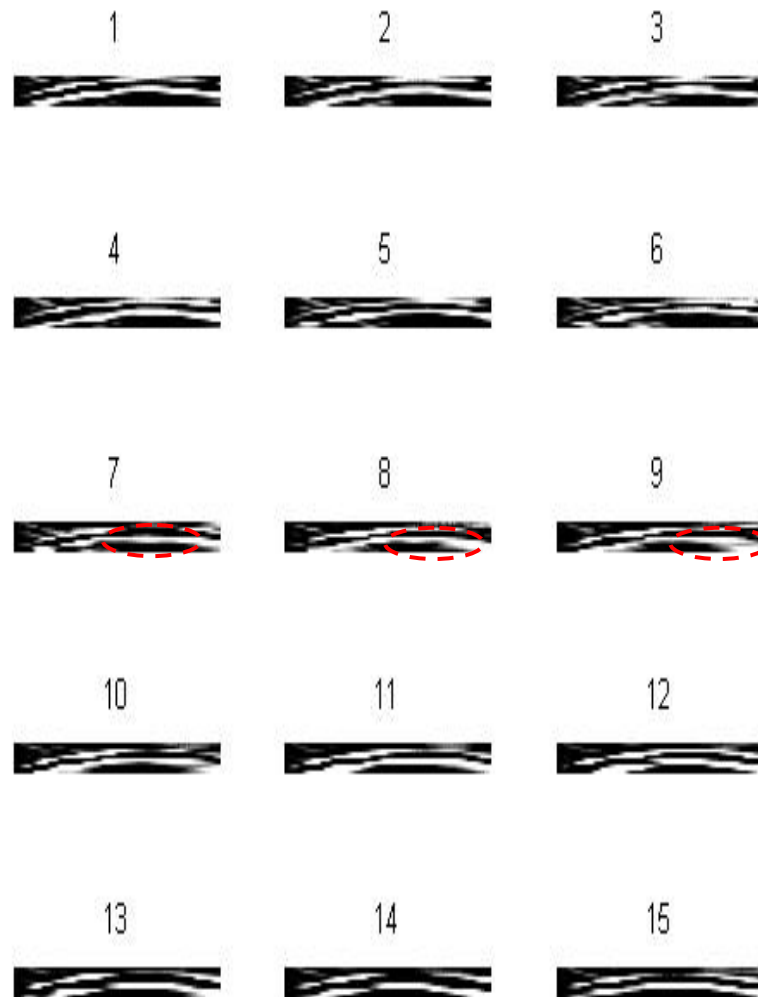
Figure 4.8. Test 1 - 15 radar images perpendicular to the pipes using the 700MHz antenna with 2 integrations. (The red dotted circles indicate areas where visual differences are evident in the scans associated with damaged pipe section.)

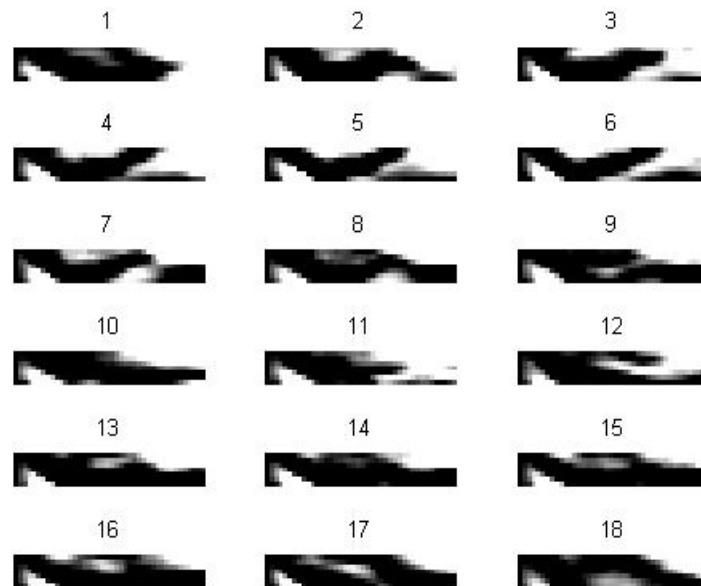
Figure 4.9. Test 1 - 18 radar images axially along the pipes using the 250MHz antenna with 10 integrations.

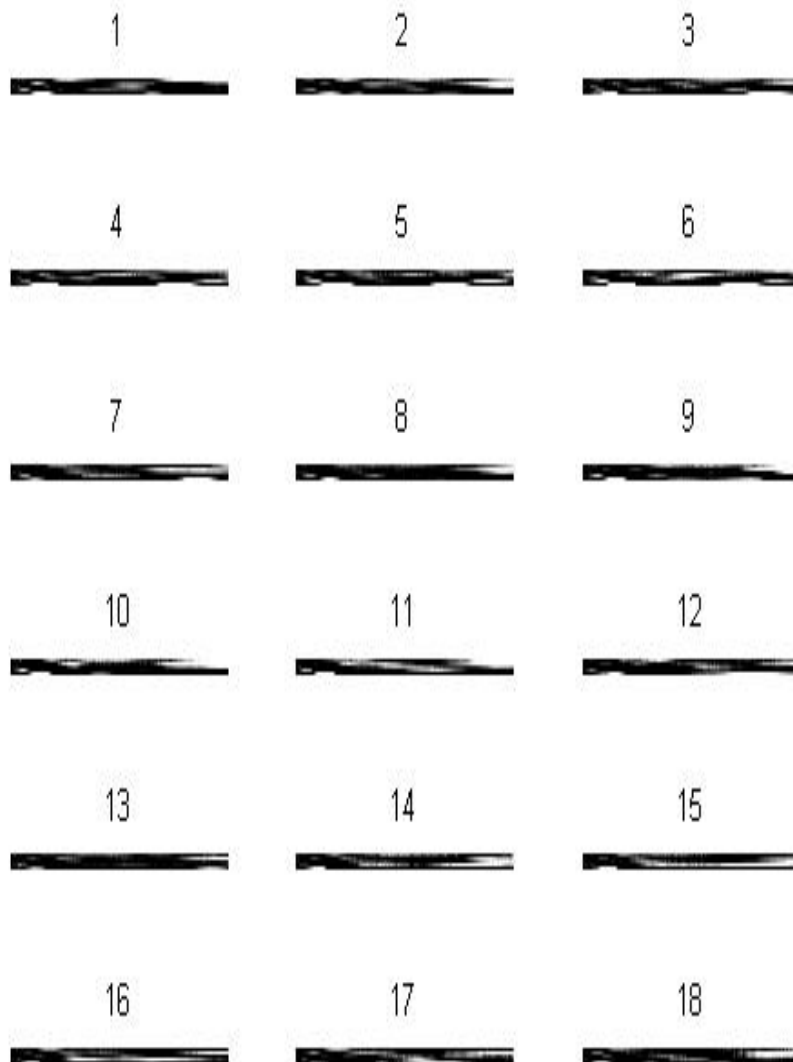
Figure 4.14. Test 1 - 18 radar images axially along the pipes using the 700MHz antenna with 2 integrations.

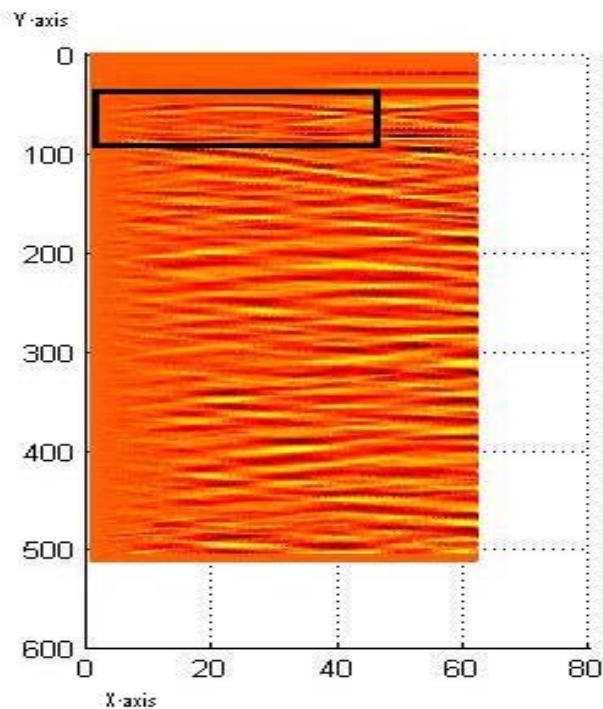
Figure 4.15. Example GPR radar image in the Matlab program used for determining the area for the subsequent MSE analysis (black rectangle)

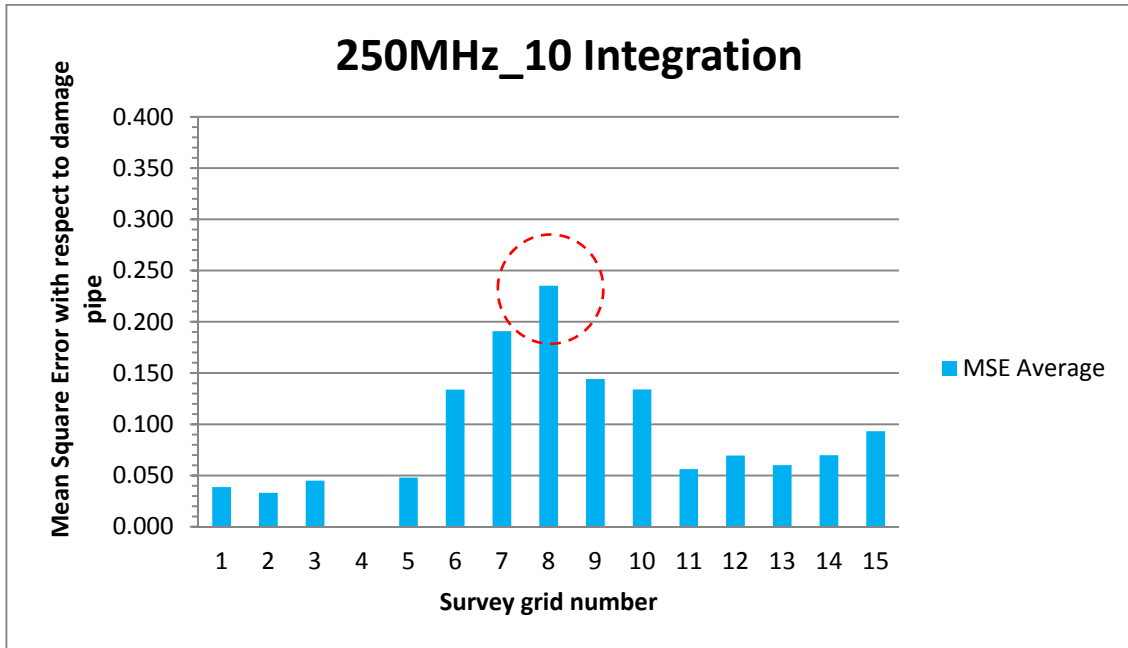
Figure 4.16: Test 1 - MSE for the 250MHz radar at 10 integrations perpendicular to the pipes

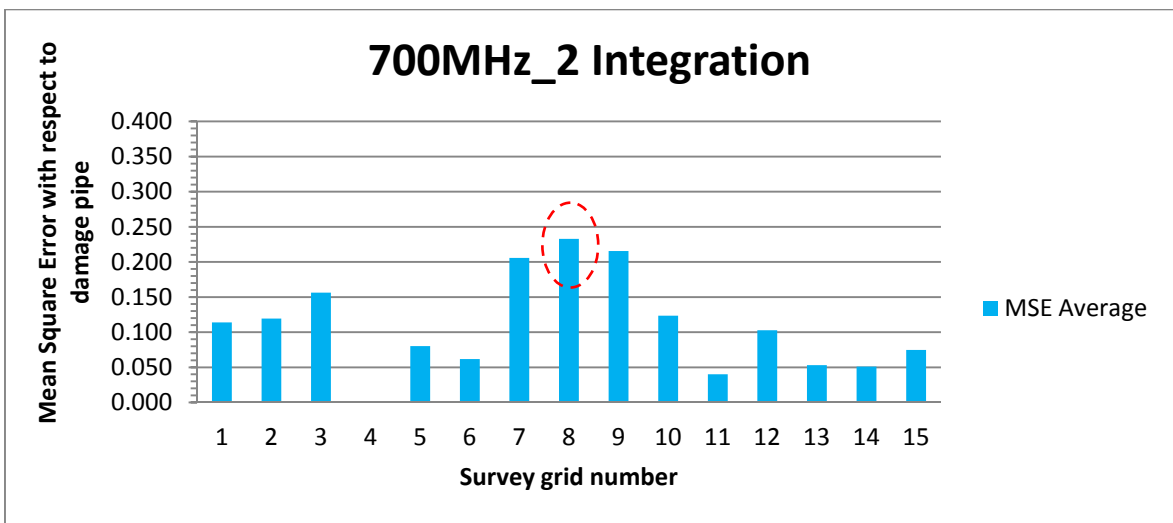
Figure 4.21: Test 1 - MSE for the 700MHz radar at 2 integrations perpendicular to the pipes

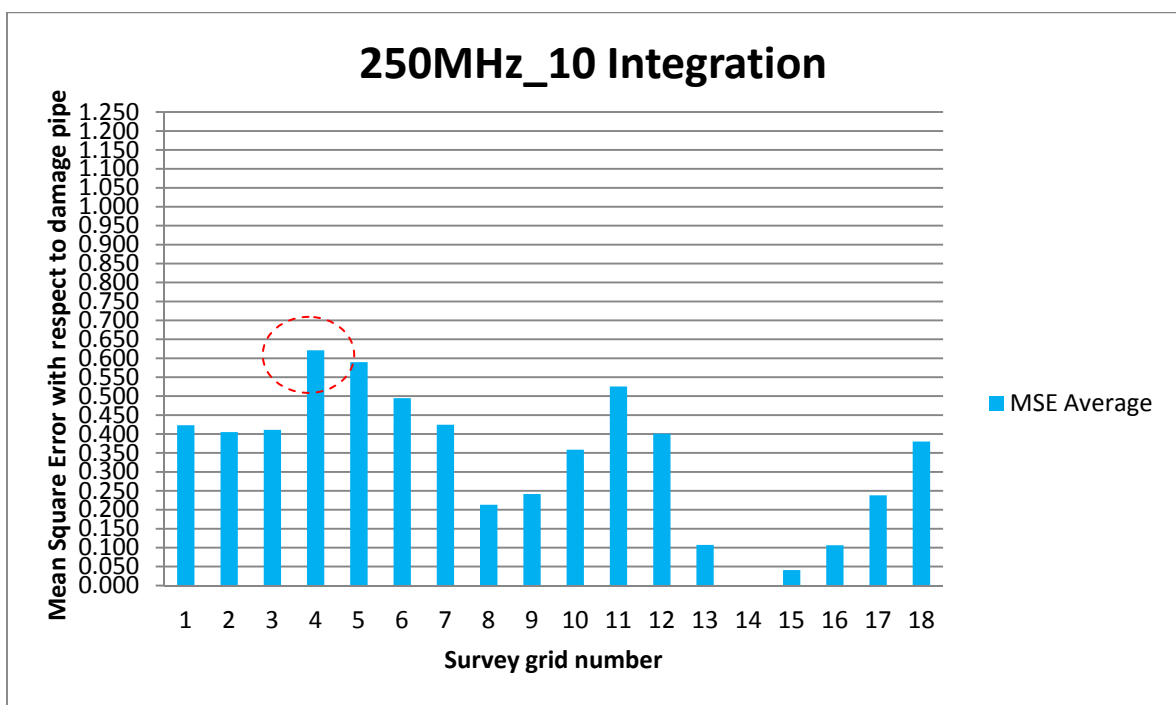
Figure 4.22: Test 1 - MSE for the 250MHz radar at 10 integrations axially along the pipes

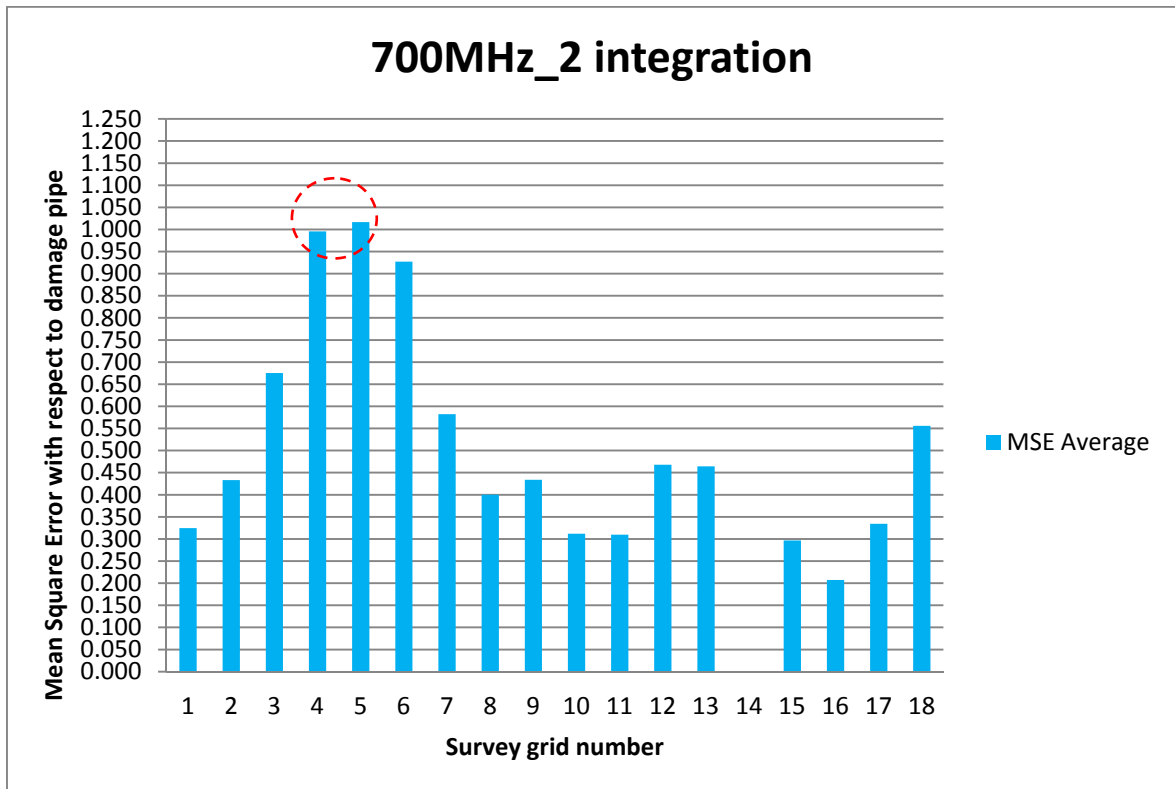
Figure 4.27: Test 1 - MSE for the 700MHz radar at 2 integrations axially along the pipes

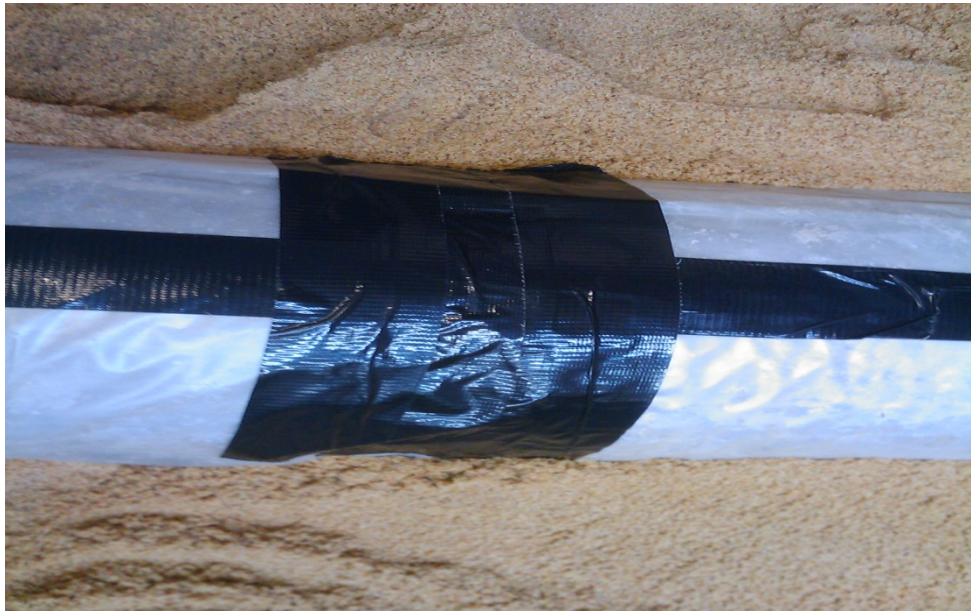
Figure 4.28. Test 2 - Broken pipe with a 5cm gap with a plastic cover

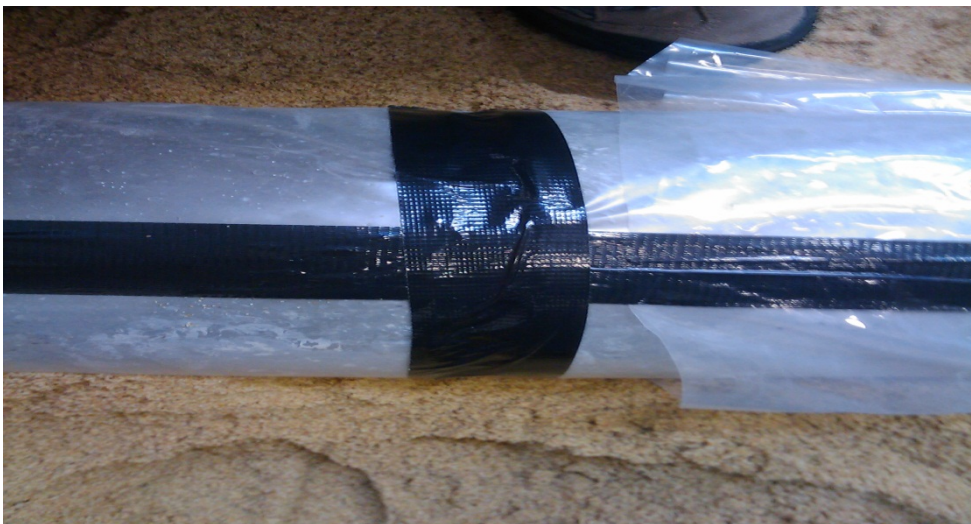
Figure 4.29. Test 2 - Broken pipe with a 2cm gap with a plastic cover
