**ASSESSING THE CONDITION OF
BURIED PIPE USING GROUND
PENETRATING RADAR**

A Thesis submitted to
The University of Birmingham
For the degree of
MASTER OF PHILOSOPHY (MPhil)

School of Civil Engineering
College of Engineering and Physical Science
The University of Birmingham
August 2013

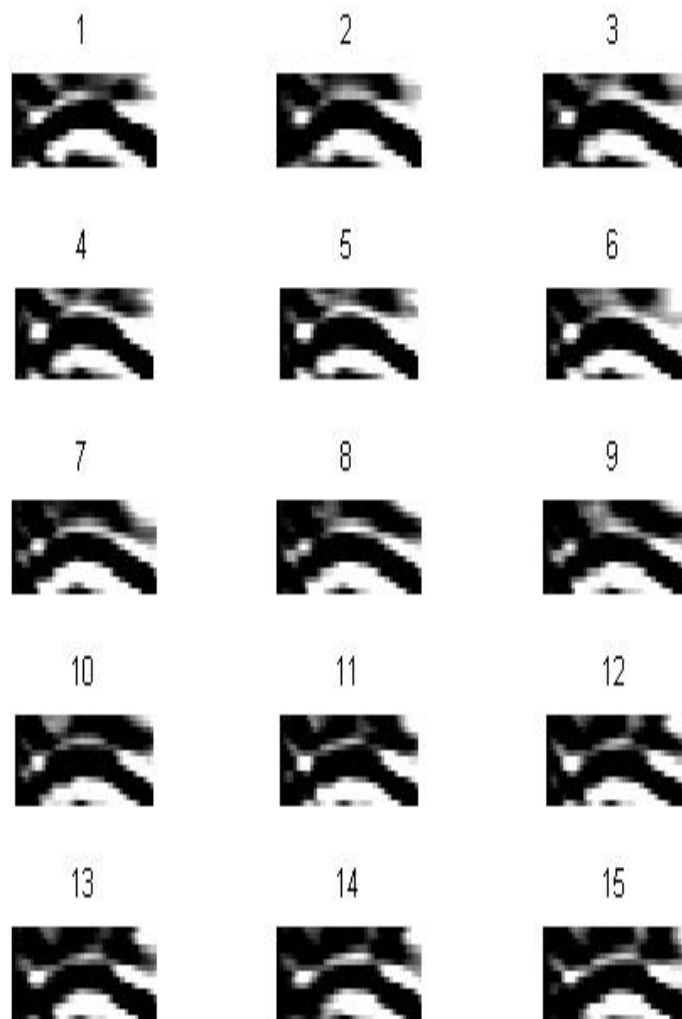
Figure 4.30. 15 radar images perpendicular to the pipes using the 250MHz antenna with 10 integrations (Test 2)

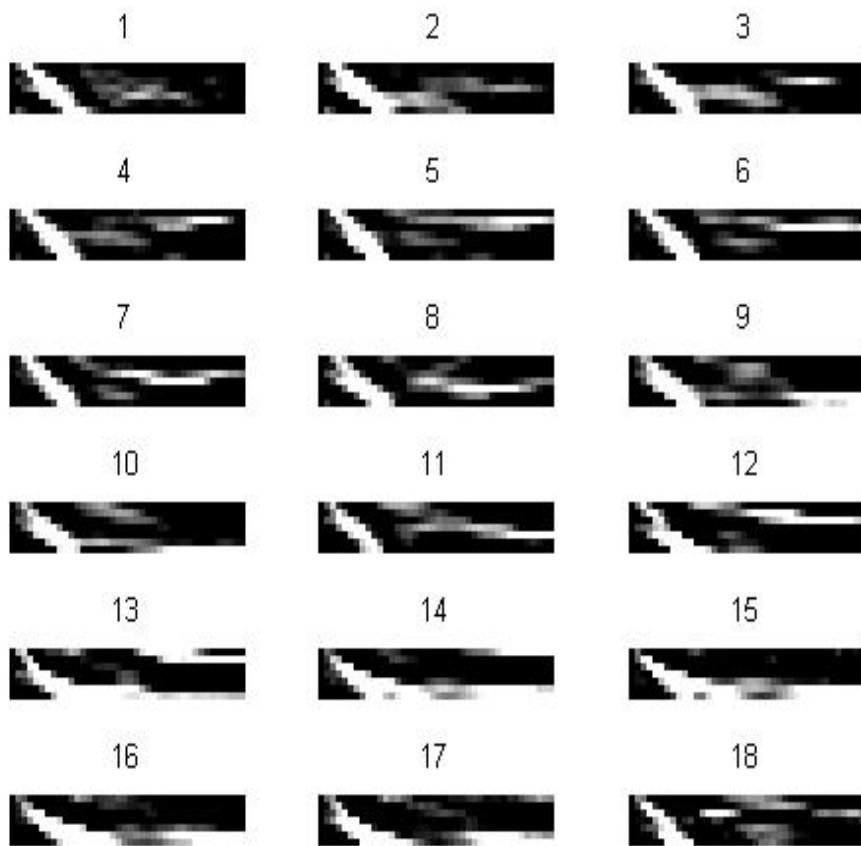
Figure 4.33. 18 radar images axially along the pipes using the 700MHz antenna with 10 integrations (Test 2)

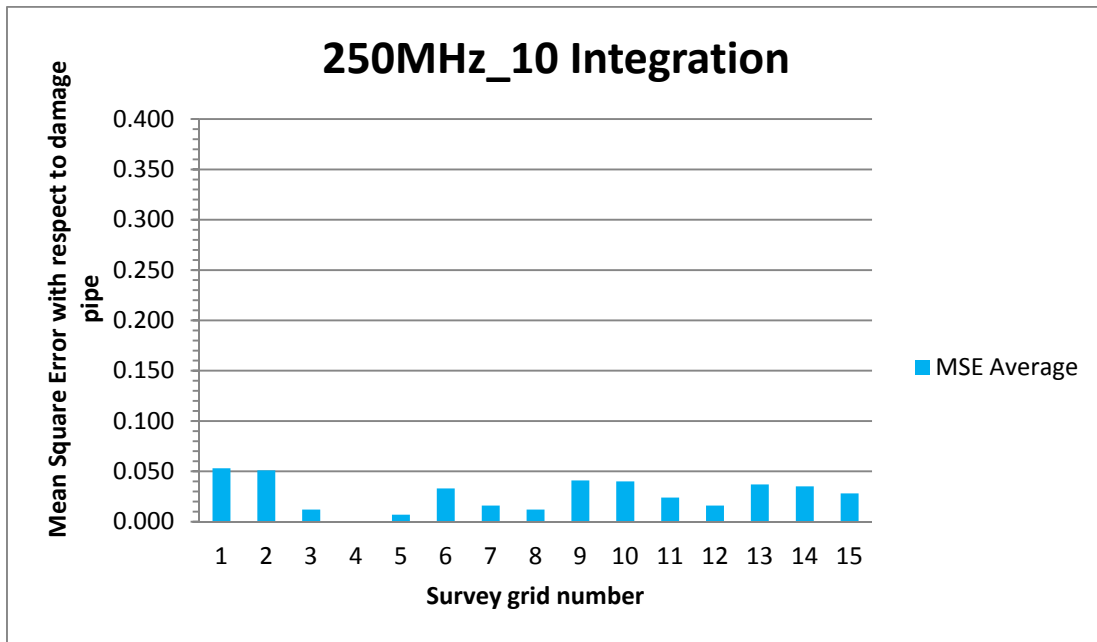
Figure 4.34: MSE for the 250MHz radar at 10 integrations perpendicular to the pipes (Test 2)

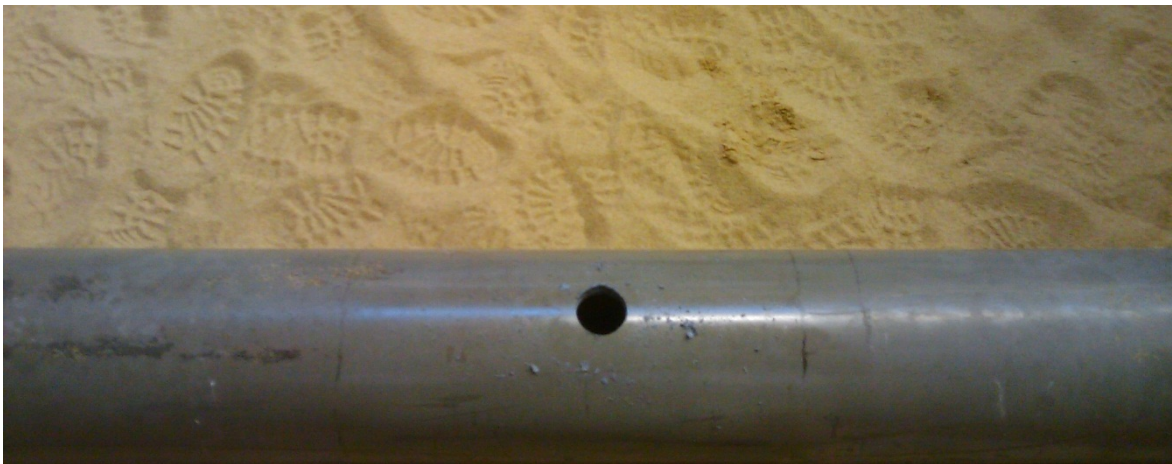
Figure 4.38: Test 3 –5cm hole in the pipe prior to being covered with sand

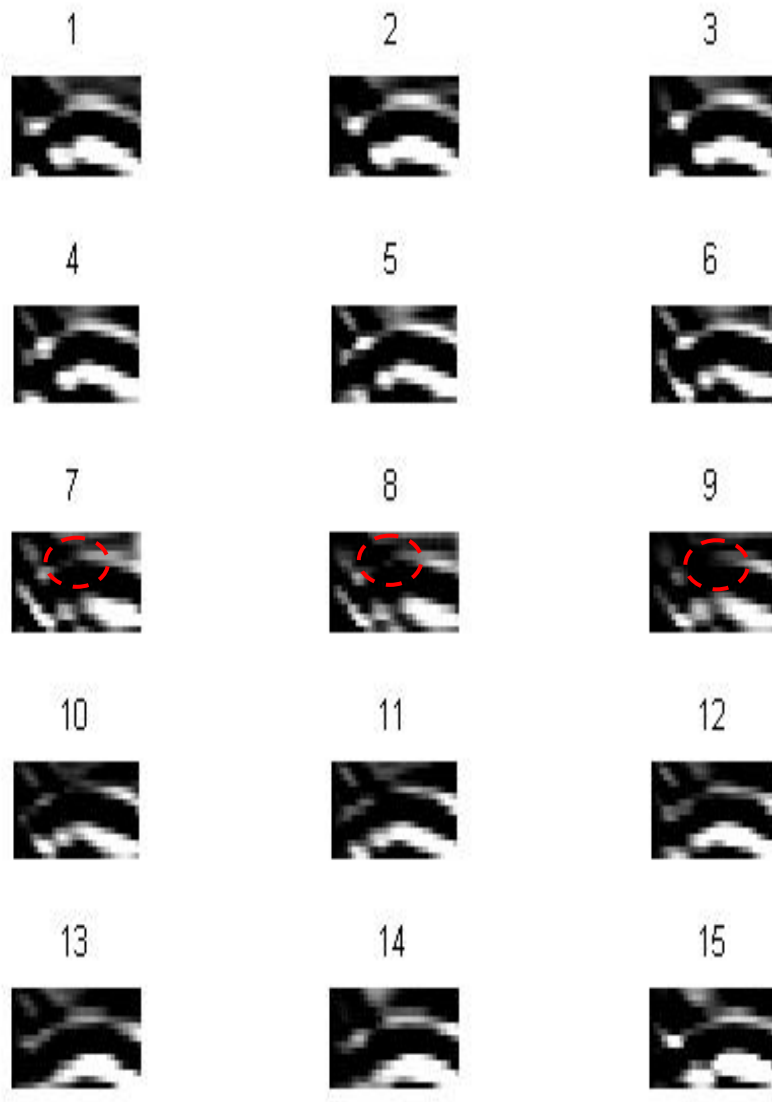
Figure 4.39: 15 radar images perpendicular to the pipes using the 250MHz antenna with 10 integrations (Test 3). (The red dotted circles indicate where visually there is potential evidence of damage due to differences in the scans.)

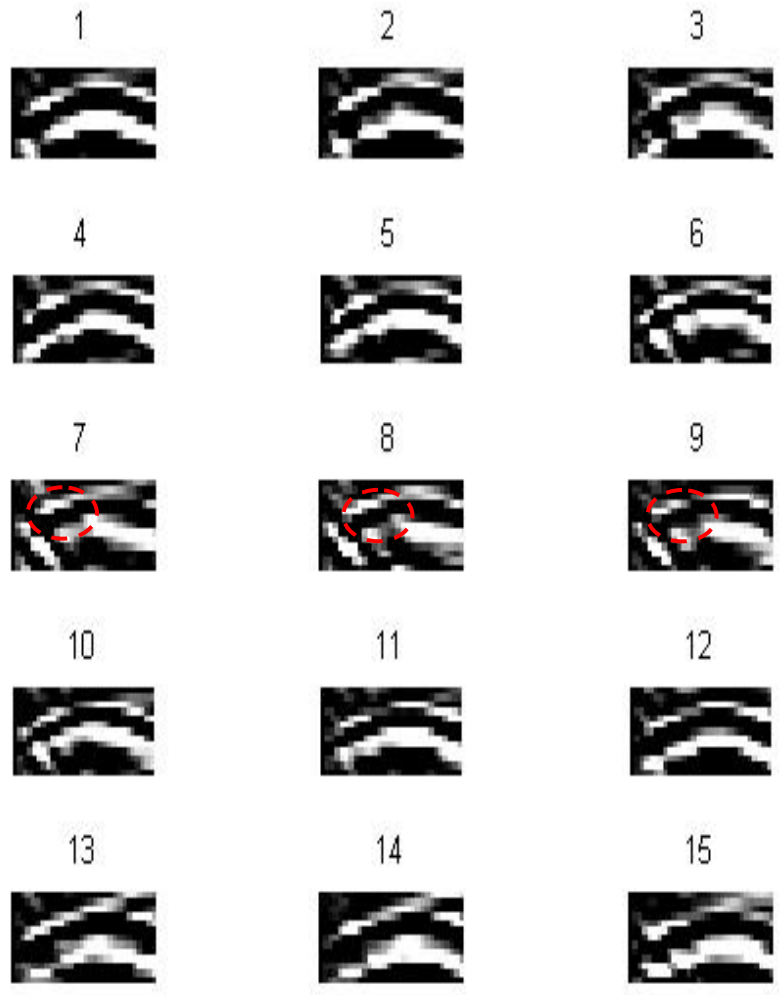
Figure 4.40: 15 radar images perpendicular to the pipes using the 700MHz antenna with 10 integrations (Test 3). (The red dotted circles indicate where visually there is potential evidence of damage due to differences in the scans.)

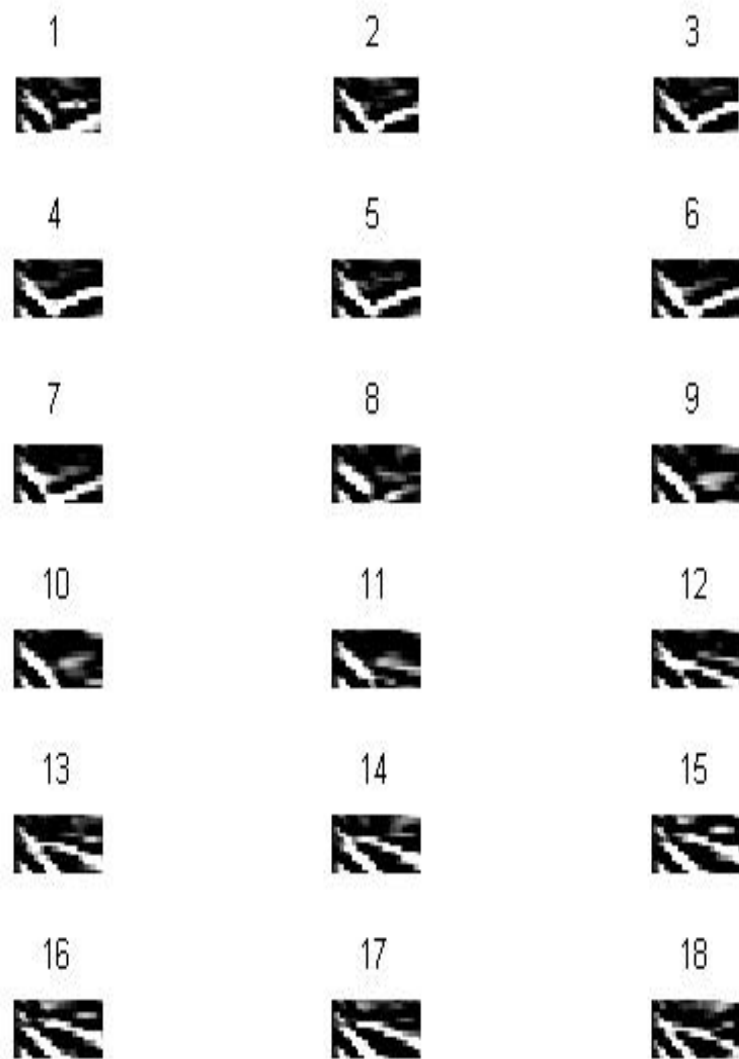
Figure 4.41: 18 radar images axially along the pipes using the 250MHz antenna with 10 integrations (Test 3).

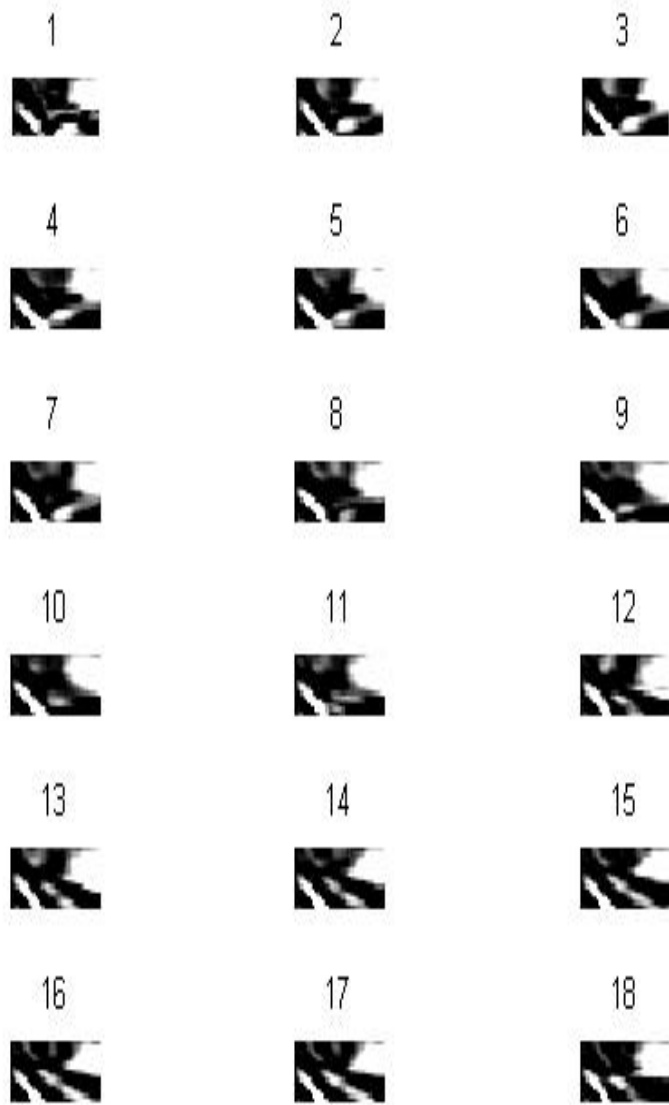
Figure 4.42: 18 radar images axially along the pipes using the 700MHz antenna with 10 integrations (Test 3).

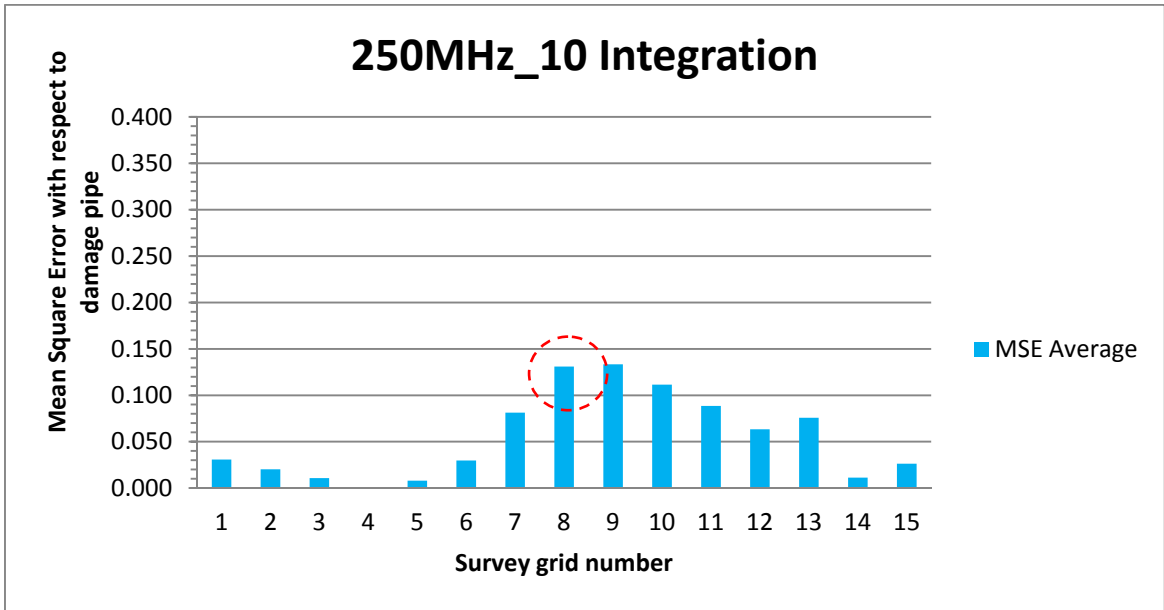
Figure 4.43: MSE for the 250MHz radar at 10 integrations perpendicular to the pipes (Test 3)

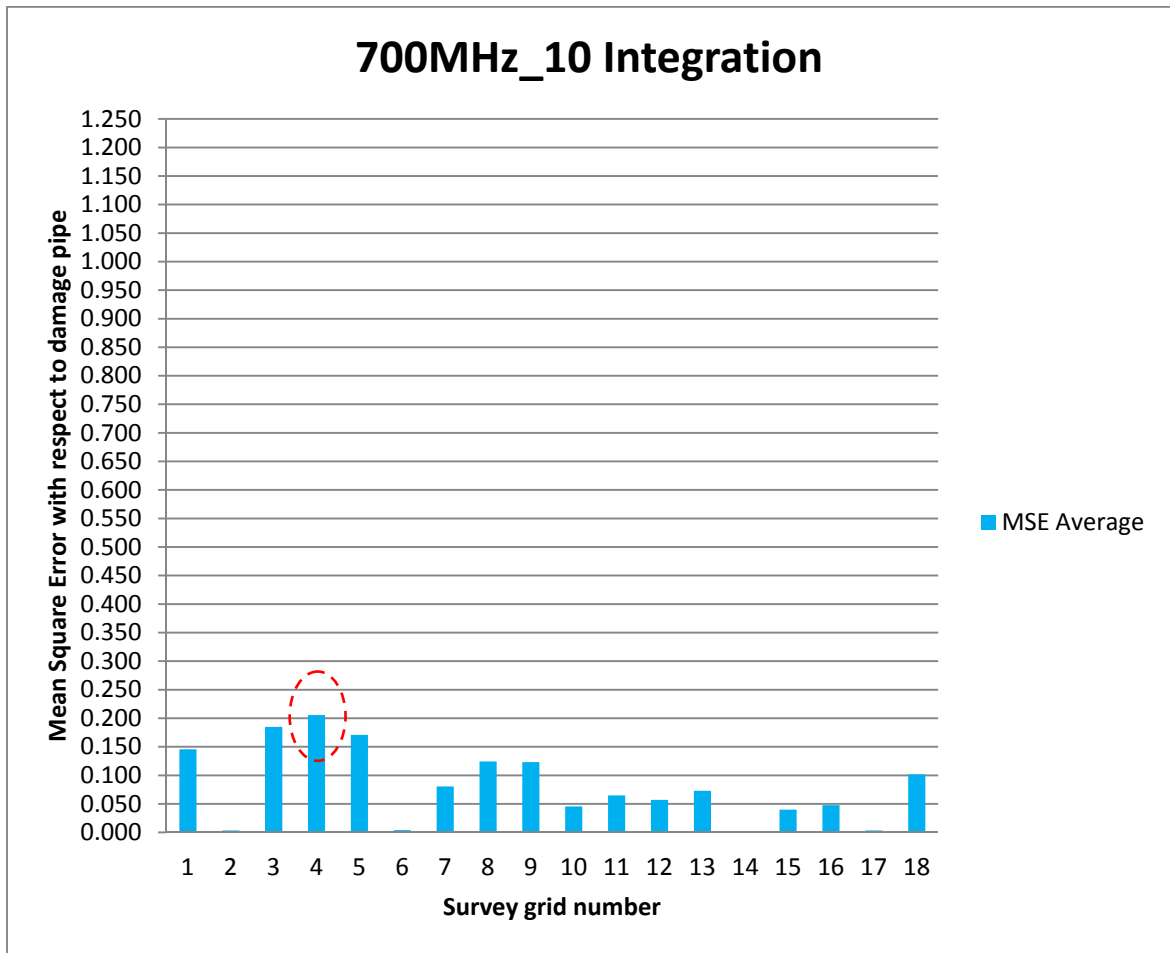
**Figure 4.46: MSE for the 700MHz radar at 10 integrations axially along the pipes
(Test 3)**

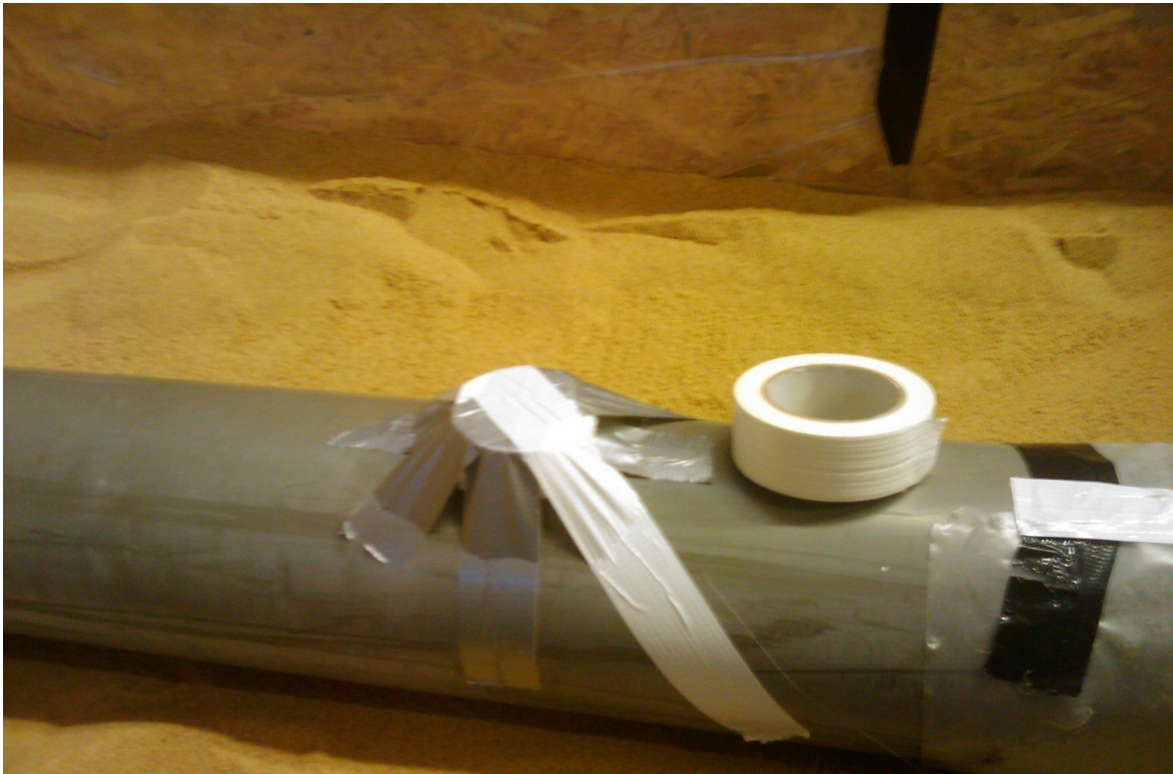
Figure 4.47: Test 4 – 5 cm hole in the pipe covered by polystyrene prior to being covered with sand

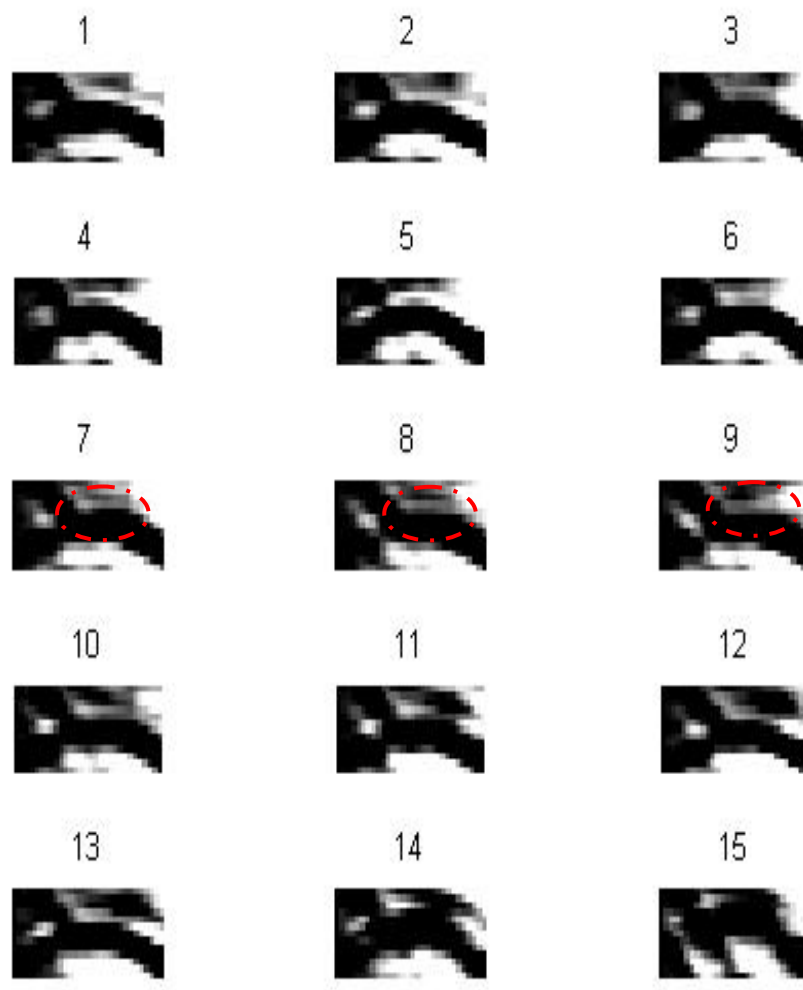
Figure 4.48: 15 radar images perpendicular to the pipes using the 250MHz antenna with 10 integrations (Test 4).

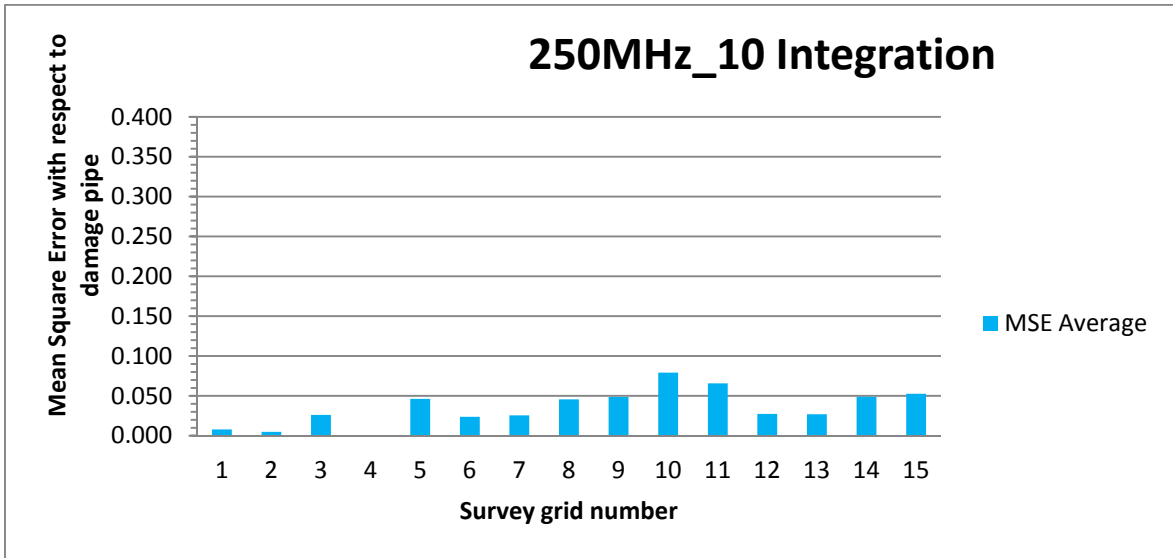
Figure 4.52: MSE for the 250MHz radar at 10 integrations perpendicular to the pipes (Test 4).

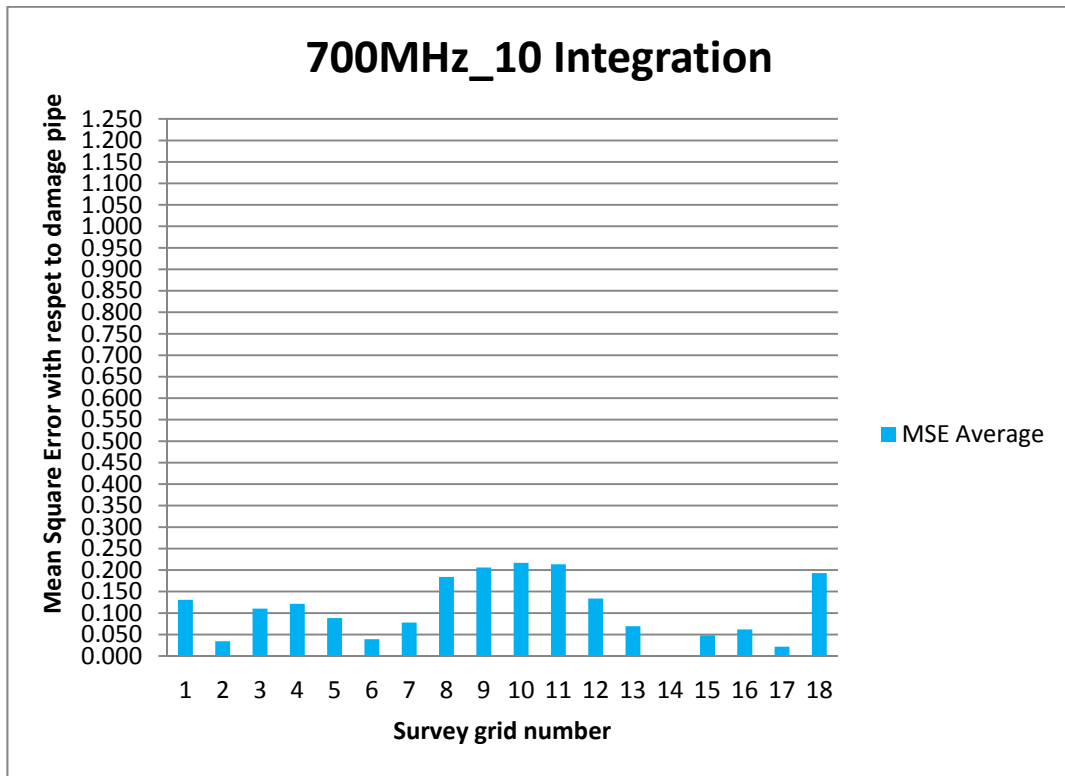
Figure 4.55: MSE for the 700MHz radar at 10 integrations axially along the pipes (Test 4).

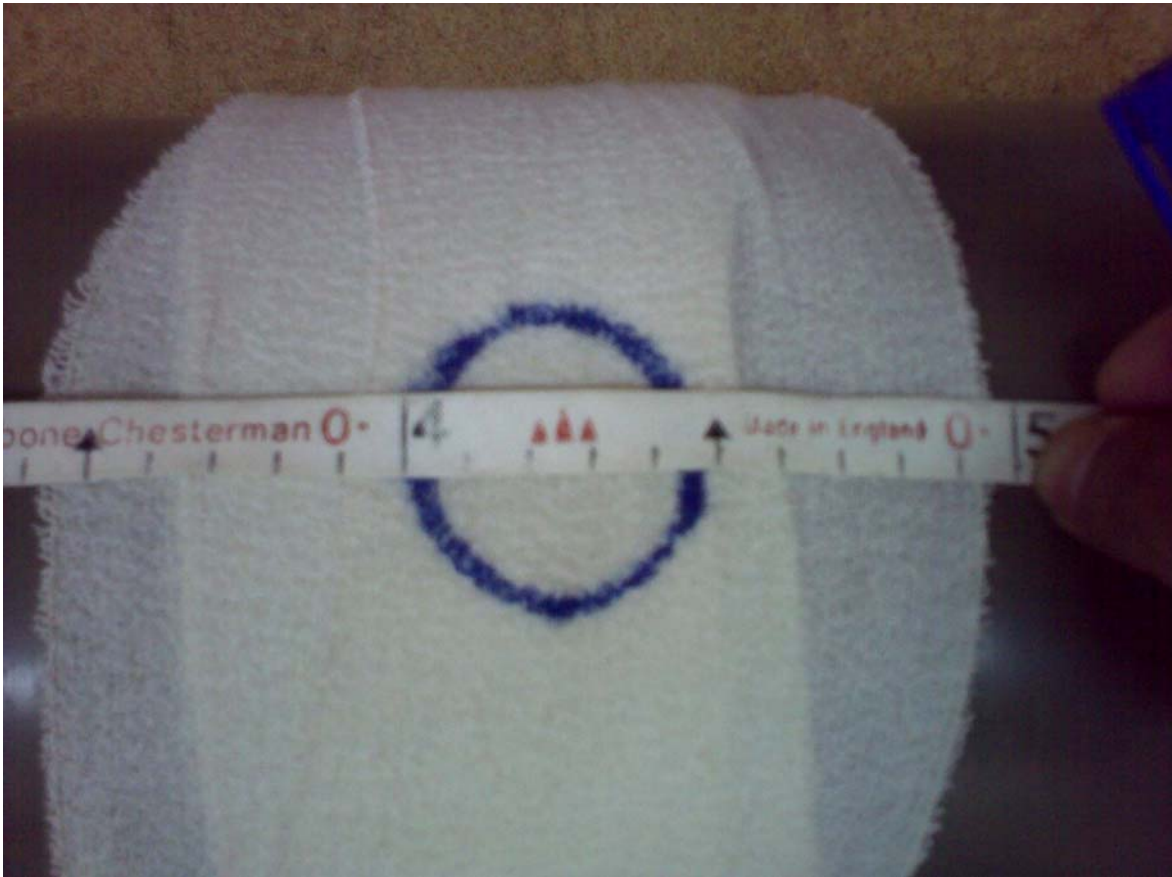
Figure 4.56: Test 5 – 5cm diameter hole in the pipe covered by fabric prior to being covered by sand.

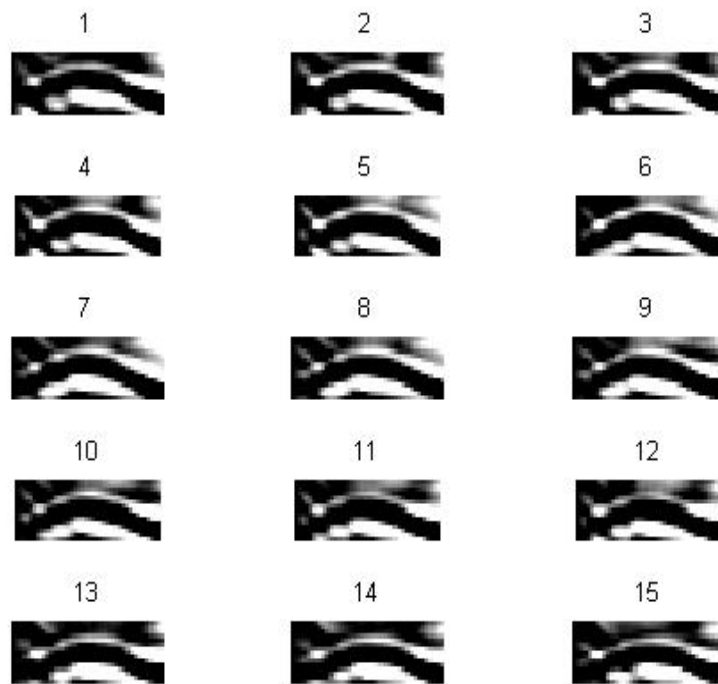
Figure 4.57: 15 radar images perpendicular to the pipes using the 250MHz antenna with 10 integrations (Test 5).

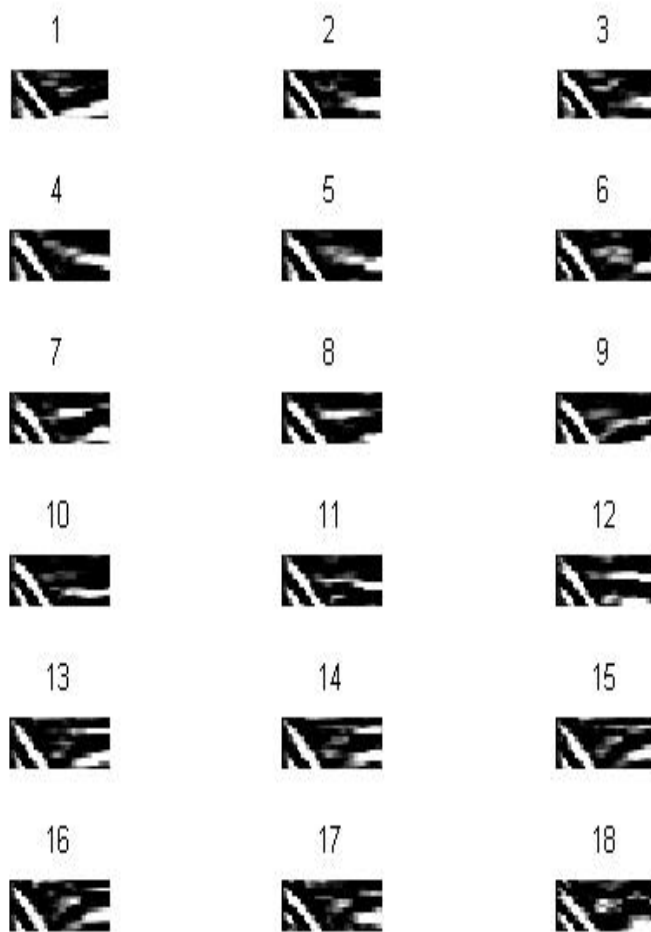
Figure 4.60: 18 radar images axially along the pipes using the 700MHz antenna with 10 integrations (Test 5).

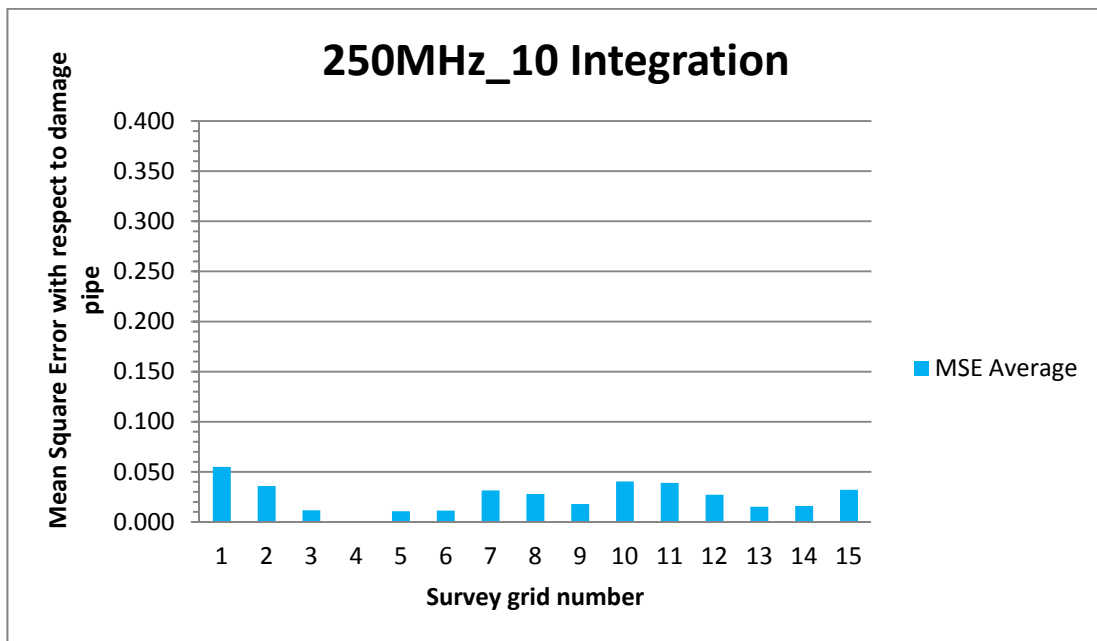
Figure 4.61: MSE for the 250MHz radar at 10 integrations perpendicular to the pipes (Test 5).

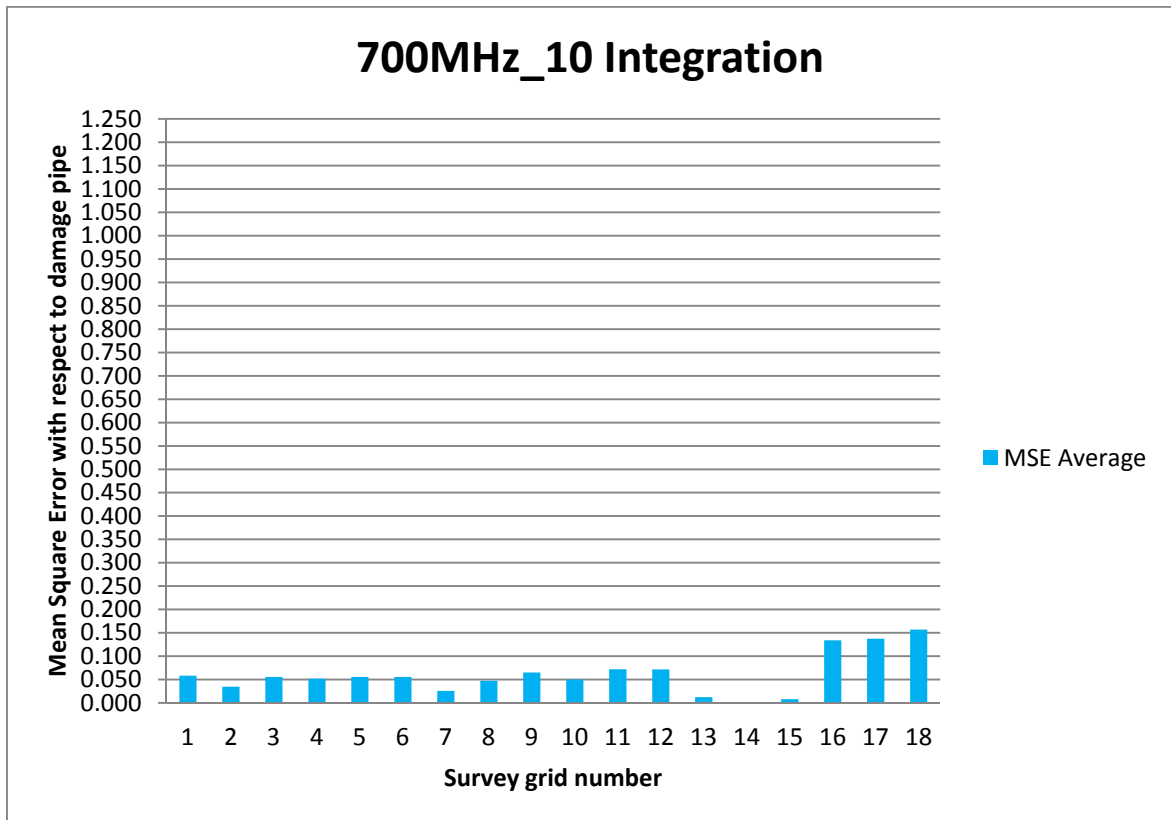
Figure 4.64: MSE for the 700MHz radar at 10 integrations axially along the pipes (Test 5).

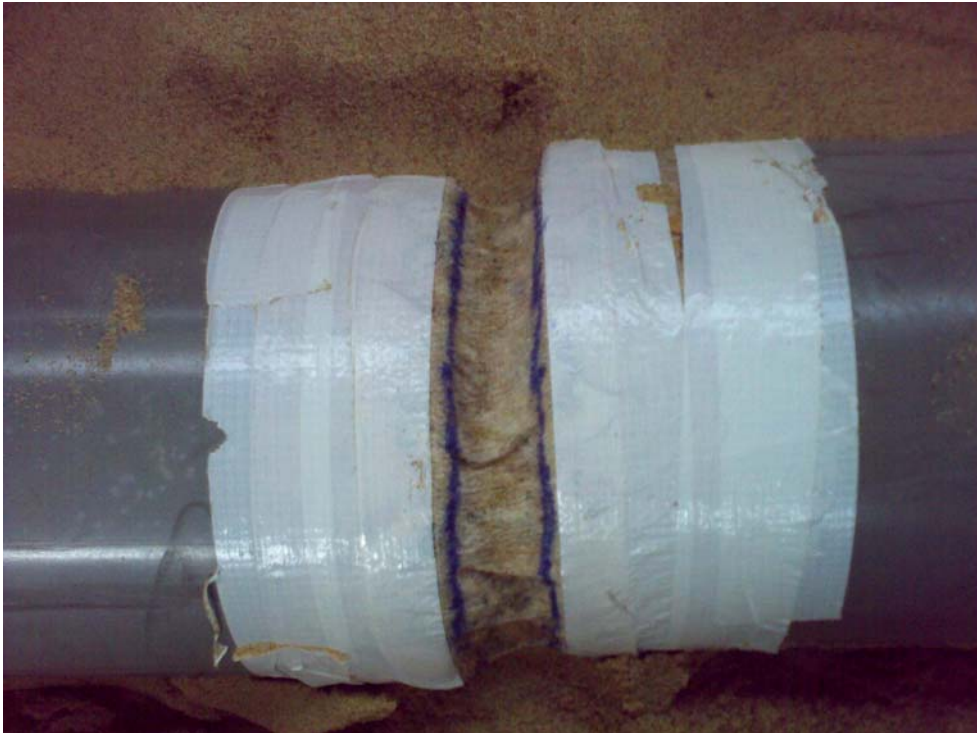
Figure 4.65: Test 6 - Broken pipe with a 5cm gap (sand prevented from passing through the gap by a fabric cover)

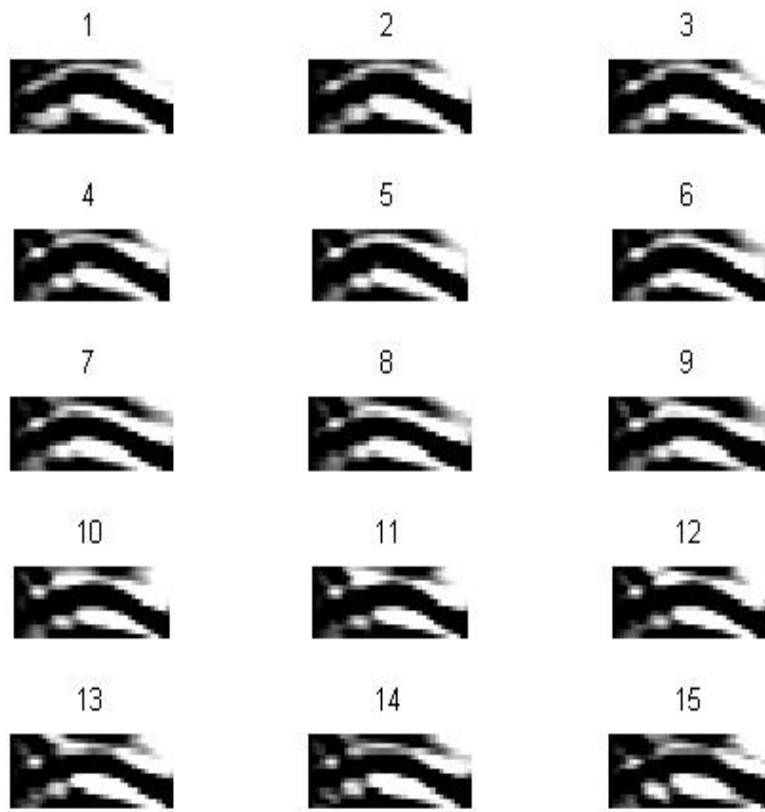
Figure 4.66: 15 radar images perpendicular to the pipes using the 250MHz antenna with 10 integrations (Test 6)

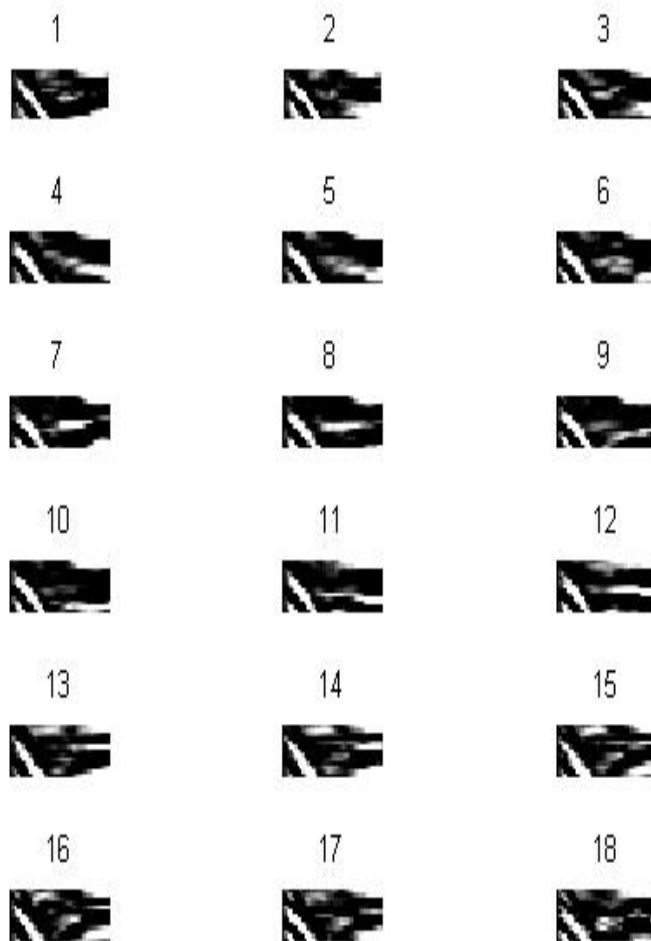
Figure 4.69: 18 radar images axially along the pipes using the 700MHz antenna with 10 integrations (Test 6)

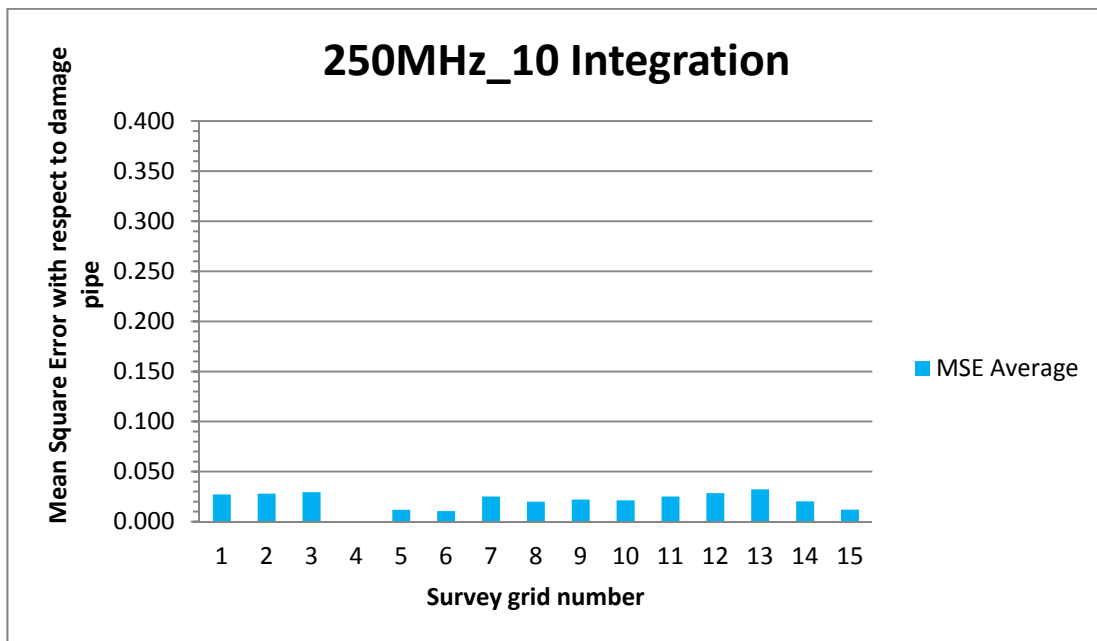
Figure 4.70: MSE for the 250MHz radar at 10 integrations perpendicular to the pipes (Test 6).

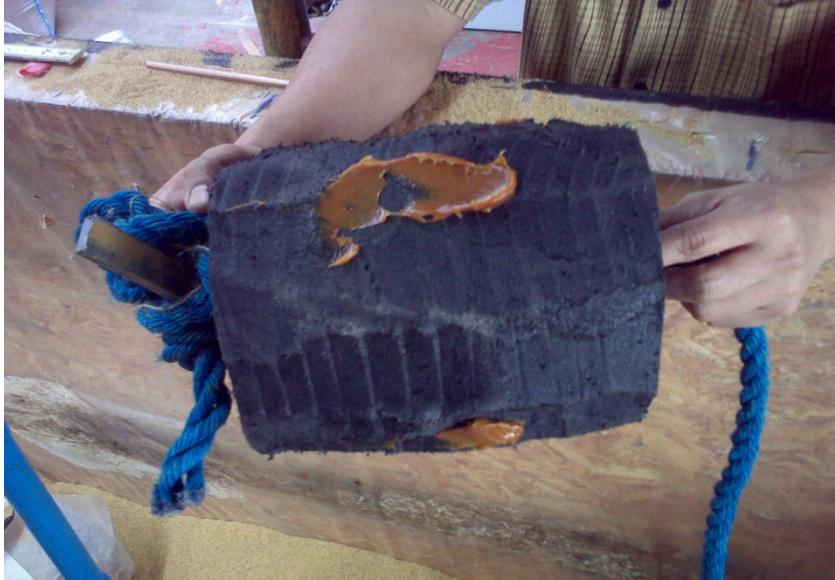
Figure 4.75. Test 7 - A sponge was used to block the hole in the pipe that could be subsequently removed

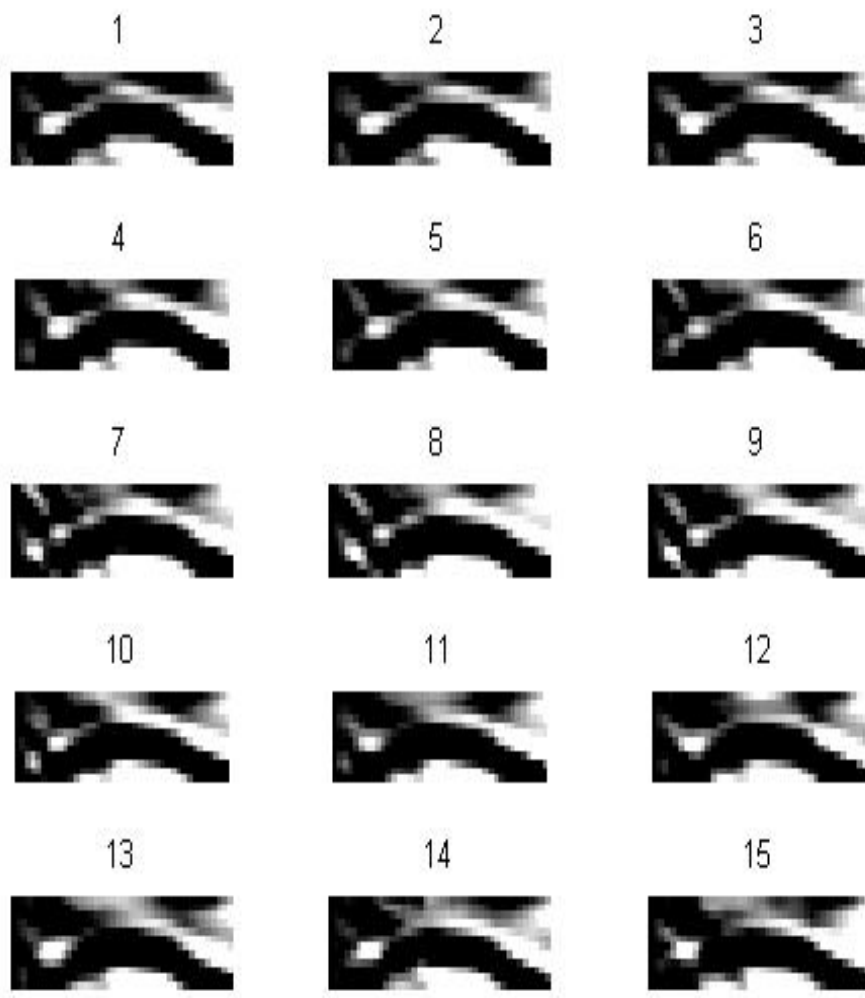
Figure 4.76: Test 7 - 15 radar images perpendicular to the pipes using the 250MHz antenna (before the sponge was removed).

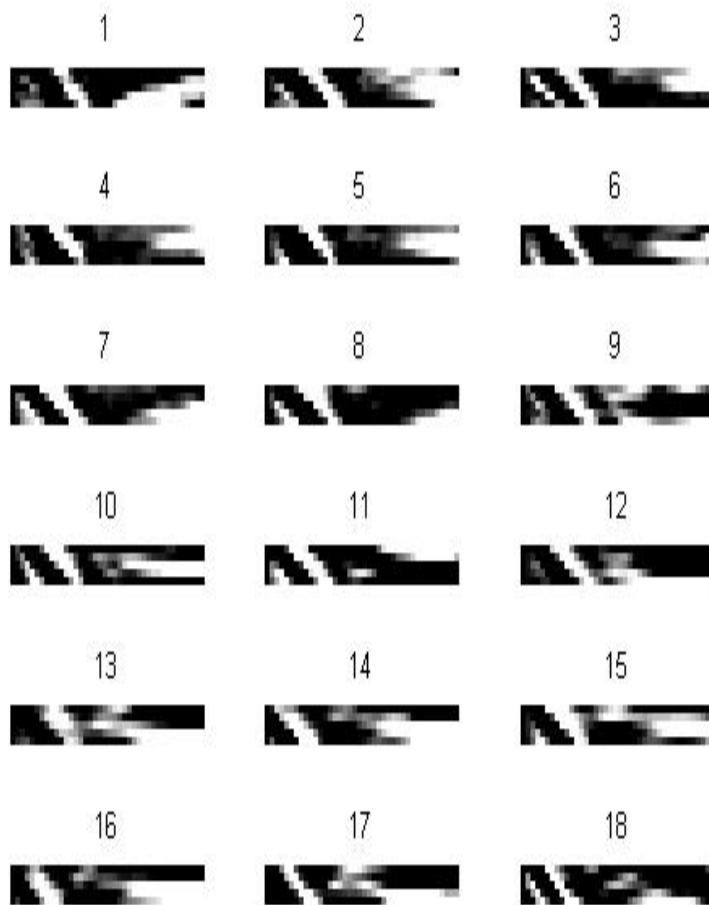
Figure 4.83: Test 7 - 18 radar images axially along the pipes using the 700MHz antenna (after the sponge was removed).

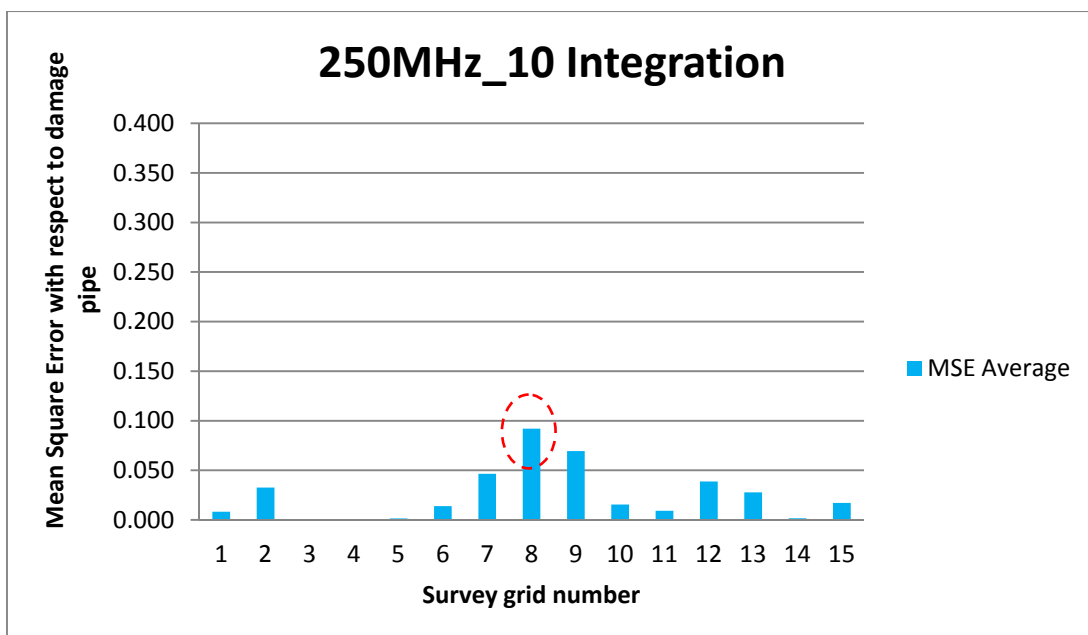
Figure 4.84: Test 7 - MSE for the 250MHz radar at 10 integrations perpendicular to the pipe (before the sponge was removed).

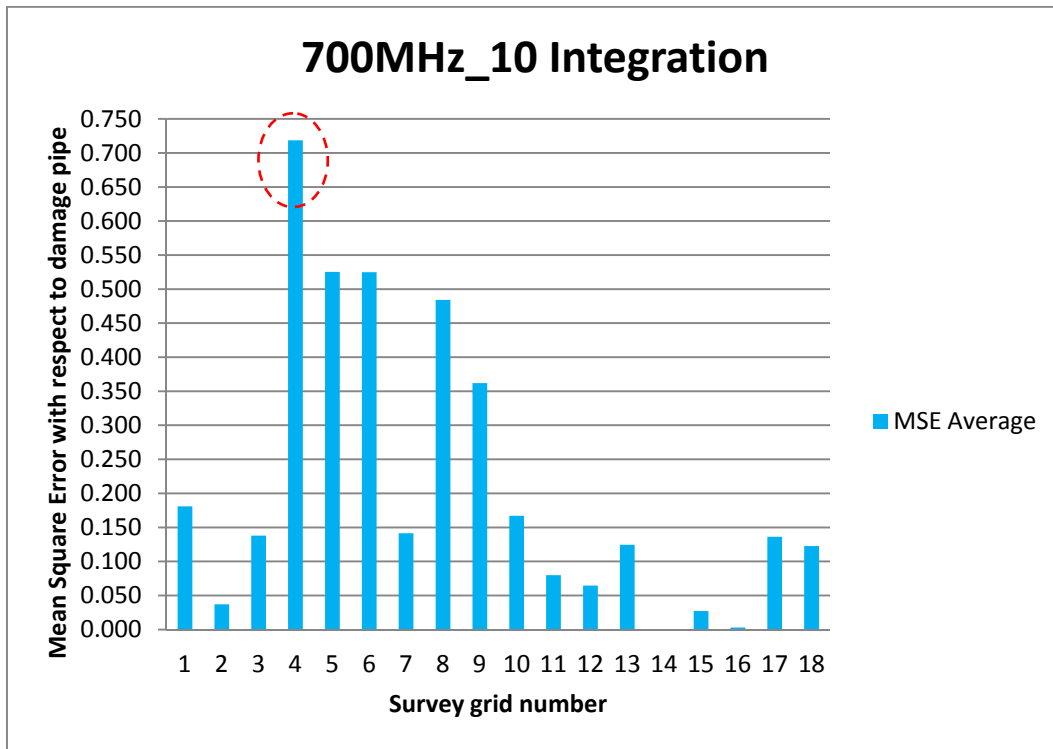
Figure 4.91: Test 7 - MSE for the 700MHz radar at 10 integrations axially along the pipes (after the sponge was removed)

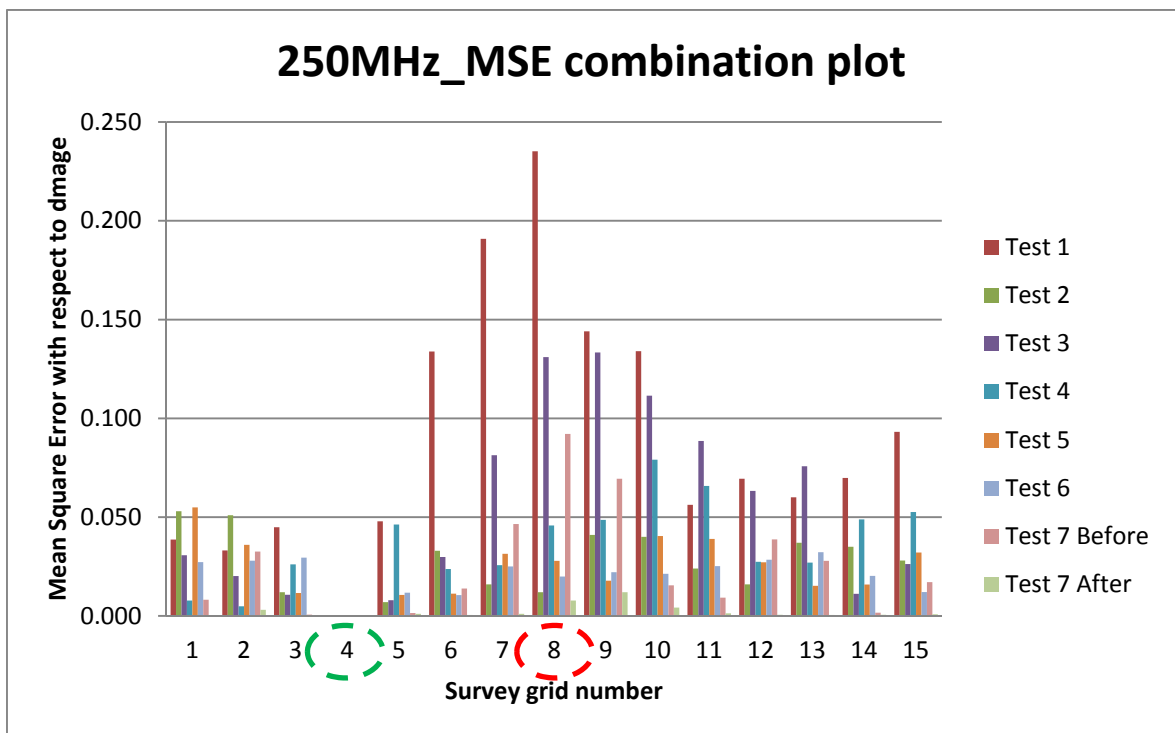
Figure 4.92: All tests of MSE for the 250MHz radar scans perpendicular to the pipes, the green circle highlights position of undamaged pipe, while the red circle highlights position of damaged pipe, both are known *a priori*

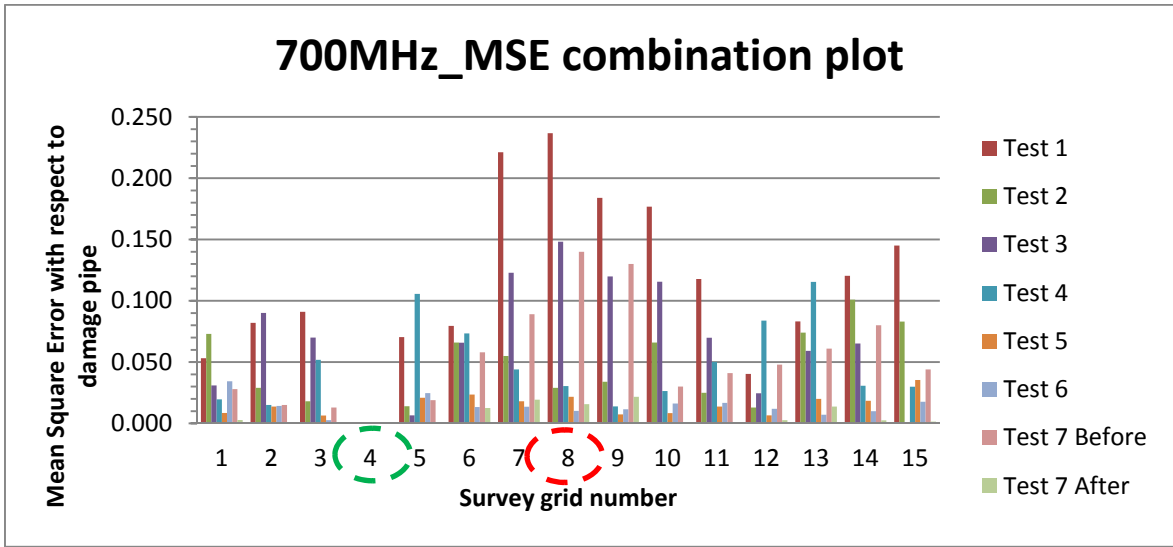
Figure 4.93: All tests of MSE for the 700MHz radar scans perpendicular to the pipes.
