**ASSESSING THE CONDITION OF
BURIED PIPE USING GROUND
PENETRATING RADAR**

A Thesis submitted to
The University of Birmingham
For the degree of
MASTER OF PHILOSOPHY (MPhil)

School of Civil Engineering
College of Engineering and Physical Science
The University of Birmingham
August 2013

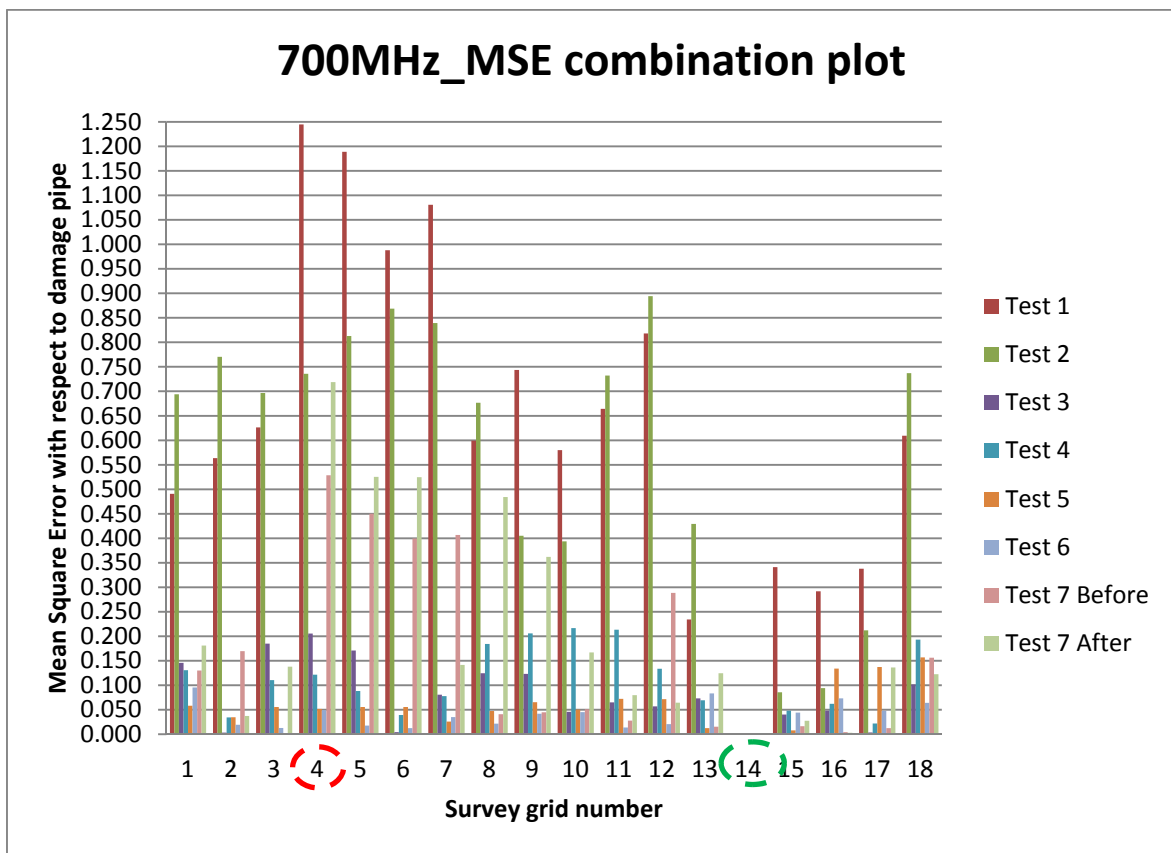
Figure 4.95: All tests of MSE for the 700MHz radar scans axially along the pipes.
