The reliability of a semi-quantitative scoring method for taper corrosion and fretting, and its usefulness for predicting the volume of material loss

Harry Hothi¹, Ashley Matthies¹, Reshid Berber¹, Robert Whittaker¹, Paul Bills², Radu Racasan², Gordon Blunn¹, John Skinner¹, Alister Hart¹

¹Institute of Orthopaedics and Musculoskeletal Science, Royal National Orthopaedic Hospital, UCL, UK

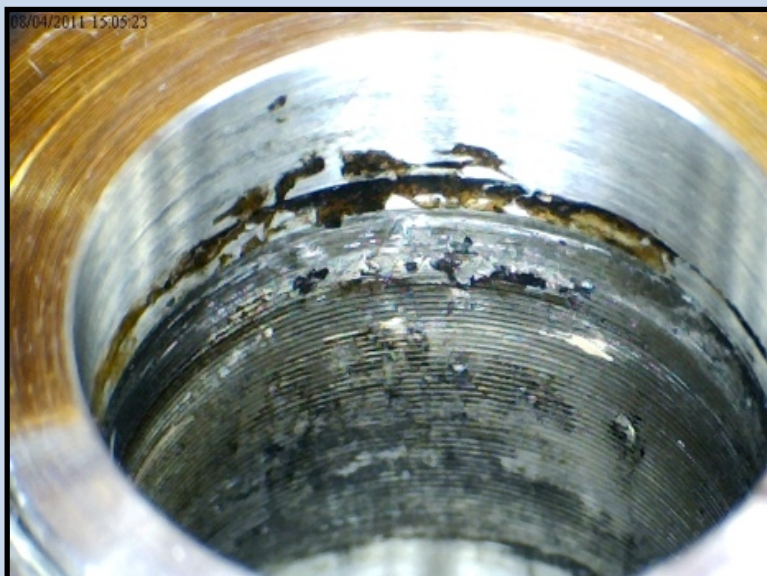
Large amount of discolouration and black deposits on head taper

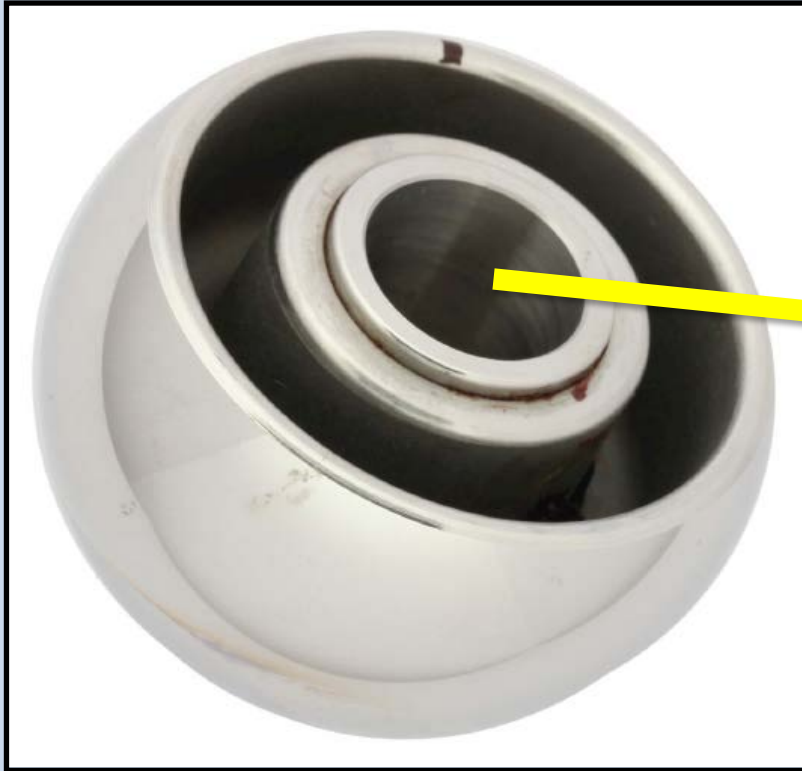
- Scores assigned to the proximal and distal halves of taper surface.
- Overall scores assigned following assessment of surface as a whole

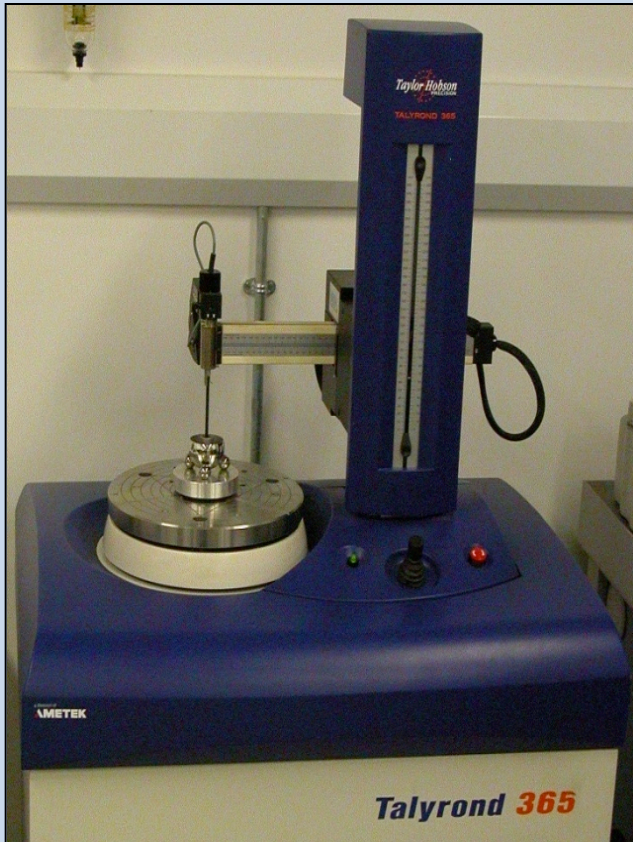
Roundness Measuring Machine (Taylor Hobson 365)

- 360 vertical traces
- 2.5 million data points
