Research Article

Online Bridge Crack Monitoring with Smart Film

Smart film crack monitoring method, which can be used for detecting initiation, length, width, shape, location, and propagation of cracks on real bridges, is proposed. Firstly, the fabrication of the smart film is developed. Then the feasibility of the method is analyzed and verified by the mechanical sensing character of the smart film under the two conditions of normal strain and crack initiation. Meanwhile, the coupling interference between parallel enameled wires of the smart film is discussed, and then low-frequency detecting signal and the custom communication protocol are used to decrease interference. On this basis, crack monitoring system with smart film is designed, where the collected crack data is sent to the remote monitoring center and the cracks are simulated and recurred. Finally, the monitoring system is applied to six bridges, and the effects are discussed.

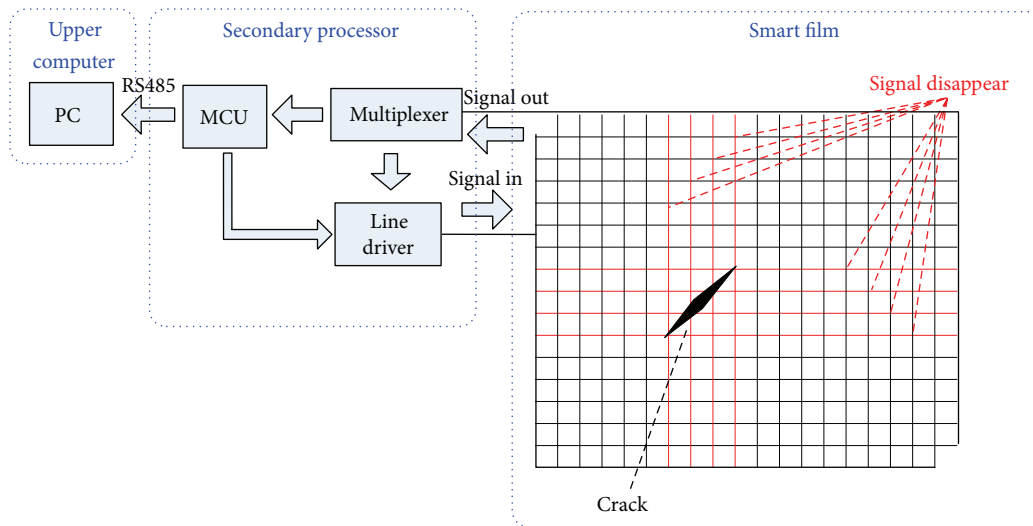
FIGURE 1: Schematic of smart film monitoring technique.

on the surface of the structure. Electrical signal is sent from one terminal of each wire, and the signal at the other hand is simultaneously detected. When a crack initiates, the conducting wires will break correspondingly. Therefore the signals will not get through those broken wires. By analyzing the conducting and breaking wires, initiation, length, shape, propagation, and the location of cracks can be identified. At the same time, crack width can be monitored by using the corresponding relationship between the diameter and crack width [16–18].

The crack sensing system built by this technique mainly consists of smart film, secondary processor, and upper computer. The smart film can be used for crack sensing. The secondary processor determines the location and the length of the crack according to the signal of the smart film and communicates with the upper computer for sending crack data. The upper computer processes and sends crack data to the remote monitoring center [16] (see Figure 1).

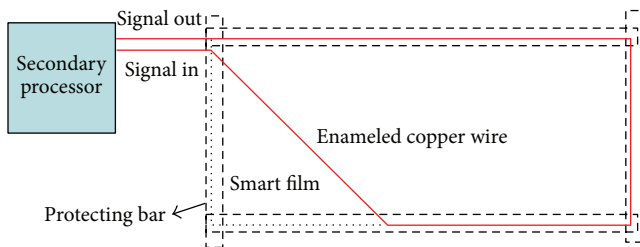
FIGURE 3: Road for one wire.

According to the crack monitoring technique based on smart film, enameled wires form the smart film regularly. Due to the small diameter of the wires, they are not easy to be fixed during the fabrication but easy to be broken. Therefore, plastic film with adhesive is used as substrate and glossy paper as the protection framework; then each wire is adhered on substrate as well as the bus protection framework and forms a grid as shown in Figure 3.

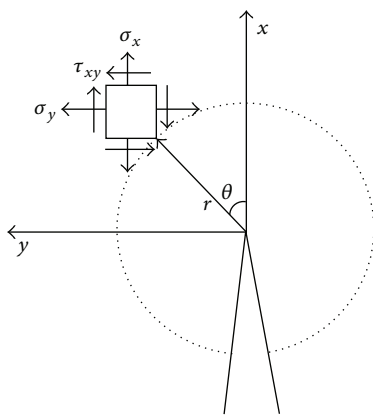
Considering that the structures being monitored are much larger than diameter of enameled wires, and the cracks will pierce through transverse direction of the wires, then the crack problem can be regarded as a 2D plane strain problem, as illustrated in Figure 5.

FIGURE 5: 2D plane strain of a crack.

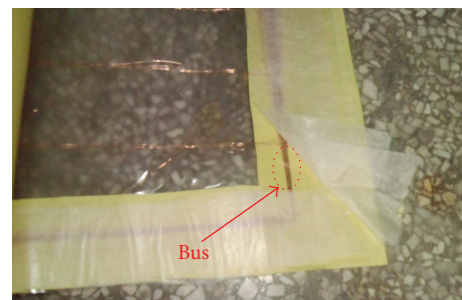
3.2. Antiinterference Analysis. It can be seen from the structure of smart film that enameled wires are forming parallel lines at regular intervals (see Figure 7). During the period of sending detecting signal to judge wires' condition, the voltage of interference coupling is so easy to be generated due to parasitic capacitance that conditions are judged wrongly. Hence it is necessary to analyze coupling interference among the bus of smart film and find the suitable detecting signals and detection ways, aimed to reduce coupling interference and enhance the accuracy of condition judgments of wires.

FIGURE 7: Bus of smart film.

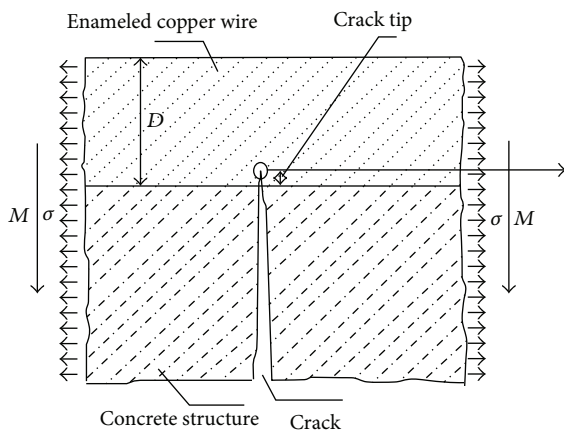
Assume that the crack appearing on concrete structure has pierced enameled wire to generate a crack tip (Figure 6); the stress field in the vicinity of crack tip can be obtained. Then strain field nearby the crack tip (the singular) will be much greater than the ultimate strain. Hence, as long as the crack pierces the enameled copper wire, it will be broken [17].

FIGURE 6: Concrete crack pierces to enameled wires.

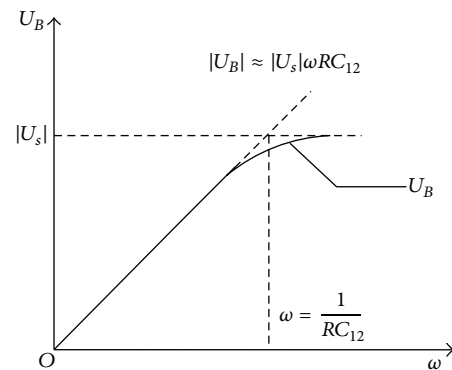
Selecting two wires from the bus in Figure 7, a model can be formulated to analyze and infer the relationship between the voltage U_B of coupling interference and the frequency ω of detecting signal, as demonstrated in Figure 8.

FIGURE 8: Relationship between coupling voltage and the frequency of detecting signal.

It can be seen from the figure that interference still exists. Only by lowering the frequency of detecting signal, coupling interference generated by parasitic capacitance can be effectively reduced. However, the speed of detection will be affected if the detecting frequency is very low. Therefore, 1kHz is used as the frequency of the detecting signal in

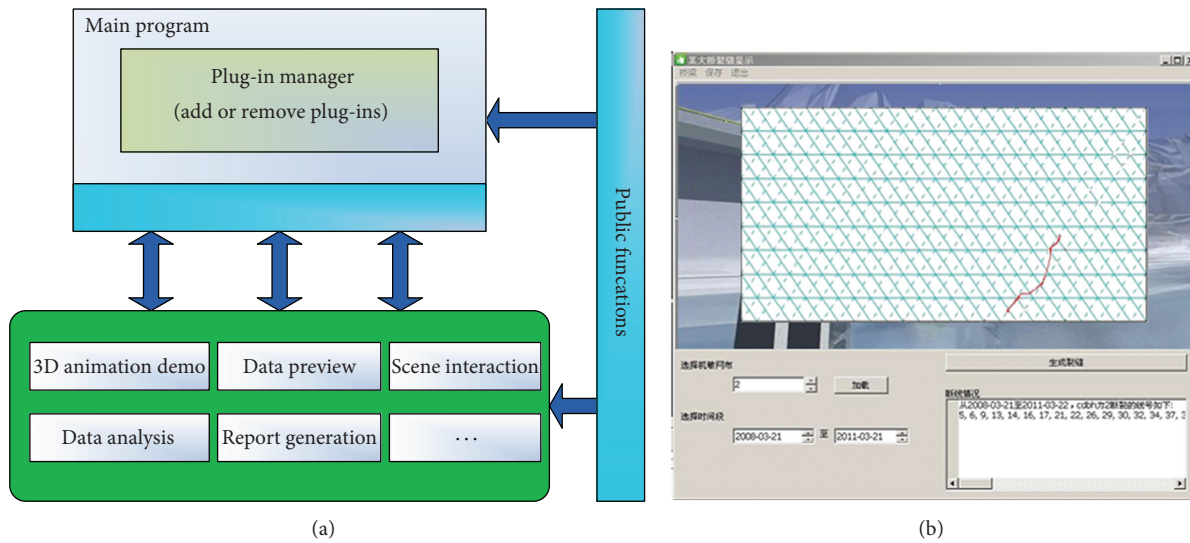
The remote monitoring center is based on the plug-in 3D visualization design, including database management, scene interaction, data analysis and recurrence, 3D animation design in structure, report generation, and interface design. To deal with the problem of data analysis and recurrence, the least squares B-spline curve algorithm, which is usually used for drawing curve from points, is adopted to compose the broken points into a virtual crack. Then, the readability of the data can be improved. Figure 10 illustrates the 3D system.

FIGURE 10: 3D visualization system: (a) system framework and (b) the plug-ins of analysis and recurrence of crack data.

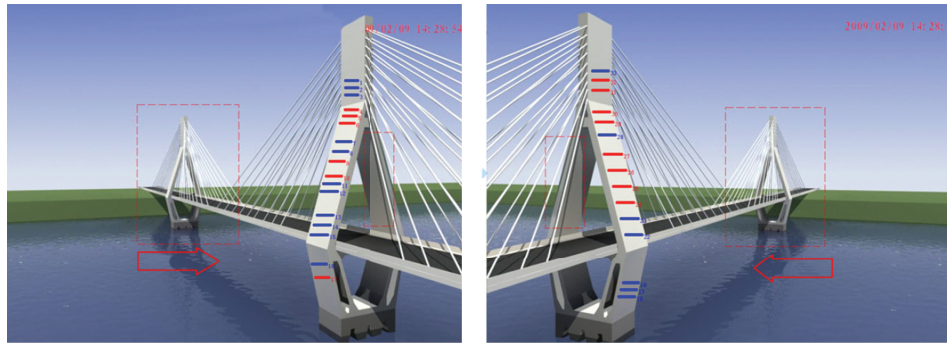
5.1.2. The Interactive 3D Scene. Since the 3D scene of Masangxi Yangtze River Bridge is formulated using 3DS MAX, the real geographic environment, bridge structure, and the distribution of the monitoring equipments can be simulated visually. After the running of plug-in of the interactive 3D scene, a single tower is used as the entrance and the scene interacts down layer by layer. In the main screen of each tower, a button of each smart film is created from different perspectives. When clicking the button, the crack will be recurred by the smart film (see Figure 12).

FIGURE 12: 3D scene of Masangxi Yangtze River Bridge.

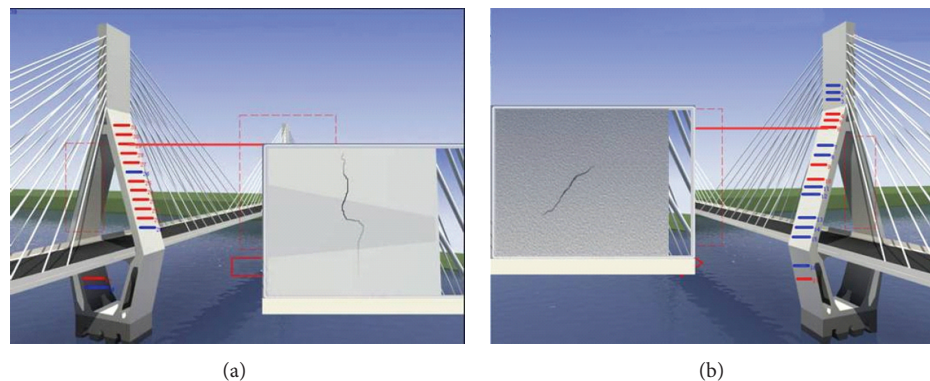
In tower no. 1, cracks were found in December 2008, which appeared on the smart films with sequence number of 3, 4, 6, 7, 9, 10, 24, 26, 29, 30, and 31. In addition, all the wires in the smart films with the sequence numbers of 4, 6, 9, 10, and 26 broke due to the penetration of cracks. The width of the smart film is 30 cm. Therefore, the lengths of the cracks are more than 30 cm.

FIGURE 13: Visual recurrence of the real crack: (a) 29th smart film of tower no. 1 and (b) 31st smart film of tower no. 1.

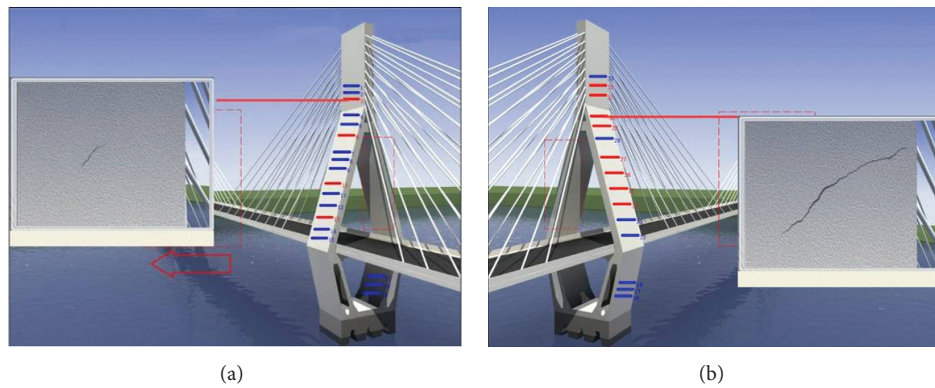
FIGURE 14: Visual recurrence of the real crack: (a) 4th smart film of tower no. 2 and (b) 30th smart film of tower no. 2.

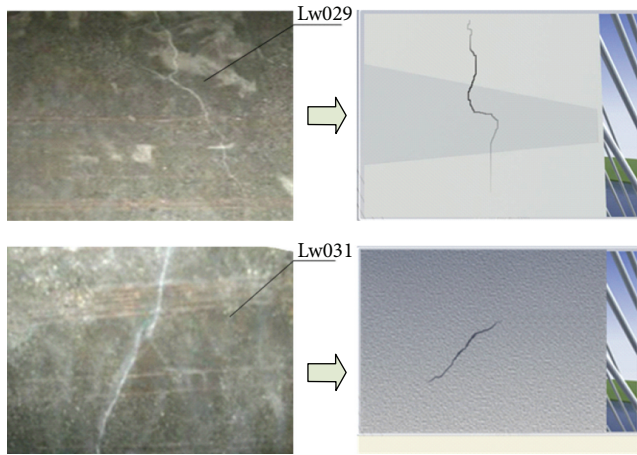
5.1.4. Comparison of Data. In order to verify the validity of monitoring data and grasp the propagation conditions of the cracks, professionals had been repeatedly sent to the scene to observe the problem. Figure 15 shows the comparison charts of tower no. 1 between man-operated detection and monitoring using the plug-in of recurrence of crack. And it can be drawn that the result of remote recurrence of crack is basically consistent with that of the local detection.

FIGURE 15: Comparison of tower no. 1 between man-operated detection and monitoring using the plug-in of recurrence of crack.

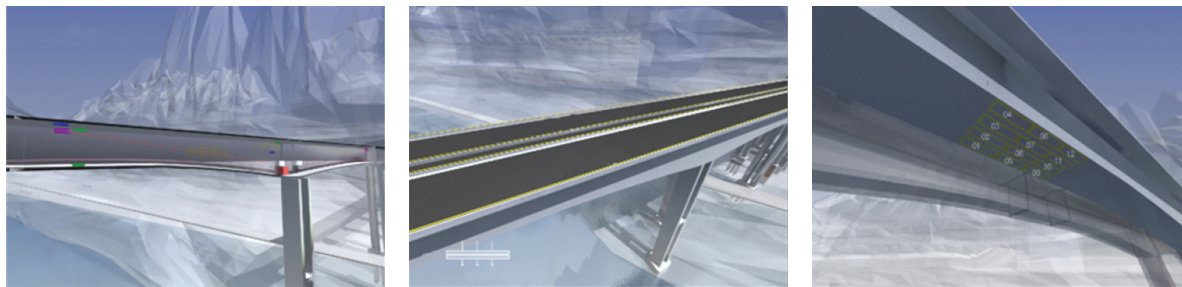
5.2.2. *The Interactive 3D Scene.* Since the 3D scene of Tukan Wujiang River Bridge is formulated using 3DS MAX, the real geographic environment, bridge structure, and the distribution of the monitoring equipments can be simulated visually. After running of the plug-in of the interactive 3D scene, a single tower is used as the entrance and the scene interacts down layer by layer. In the main screen of each tower, buttons of each smart film are created from different perspectives. When clicking the buttons, the corresponding scenes will be recurred (see Figure 17).

FIGURE 17: Effect of the interactive 3D scene.

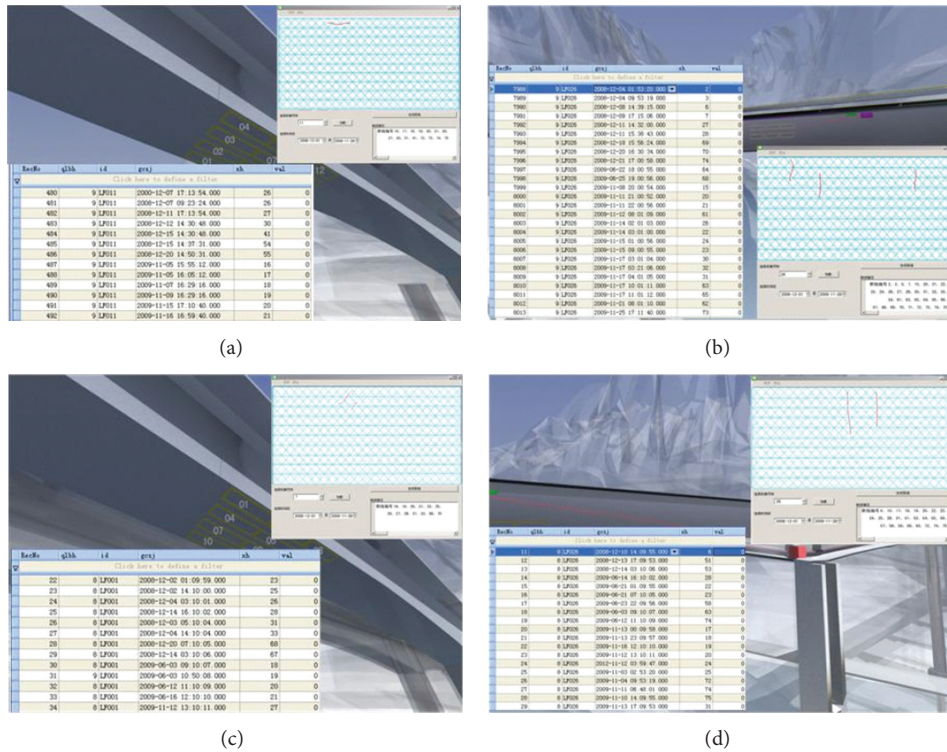
Through the plug-in of analysis and recurrence of crack data, a vertical crack with a length about 15 cm could be found by sensor 11 (Lw011) which was arranged in the base plate of box girder from the mid-segment of main span of the right bridge, and it emerged in early November 2009, as shown in Figure 18(a). Three vertical cracks with the lengths ranging from 13 cm to 28 cm could be found by sensor 26 which was arranged close to the roof of box girder of pier 0 on the

right bridge, and they appeared in early September 2009, as shown in Figure 18(b). Two vertical cracks with the lengths from 7 cm to 15 cm could be found by sensor 1 (Lw001) which was arranged in the base plate of box girder from the mid-segment of main span of the left bridge, and they occurred in mid February 2009, as shown in Figure 18(c). Two vertical cracks with the lengths from 24 cm to 35 cm could be found by sensor 26 (Lw026) which was arranged in the roof of box girder of pier 0 on the left bridge, and their initiation time was mid November 2009, as shown in Figure 18(d).

FIGURE 18: Recurrence of crack on Tukan Wujiang River Bridge.

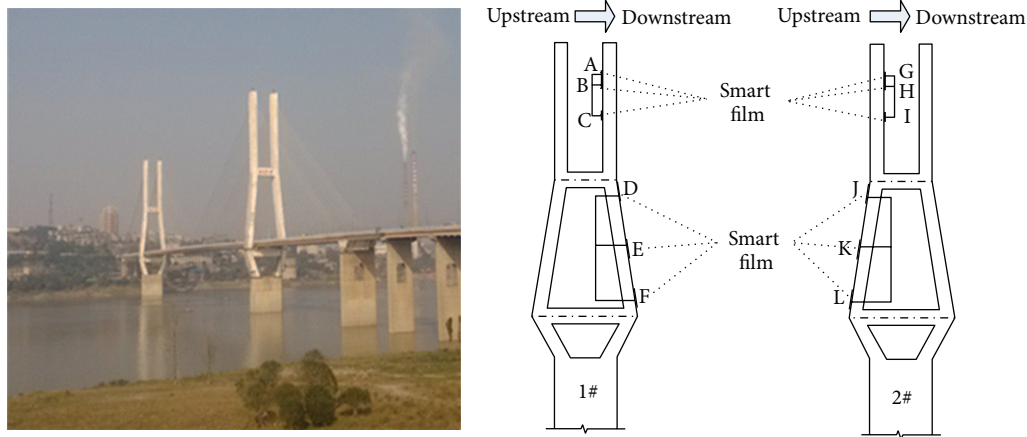
FIGURE 21: Lijiatuo Yangtze River Bridge and its sensor layout.

Lijiatuo Yangtze River Bridge, located in Chongqing Municipality, China, is a prestressed concrete cable-stayed bridge with the main bridge of 169 m + 444 m + 169 m. Its total length is 1288 m. The bridge has a structure of double-tower and double-cable-plane and consists of two transitional holes, eight approach bridges, and a main bridge. Each transitional hole has a length of 53 m. The length of each approach bridge is 50 m. Two sets of smart film crack monitoring systems are installed on two towers, respectively. For each tower, sensors are installed on two connection parts. For the girder, sensors are installed on 1/4-segment of two side spans, the mid-segment of main span, and 1/4-segment of main span. The monitoring system was installed in September 2012. So far, the systems are running well (see Figure 21).

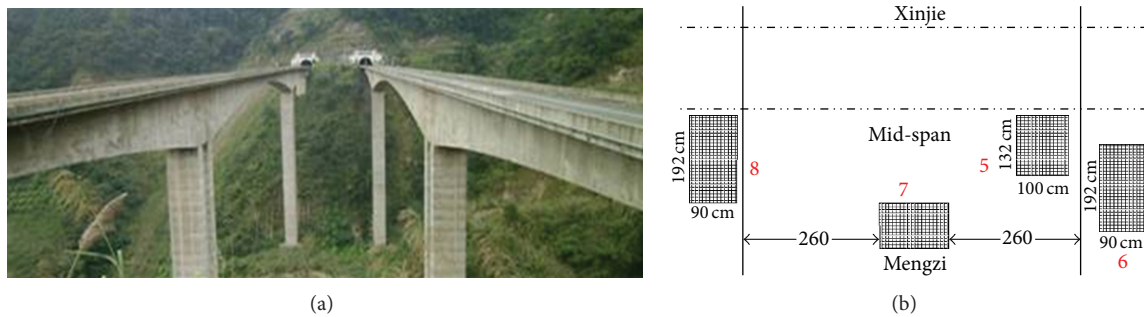
Heichonggou Bridge, located in Zhamakong of Meng-Xin expressway connecting Mengzi and Xinjie, Yunnan province, China, is into a prestressed concrete continuous bridge with the main bridge of 98 m + 180 m + 98 m. It is divided two

independent bridges. A single cell and single box section is used in the box girder of the main bridge. Crack sensors are installed on the roof of pier of Mengzi Direction, the roof of pier of Xinjie Direction, the mid-segment of main span, and plate of 1/8-span of the left bridge. The monitoring system was installed in December 2012. So far, the system is running normally (see Figure 23).

FIGURE 23: Heichonggou Bridge and its sensor layout.
