Research Article

Monitoring Interior and Exterior Wall Inspections within a Virtual Environment

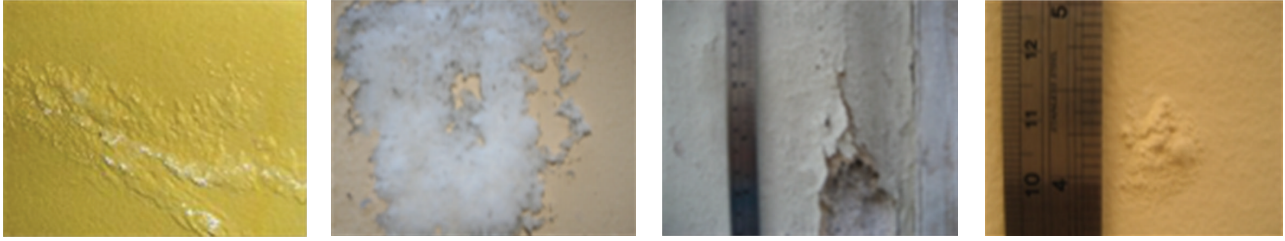
FIGURE 1: Swelling, efflorescence, cracking, and blistering [16].

resolution were established. Figure 1 shows common defects in painted interior walls.

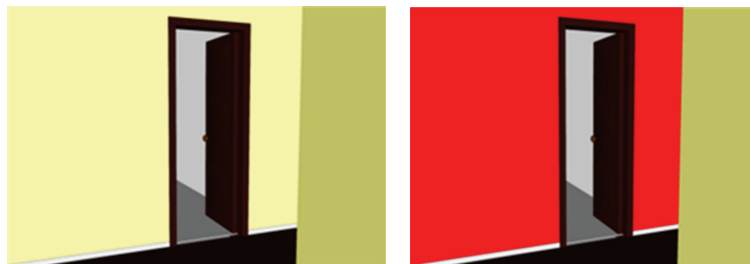
FIGURE 8: Chromatic alteration of the coating according to its state of deterioration.

Based on these data, it is possible to link in the date the virtual model is consulted and visualize, in the geometric model, the level of wear and tear as a function of time (see *state of repair*, Figure 7). The period of time between the date indicated and the date when the paint was applied is compared to the duration advised, in the technical literature, for repainting. The value given for this comparison is associated to the red, green, and blue (RGB) parameters which define the color used for wall in the virtual model (Figure 8).

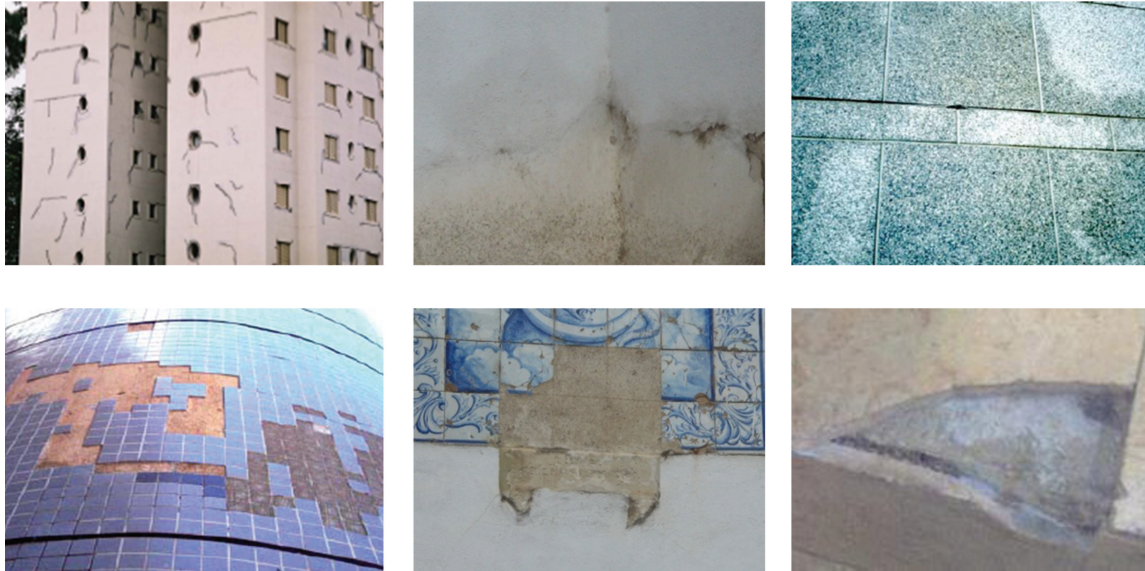
FIGURE 9: Different types of materials applied as façade coatings and some irregularities.

In order to better understand the operation of façade coating, bibliographic research of materials usually applied to this type of material was carried out and a table of characteristics of these was drawn up. Subsequently, a survey was made of anomalies, probable causes, solutions, and methods of repair for each of the coatings studied. The visualization of the maintenance data of a building and the impact of time on the performance of these exterior closure materials require an understanding of their characteristics [20] (Figure 9):

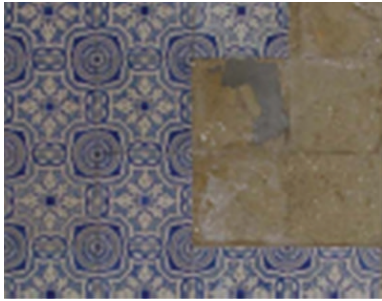
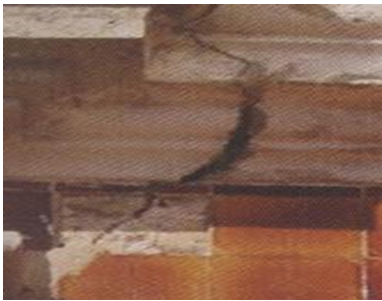
TABLE 3: Example of anomalies and the associated repair solution.

Detachment	Cracking/fracturing
Anomaly

Specification of the anomaly	Fall in areas with deterioration of support	Failure of the support (wide cracks with well-defined orientation)
Repair solution	Replacement of the coat (with use of a repair stand as necessary)	Replacement of the coat (with repair of cracks in the support)
Repair methodology	<ol style="list-style-type: none"> (1) Removal of the tiles by cutting grinder with the aid of a hammer and chisel (2) Timely repair of the support in areas where the detachment includes material constituent with it (3) Digitizing layer of settlement (4) Resettlement of layer and tiles 	<ol style="list-style-type: none"> (1) Removal of the tiles by cutting grinder (2) Removal of material adjustment in the environment and along the joint (3) Repair of cracks, clogging with adhesive material (mastic) (4) Settlement layer made with cement in two layers interspersed with glass fibre (5) Resettlement of layer and tiles

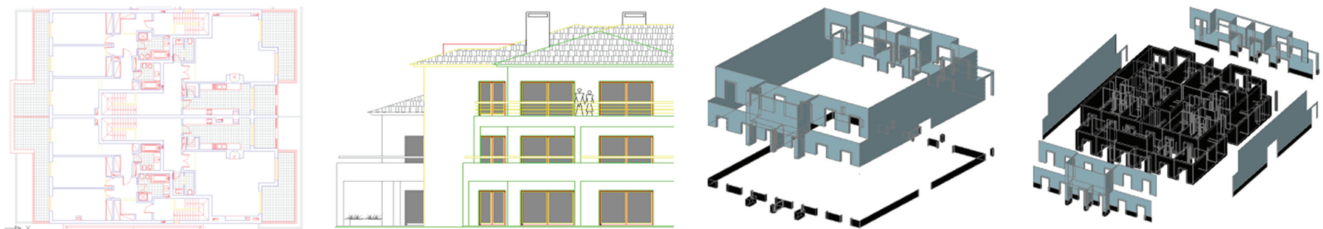
FIGURE 13: Steps in the geometric modelling process.

3.3. Case Study. First, the 3D geometric model of a building was created (Figure 13). In this case, the building consists of a ground floor, a 1st floor, and an attic with dwelling space. The coating elements of the walls were then modeled as independent geometric objects. In this way, each element can then support characterization data of the applied material and different kinds of information related to maintenance.
