# FORT RODD HILL N.H.S.C.: WORKFLOW AND BENEFITS IN THE USE OF PHOTOGRAMMETRIC AND LIDAR DOCUMENTATION FOR THE PRODUCTION OF CONSTRUCTION TENDER DOCUMENTS

C.S.Kretz

Heritage Conservation Services, Public Services and Procurement Canada, 30 rue Victoria, K1A 0M6,  
Gatineau, Canada - Shawn.Kretz@tpsgc-pwgsc.gc.ca

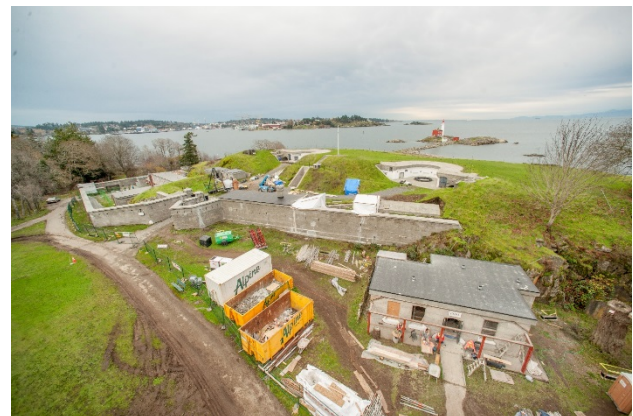
Figure 1: Aerial view of Fort Rodd Hill National Historic Site of Canada Lower Battery rehabilitation.

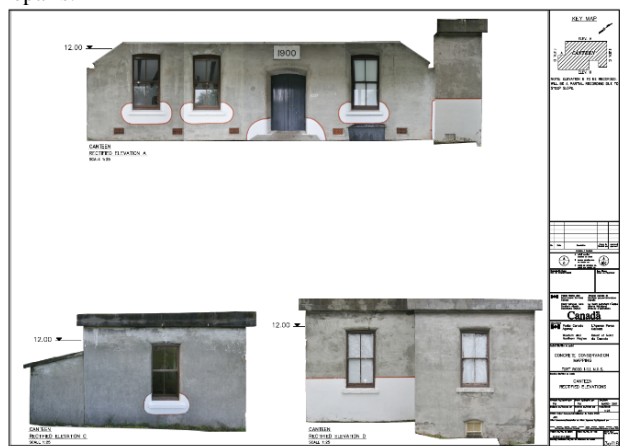
Figure 4: Example of ortho-rectified elevations.

There are numerous benefits to ortho-photo production from a 3D model versus the previously rectified elevations, most notably; greater coverage, more reliable profiles, relative scale of non-planar parallel surfaces, and the elimination of misleading information introduced by perpendicular surfaces which are a product of camera perspective (figure 3 shows the orthographic elevation generated from the model and figure 4

Because the rear elevation of the Canteen building has only a 1m gap between a cliff face and the wall, not allowing for sufficient backup to capture the head on photos typically required for rectification. The documentation time on site required for photogrammetry is typically much less than that needed for rectification, which typically requires four measured control points to rectify each photo. Once the model has been generated, each ortho-photo is quickly created and laid out in
