DOCUMENTATION FOR EMERGENCY CONDITION MAPPING OF DECORATED HISTORIC SURFACES AT THE CAÏD RESIDENCE, THE KASBAH OF TAOURIRT (OUARZAZATE, MOROCCO)

K.Percy^a, C.Ouimet^a, S. Ward^a, M. Santana Quintero^a, C.Cancino^b, L.Wong^b, B. Marcus^b, S.Whittaker^b, M.Boussalh^c.

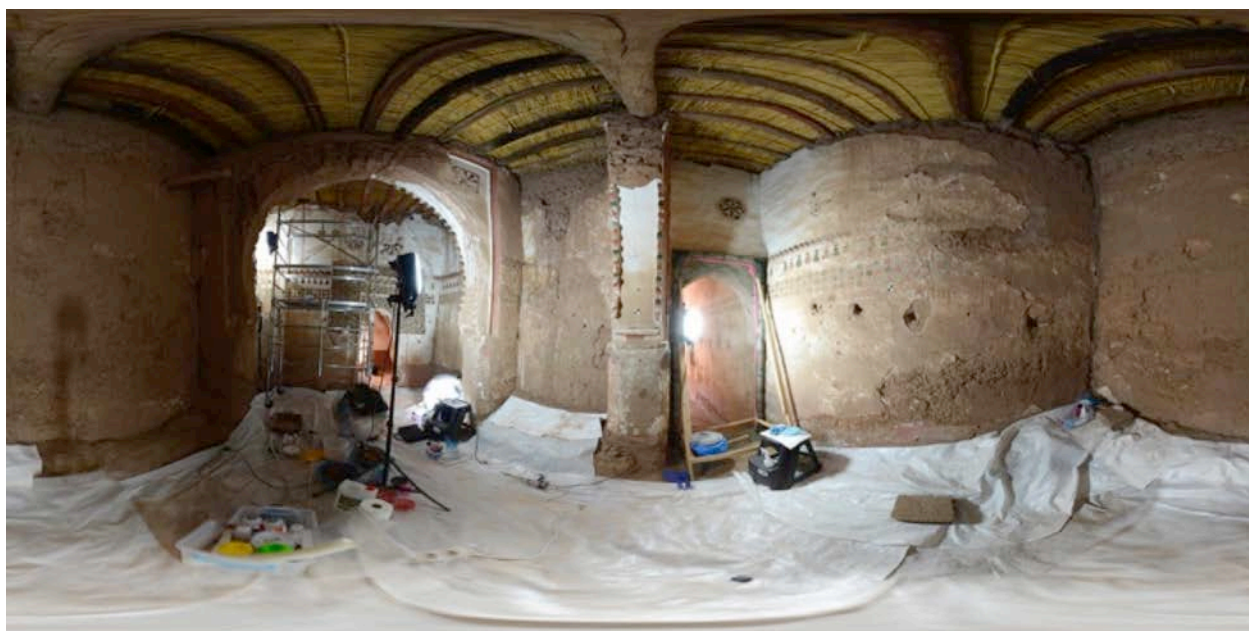
Figure 1: Panoramic view of one of the decorated rooms at the Caïd Residence at Kasbah of Taourirt.

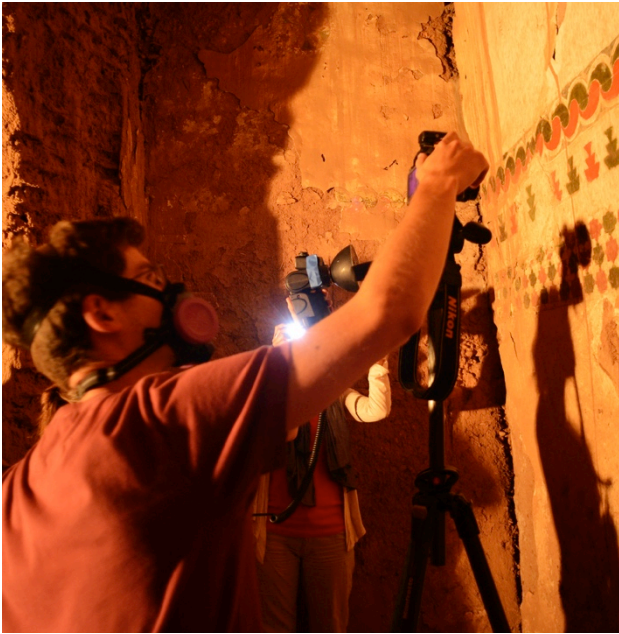
Figure 2: A GCI team member undertaking non-invasive technical imaging.

The resulting orthographic images were used to graphically record the conditions of the wall paintings. Complementary non-invasive technical imaging (visible and infrared reflected and ultraviolet-induced fluorescence) was used to further understand the technology and condition of the paintings (Fig. 2).

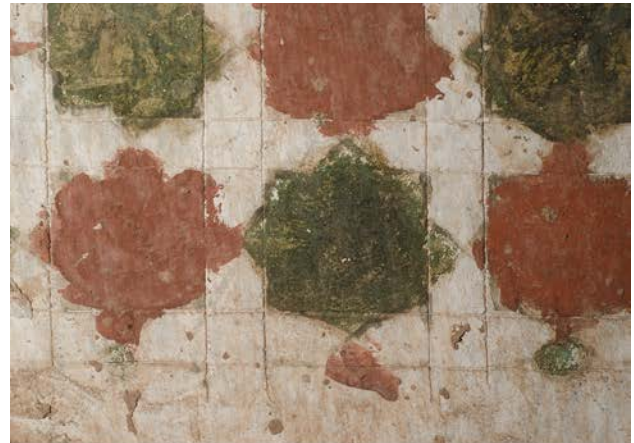
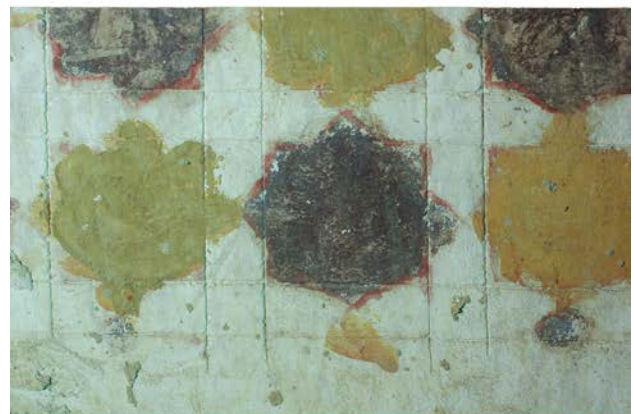
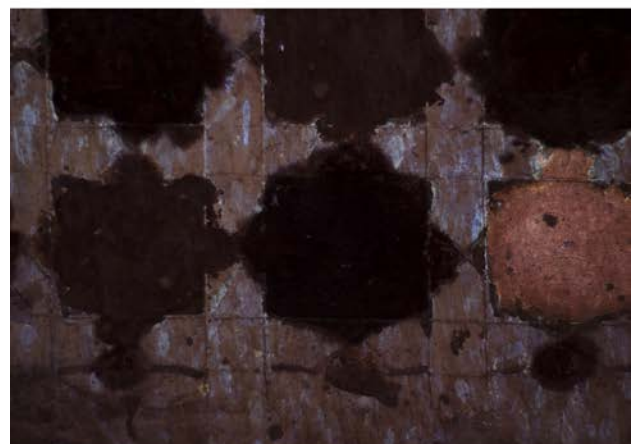
Figure 3: Non-invasive imaging. Image A visible reflected image. Image B IR false colour image. Image C is the UV-induced visible fluorescence image.

The resultant RGB visible and IR reflected images were merged to create an IR false-colour image, a technique that is useful for the preliminary identification of pigments and mapping of differences in materials.

These imaging techniques were successfully used to detect and visualise two phases of painting. UVF imaging recorded a red pigment fluorescing orange, whereas in surrounding areas where a similar red has been used this fluorescence was not detected, suggesting a different phase of later painting. Furthermore, these findings were corroborated by the behaviour of the two reds when imaged with reflected IR radiation. The first fluorescent red is invisible to IR, whilst the latter red is clearly visible, suggesting two separate materials and two phases of painting. The IR false-colour images recorded the use of under-drawing to organise the geometry of the motifs used throughout the painted scheme in the *Caid Residence*. Each geometric element was first outlined with the same pigment that appears bright red in the IR false colour image. Subsequently, the elements were blocked in with alternating red and green.

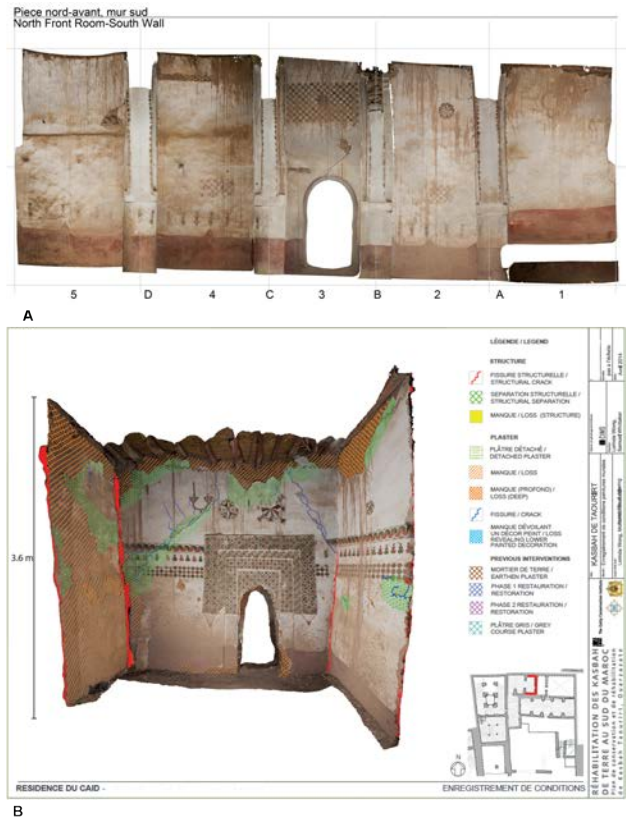
Figure 4: Resulted orthophotograph (A) and 3D condition assessment of ortho photograph (B).

Once the condition of the wall paintings was recorded and digitized in AutoCAD, these images were then used to re-render the photogrammetric model with the output of the condition recording. This created a three-dimensional model of the wall paintings with the condition phenomena mapped onto the surface allowing spatial visualisation to aid in diagnosis of deterioration patterns. The rendering of the new photogrammetric model (OBJ format) with the wall painting conditions mapped onto the surface was created using Adobe Photoshop’s 3D capabilities. Other uses of the photogrammetric model included animation like a fly through of the space or the detailed view of the wall paintings texture with the lighting of the surfaces with artificial light.

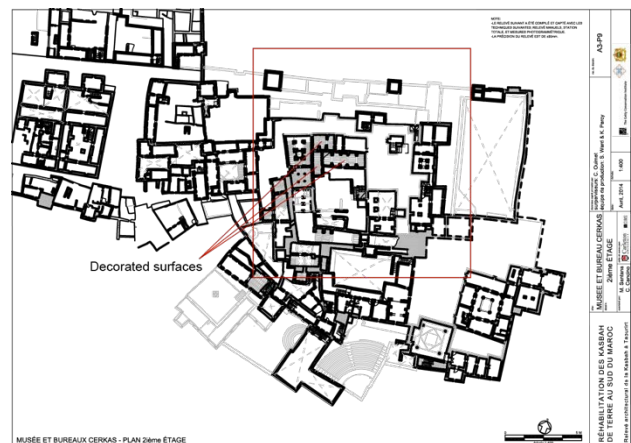
Figure 5: Second floor plan of the *Caid Residence* with *Kasbah Taourirt* indicating location of rooms with decorated surfaces.

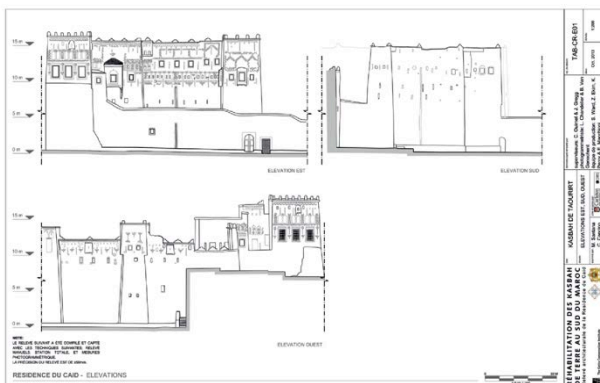
Figure 6: Elevations of the *Caïd* Residence within the *Kasbah Taourirt*, created from photogrammetric models.

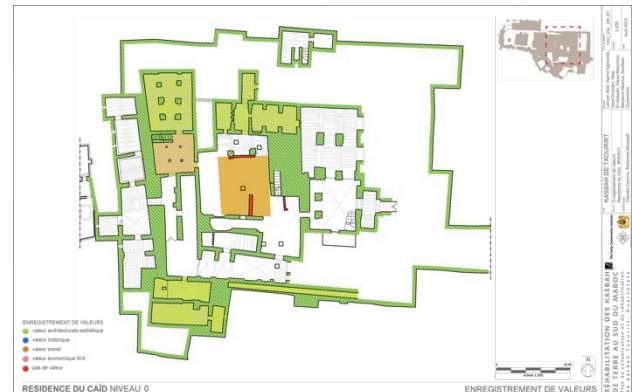
Figure 7: Values assessment of the *Caïd* Residence.

In addition to record and locate the conditions of the wall paintings, the measured drawings of the *Caïd* Residence were used to record the architectural conditions of the site (Fig. 7). The drawings were the base maps for properly assessing and mapping deterioration and structural problems, and allowed the team to identify significant and character defining features of the site (Fig. 8). The measured drawings were also used to develop a plan of emergency interventions aimed at protecting the physical integrity of this area. The same set of drawings was then used by CERKAS to prepare a budget of conservation interventions and to select the proper contractor to implement them.

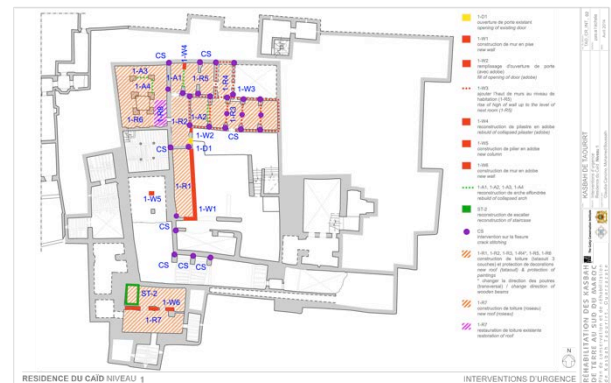
Figure 8: Interventions planned using the measured drawings of the *Caïd* Residence.

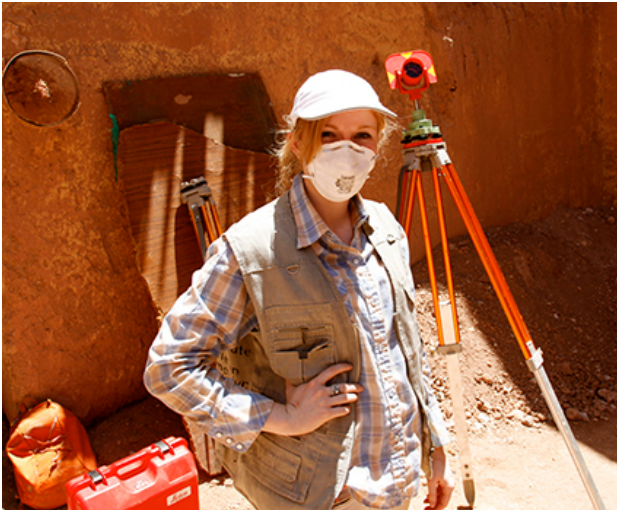
Figure 9: CIMS team member using protective gear during documentation of the *Caid Residence* within the *Kasbah Taourirt*.

The CIMS and the GCI took necessary precautions for the health and safety of the team and to insure that the risks were mitigated (Fig. 9). The areas to be surveyed and assessed were initially cleaned, structurally assessed and the team was required to use adequate respiratory protection gear. Furthermore, the surveyed techniques chosen allowed the teams to stay only for limited periods of time to capture the necessary geometric configuration of the historic fabric of these spaces.
