The logo for ICONHIC 2016 features a stylized graphic of several parallel lines of varying lengths on the left, followed by the text 'ICONHIC 2016' in a bold, sans-serif font.1<sup>st</sup> International Conference on Natural Hazards & Infrastructure

28-30 June, 2016, Chania, Greece

## Assessment of the Multi-Hazard Vulnerability of Priority Cultural Heritage Structures in the Philippines

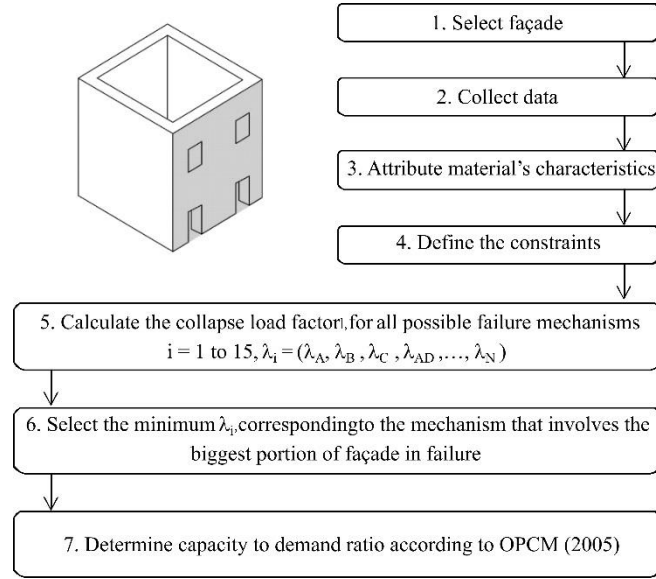
**Figure 1.** FaMIVE procedure outline

The FaMIVE approach (D'Ayala & Speranza 2003) has been developed in the last 15 years, starting from a procedure to identify possible and most probable collapse mechanisms for masonry façades with diverse level of lateral constraint, to a method to derive capacity curves (D'Ayala 2005) and compute fragility functions for populations of buildings of similar typology or collapse modes (D'Ayala 2013). The method has been applied in several locations worldwide in pre- and post-earthquake situations.

In the application to the Philippines heritage, the use of FaMIVE benefited from direct access to most of the buildings and from availability of full sets of drawings. A first phase of the data collection requires the identification of construction details and fabric of load bearing masonry and floors/roof layout and structural elements. The second phase is based on completing survey datasheets containing geometric and structural information related to external bearing walls. Irregular and complex buildings are subdivided in simpler subunits. For each of them the most important or critical elevations are identified and one form (D'Ayala, Putrino, 2016) is filled in for each elevation or homogeneous portion of elevation in the building. Given the way in which FaMIVE is coded the procedure, and hence the form, can be tailored to best suit the sample, by adding or removing parameters that are relevant to the seismic behaviour of the buildings analysed. The form used for the application in the Philippines is shown in the companion FaMIVE Manual which also contains detailed explanation and coding of each of the form entries. The datasheet includes 11 sections: 1) Urban Data – related to the general description of the surveyed compound and its urban context; 2) Plan Characteristics of the Building - data to identify the geometry of the building and its typology, the relative position of the facade within the building, plan layout and vertical layout, type of loadbearing structures present; 3) Geometric Characteristics of the Façade - data on the geometric characteristics of the façade and its relationship with other walls. Consider also the presence of gable and towers; 4) Openings Layout - layout of openings, details of their number, width, height, dimension of edge piers, height of upper horizontal spandrel and type and material of lintels; 5) Structural Characteristics - data on the structural properties of the floor structures bearing on the façade; on the presence and type of elements restraining the façade; on characteristics of buttresses; 6) Load Bearing Structures Data - data on the structural characteristics of the façade including materials and size of the masonry units and the preservation condition; 7) Further Vulnerability Elements - data on presence and dimensions of construction elements that might generate actions that reduce the capacity of the facade and increase its vulnerability; 8) Tower System - section specifically dedicated to the tower system, when this is above/adjacent to the analysed façade; 9) Roof-Truss System – data on complex roof-truss system present in many of the surveyed churches and convents; 10) Damage Record and Crack Pattern - requires the identification of seismic damage, for each structural element of the façade and for any artistic asset attached to the façade; 11) Mechanism Identification - it requires the surveyor to indicate the mechanism/s that the surveyor is able to identify on the basis of the in situ observation and crack pattern recorded. For each section a reliability index is also scored, to provide a measure of the uncertainty associated with the input data.

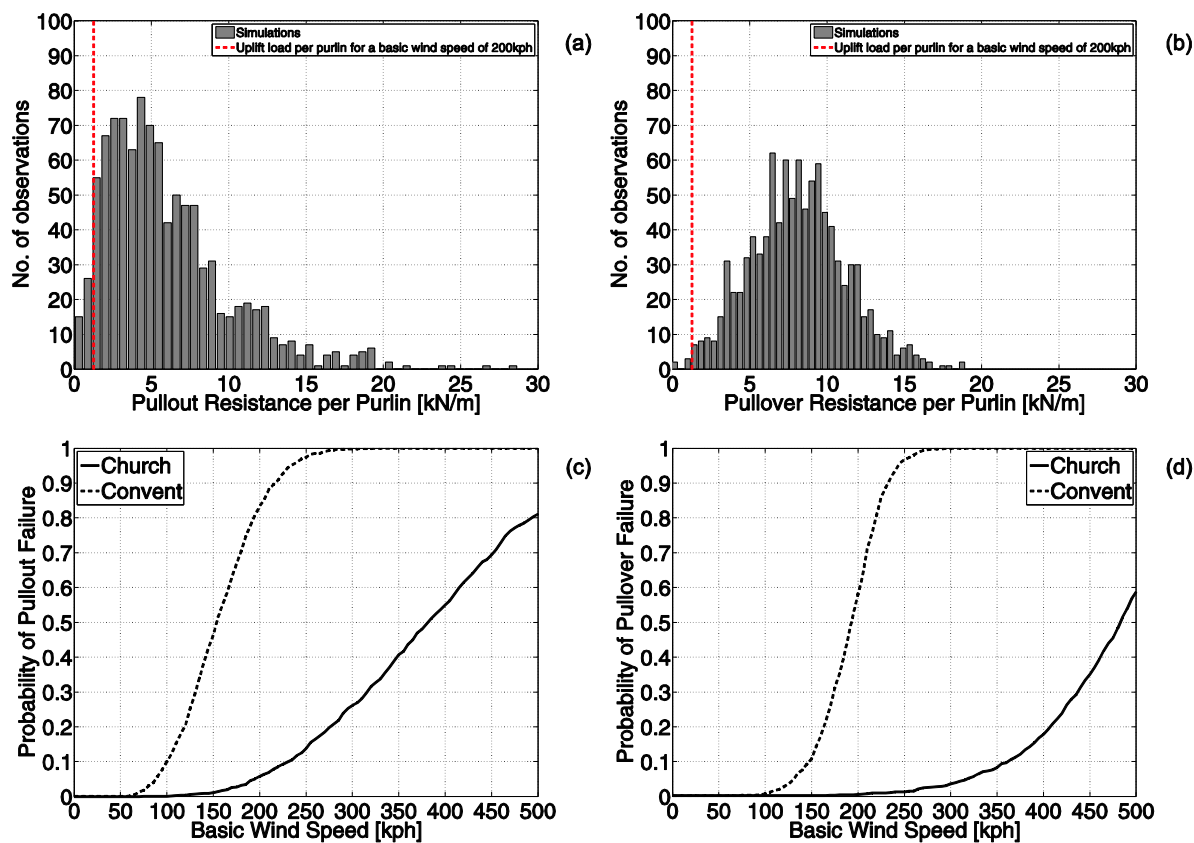
simulation (1,000), the probability of pullout failure of fasteners (screw/nail) for the specific example is 5% while the probability of pullover failure of panel is 1%. Fragility functions for both buildings are shown in Figure 7c (for pullout failure mode) and Figure 7d (for pullover failure mode).

Figure 7. Summary of Wind Vulnerability Results – Dimiaio Complex

It is worth noting that the results of the analysis are based on conservative assumptions and strongly depend on the poor quantity and quality of the available data. An improved data collection is highly recommended before recommending/considering any mitigation strategy for wind risk reduction. Also, recent studies suggest lower design wind speed for the considered location, thus the actual risk values are expected to be lower than the considered one. An improved wind hazard assessment for the consideration location is highly desirable. For a more detailed explanation of the results and their interpretation refer to Chapter 5 of the “Multi-hazard risk assessment manual of the Philippines’ built environment” (ARS Progetti et al., 2016).
