Semi-fortified Palatial Complexes in Central Asia: New Work at the Great Kyz Kala, Merv, Turkmenistan

Within Central Asia there is an unusual group of earthen buildings (köshks), usually constructed on raised platforms, with vertical engaged columns forming iconic ‘corrugations’ on the exterior walls. The complexes are semi-fortified, with a second storey entrance, and often with asymmetrical ranges of rooms around an internal courtyard. Little systematic archaeological work has taken place on these monuments, which have mainly been studied as relatively eroded standing structures. However, recent work at the Great Kyz Kala at Merv, Turkmenistan, the largest surviving monumental köshk in Central Asia, has provided more details of construction and use. The excavations suggest that this complex was constructed in the 8th/9th century CE, with well-appointed rooms on the second storey, including a large hall, and functional rooms and storage spaces around a courtyard on the lower floor. The complex was set within an enclosure, containing gardens and possibly ancillary buildings. This particular köshk may have acted as an elite palatial suburban residence, perhaps for the governor of M

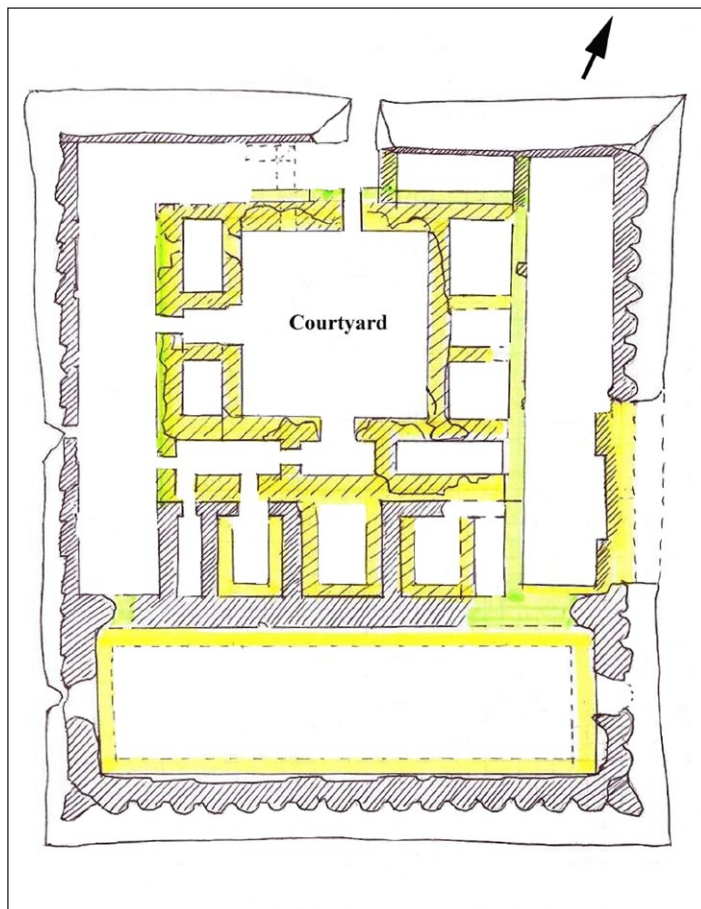
Figure 8: Sketch plan of lower storey, with courtyard surrounded by vaulted spaces. Hatched walls observed. Unhatched conjectured. Not to scale (original drawing by Rejep Jepbarov, modified by Tim Williams).

A courtyard is surrounded by vaulted spaces (**Figure 8**). The courtyard is connected by a staircase descending from the second-floor level in the northwest corner. The base of these steps gives a good indication of the original courtyard level, although these may have been modified during later reuse of the courtyard. A central well or cistern (not fully

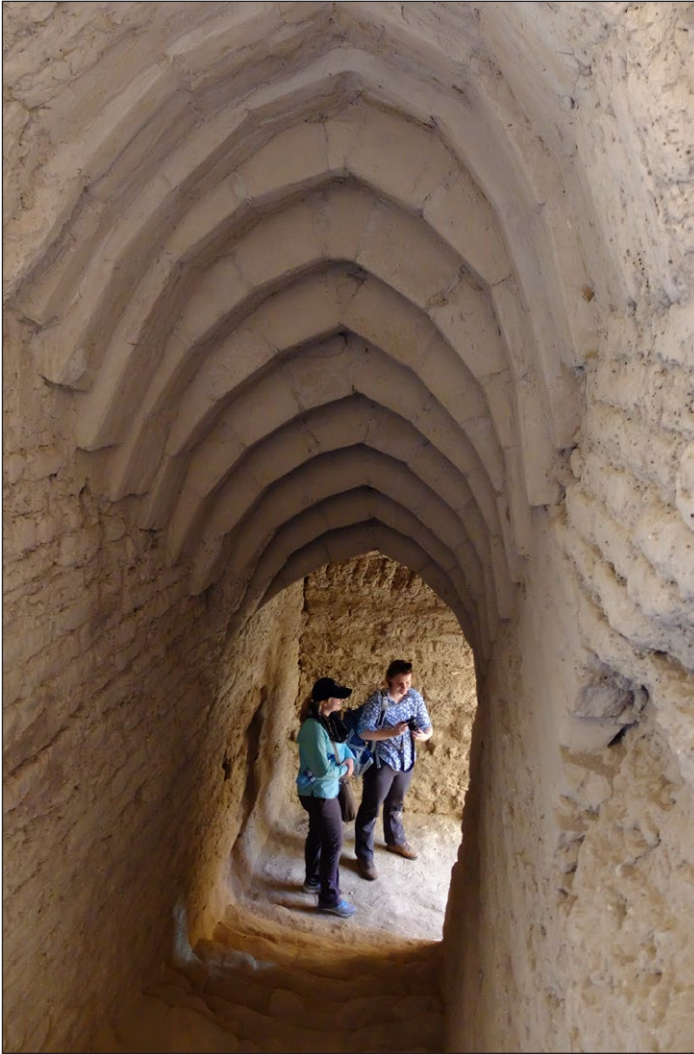
Figure 13: Internal staircase, roofed by a series of stepped tunnel vaults, leading down from second storey to the courtyard (Photograph Sébastien Moriset).
