The need for an integrated approach to understanding and managing coastal change in river delta areas

The case of the Rewa River

Ulukalesi Bale Tamata, James Comley and Lanieta Tokalauvere

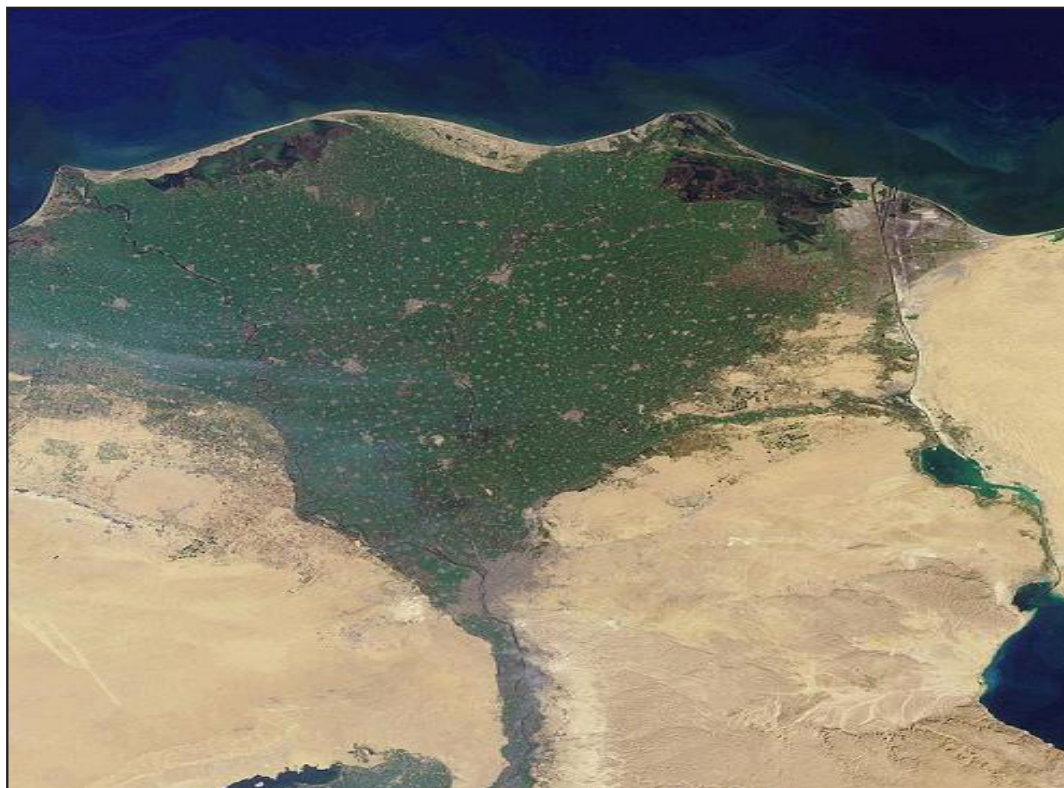
Figure 1a River Nile delta, of which the term delta was first used. The shape resembling the fourth letter of Greek alphabet, which explains the origin of the name delta, is clearly seen.

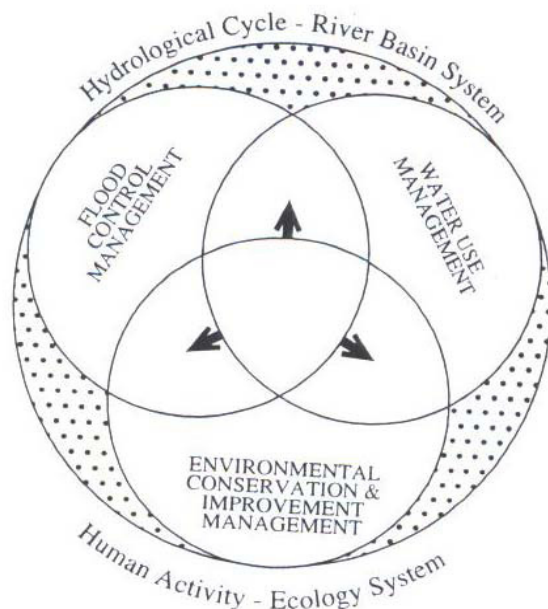
Figure 8 The proposed Framework for Watershed Management (JICA, 1998).

The JICA study of major watersheds in Fiji proposed a Framework for Watershed Management, as a sustainable framework for flood mitigation (Figure 8).

The Framework recognises the connection between two main systems: the hydrological cycle – river basin system; and the human activity – ecology system.

The balance between these two systems can be achieved by the sustainable management of three inter-connected sub-systems: flood control management; water use management; and environmental conservation and improvement management.

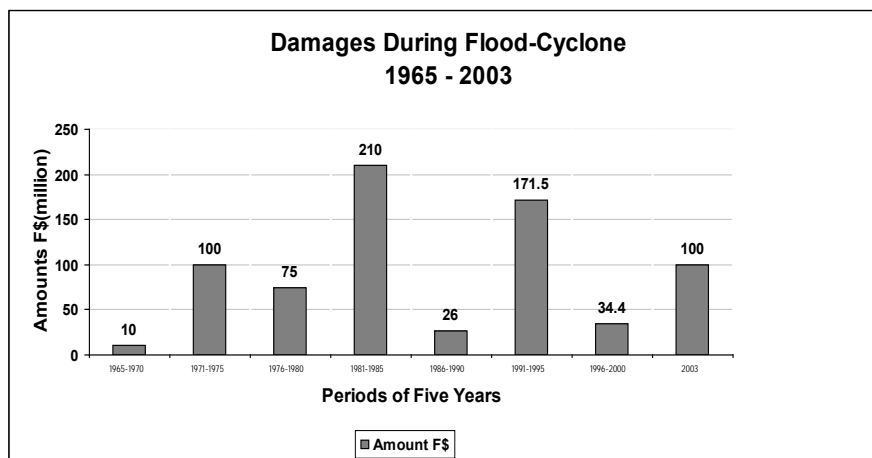
Figure 4 Costs of damage from floods and cyclones in Fiji

Note Highest peak of 210 m (1981–1985) from 7 cyclones in Fiji.

The worst floods and associated economic costs are directly linked to major tropical cyclones in Fiji (Figure 4, see appendix). In December 2009, one of the worst ever cyclones to affect Fiji, cyclone Mick, caused devastating floods in the Rewa River and delta (Figures 5a–d, in the appendix). The total economic loss from effects of floods associated with cyclone Mick was estimated at around FJ\$38 m, according to the National Disaster Management Office (NDMO, January 2010). Flooding and the progressive interplay between the processes of sediment deposition and erosion around the Rewa River estuary have resulted in shifting shorelines and coastlines, as shown in the series of maps (Figures 6; 7a–c). The maps have been produced from GIS analyses using aerial photographs from 1954, 1967 and 1998, and the 2009 acquired satellite image of the lower Rewa River and delta.

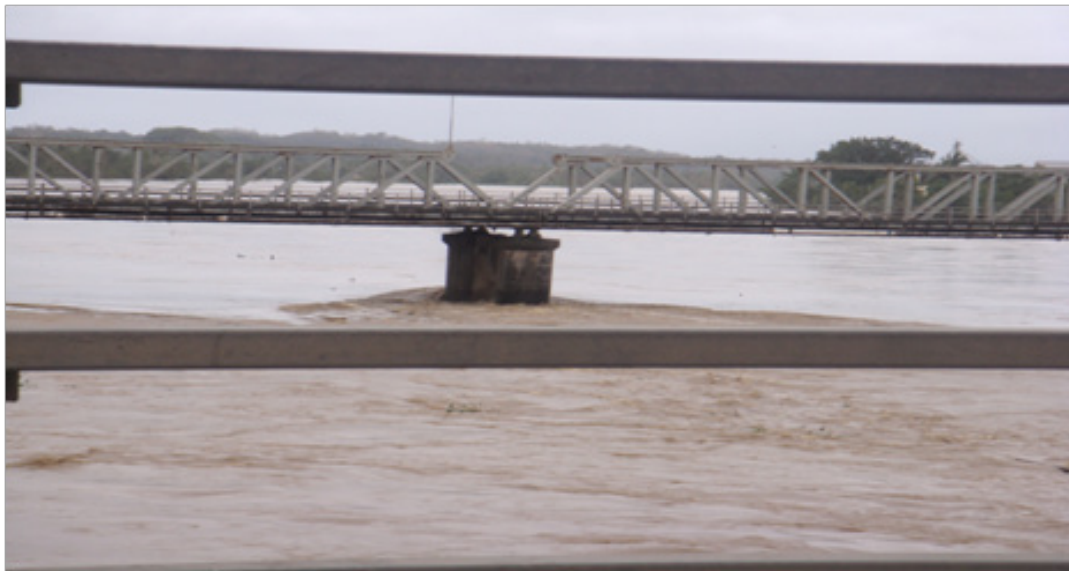
Figures 5a–d Cyclone Mick of December 2009 caused devastating floods in the Rewa, as seen in the photographs a, b, c, and d.

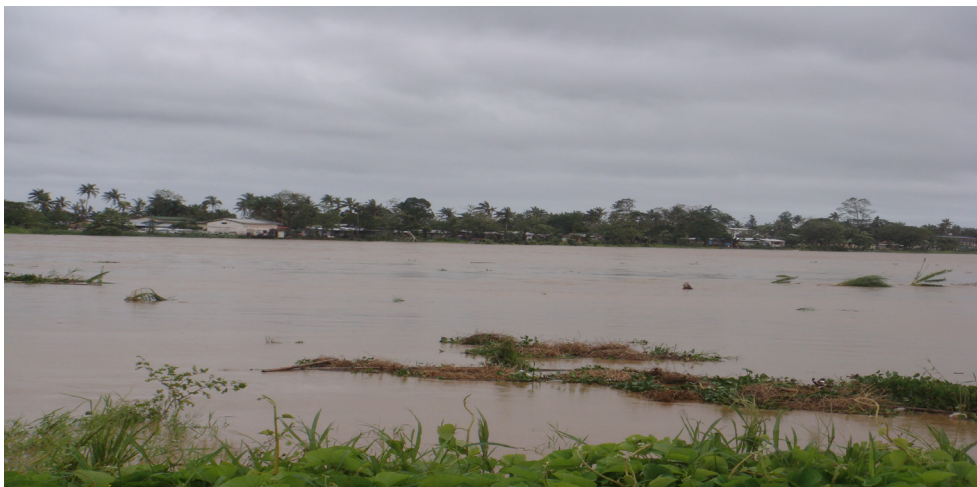
a. Water level beneath the old bridge as seen from the new bridge.

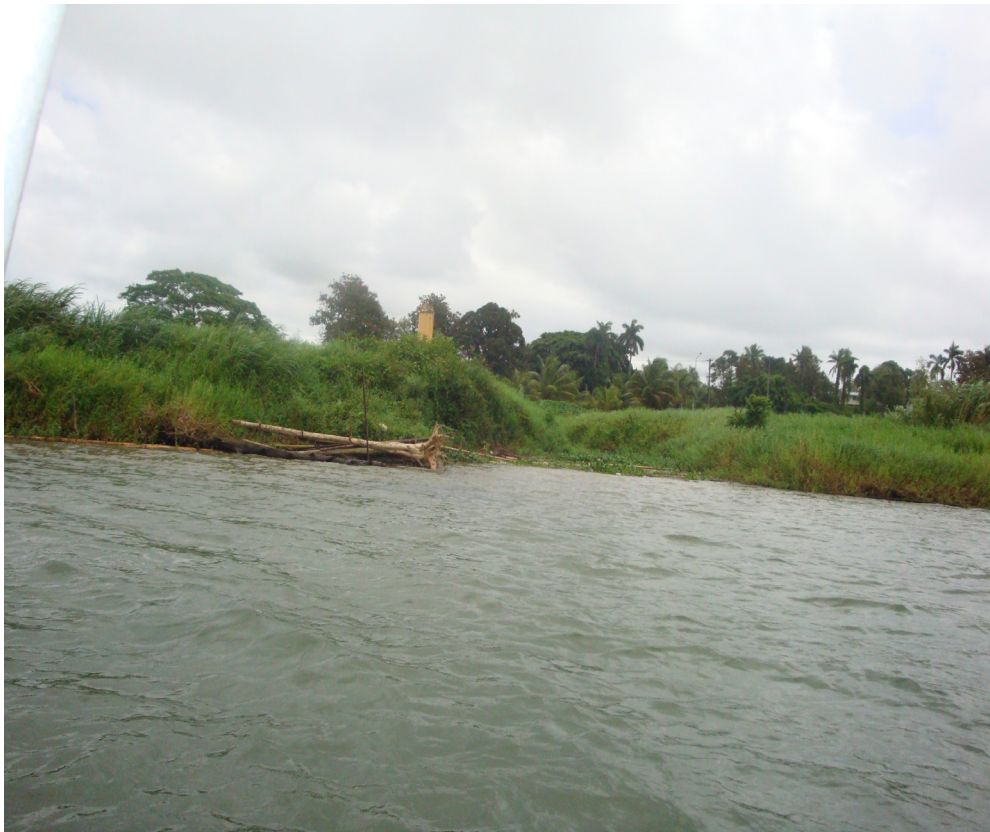
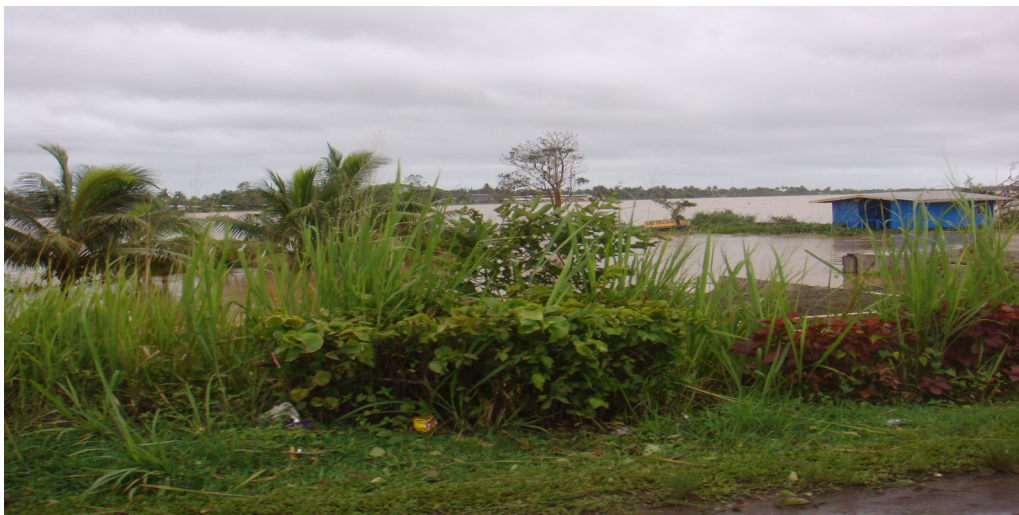
c and d Before the floods (above, photo taken from boat looking towards Davuilevu) and during the floods (below, photo taken from highway looking towards Nausori), showing destruction to Metromix cement plant (yellow).
