# Damage Detection of Shear Connectors in Bridge Structures with Transmissibility in Frequency Domain

Shear connectors are generally used to link the slab and girder together in slab-on-girder bridge structures. Damage of shear connectors in such structures will result in shear slippage between the slab and girder, which significantly reduces the load-carrying capacity of bridges. A damage detection approach based on transmissibility in frequency domain is proposed herein to identify the damage of shear connectors in slab-on-girder bridge structures with or without reference data from the undamaged structure. The transmissibility, which is an inherent system characteristic, indicates the relationship between two sets of response vectors in the frequency domain. Measured input force and acceleration responses from hammer tests are analyzed to obtain the frequency response functions at the slab and girder sensor locations by the experimental modal analysis. The transmissibility matrix that relates the slab response to the girder response is then derived. By comparing the transmissibility vectors in the undamaged and damaged states, the damage level of shear connectors can be identif

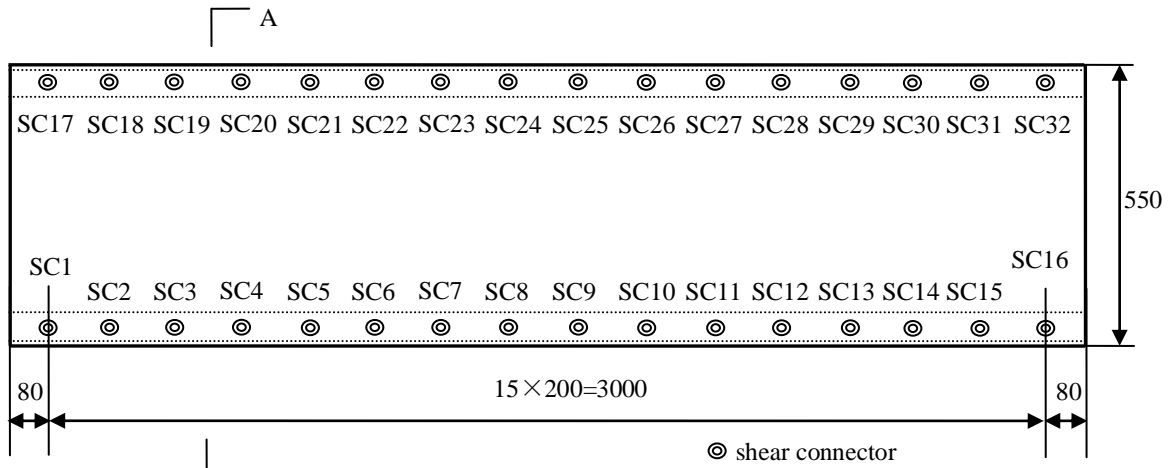
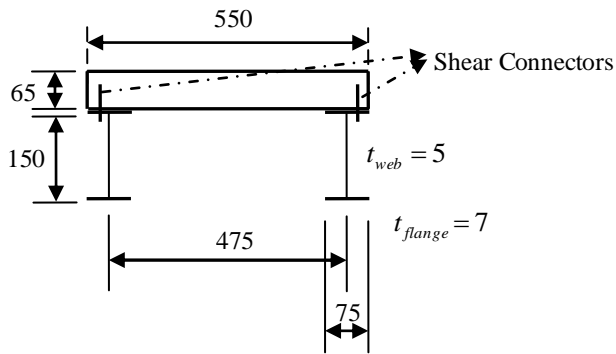
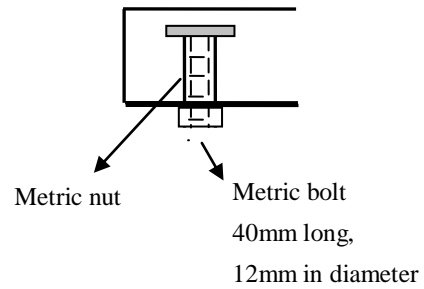
(a) Plan view of the model

(b) Cross section of the model (A-A)

(c) Shear connector

Figure 1 - Dimensions and shear connector details of the slab-on-girder structure (unit: mm)

Numerical studies on a simply-supported slab-on-girder structure are conducted to demonstrate the accuracy and efficiency of the proposed approaches for damage detection of shear connectors in composite bridges. Figure 1 shows the plan view and cross section of the structure and details of a

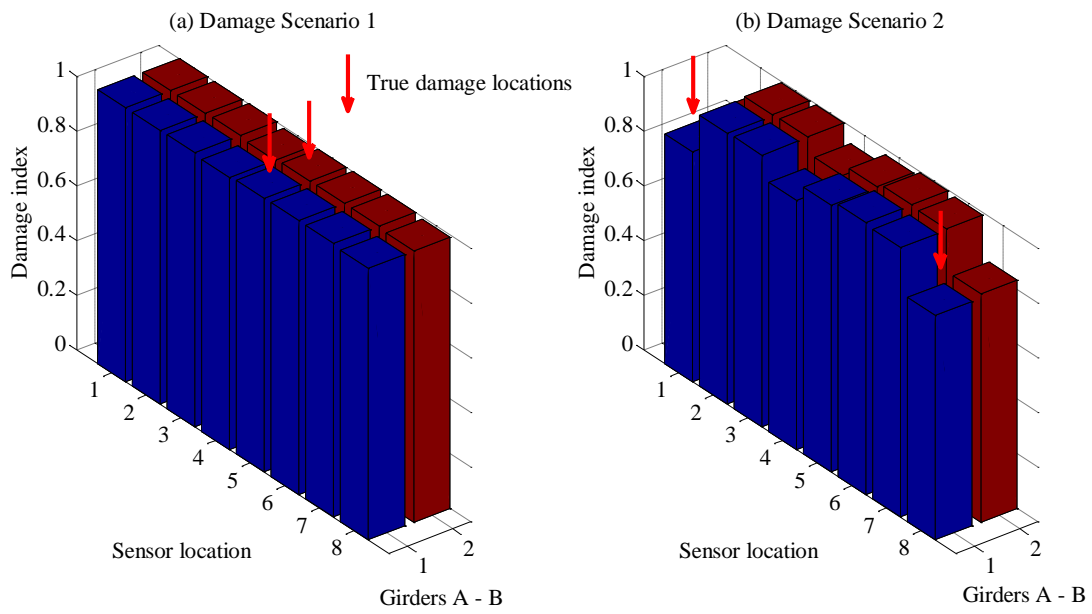
Figure 3 - Damage detection results with COMAC

Damage detection results with COMAC based on the identified four mode shapes are shown in Figure 3. It can be seen that COMAC fails to identify the damages in Scenario 1 as no obvious reductions in COMAC values are observed at the sensor location No. 5 in both girders. For Scenario 2, COMAC can identify the damages in sensor locations No. 1 and No. 8 of Girder A. However, two false identifications are detected at sensor locations No. 1 and No. 8 of Girder B as they are located in the opposite girder of the true damaged locations, and two more false identifications are observed at sensor location No. 4 in the middle of both girders. Figure 4 shows the damage detection results with changes in flexibility. It can be found that the damages in sensor location No. 5 of Scenario 1 can be detected, while two false identifications are observed at sensor location No. 6 in both girders as they are adjacent to the true damage locations. The damages simulated in Scenario 2 are identified accurately indicating that the detection using changes in flexibility is more sensitive than COMAC by comparing Figures 3 and 4. However, the detection results with global modal information from noisy responses can be much worse with more possible false identifications.

Detection results with COMAC and changes in flexibility shown in Figures 3 and 4 demonstrate that using global modal information may not correctly identify the damages of shear connectors in minor damage case with very small frequency and MAC changes. The proposed local dynamic condition assessment approach can successfully identify the shear connector damage locations in two damage scenarios and shows the advantages over the traditional detection method based on global modal information with more accurate results and less false identifications. A few false identifications occur at the mid span owing to relatively large displacement response at this location since the steel girders and concrete slab are not continuously connected together in the model considered in this study.

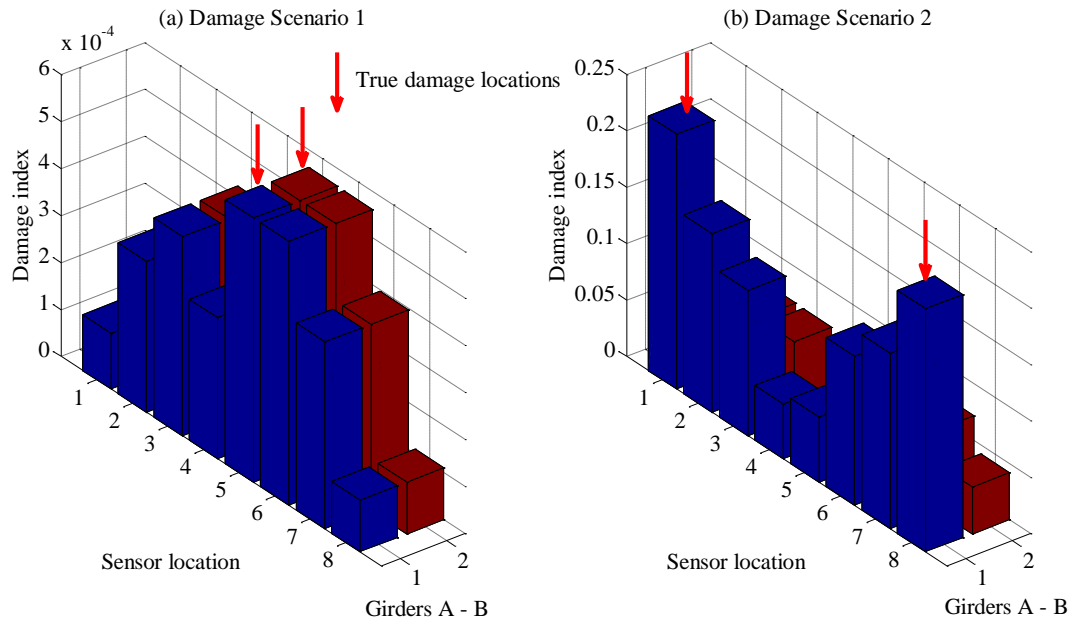
Figure 4 - Damage detection results with changes in flexibility

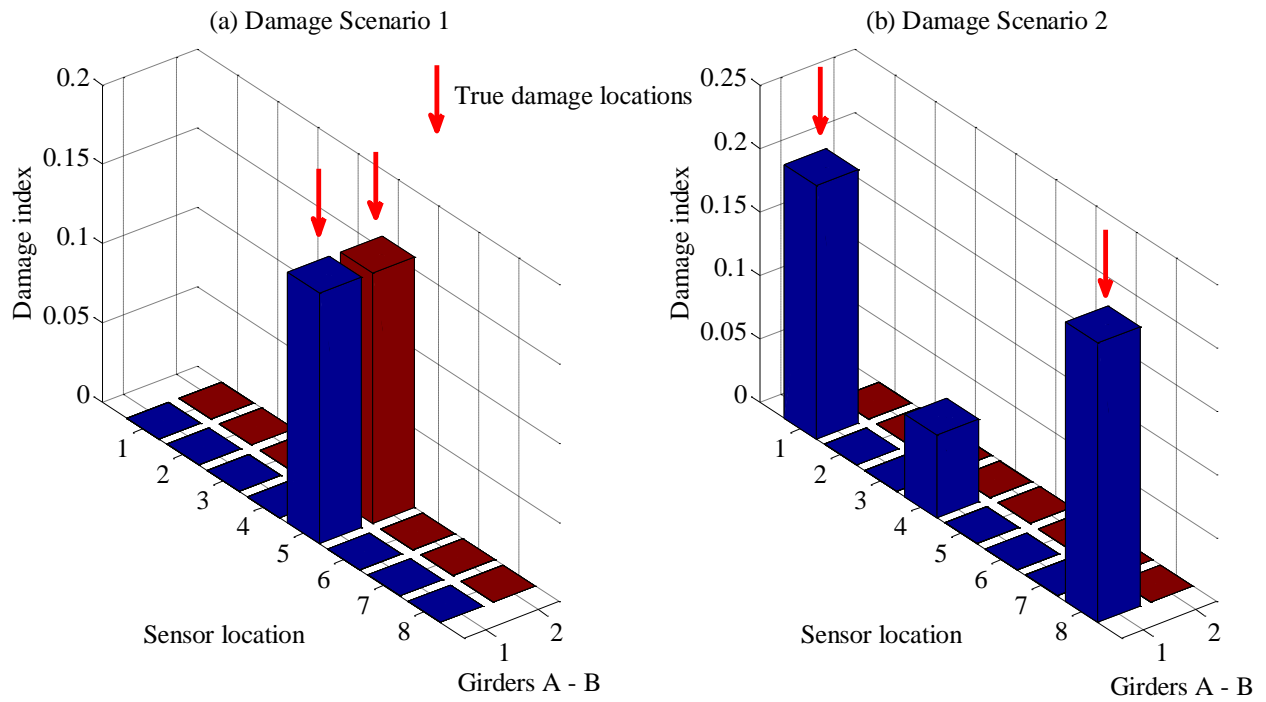
Figure 5 - Damage detection results with measured data of undamaged structure (without noise)

The transmissibility vectors in the frequency range of 25~125 Hz in the undamaged and damaged states are used to calculate the damage index. This frequency range covering only the first two modes is defined to investigate the reliability and robust of the proposed damage detection approach.  $\alpha$  is set to be 0.02 in Equation (18) to obtain the upper confidence limit and then compute the damage index ( $DI - UL$ ) with consideration of this threshold value. Figure 5 shows the damage detection results from measurements without noise effect. The identified results of Scenario 1 for girders A and B are shown in Figures 5(a). It can be clearly seen that higher damage indices at the sensor location No. 5 close to the damaged shear connectors in both girders are observed. Figure 5(b) shows the detection results of Scenario 2 in girders A and B. It can be seen that damage index values at sensor locations No. 1 and No. 8 in girder A are around 0.2, which indicates that the damage of shear connectors are presented in these sensor locations. These identified locations matches well with the

introduced damage locations. However, it should be noted that the damage index at sensor location No.4 in girder A is also relatively high and around 0.05. This may lead to a false identification because the response at the mid span of the simply-supported model is the largest. The steel girder and concrete slab in the current structure model are only connected by 16 shear connectors between each girder and slab. Some difference in responses on slab and girder is expected, and is most significant when the response is relatively large at the mid span. This response difference is also picked up by the proposed damage index. Nonetheless the proposed method successfully identified all the simulated shear connector damages, which are not likely to be detected with visual inspections because shear connectors are buried inside the structures, and might not be able to be identified accurately with other vibration-based parameters such as frequencies, mode shapes and flexibility as demonstrated above.

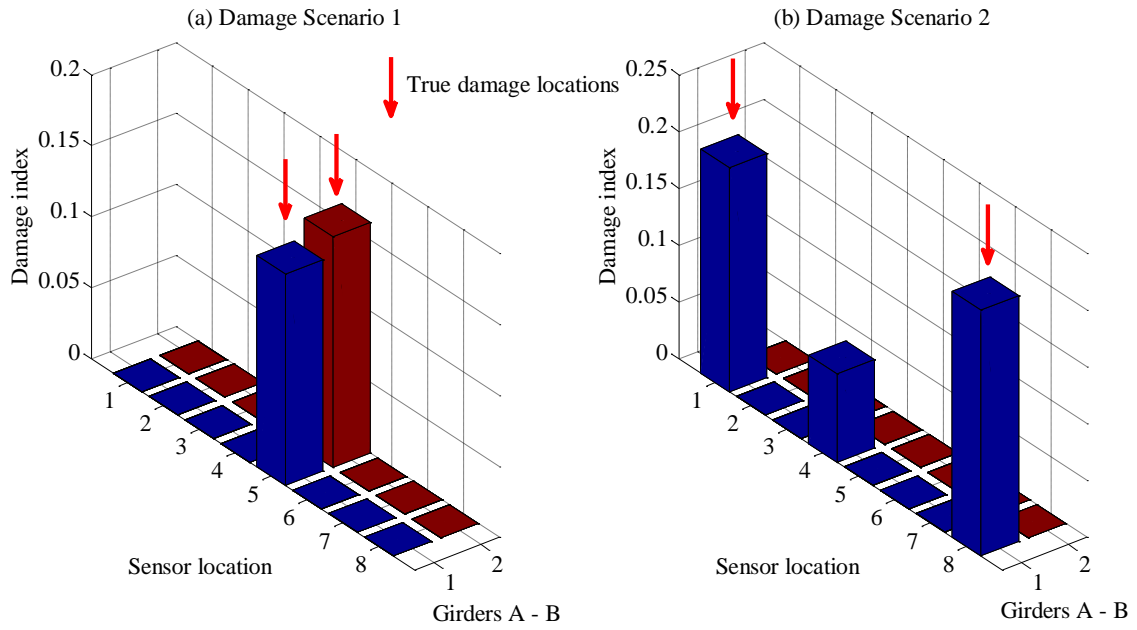
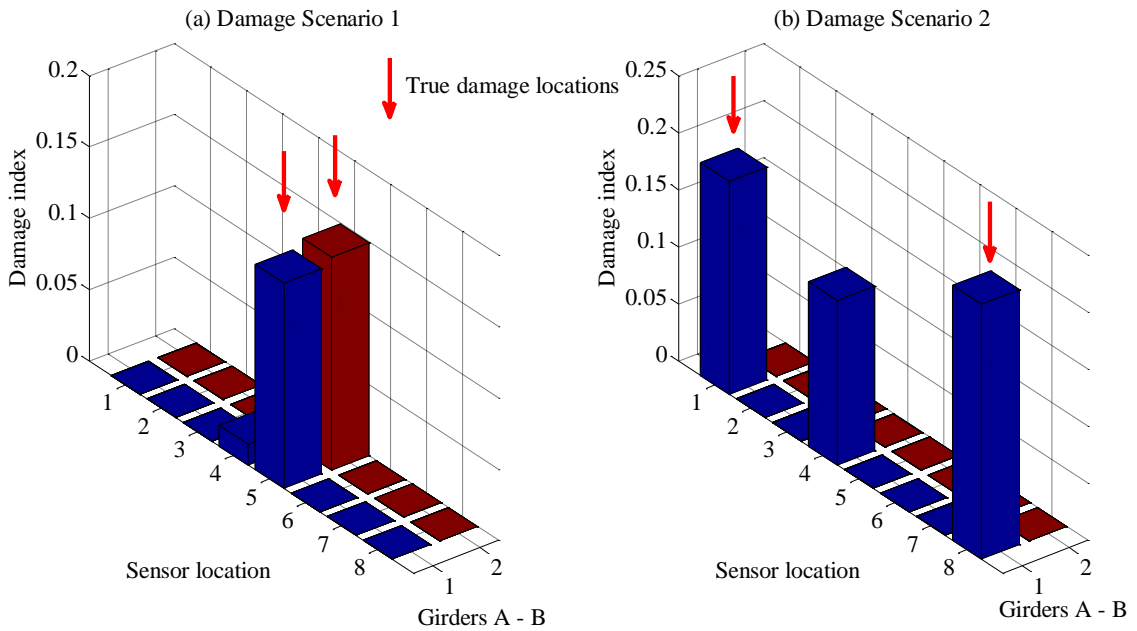
Figure 6 - Damage detection results with measured data of undamaged structure (with noise)

Figure 6 shows the detection results from the simulated data with smeared noise. The damage index values in Scenario 1 at sensor location No.5 in both girders A and B are around 0.15 in two noise cases, indicating the existence of damage of shear connectors in the nearby area. Damage index values in Scenario 2 at sensor locations No.1 and No.8 in girder A are around 0.2 in two noise cases. The introduced damages of shear connectors in both Scenarios 1 and 2 are identified correctly even the vibration signals are smeared with noise. The robustness of the proposed approach for damage detection of shear connectors from noisy measurements is demonstrated. However, similar to the results shown in Figure 5(b), a false identification at sensor location No.4 in girder A occurs in Scenario 2. The damage index value at this location increases with the noise level and is up to 0.1 when the noise level is 5%.

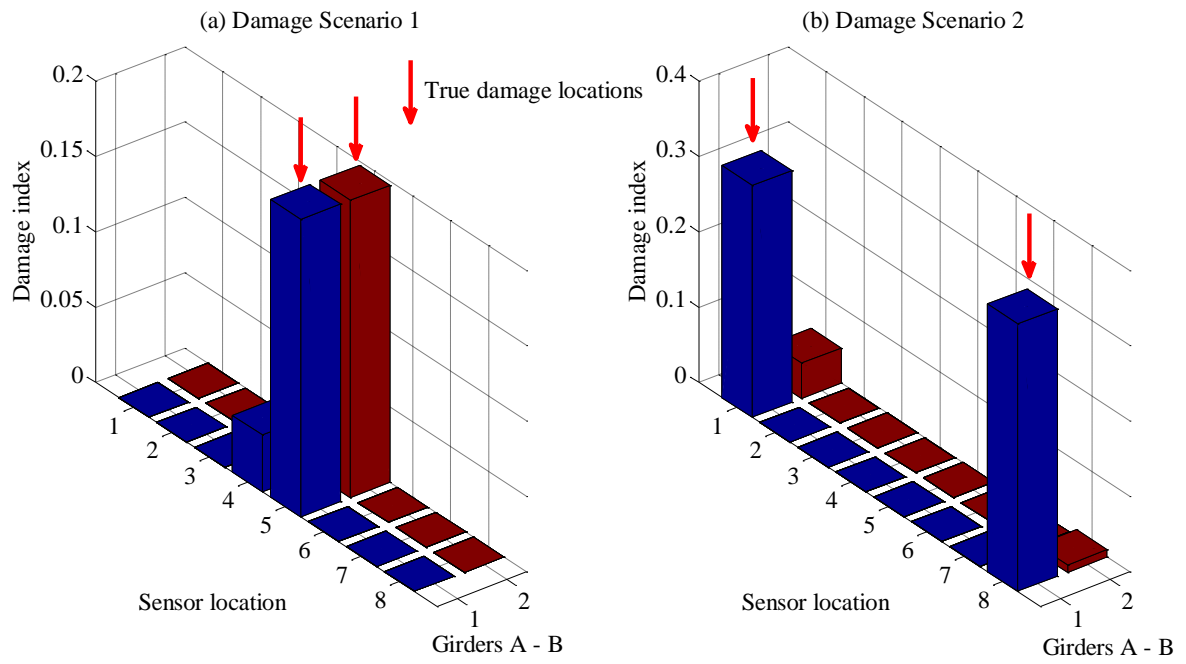
Figure 7 - Damage detection results with RDFRF (without noise)

The relative difference between frequency response functions on the slab and corresponding girder locations is used to detect the damage of shear connectors. Figures 7 and 8 show the damage detection results based on the relative difference of frequency response functions without and with noise effect, respectively. The introduced damages are identified correctly with several false identifications on the close sensor locations, such as sensor location No.4 in Scenario 1 and sensor locations No.1 and No.8 of Girder B in Scenario 2.

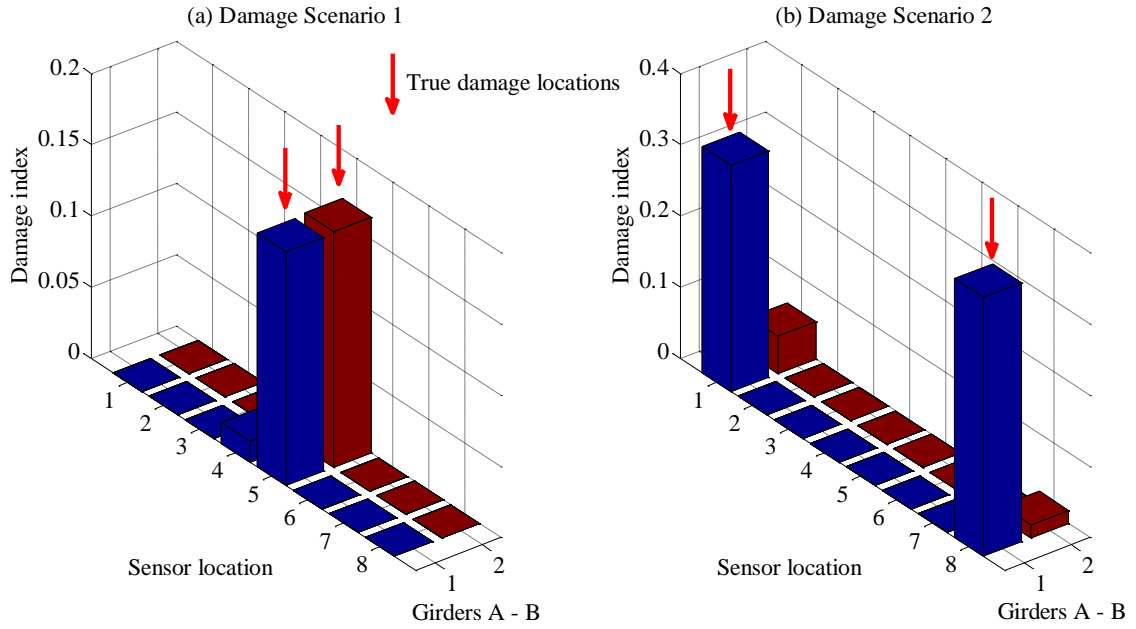
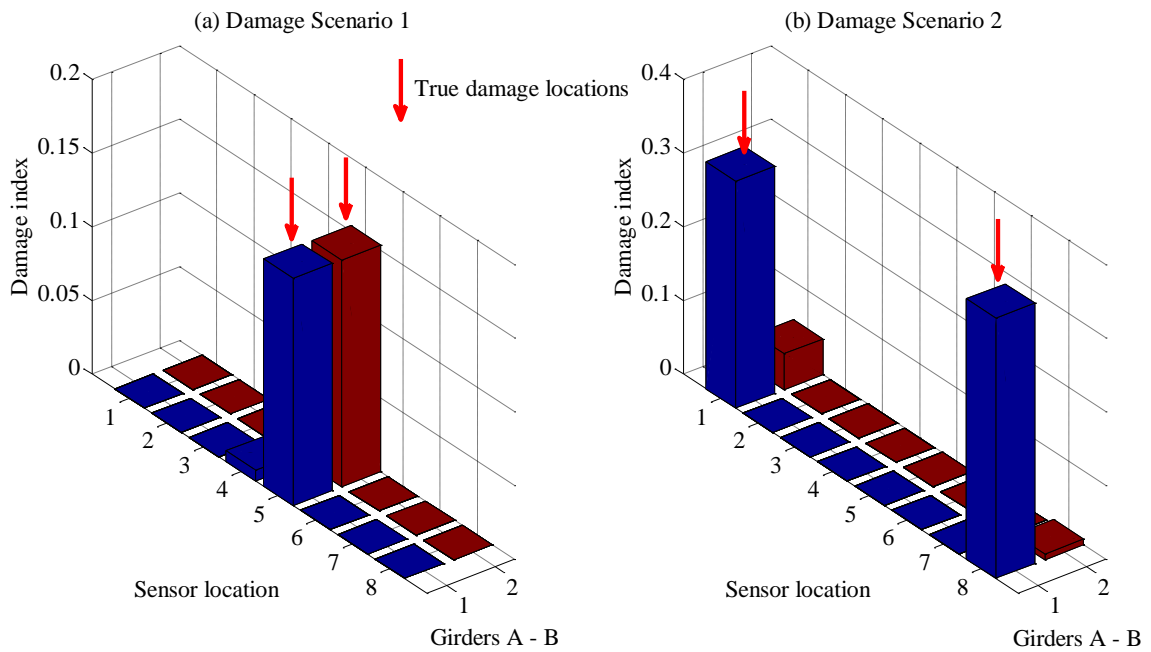
Figure 8 - Damage detection results with RDFRF (with noise)

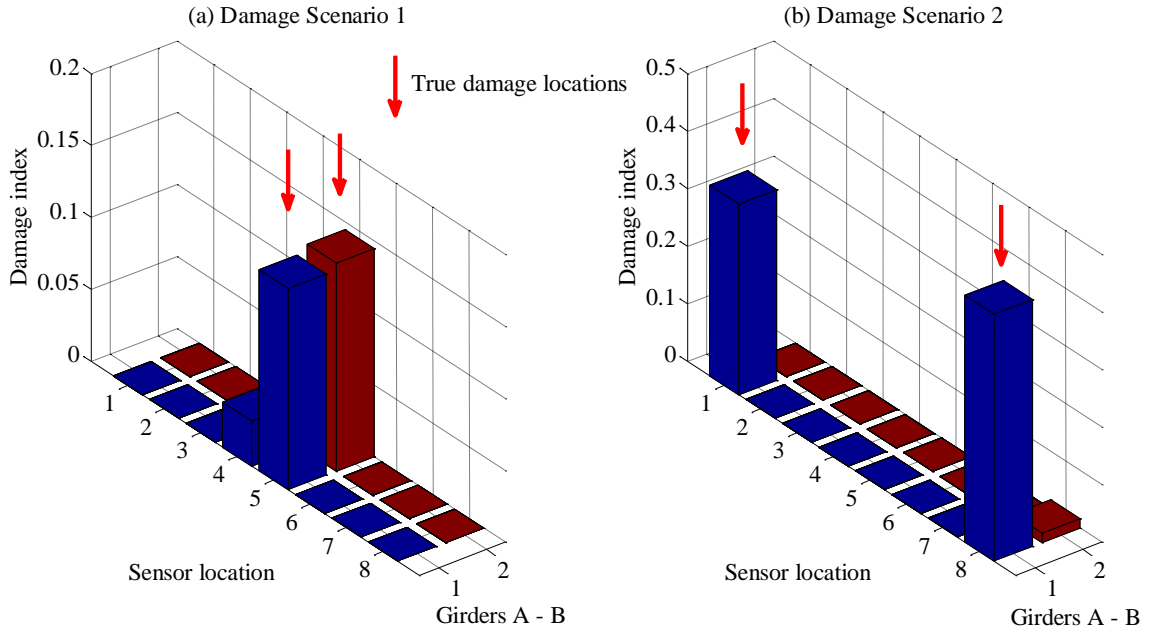
Figure 10 - Damage detection results with noise and without data of undamaged structure

The damage index values in Scenario 1 at sensor locations No.5 in both girders are around 0.15 in two noise cases. The identified damage indices in Scenario 2 at sensor locations No.1 and No.8 in girder A are around 0.3. Several false identifications at sensor location No.4 in girder A in Scenario 1 and No.8 in girder B in Scenario 2 are observed and their damage index values increase up to 0.05 with 5% noise included in the responses.

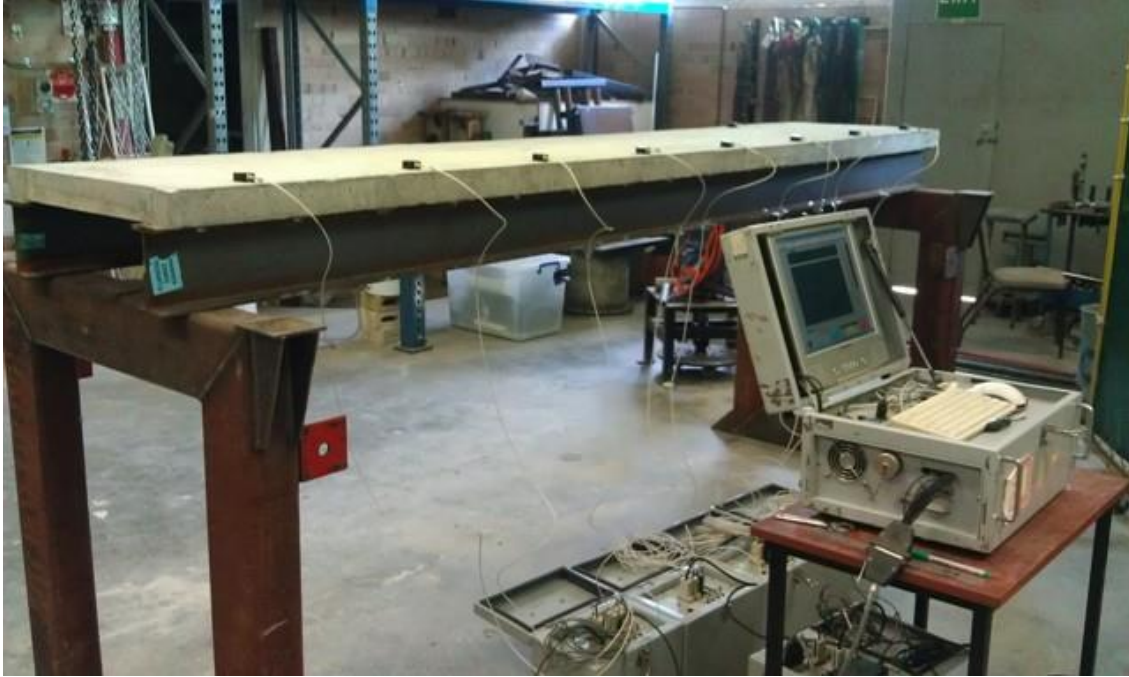
Figure 11 - Experimental test setup of the slab-on-girder structure

A structural model with a concrete slab supported on two steel girders was designed and constructed. Sixteen shear connectors were equally mounted in each girder linking the slab and steel girder together. The bridge was located on two steel frames which were fixed on the strong ground as shown in Figure 11. The design of shear connectors considers the ability not only to simulate failure of specific shear links, but also to reset-up them to the undamaged state. Therefore, a metric bolt screwing into a metric nut connecting the slab and girder was simulated as the shear connectors. The metric nuts were welded onto the reinforcement bar in the slab before pouring. Design and setup of shear connectors can be seen in Figure 12. If all the bolts are screwed into the nuts, the structural condition corresponds to the undamaged state. The damage of shear connectors is introduced into the structure by fully removing some of the bolts to simulate the failure of bolts. The dimensions of the laboratory model are the same as those of the model in the numerical study. It should be noted that since the proposed damage detection approach for shear connectors is non-model based, the finite element model of the structure is not required. Therefore the dimensions and material properties of the slab, girder and shear connectors are not required for identification.

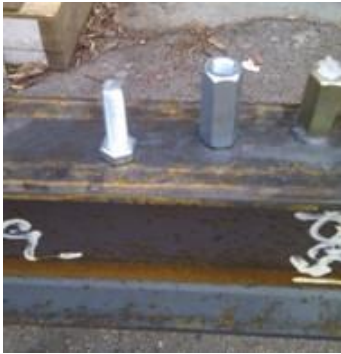
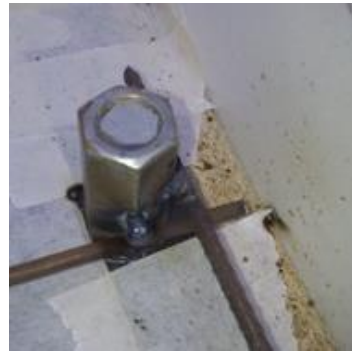
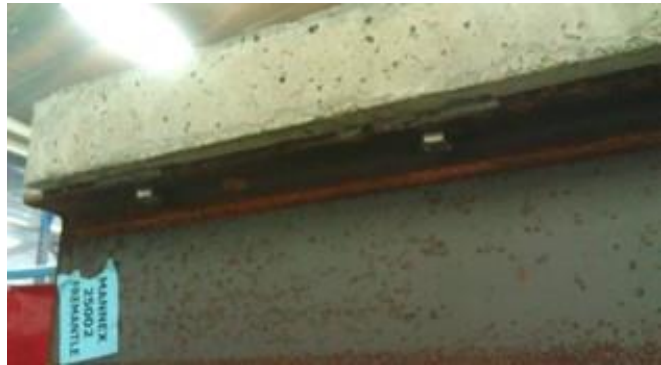
(a) Metric bolt and nut

(b) Bolt screwed into the nut

(c) Plan view of shear connectors

(d) Shear connector in the structure

Figure 12 - Design of shear connectors

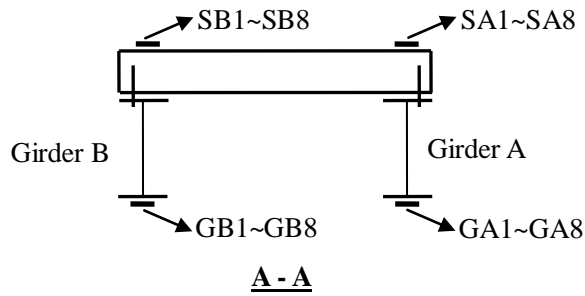
Figure 13- Experimental sensor placement

used to generate the impact excitation. Figure 13 shows the numbering of shear connectors and sensor locations defined in the testing model. One sensor is placed on the reference location and other eight sensors were repeatedly placed on the slab or underneath the girders to measure the responses at sensor locations SA1~SA8, SB1~SB8, GA1~GA8 and GB1~GB8. Two damage scenarios are listed in Table 4. Excitation with hammer impact was applied at the left quarter span of the slab as shown in Figure 13. The measuring sampling frequency was set as 2000Hz. DIAMOND data analyzing software was employed to conduct the experimental modal analysis and obtain the frequency response function at each sensor location.

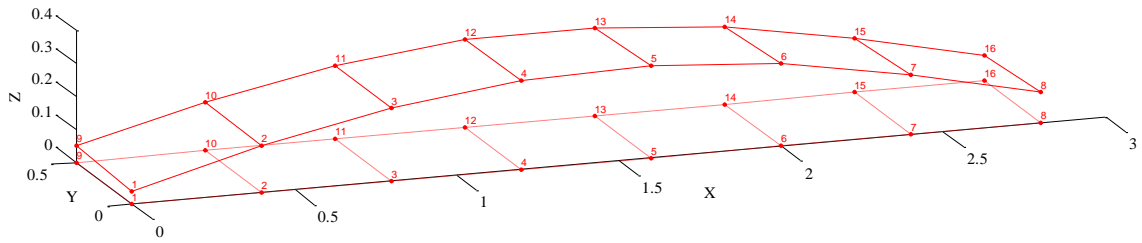
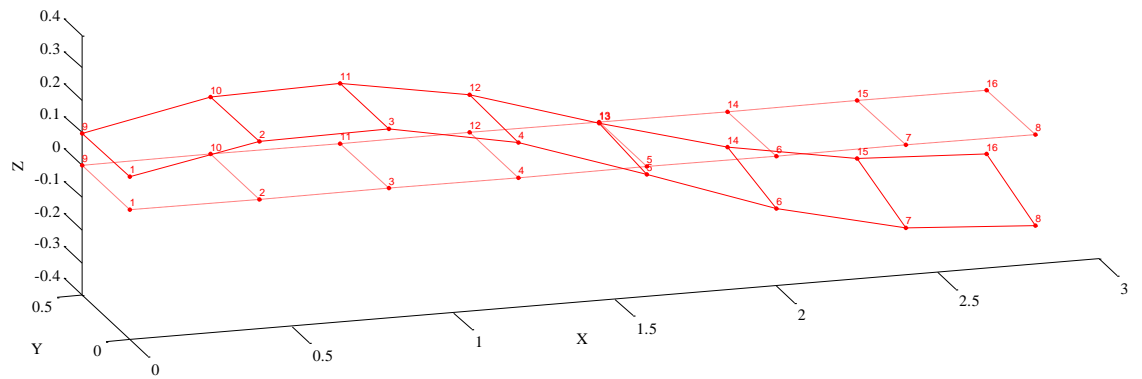
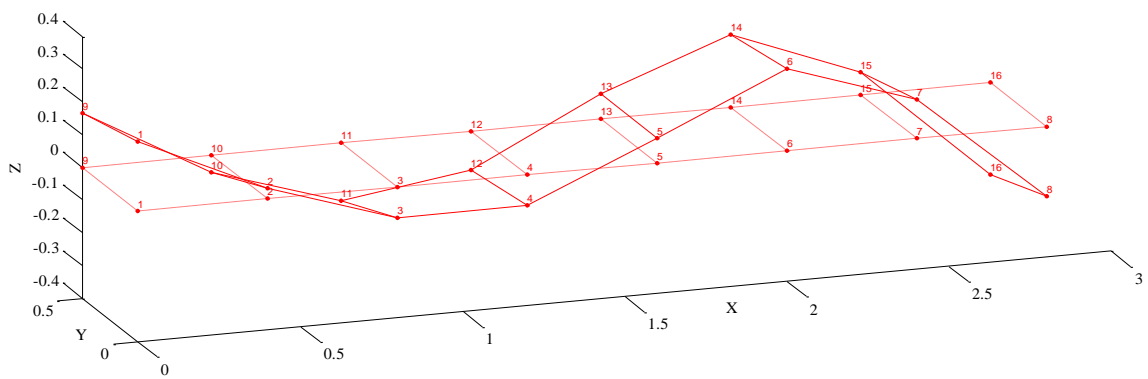
Figure 14 - Identified first three mode shapes of the undamaged structure

The first three identified natural frequencies of the structure in the undamaged and damaged states are listed in Table 5. Figure 14 shows the corresponding identified mode shapes of the undamaged structure. The identified mode shapes of the damaged structure are similar and not shown in this paper due to the page limit. MAC values of three mode shapes at the slab sensor locations of two damage states are shown in Table 6. It can be seen from Table 5 that the minor changes of the first three frequencies are observed in damage Scenario 1. The largest one is 0.82% at the third frequency, and its corresponding MAC value is 0.923. Therefore it could be difficult to identify the damage with the changes of frequencies and mode shapes. For the damage Scenario 2, the largest change of natural frequency is 17.08% at the third mode, and its MAC value is 0.449. This observation is consistent with those in the modal analysis of numerical studies with same explanations.

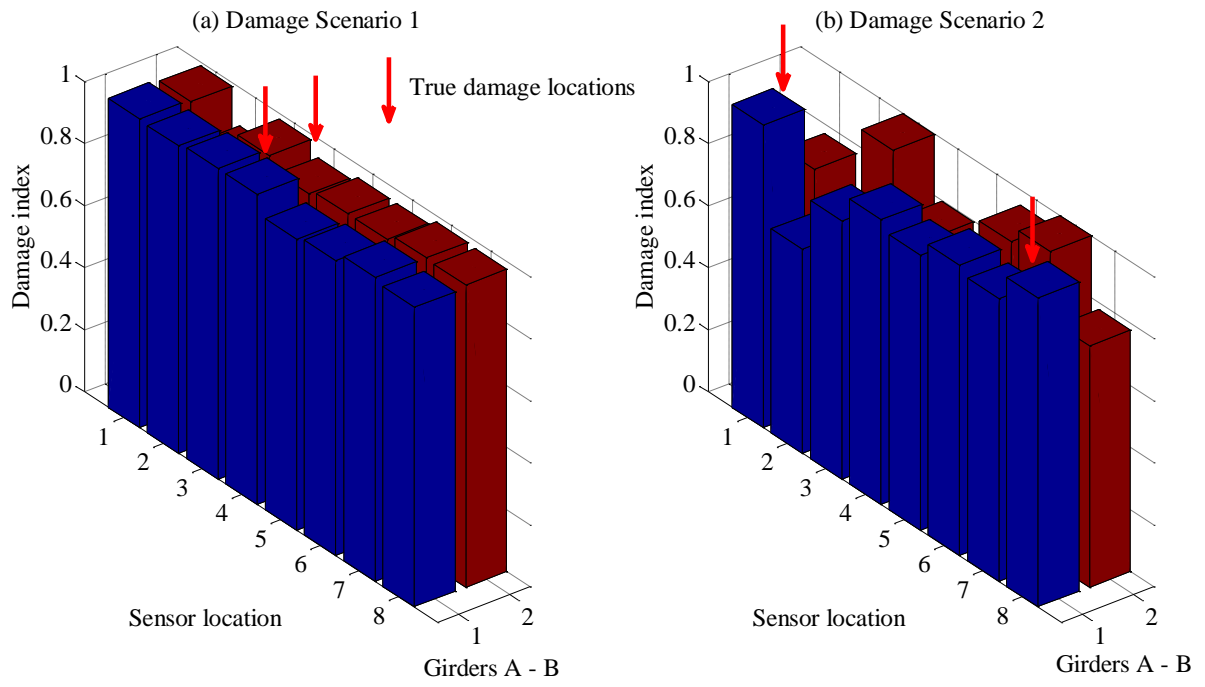
Figure 15 - Damage detection results with COMAC

Figure 15 shows that COMAC fails to identify the damages in Scenarios 1 and 2 indicating that COMAC is not a good indicator to detect the local damage of shear connectors because the identified frequency and mode shapes would be polluted by the noise effect in lab testing and not easy to locate the local change of shear link conditions. Figure 16 shows the damage detection results with changes in flexibility. It can be found that the damages in Scenario 1 are not detected correctly, while damages in Scenario 2 are identified accurately indicating that the detection using change in flexibility is better than COMAC but not applicable for the minor damage case with smaller modal information changes.

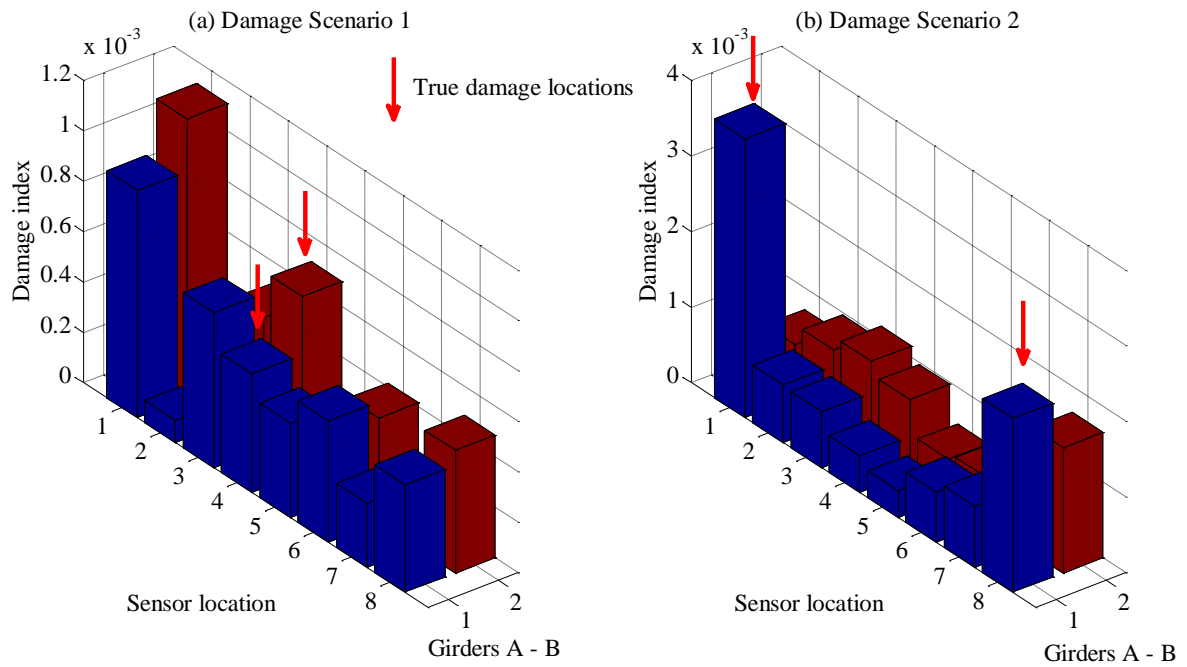
Figure 16 - Damage detection with changes in flexibility

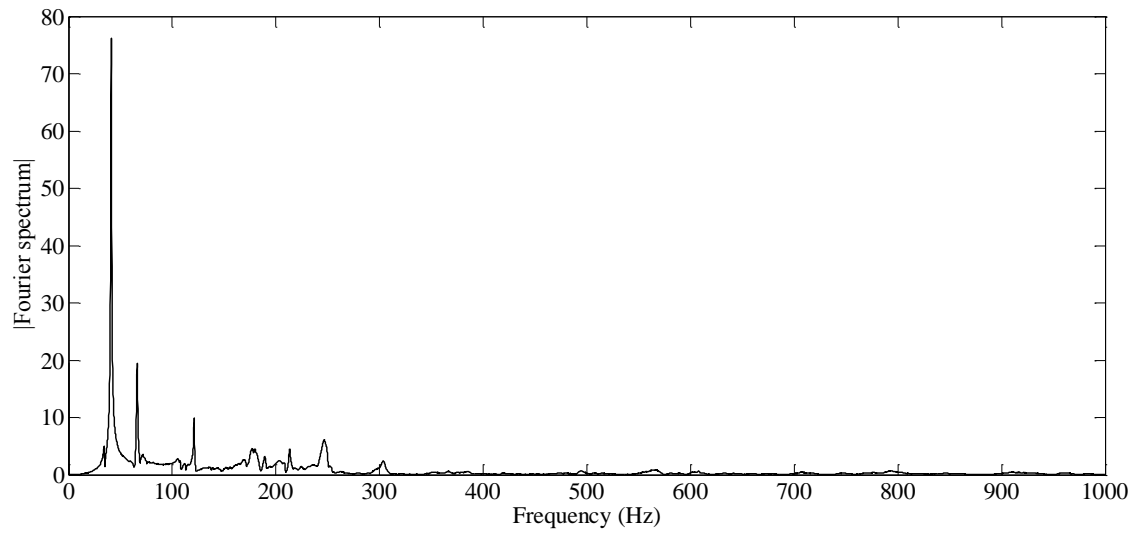
Figure 17 - Fourier spectrum of the measured response at SB5 in the damaged state

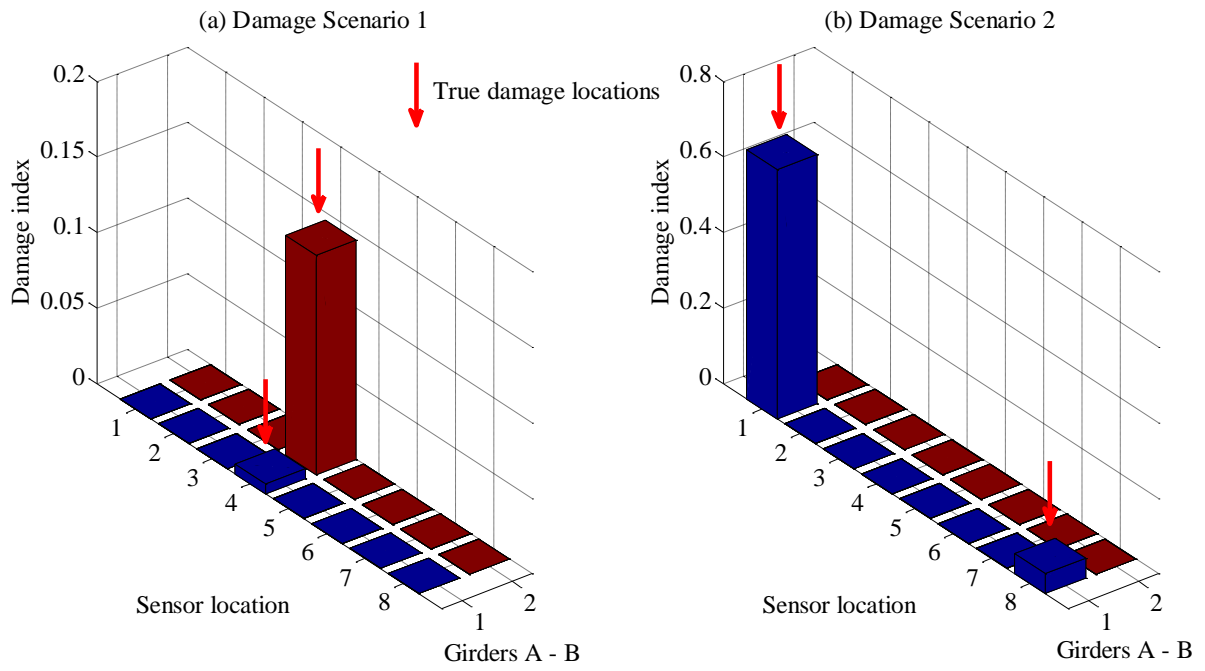
Figure 18 - Damage detection results with measured data of undamaged structure

Figures 18(a) and 18(b) show the identified results of Scenarios 1 and 2, respectively. It can be found from Figure 18(a) that two damage index values at the sensor location No.4 in two girders are observed indicating that the damage of shear connectors presented in this area in Scenario 1. This observation illustrates that the introduced damage of SC7, SC8, SC23 and SC24 can be identified correctly. It should be noticed that the damage index at the sensor location No.4 in girder B is around 0.15, while it is very small at sensor location No.4 in girder A although the damage severity at the two locations is the same. This may be because the residual friction forces between the concrete and the steel girder in these two locations are not exactly the same. A larger residual friction force may exist in sensor location No.4 of girder A, making the difference between the responses on the slab and underneath the girder not significant. This observation indicates that it is difficult to use damage index value to quantify the damage. This limitation is the same as other non-model based methods, i.e., they can locate the damage but very difficult to quantify the damage. Damage detection results for Scenario 2 in girders A and B are shown in Figure 18(b). It can be found that these two damage locations are identified accurately. The damage index at sensor location SA1 is around 0.6, while its value at SA8 is around 0.05. This is similar to the observations of Scenario 1 with the same possible explanation.

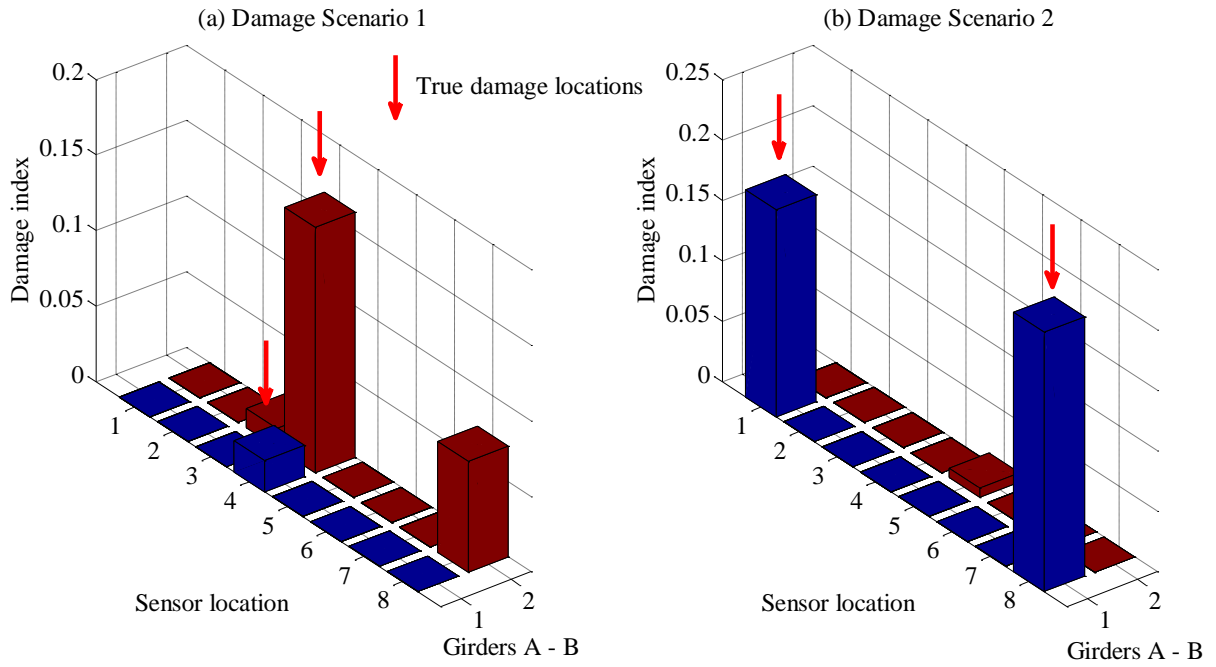
Figure 19 - Damage detection results with RDFRF

Figure 19 shows the damage detection results with the relative difference of frequency response functions between slab and girder. Measured acceleration and hammer impact force data are used to extract the frequency response functions in the damaged state for identification. The damages in both scenarios are identified, while with several false identifications, for example, sensor locations No.3 and No.8 of Girder B in Scenario 1, sensor location No.5 of Girder B in Scenario 2.

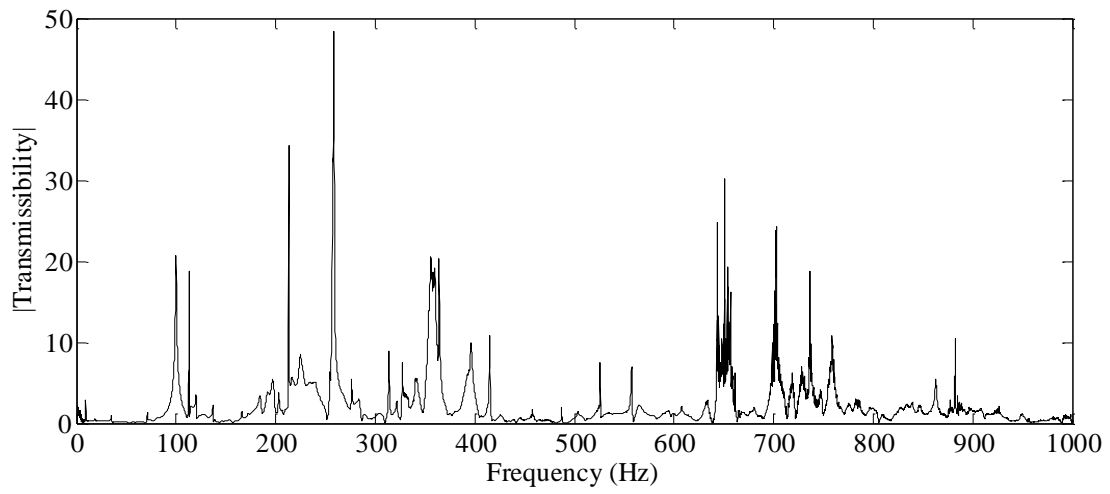
Figure 20 - Transmissibility at sensor location SA1 of damage Scenario 1

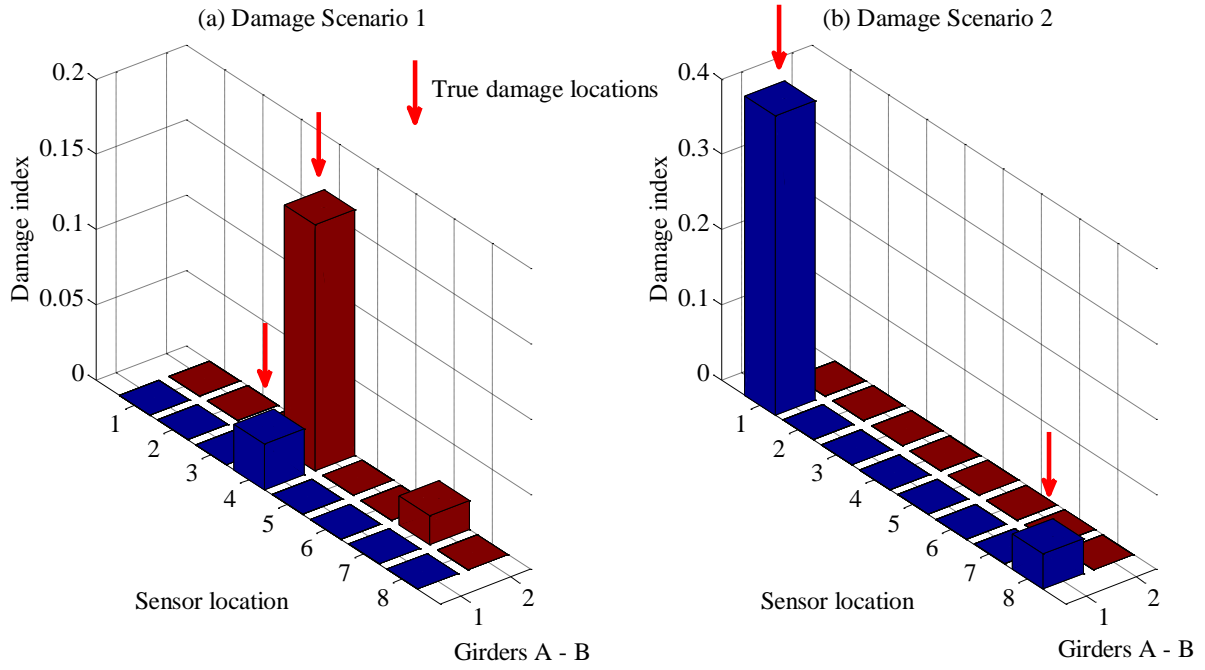
Figure 21 - Damage detection results without measured data of undamaged structure

When only the measured responses from the damaged structures are available, the transmissibility vectors from a reference sensor response to a slab response and a girder response respectively can be computed and used to derive the damage index with Equation (16). A reference sensor location is defined as shown in Figure 13 in this study. Figure 20 shows the magnitude of the transmissibility from reference sensor response to slab response at sensor location SA1 in damage Scenario 1. It can be seen that this transmissibility covers all the frequency range with same order of magnitudes. Therefore, transmissibility matrices in the frequency range of 15Hz~1000Hz are used to compute the damage index. Figures 21(a) and 21(b) show the damage detection results from the measured responses in the damaged states for Scenarios 1 and 2, respectively. It can be seen that the introduced damages of shear connectors in both damage scenarios are identified accurately. A small false identification is observed at sensor location No.7 in girder B in Scenario 1. The identified results in experimental studies demonstrate that the locations of damages in both scenarios are detected accurately with only the measured responses from the damaged structure.

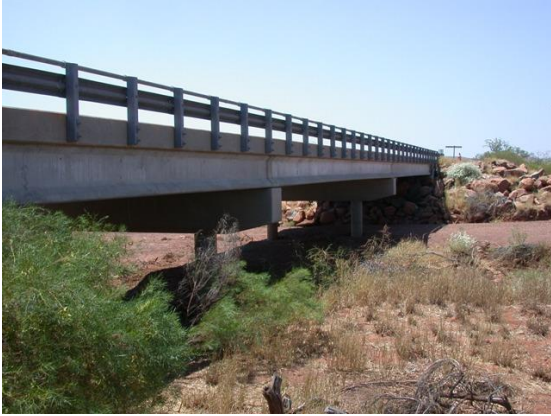
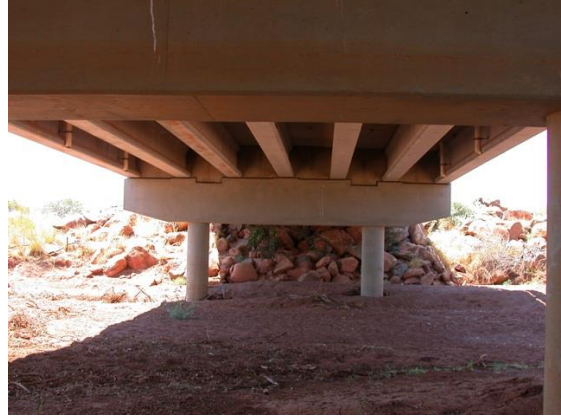
Figure 22 - General view of Bridge No. 852

The proposed damage detection method is further applied to evaluate the shear link conditions of a real bridge. Bridge No.852 is located on North West Coastal Highway over the Balla Balla River in the Shire of Roebourne, Western Australia. It is a pre-stressed concrete bridge constructed in 1975, which consists of three spans with an overall length of 53.95m and width of 9.398m. The central span of the bridge is 18.288m and the external spans are 17.831m. The deck of the bridge is the cast-in-situ reinforced concrete slabs supported by seven precast pre-stressed I-type girders, as shown in Figure 22. The shear connectors are used to link the slab and girders together. They are 12mm in diameter and enter the RC slab for a 100mm length before being bent for anchorage. Spacing of the connectors varies from 76mm in the ends to 381mm in the center of the girders. More details about the design of the bridge are referred to a technical report [29].

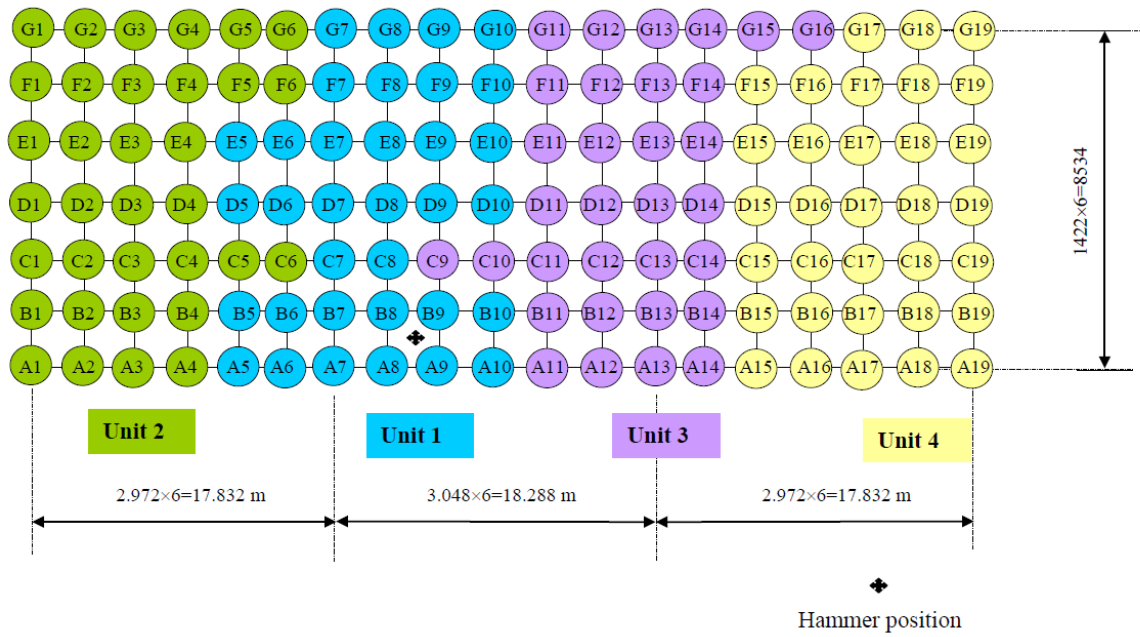
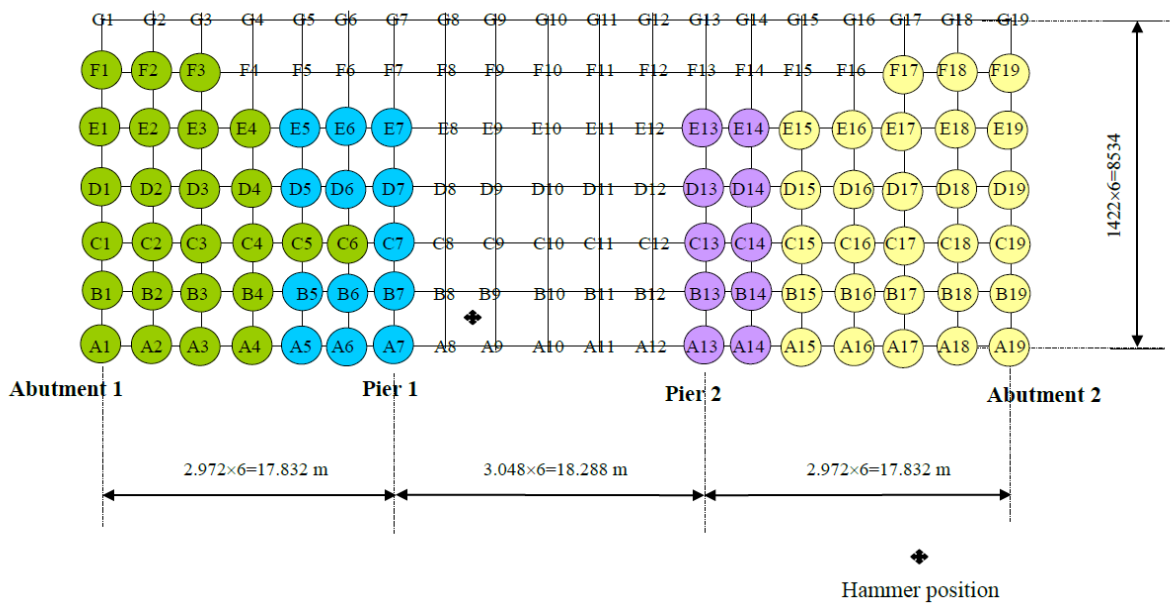
Figure 23 - Sensor placement on slab and girders

Field dynamic testing on this bridge was carried out in 2005 [29]. These data are analyzed in this study to identify shear link conditions with only the measurements from the existing structure. Figure 23 shows the sensor placement on the slab and girders. The bridge has three spans each with seven girders, and so accelerometers were placed on the slab locations corresponding to the seven girders, allowing comparison with the underneath girder measurements. There are nineteen sensor locations on the slab along the longitudinal direction in each row. Site condition and in-field testing safety concerns make the measurement points underneath the girders limited to the sensor locations shown in Figure 23(b). The girders are numbered as A, B, C, D, E, F and G, respectively. An instrumented DYTRAN 5803A sledge hammer was used in the impact tests, and eight Kistler accelerometers were repeatedly employed to measure the acceleration responses on slab and girders. The sampling rate was set to 100Hz, and 1024 data points were recorded in each impact.
