# Damage Detection of Shear Connectors in Bridge Structures with Transmissibility in Frequency Domain

Shear connectors are generally used to link the slab and girder together in slab-on-girder bridge structures. Damage of shear connectors in such structures will result in shear slippage between the slab and girder, which significantly reduces the load-carrying capacity of bridges. A damage detection approach based on transmissibility in frequency domain is proposed herein to identify the damage of shear connectors in slab-on-girder bridge structures with or without reference data from the undamaged structure. The transmissibility, which is an inherent system characteristic, indicates the relationship between two sets of response vectors in the frequency domain. Measured input force and acceleration responses from hammer tests are analyzed to obtain the frequency response functions at the slab and girder sensor locations by the experimental modal analysis. The transmissibility matrix that relates the slab response to the girder response is then derived. By comparing the transmissibility vectors in the undamaged and damaged states, the damage level of shear connectors can be identif

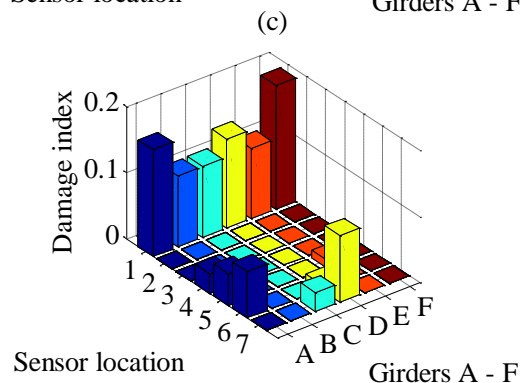
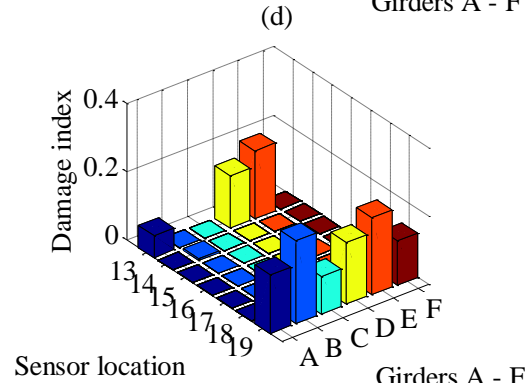
Figure 24 - Damage detection results for Bridge No.852 (a) with RDFRF, left span; (b) with RDFRF, right span; (c) with transmissibility, left span; (d) with transmissibility, right span

Frequency response functions were extracted from the measured acceleration response data and hammer impact force with DIAMOND toolbox. Frequency range from 1 ~ 21Hz is used to include the first ten modes [29]. Five reference sensors, e.g. A10, B10, C10, D10, E10 and F10 are defined to average the damage index. Figure 24 shows the identification results based on the differences of frequency response functions and transmissibility vectors. Damages of shear connectors from both methods are mostly identified at the support locations, especially near the abutments 1 and 2 as the shear forces at the supports are generally larger than those at other locations. The condition

assessment results are reasonable since the shear connections at the support locations are more easily and likely to be damaged.
