Motor Vehicles: Are they emerging threats to Lake Victoria and its Environment?

Joseph L. Awange¹ and Benard Obera²

Abstract

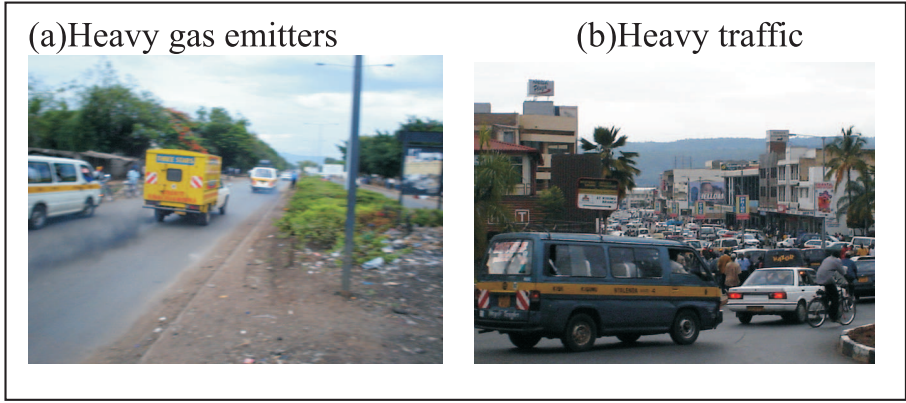
Figure 1: Vehicle congestion and exhaust pollution

The location of Kisumu City is so strategic in that the western part of Kenya is largely accessed via it. To reach Uganda from Kenya, one passes Kisumu through to Busia border. From Kisumu, Tanzania can be accessed via Migori. It is the largest City directly situated within the lake's surrounding. The volume of the vehicles in some roads of Kisumu during 2004 is summarized in Table 1 (KCEP, 2005), while the congestion is depicted by Figure 1a. Most of the vehicles within the town, and indeed the whole country,

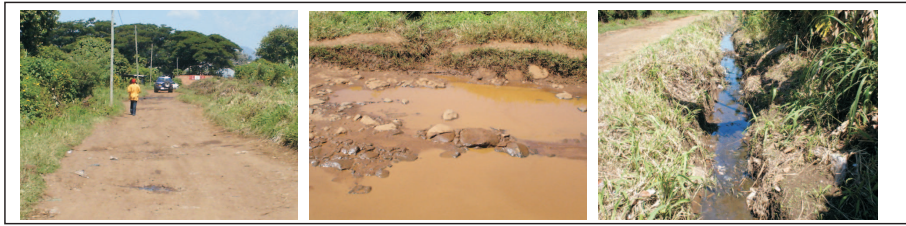
Figure 2: Eroded earthen roads and trenches at some of the beaches

are of the old generation which cannot run sustainably on unleaded fuel. The high lead content combined with the low combustion efficiency of the old type of engines lead to emission of high volumes of exhaust gasses, which contain semi-combusted fuels combined with worn out engine parts and waste oils, hence high concentration of particulate matter in the air (Figure 1a). These contributes towards atmospheric pollution of the Lake Victoria, leading to further eutrophication. Atmospheric pollution has been shown by LVEMP (2003) to be the leading pollutant of the lake contributing more than 30%. Tamatamah et al. (2005) puts the total atmospheric pollution of Lake Victoria to 55%. Major motor vehicle related activities which end up polluting the Lake as runoff included; *sand transportation from the beaches, bus park, garages* (locally known as 'jua kali', translated as hot sun since people work in open areas) and the *oil depots* or Petrol stations (Figure 2).

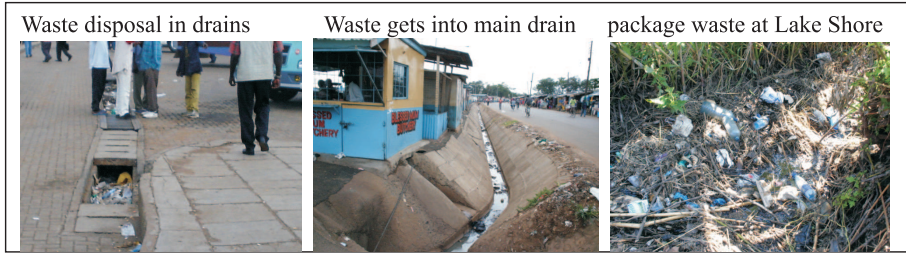
Figure 3: Waste accumulation at bus termini

In terms of waste being washed by runoff water into the lake, the bus park stands out as the leading contributor. Almost all of the 28,800 commuter vehicles (Matatu) and 1,259 buses listed in Table 1 pass through the bus park. With high rate of unemployment, i.e., Kisumu population is close to 350,000 million people with 30% unemployment rate (KCDS 2004), most people engage in hawking and food vending at the bus park. The provision for vehicle parking and transport however comes with the need for provision of services for the passenger-generated waste which is not the case for Kisumu. Passenger waste thus result in severe waste problems at the Kisumu bus park, the highways and taxi parking. This has seen the accumulation of both liquid and solid wastes at the termini. With the low waste services in the town, most of the wastes end up in the drains hence blocking them during rainstorms or swept into the lake via these drainage channels as illustrated in Figure 3.

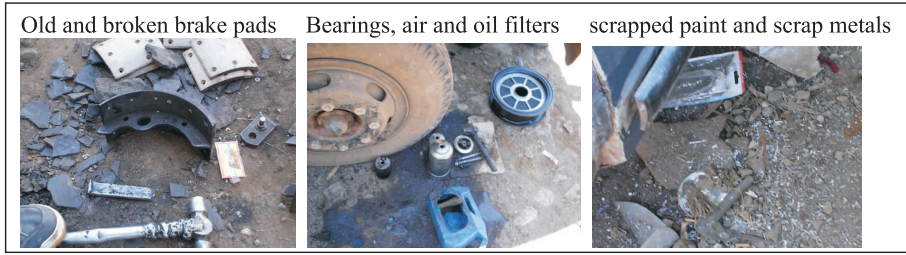
Figure 4: Wastes from vehicle repair known as Jua Kali

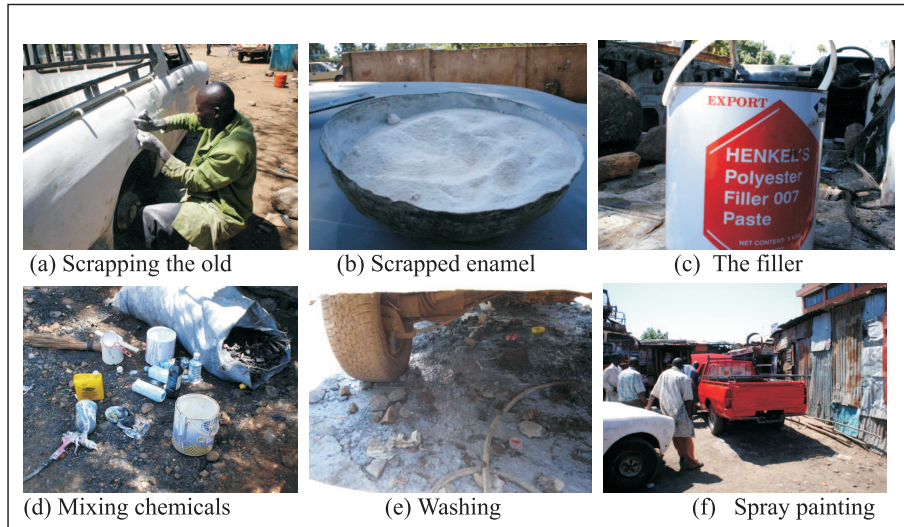
Figure 5: The spray painting process and wastes

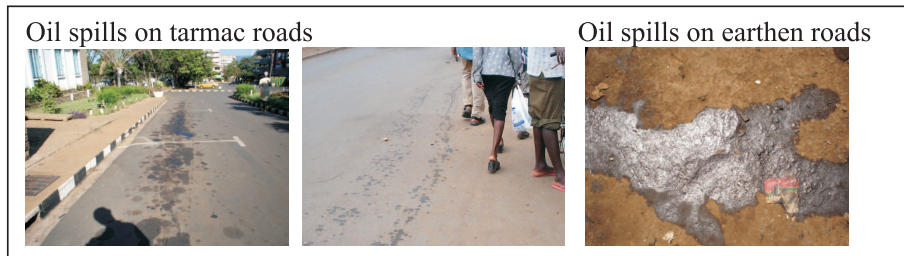
Figure 6: Oil spills

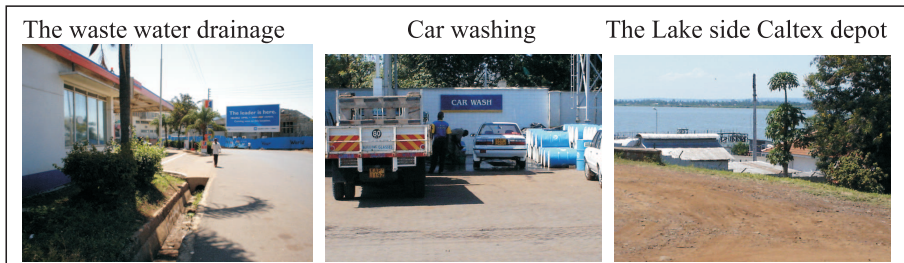
Figure 7: Petrol station operations and the Caltex petrol depot at the lake side

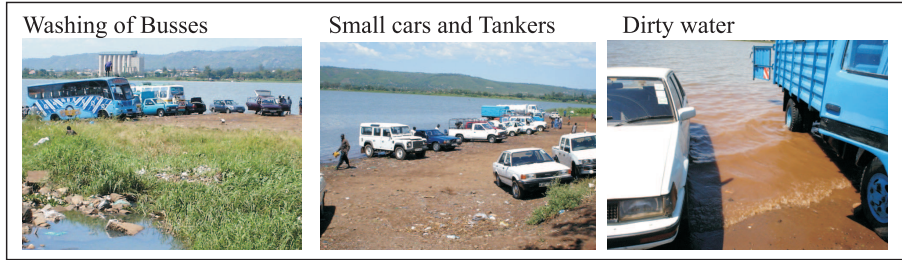
Figure 8: Direct motor vehicle washing at Kichinjio beach

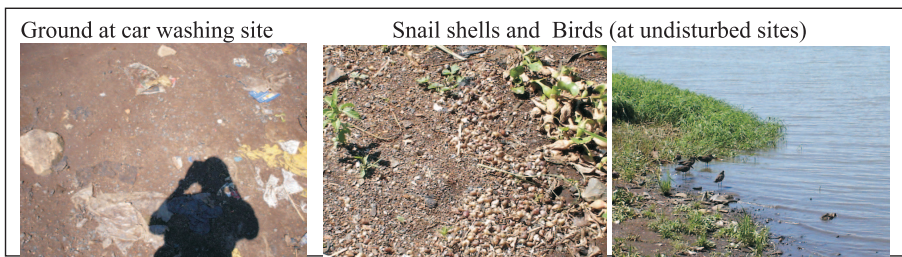
Figure 9: Difference between disturbed and undisturbed sites at Kichinjio beach

Other impacts of motor vehicles related activities on the lake were also noted. For these, we could not undertake the absolute measurements but provided relative presentation. For instance, a casual observations at car washing sites reveal that the shore waters are now dirtier and greasier. The waste oils from the vehicles, dirt accumulated in transit are all washed into the lake. Some of the vehicles have leaking systems hence the oils or the fuels drip into the lake, causing further problems. As can be seen in Figure 8, the shores are no longer supporting the original vegetation or other small life forms, due to the conscious removal by the motor vehicle washers or possibly due to the decrease in the oxygen levels in the water occasioned by the oil covering the water surface. The oils washed off the vehicles (particularly petroleum vehicles, e.g., Figure 15) floats on the water surface forming a seal hence reducing the amount of oxygen available in the water for the survival of the flora and fauna. This would interfere with the amount of food available (see, e.g., Tet Leong, 2003) hence the trophic relationships at the particular site. This could explain the reason why there are no snail shells and predatory birds (like the Harmakop, in Figure 9) at the motor vehicle wash place.

It is important to note, however, that the motor vehicle washing has increasingly become popular due to the other services offered. This includes the vibrant food kiosks specializing in fish business, boat riding and sight seeing. This could have an adverse effect on the long-term sustainability of the lake, as it will experience a rise in the concentration of pollutant elements. Comparing car washing points 2,4 and 5 to non-car washing points 3 and 6, the floral and faunal composition has changed as can be seen in Figure 9. This indicate the physical impacts of motor vehicle washing in the lake.

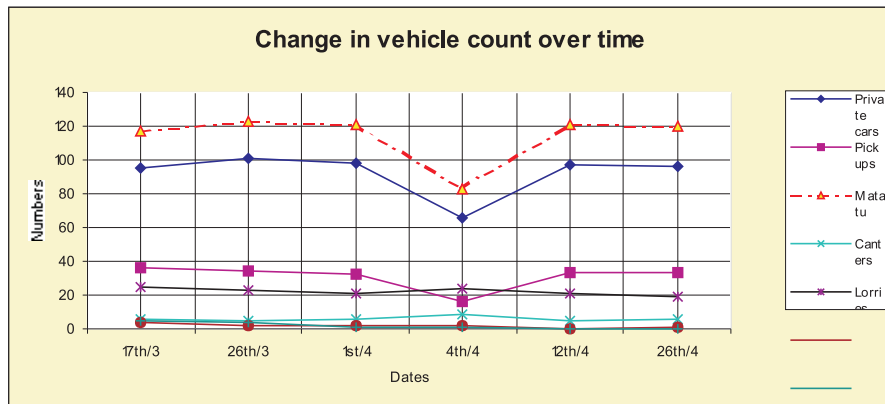
Figure 10: Daily changes in the vehicle count at the motor vehicle washing points for the sampled days

Table 1 and Figures 10-12 present the daily records of the types of the vehicles washed at Kichinjio beach for the sampled period. The results indicate that Public Service Vehicles (normally of 14 seater Nissan type known locally as Matatus) recorded the highest daily average number of vehicles washed at the beach (42%), followed by the private cars (34%). Figure 12 presents the daily trend in motor vehicle washing activity during the day. The highest number of vehicles being washed at the beach is indicated to have occurred during lunch hour, with most being private cars. The highest Matatus (Public Service Vehicles)

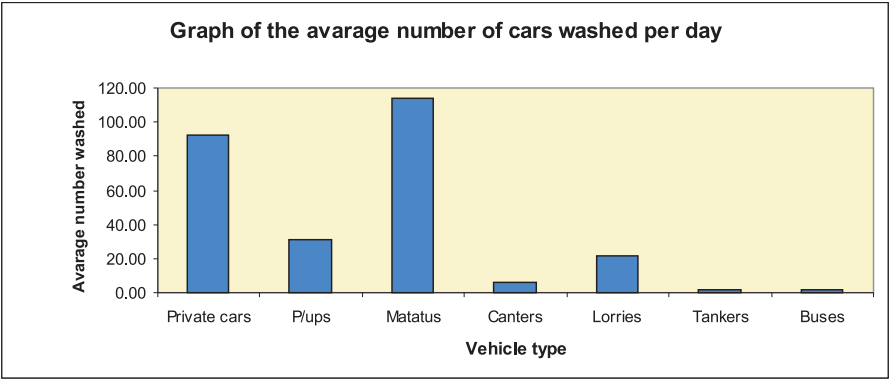
Figure 11: Daily averages number of vehicles washed at the beach

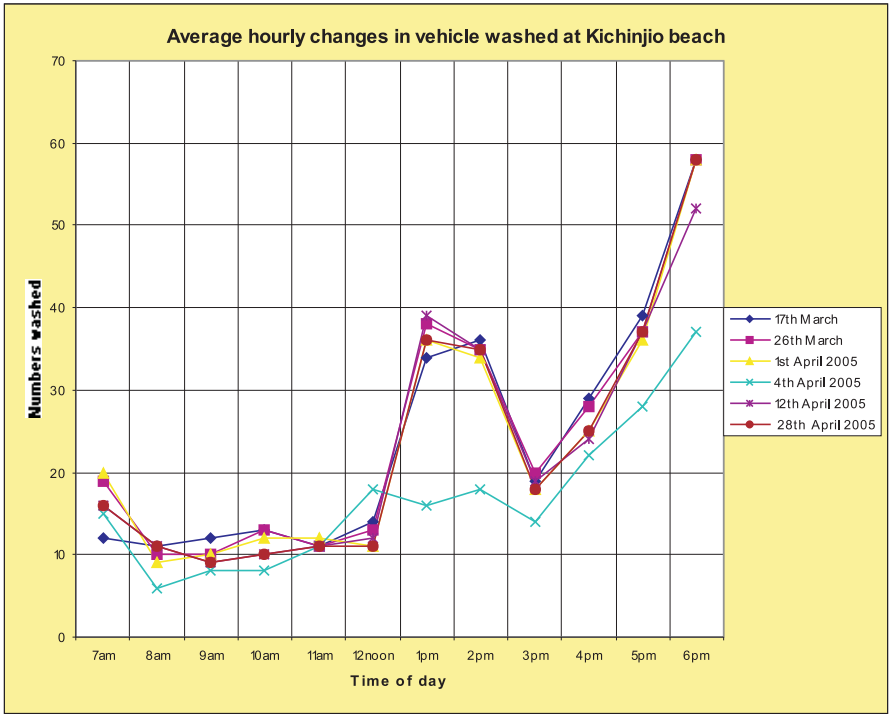
Figure 12: Average hourly change in vehicles being washed at the beach

In Figure 12, the vehicle counts indicated higher numbers for Matatus and private cars. The change in the numbers recorded throughout the day indicated that the highest private car counts were recorded at around lunch hour. The flourishing fish eating business at the beach is an indicator that most of the private cars come to the beach for lunch and only have their cars washed as a value added service. As such they do not come to the beach specifically for washing. However, the matatus (commuter vehicles) had a different pattern. The highest counts were recorded after working hours, i.e., from 5pm when apparently the vehicles come down for washing at the close of the day's business.

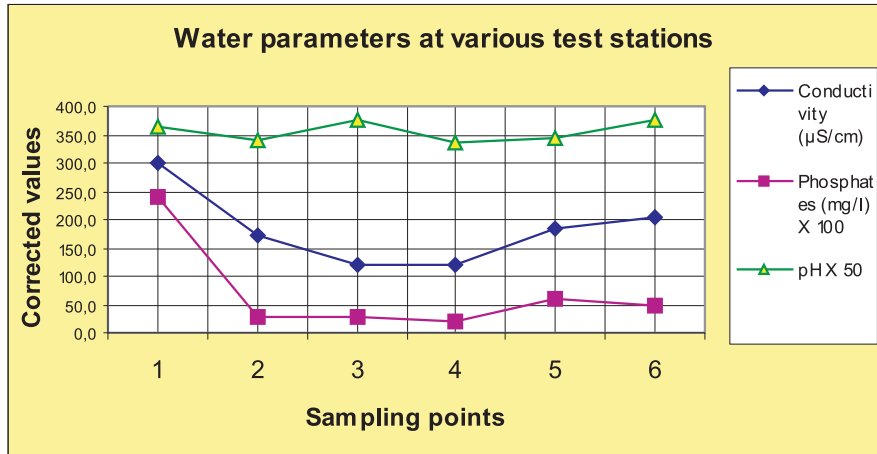
Figure 13: Water parameters at various test stations

In Figure 13, water quality parameters at various stations are presented. Figure 14 presents relationship between the three water parameters and the total daily motor vehicle counted during the sampling period. The correlation coefficients are computed and presented in Table (3).

In terms of pH, Figure 13 indicates the motor vehicle washing points 2, 4, and 5 to have lower values. This can also be seen in Table 4. It is however indicative of how motor vehicle is contributing to acidity at the car washing points. Table (3) and Figure 14 indicate the daily mean pH of over 7 for all the sampled days except on 4th April 2005 when the vehicle count was low. The correlation coefficient of 0.77 indicate a strong correlation between the number of vehicles washed and the pH measured. The values of pH in car washing points ranged from 6.7-6.9 (Table 4). For the same area, Calamari et al. (1995) recorded values ranging from 7.9-8.9. This indicates a reduction of between 1.2-2.0. The reduction shows the possibility of direct motor vehicle washing causing an increase of acidity of the lake by 29%.

Figure 13 indicate a higher value of total Phosphorus (TP) for the runoff entry point 1 (see also Table 4). This shows the incoming runoff from the open shed garages and bus park to be rich in-terms of nutrient of Phosphorus type. Figure 14 indicates a lower value of Phosphate on the 4th of April, a period which low number of vehicles were recorded as having been washed. The computed correlation coefficient of 0.77 shows a strong correlation between the total number of vehicles washed during the sampled period and the Phosphate in the lake waters. Small as they may be, these values contribute to the eutrophication of the lake as already pointed out by Okonga (2001) and Helmer and Espanhol (1997), leading to algae growth. LVEMP (2003) have estimated the total contribution of Phosphorus to eutrophication of the lake to be 32,050 tonnes/year. For Nyanza gulf, the region where we conducted our experiment, Njuru and Hecky (2005) have estimated the total Phosphorus for Kisumu to be 0.7mg/l. The average of the car washing points (2,4 and 5) in these study from Table 4 is 0.38mg/l. In comparison to the value of Njuru and Hecky (2005), therefore, the contribution of direct car washing on the lake is about 54% of the total

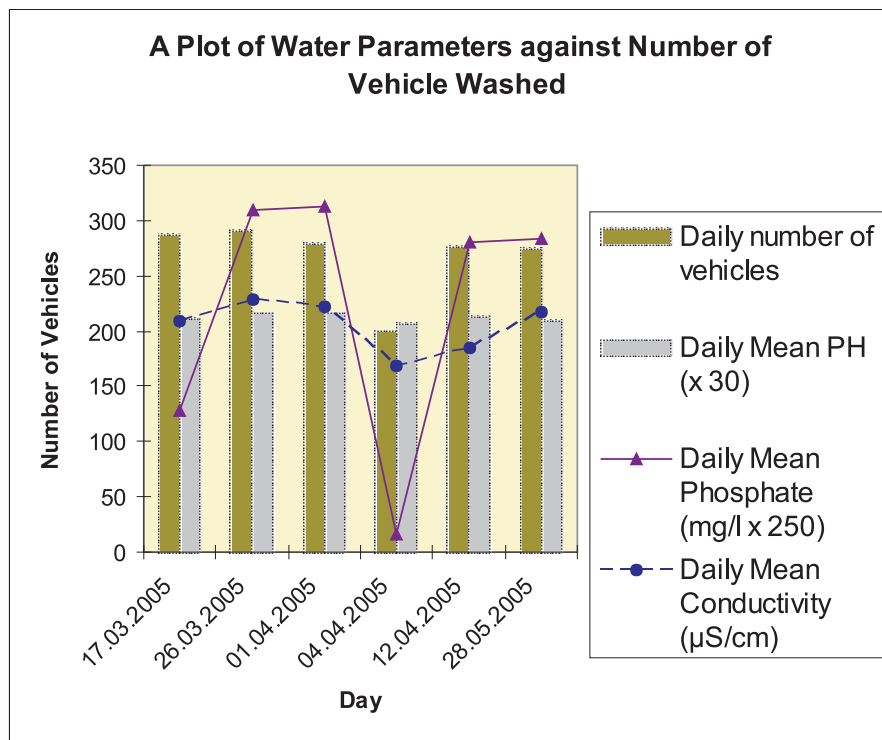
Figure 14: Correlation between water quality parameters and total number of daily vehicle count

High conductivity recorded at the point 1 (i.e., $301\mu S/cm$) indicate the in-coming urban runoff to have high concentration of metals. These is expected as the garages are engaged with so much metal works and often deal with solutions and chemicals, most of which find their way into the lake. Figure 14 indicate the phosphate and conductivity values to be particularly low on the fourth of April, thus coinciding with the day when the number of cars washed was low. A strong correlation coefficient of 0.81 indicate a strong correlation between the total number of vehicles washed and the measured conductivity. For the same area, Njuru and Hecky (2005) indicate an average conductivity of $171\mu S/cm$. The average of the car washing points (2,4 and 5) in these study from Table 4 is $180.3\mu S/cm$, i.e., an increase of about $9.3\mu S/cm$ or a contribution of about 5.5% from direct car washing. For the runoff point 1, this will be 76% increase in metallic substances from open shed garages. Undisturbed point 6 recorded a higher value of 19.8%. This could be due to other Municipality waste, i.e., from a burst sewer.

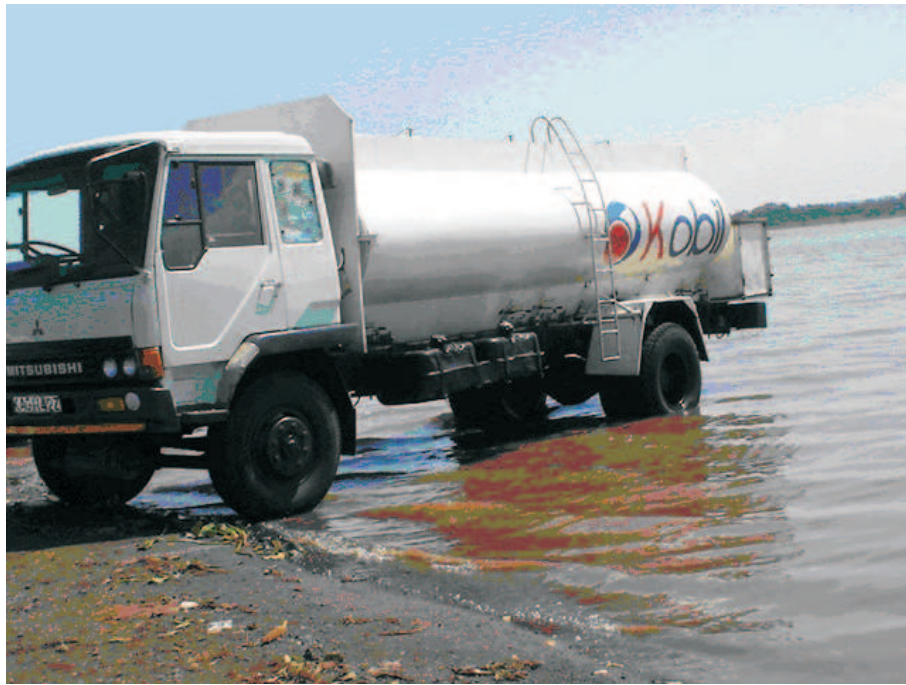
Figure 15: Washing of petroleum vehicles at Kichinjio beach

count in contrast was recorded after 6pm. Though few, buses and trailer trucks (tankers) were recorded being washed at the site (see, Figure 15). The number of vehicles being washed was fairly constant throughout the period of the study apart from 4th of April when a general low count was recorded in all categories apart from lorries. The 28th of March recorded the highest vehicle counts.
