Article

The Case Study of the Medieval Town Walls of Gubbio in Italy: First Results on the Characterization of Mortars and Binders

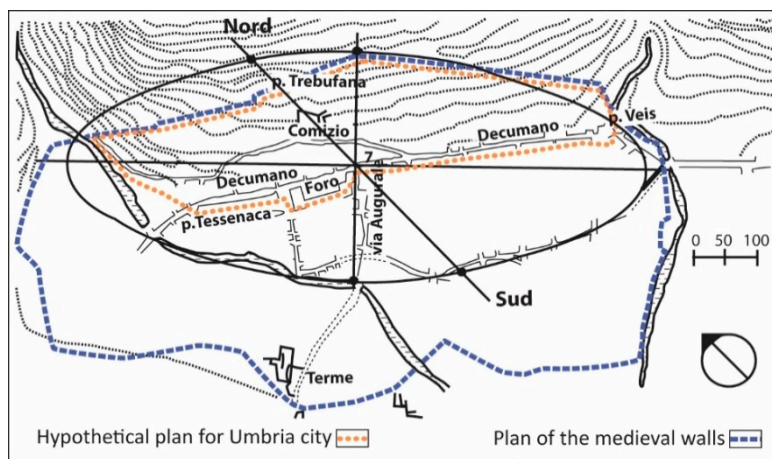
Figure 1. Ancient Umbrian walls (XV BC. to IV AC.) (in orange) and medieval walls (in blue). Adapted from HERACLES Project [15].

Inserted in the urban landscape, the Town Walls of Gubbio are a fundamental part of the city. Archaeological remains indicate that the construction of the walls dates from before the medieval period and that at least part of its structure may have initially been built as a protection system of the village against the floods of the river Camignano [11]. The Middle Ages were marked by the strong expansion of several cities in the central and northern regions of Italy, in which the expansion and adaptation of the walls assumed both the functions of defense of the village and urban planning [12,13]. Gubbio was an important city in the medieval period and its walls accompanied its development, mainly from the beginning of the 14th century, when the walls also played a protective role of the village against the attacks of enemies and invaders [13]. The tracing of the medieval walls accompanied the old walls along the slope of Ingino Mount, in the N–NE direction. The extension located in the lower part corresponds to the expanded territory. The construction of this extension of the walls was completed before 1350 [14] (Figure 1).

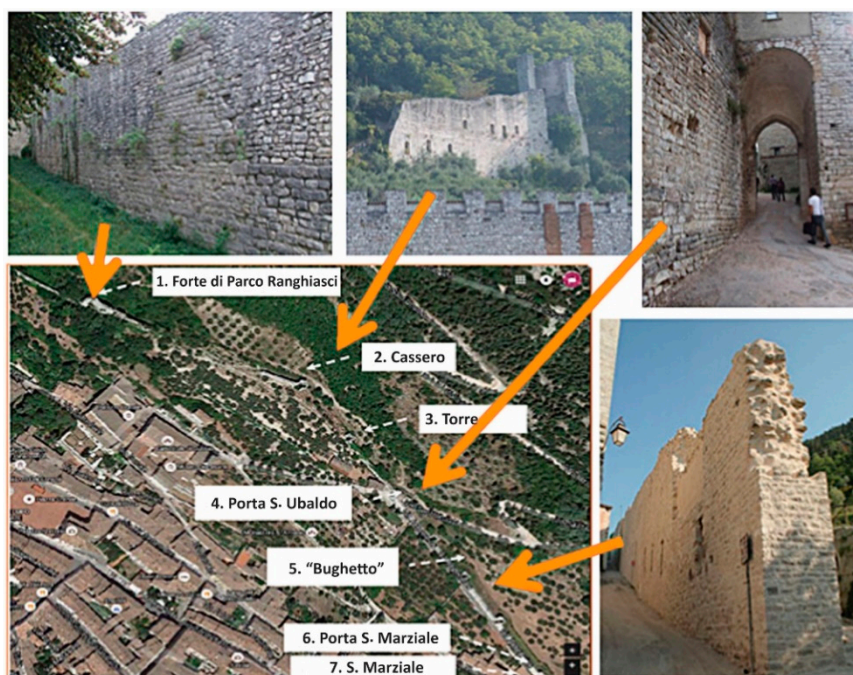
Figure 2. Old town wall—sample collection sites: Fort of the “Ranghiasi” park (1); “Cassero” (2); Tower (3); Gate of St. Ubaldo (4); “Bughetto” (5); Gate of St Marziale (6); St. Marziale Church (7).

At least three types of stones were used in the construction of the oldest part of the walls, namely, limestone, travertine, and sandstone joined by mortar. The medieval walls also present apparent material differences, resulting from successive construction additions, reinforcement of the structure, and restoration/renovations that occurred over the centuries. For the HERACLES Project, five zones of the walls were chosen as the focus for sample collection and material characterization in the laboratory (ex-situ analysis). However, the materials collected in Zone 1 do not correspond to mortar samples, and therefore are not included in this study. The location of the sampling zones shown in Figure 2 are: Zone 1—“Forte di Parco Ranghiasi”; Zone 2—“Cassero”; area between Zone 3—“Torre”—and Zone 4—“Porta S. Ubaldo”; area between Zone 4—“Porta S. Ubaldo”—and Zone 5—“Bughetto”; Zone 5—“Bughetto”.

It is estimated that the oldest part of the walls corresponds to Zone 1, completed in 1301. Zone 2, also built in the Middle Ages, underwent several changes in the late 14th and early 15th centuries and was largely destroyed in the nineteenth century. Zone 3 does not present signs of recent intervention. Zones 4 and 5 correspond to the same period of construction of Zone 1 but suffered the largest interventions in relation to the removal of accumulated land against the walls and actions of restoration and preventive conservation.

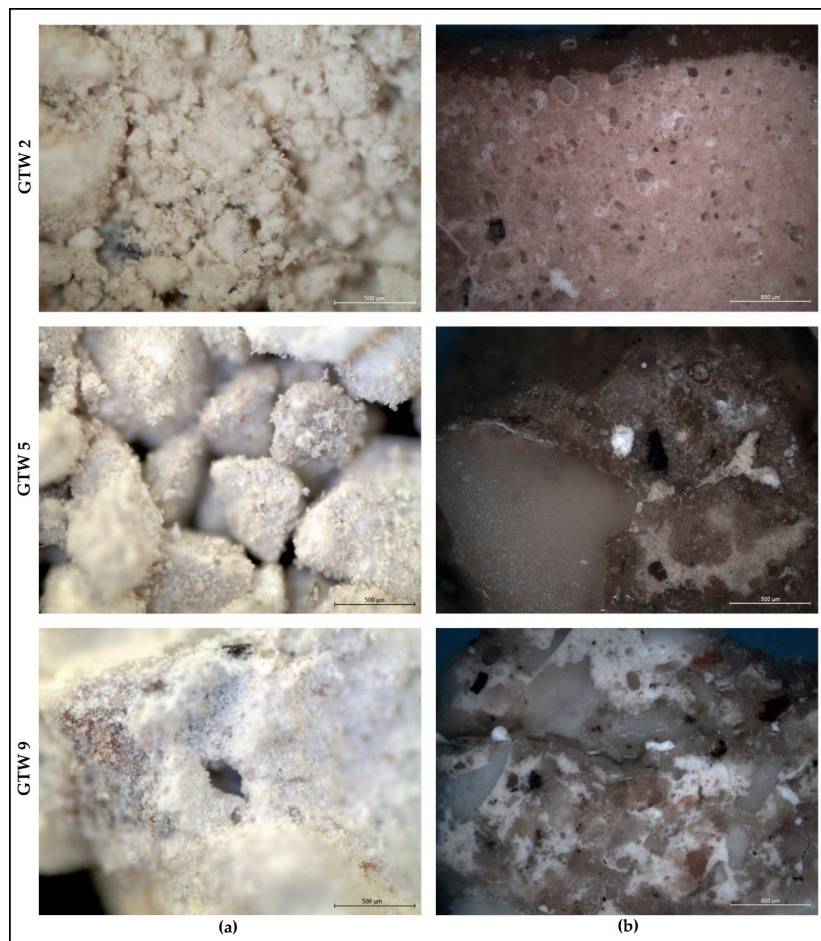
Figure 3. OM observation of mortar samples 2, 5, and 9, (a) direct mode and (b) polished sections. All observation was done in darkfield observation mode and 5× magnification.

Considering the morphology of the material, the mortar samples show a great variation of granulometry of aggregates. Through optical microscopy, it was possible to note that two of the samples exhibit relatively homogeneous dimension of grains, approximately $75\ \mu\text{m}$ (GTW 2 and GTW 4), well distributed in the binder matrix. The regular size of the grains can be related with the quality of the mortar and the homogeneous distribution of aggregates suggests a good mixing process during mortar preparation [18]. However, for the remaining samples, the size, shape, and color of the grains are quite varied, as is the dispersion of aggregates in the binder. In general, the binder shows a pink homogeneous coloration but in some samples appears mixed with portions of lighter color. Figure 3 illustrates the main characteristics observed for the mortars of the medieval walls of Gubbio. The OM direct observation was performed on disaggregated parts of the samples, while the polished section observation was performed on fragments of these same samples. This variation of the observed morphology is not, apparently, reflected in the results of the chemical analysis.

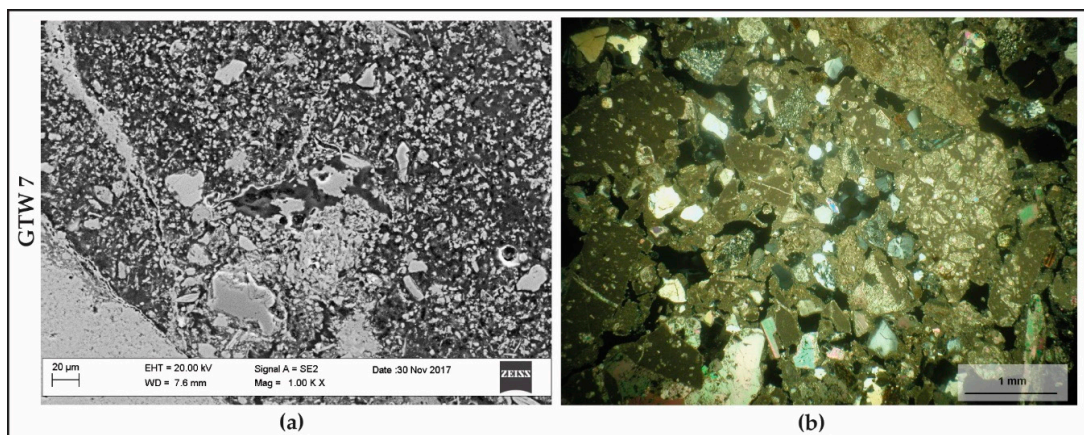
Figure 4. (a) SEM micrograph of sample GTW7 (1.0 kX), where porosity of sample can be observed. (b) Sample GTW7 observed in crossed-polarized light, where it is possible to observe the aggregates of the mortar sample.

In general, the mortar contains coarse aggregate grains of calcareous lithotypes and, in some cases, the aggregates are in the range from 1 to 2 mm, angular to sub-rounded in shape. Fine aggregate grains consist of dominant limestone, polycrystalline sparite and chert and subordinate arenite, calcarenite, and metamorphic and igneous rocks. Monocrystalline grains include quartz, plagioclase, K-feldspar, biotite, white mica, and sparry calcite. Foraminifera skeletons along with rare vegetable fibers and *cocciopesto* fragments are also present. The binder is a poorly homogeneous micritic lime matrix with uncarbonated lumps of lime and ca. 5–10% vol porosity due to irregular-shaped voids and fissures (Figure 4b). The internal cracks in the binder can have different causes, which may result from the process of hardening of the mortar, freezing and thawing cycles, mechanical movement processes, crystallization of salts, lack of adhesion between aggregates and binder, tensions caused by expansion and retraction of the components, and low quality of mortar preparation, among other factors [18,19].

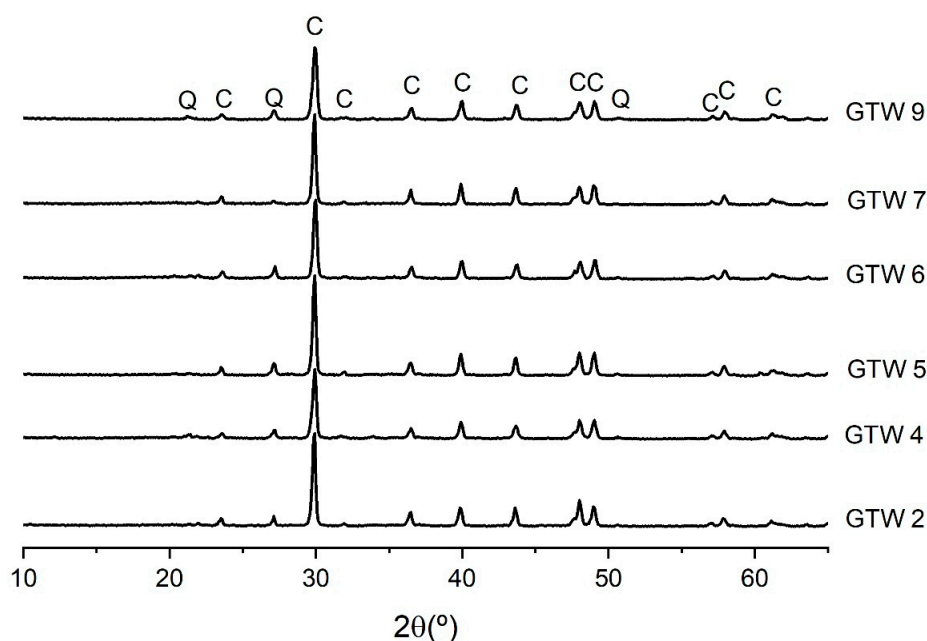
**Figure 5.** XRD results for Gubbio Town Walls samples. C—Calcite (CaCO₃) (5-0586), Q—quartz (SiO₂) (46-1045).

Despite the observations made by polarized light microscopy (PLM) of the assorted nature of the aggregate, X-ray diffraction results did not reflect this variety. The resulting data indicate that calcite and quartz are the main crystalline components for all samples, with very slight differences (Figure 5). Other crystalline phases have been identified based on very low intensity peaks only in a few samples, being attributed to gypsum and possibly some feldspar. Gypsum was identified in samples presenting the highest sulphur content (Table 2). It is important to note that XRD and WDXRF assays were performed in macerated samples, without the separation of the binder and aggregate. WDXRF results showed calcium and silicon as the components with the highest concentration for all samples. As observed by PLM, most of the aggregates, especially the coarser grains, are calcitic in nature, while the finer grains were identified as noncalcitic. Considering that the ligand is also composed of calcite, XRD results reflect the predominance in intensity of the crystalline phases of the main components.

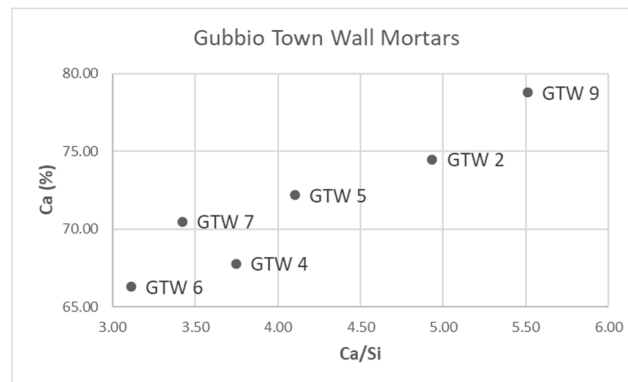
**Figure 6.** Ca/Si ratio compositional trend for Gubbio Town Walls samples.

Based on the results obtained, a relationship was established between the two main components identified, calcium and silicon (Table 3) [20,21]. Although this relationship cannot correspond directly to a value of the ligand/aggregate ratio once calcium is included in components other than the ligand, as identified by polarized light microscopy (Figure 4b), it may assist in the perception of a compositional trend between samples (Figure 6). It is possible to perceive that the two samples that present Ca/Si ratio values close to or greater than 5 correspond to the samples collected in areas where the mortars were considered recent.

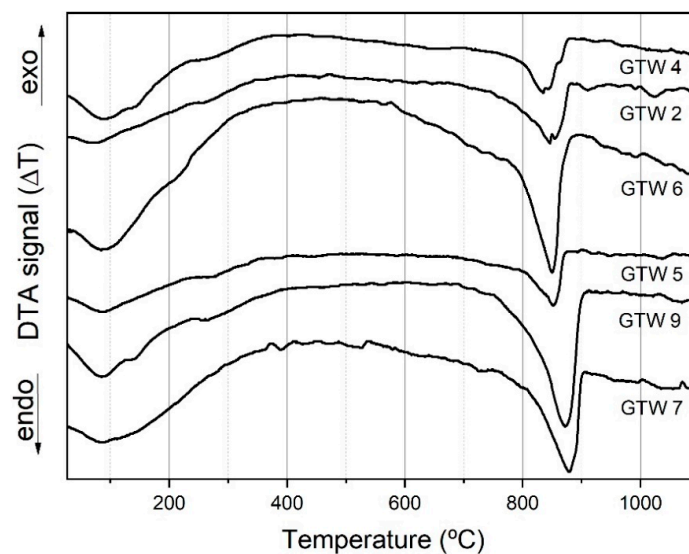
**Figure 7.** Comparison between differential thermal analysis (DTA) curves of mortar samples from the Gubbio Town Walls.

Despite the visible differences in the appearance of specimens observed in OM, the results obtained with TG-DTA showed a similar trend for all samples (Figure 7), with calculated mass loss between 19% and 24%. Mass loss below 110 °C is not considered, because samples were kept in a drying oven for 1 h at that temperature before the start of the measurement for the elimination of the adsorbed water. For this study, the water loss of hydrated compounds was considered from the difference between the total mass loss and loss due to CO₂ during decarbonation. The main mass loss was observed in the endothermic peak starting at 600 °C associated with the release of CO₂, due to the process of decomposition of carbonates. The maximum processing temperature of the carbonate occurs between 750 °C and 850 °C [6,22]. In the case of the medieval wall samples, the maximum transformation takes place between 800 °C and 850 °C (Figure 7).

Two of the samples present a DTA curve with a double endothermic peak near 130 °C, attributed to the loss of hydrated water from gypsum [6,23], which confirms the presence of this component in samples GTW4 and GTW9, also identified by XRD. This gypsum may be associated with the deterioration of the mortar, arising from the reaction with pollutants, or may have been added in the formulation of the mortar [6]. The calculated values for mass loss and water loss resulting from TG analysis are presented in Table 4. Water loss occurring below 200 °C corresponds to some water adsorbed and the loss of water from hydrated salts. Between 200 °C and 600 °C, that loss corresponds to the structural water of hydraulic compounds present in the samples [6,23,24].
