**Distributed fiber optics sensing and coda wave
interferometry techniques for damage monitoring in
concrete structures**

Antoine Bassil, Xi Wang, Xavier Chapeleau, Ernst Niederleithinger, Odile
Abraham, Dominique Leduc

Distributed Fiber Optics Sensing and Coda Wave Interferometry Techniques for Damage Monitoring in Concrete Structures

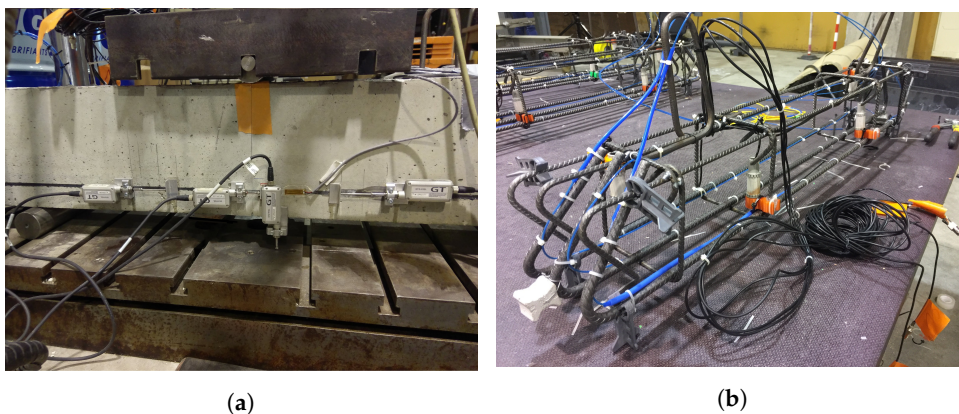
Figure 3. (a) front view of the loading arrangement and the beam instrumented with sensors before testing; (b) Ultra Sonics (US) and Distributed Fiber optics (DFO) sensors attached to the rebars before casting of concrete.

A $20 \times 20 \times 100$ cm reinforced concrete beam was tested under continuous three-point loading with a loading speed of 1 kN/min (Figure 3a). As shown in Figure 4a, the beam was reinforced with three $\phi 10$ longitudinal reinforcement bars (rebars) in the tension area and three $\phi 6$ rebars in the compression area, attached together by four $\phi 6$ stirrups. The beam was instrumented with SG (green color), LVDT (grey color), Ultra Sonic US (red color) and DFO (blue color) sensors. Before casting of concrete, four US sensors were attached to the stirrups while one optical cable was fixed over the length of four rebars (Figure 3b). After casting, the same optical cable was bonded to the surface of the beam by making a groove in the concrete at the same level of rebars and gluing the optical cable using a two components epoxy adhesive.

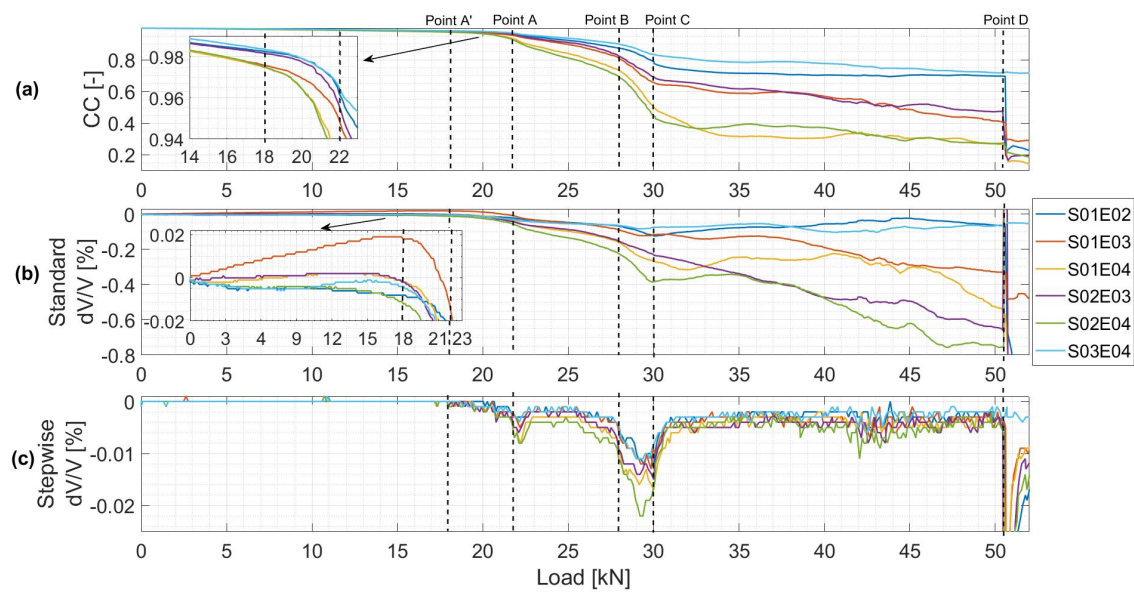
Figure 9. (a) CC plots for each $S_{xx}E_{yy}$ combination. (b) dV/V plots for each $S_{xx}E_{yy}$ combination. (c) Stepwise dV/V plots for each $S_{xx}E_{yy}$ combination.

The CC and dV/V values, calculated by standard and stepwise CWI for all different combinations of sensors $S_{xx}E_{yy}$ (transmitter xx and receiver yy), are plotted in Figure 9. A reference signal was chosen for standard CWI calculations before any load was applied. The CC values for all different combinations decrease as the load increases continuously during the test (Figure 9a). CC and deflection plots took a similar trend as they are related to the stiffness of the reinforced concrete beam. As micro cracks propagate over the height of the beam, the similarity between the ultrasonic signals reduces and is accompanied by a rapid decrease in CC values. Similarly, standard dV/V values decrease during the test depending on stress changes and positions of the sensors (Figure 9b). During the linear elastic state, these values vary between 0.02% and -0.01% for S01E03 and S02E04 combinations where the two sensors were positioned, respectively, in the upper and bottom part of the beam. While dV/V decreases for combination S02E04, S01E03 dV/V increases linearly with the increase in compression stresses in the upper part of the beam. Indeed, the stress–velocity variation coefficient changes between different combinations depending on the location and the distance between the two transducers [34]. Local velocity changes compared with the previous signal are observed clearly from stepwise dV/V (Figure 9c). The changes in stepwise dV/V plots help distinguishing four main remarkable load levels similar to those observed in the deflection plots. CWI results and their relation to damage propagation will be discussed and compared with other sensors in Section 5.1.3.

While Figure 9 presents the results of CC and dV/V calculated from US sensors measurements, Figure 11 shows the DFO strain measurements at the location of cracks 1 and 2 compared to displacements (crack openings) and strains measured respectively by LVDT (1, 2, 3) and SG (1, 2). Cracks 1 and 2 refer to the first crack detected at the center of the beam and the second one 20 cm away from the center (monitored by LVDT 3).

The formation of crack 1 is first detected by US and DFO sensors. When the load exceeded 18 kN, a first variation in velocity for S02E04 combination is observed from stepwise dV/V plot (Figure 9c). This decrease in dV/V followed shortly by other combinations is due to the propagation of the micro crack. The standard dV/V plots show that this fall in dV/V value is the highest between the two closest transducers located on the bottom part of the beam (combination S02E04). On the other hand, the smallest variations are observed for combinations S01E02 and S03E04 as the direct waves between these transducers do not bridge through the crack. CC plots follow a similar trend as dV/V plots.

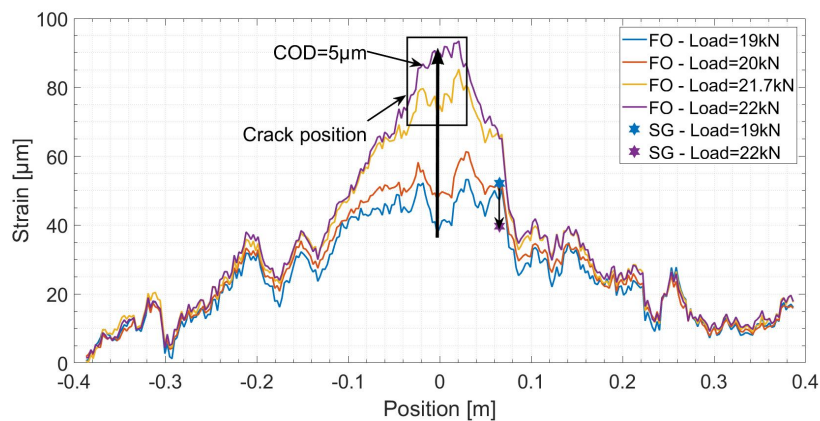
Figure 10. Spatial strain distribution over the length of Fiber Optics (FO) Line 1 before and after the creation of the first micro crack.

Figure 10 shows the measured strain versus the position for different load levels. For the specific (cable, glue, concrete) combination used in this experimentation, a crack opening of $5\ \mu\text{m}$ resulted in an increase to 200% in the strain measured near the location of the crack. On the other hand, the strain measured by SG sensors decreased to 80% at 6 cm far from the crack location. If the crack location were closer to the SG sensors, a bigger rate of strain decrease would have been detected. However, if the crack bridged through the SG sensor, high strain values would have been measured. Since these two cases are rare when instrumenting real scale structures, crack detection using SG sensors is in most cases an indirect detection.

The shear lag parameter, estimated by fitting Equation (1) to the measured strain profiles, has a constant value that varies between 22 and 28 m^{-1} for each FO Line. Thus, the DFO system with a strain resolution (1 $\mu m/m$) and strain repeatability ($\pm 2 \mu m/m$) can therefore detect the change in CIS around 5–7 times less than $\frac{\beta}{2}$ value. While the latter corresponds to an increase of 1 μm in COD, LVDT sensors used in this experiment with a resolution of 1 μm , are therefore 5–7 times less sensitive to micro crack propagation than the DFO system.
