47<sup>TH</sup> TURBOMACHINERY & 34<sup>TH</sup> PUMP SYMPOSIA  
HOUSTON, TEXAS | SEPTEMBER 17-20, 2018  
GEORGE R. BROWN CONVENTION CENTER

# Correction of High Vibration on a Vertical Turbine Deep Well Pump with a Dynamic Vibration Absorber

# Case study on the correction of chronic high vibration on a Vertical Turbine Deep Well Pump with a Dynamic Vibration Absorber

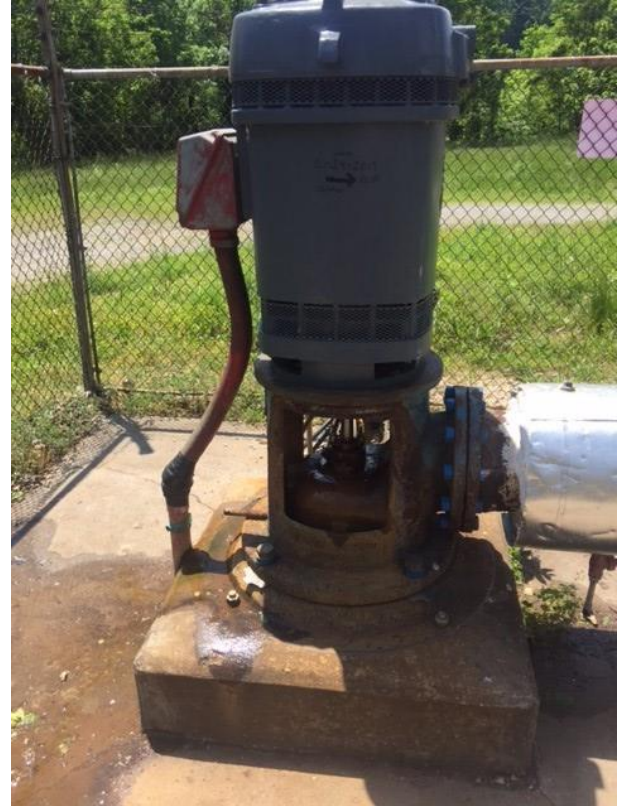
- A 100hp, 1780 RPM, 180 ft. deep well vertical turbine pump experienced chronic recurring high vibration.
- Despite multiple repair and rebuild attempts to the pump, motor, and foundation the issue would return within a few months of operation.
- This pump was rebuilt in early March, 2017 and experienced alert and fault level alarms ( $> 0.8$  ips velocity overall) by late April.

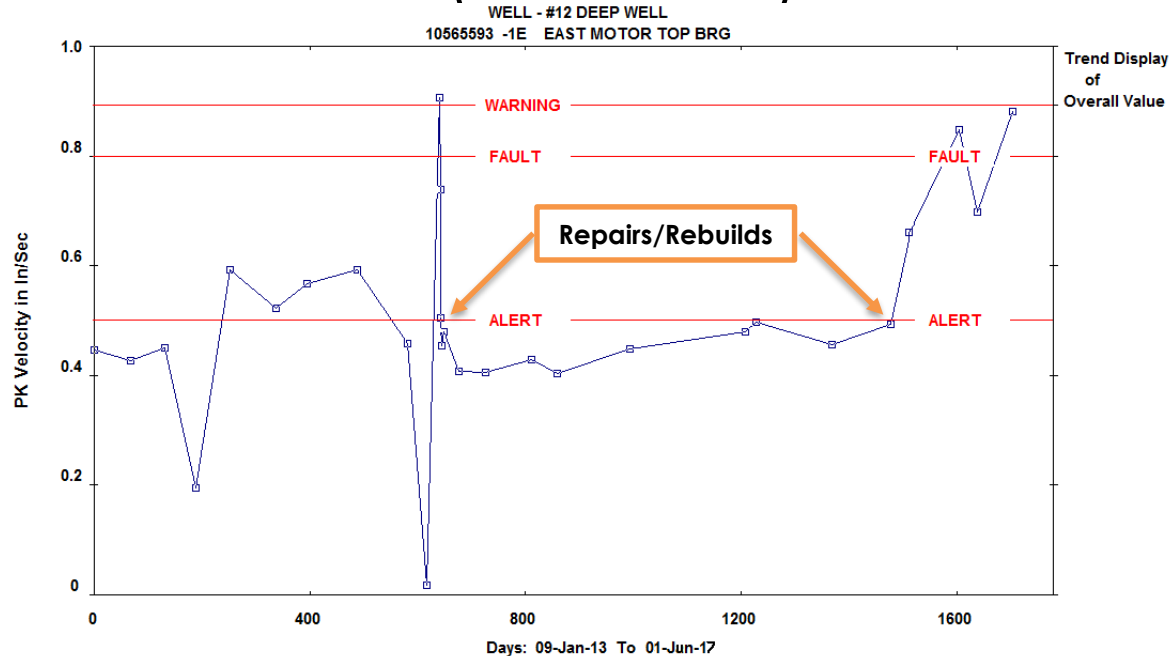
- Consistently recurring high vibration despite multiple repairs and rebuilds (2013-2017)

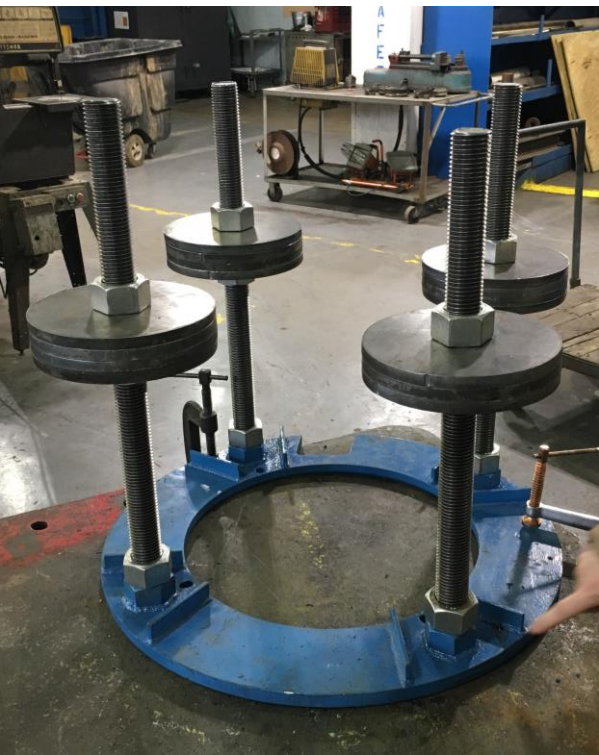
# Dynamic Vibration Absorber Design

- The initial design to use one weight plate supported by four threaded rods was impractical due to the difficulty of tuning.
- To solve this, the weight was divided in four and individual weight plates were placed on each of the four threaded rods. This method was much easier to install and tuning was predictable with length.

- Dynamic absorber chosen for practicality and for proximity to a second natural frequency
- A design routine published in 1998 November Edition of Sound and Vibration Magazine authored by Richard Smith “Dynamic Vibration Absorbers” was utilized for absorber engineering
- Cardboard templating came in handy too

Weight of Motor	lb	1200	$M_{eff} = \frac{W \times (MER)}{g}$	Weight Per Foot of Rod	lb /in of 1.5" all t.	0.462
Mass Effectiveness Ratio		0.9		Weight of spring	lb	22.176
Mass Effectiveness Ratio	in*lb/sec^2	2.797927461		Mass Effective Correction	lb	102.1527045
				Mass Per Spring		25.53817613
				<b>Support Plate</b>		
Resonance Frequency	CPM	1780	$dt = \left(\frac{1}{RPM}\right) \left(60 \frac{Sec}{Min}\right) \left(\frac{1R}{4}\right)$	Plate Thickness	in	0.75
Measured Velocity	in/sec	1		Plate Inner Diameter	in	16.5
Elapse Time - dT (1/4 Cycle)	sec	0.008426966	$a_{ave} = \frac{v \frac{inch}{sec}}{Time \ sec}$	Plate Otter Diameter	in	25.25
average acceleration	in/sec^2	118.6666667		Plate Volume	in^3	215.1866432
peak acceleration	in/sec^2	186.3066667	$a_{Peak} = 1.57 \times a_{ave}$	Weight Per Volume	lb/in^3	0.284
Weight (Force)	lb	521.2725389		Weight of Plate	lb	61.11300666
			$F = M \times A$			
				<b>Weight Plates</b>

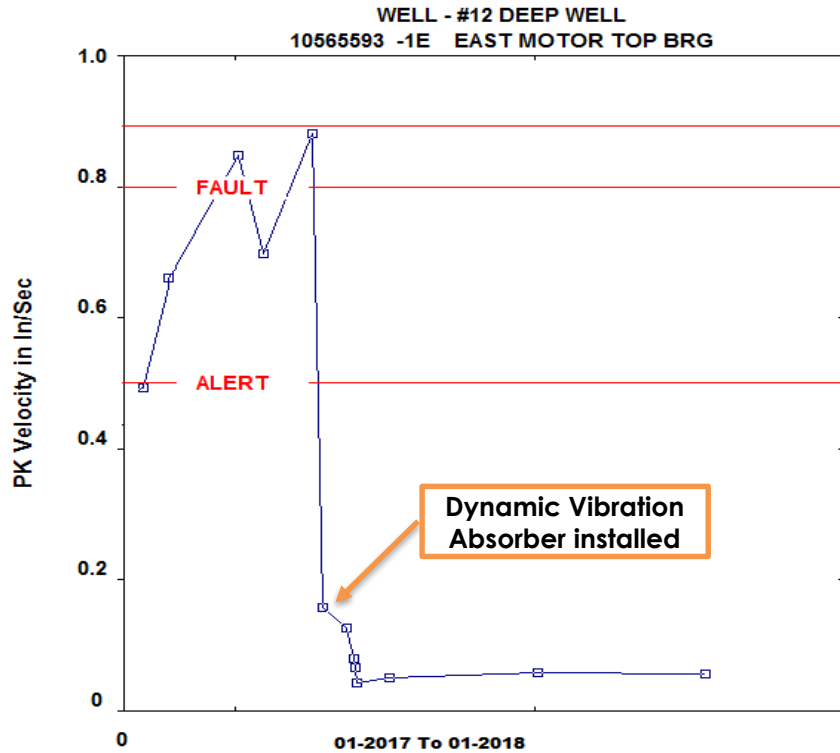
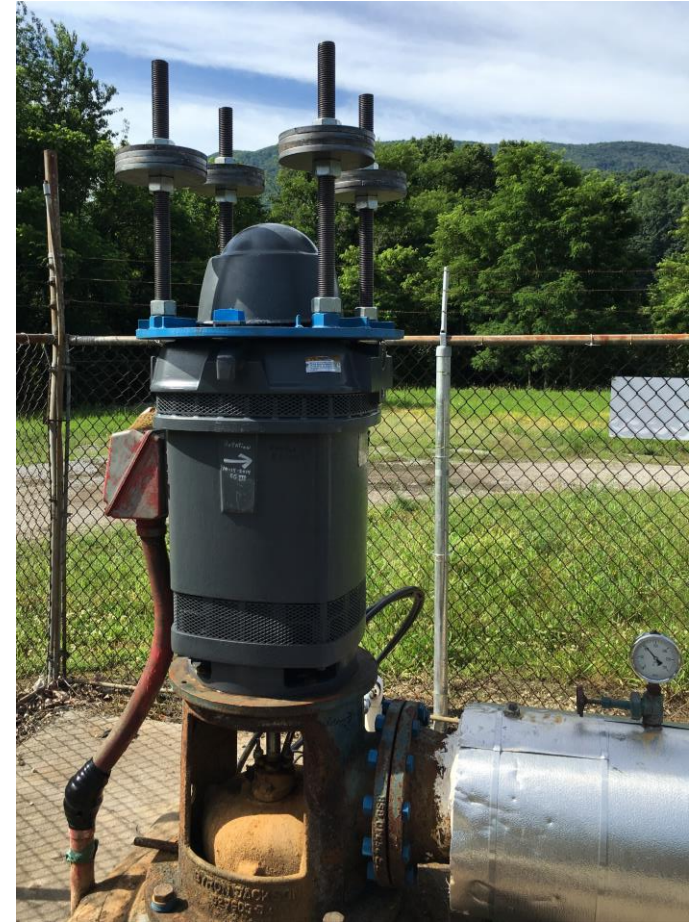
# Results

- Overall vibration was reduced from 0.947 inches per second to 0.058 inches per second peak velocity.
- 9 months run-time (to date) with no failures or significant changes in overall vibration
