# A PRELIMINARY FEASIBILITY ANALYSIS ABOUT THE STRUCTURAL HEALTH MONITORING OF RAILWAY CONCRETE SLEEPERS BY ACOUSTIC EMISSION AND DIGITAL IMAGE CORRELATION

Michele CARBONI\*, Andrea COLLINA, Rui LIU, Emanuele ZAPPA

Politecnico di Milano, Dept. Mechanical Engineering, Via La Masa 1, 20156 Milano, Italy

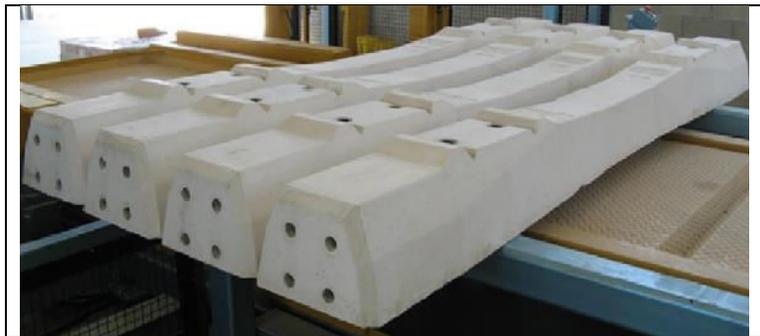
Fig. 1 Examples of prestressed railway sleepers.

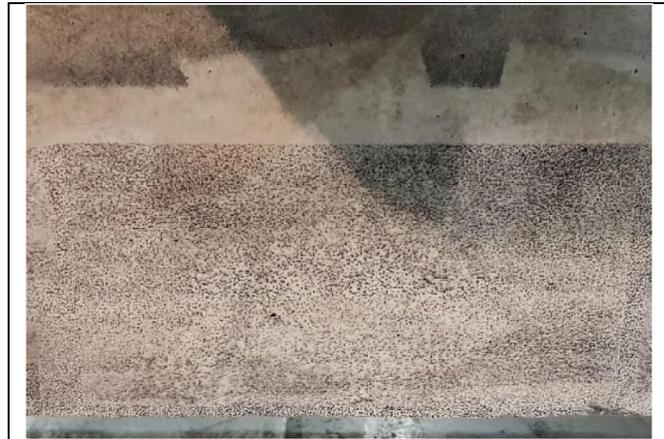
**Fig. 5** Speckled region of interest of the tested sleeper.

In order to improve damage evaluation during the test, 2D DIC was applied. Images were recorded by means of a GX3300 digital camera equipped with a Zeiss lens of 50 mm optical length. The camera was mounted on a tripod in the front of the sleeper, to face the area where cracks were most likely to appear (Fig. 2b), and was connected to an external PC controlling the camera itself by means of a custom software developed in National Instruments LabVIEW environment. Since good lighting conditions were required, two LED lamps were used. A camera calibration procedure was carried out in order to compensate for perspective distortion and to define the conversion scale from pixel to [mm] (0.083 mm/pixel). The region of interest was speckled (Fig. 5) by an airbrush, a compressor and black opaque paint. To create a controlled speckle size and distribution, a chemically machined steel plate was used as a stencil. The feature pattern of the obtained speckle is characterized by an average diameter of 3-5 pixel and a coverage factor of 40%-70%: which is in the range of optimized speckle size for DIC.
