Willem Faes*, Steven Lecompte, Zaaquib Yunus Ahmed, Johan Van Bael, Robbe Salenbien, Kim Verbeken and Michel De Paepe

Corrosion and corrosion prevention in heat exchangers

Abstract: In many industries and processes, heat exchangers are of vital importance as they are used to transfer heat from one fluid to another. These fluids can be corrosive to heat exchangers, which are usually made of metallic materials. This paper illustrates that corrosion is an important problem in the operation of heat exchangers in many environments, for which no straightforward answer exists. Corrosion failures of heat exchangers are common, and corrosion often involves high maintenance or repair costs. In this review, an overview is given of what is known on corrosion in heat exchangers. The different types of corrosion encountered in heat exchangers and the susceptible places in the devices are discussed first. This is combined with an overview of failure analyses for each type of corrosion. Next, the effect of heat transfer on corrosion and the influence of corrosion on the thermohydraulic performances are discussed. Finally, the prevention and control of corrosion is tackled. Prevention goes from g

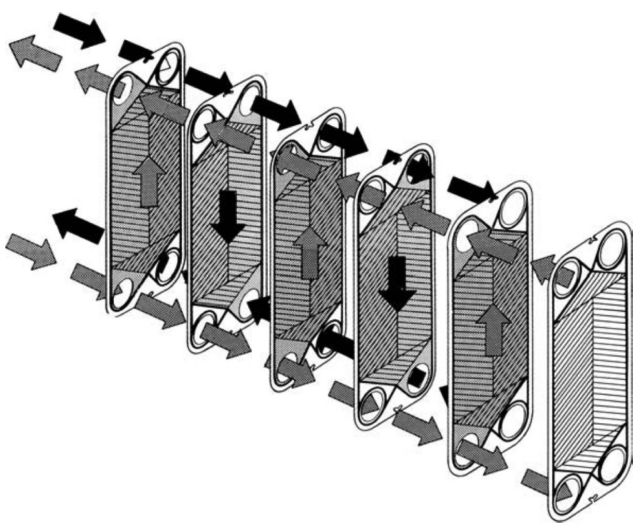
Figure 2: Plate heat exchanger with indicated flow paths. Republished with permission of Taylor & Francis Group LLC, from Kakaç et al. (2012); permission conveyed through Copyright Clearance Center, Inc.

Plate heat exchangers consist of a number of thin plates, mounted behind each other in a frame (Kakaç et al., 2012). A gasket is placed between two adjacent plates to determine the flow path and to prevent the fluid from leaking to the environment. The plates are typically corrugated to improve the heat transfer. The working principle is illustrated in Figure 2.

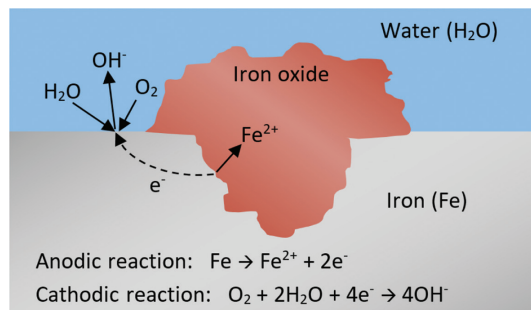
Figure 3: Schematic representation of the corrosion process of iron-based alloys in aqueous solutions.

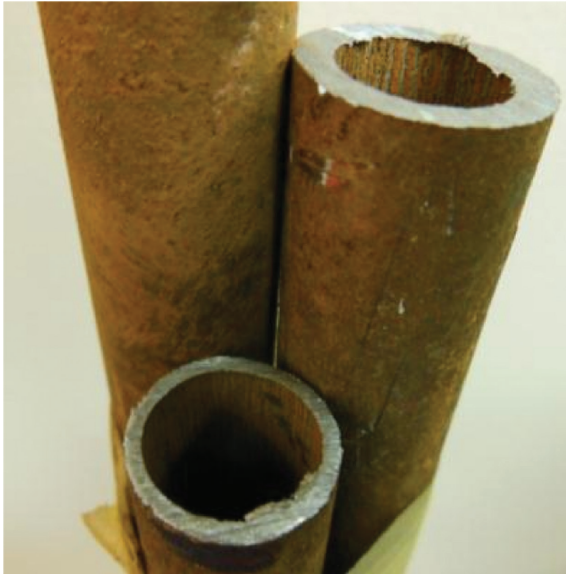
Figure 4: Section of the tube with severe uniform corrosion and wall thickness reduction.

The uniform corrosion was more severe at the cooling water side than at the internal surface of the tubes. However, uniform corrosion was not the only type of

corrosion observed inside the tubes; localised forms of corrosion, like pitting corrosion (Section 2.2) and erosion corrosion (Section 2.5), were also detected.

The recommendations made by the authors were adaptation of the water discharge to avoid the accumulation of non-condensable gases and a different type of steel.

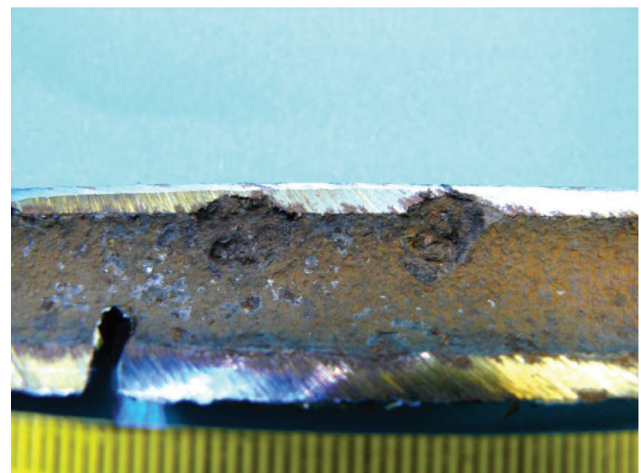
Figure 5: Cross section of a tube damaged by pitting corrosion. Reprinted from Julian et al. (2015), with permission from International Geothermal Association.

The shell-and-tube heat exchanger discussed in the failure analysis by Julian et al. (2015) was used in a geothermal plant. Deep pits, of which some perforated the tube, were discovered in the middle tubes (the lower and upper tubes were free of pits). Figure 5 shows a cross section of a part of the tube where pits are present. It was found that the

lower and upper tubes were preferentially filled with brine and steam, respectively, while the middle tubes received a mixture of condensing steam and brine. These conditions caused an increasing concentration of acid gases like CO_2 and H_2S in the condensing water, making it even more acidic. This locally high acidity was suggested as the reason for the rapid development of pits in only one row of tubes. Also, elemental arsenic, which precipitated from the brine, was observed in the pits, which might have enhanced corrosion by galvanic effects (galvanic corrosion is discussed in Section 2.7).

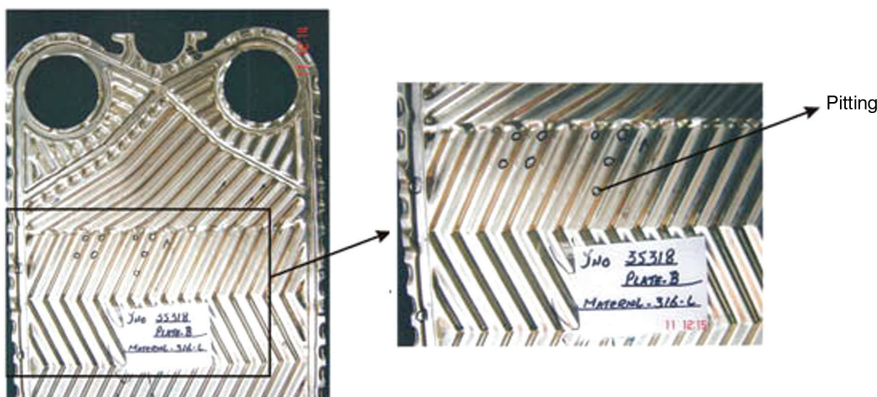
Figure 6: Pitting corrosion damage in a plate heat exchanger. Reprinted from Deen et al. (2010), with permission from Elsevier.

An example of a plate heat exchanger that failed due to pitting is described by Deen et al. (2010). In their study, the failure of a heat exchanger with plates constructed with type 316L stainless-steel plates ($\text{PREN} \approx 24.2$) is investigated. The device was used in the cooling loop of textile mill. A 316L stainless steel was originally chosen for its corrosion-resistant properties; however, when the heat exchanger was opened for maintenance after 2000 h of operation, it was observed that several of the plates were perforated by pits. An example of a failed plate can be seen in Figure 6. The authors concluded that a local breakdown of the passive oxide film occurred, which was caused by high chloride contents in the cooling water.

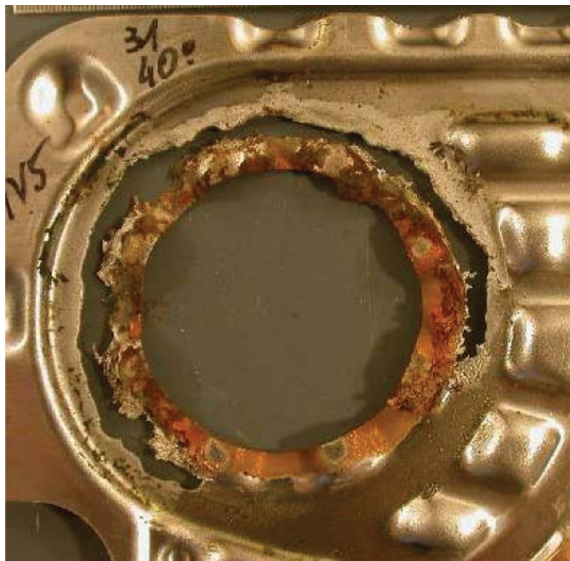
Figure 7: Crevice corrosion under the gasket of a plate heat exchanger.

The studies by Crum et al. (2007) and Cassagne et al. (2010) illustrate the difficulty of avoiding crevice corrosion in plate heat exchangers for seawater applications. In both studies, several metals are tested as plate material at elevated temperatures (up to 70°C) with both laboratory tests and exposure to real seawater (with controlled chlorine concentrations, added to suppress marine life) in dummy heat exchangers. The metals tested were super-austenitic stainless steels, nickel-chromium-molybdenum alloys, and titanium. Almost all metals, even titanium, showed signs of crevice corrosion in the most severe conditions. Only the most recent Ni-Cr-Mo alloys, like alloy 686 [Unified Numbering System (UNS) N06686], could withstand the corrosive environment. An example of severe crevice corrosion at the gasket area of a plate made from alloy 31 (UNS N08031) is shown in Figure 7. More cases of crevice corrosion in plate heat exchangers were described by Turissini et al. (1997).

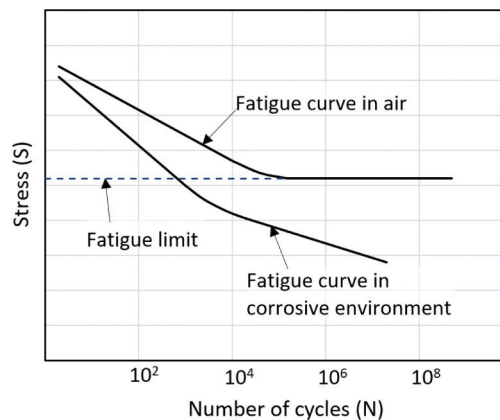
Figure 8: S-N curve illustrating the influence of corrosion on fatigue behaviour.

A second kind of corrosion where stresses play a role is corrosion fatigue. This is characterised by a fluctuating load substantially below the yield point. The fatigue behaviour of metals is affected by corrosive media. Figure 8 illustrates the influence of corrosion on the fatigue behaviour with an S-N curve. It can be seen that failure occurs within fewer cycles for a given stress, and a fatigue limit is no longer observed (Revie & Uhlig, 2008). Similar to SCC, corrosion fatigue is often initiated at various types of stress concentrations (Wang et al., 2007).

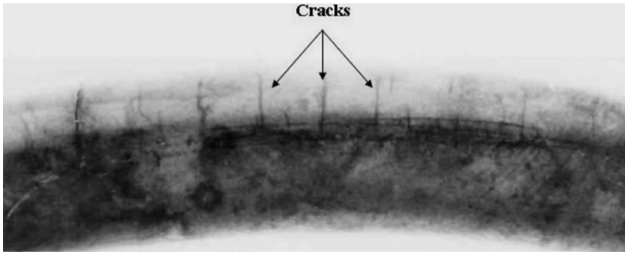
Figure 9: Stress corrosion cracks induced in a bend by polythionic acid.

Tawancy (2009) analysed the failure of a shell-and-tube heat exchanger used in an oil refinery. Leaks were detected in some bends after 48 h of starting the unit after a period of downtime. The conclusion of the author is that during the shutdown, polythionic acid was formed from sulphur-bearing deposits and condensed water vapour. This acid, in combination with internal stresses in the bend, induced the cracks in the metal (type 321 steel), shown in the photograph of Figure 9.

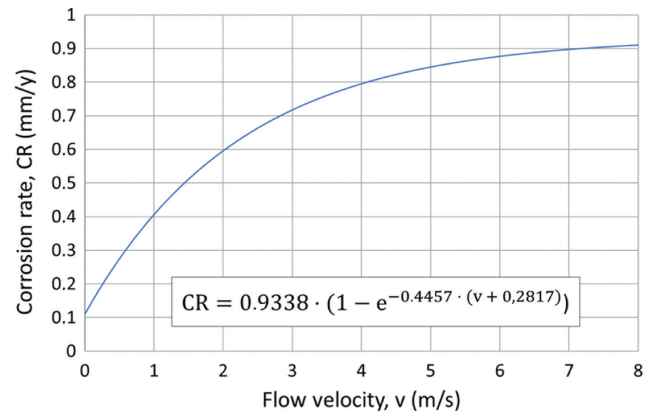
Figure 10: Effect of flow velocity on the corrosion rate of carbon steel in seawater.

Erosion corrosion is the synergistic interaction between corrosion and erosion, caused by a relative motion between a corrosive fluid and a metal wall. The combined effect of the two phenomena is larger than corrosion or erosion separately. The phenomenon normally occurs under turbulent flow conditions. Surface material is removed by the fluid shear stress, and a protective corrosion film (e.g. formed on stainless steel or aluminium) can be destroyed by the motion of the fluid. The damage increases with increasing fluid velocity, and most metals have a critical velocity above which the corrosion rate strongly rises due to the destruction of the protective film (Wang et al., 2007). In seawater, where there is a high chloride concentration, stainless steel might not be able to establish passivity, causing the corrosion rate to increase with flow velocity (Revie & Uhlig, 2008). A relationship between the flow velocity of seawater and the corrosion rate of carbon steel was proposed by LaQue (1948). This relationship was fitted to an exponential function by Guedes-Soares et al. (2011), as shown in Figure 10.

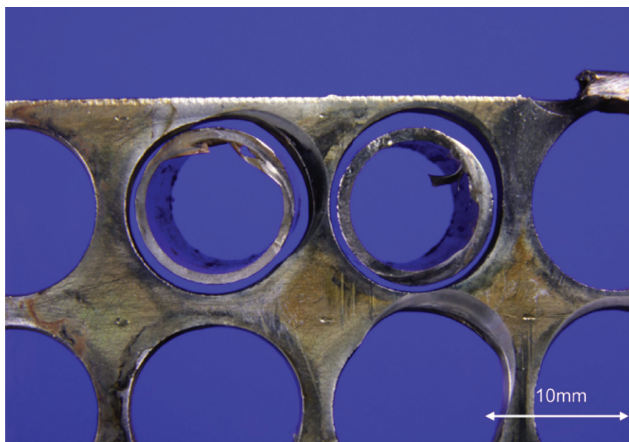
Figure 12: Worn-out holes in a baffle plate. Reprinted from Klein et al. (2014), with permission from Elsevier.

An example of a shell-and-tube heat exchanger that failed because of fretting corrosion is discussed by Klein et al. (2014). In a wastewater plant, hot vapours were used on the shell side. These vapours, however, contained some debris, fouling the outer surface of the tubes. This blocked the flow path in some areas of the heat exchanger, causing the fluid velocity to be higher in other regions. An oscillating behaviour of the tubes resulting from these high velocities caused the tubes to be in contact with each other, inducing fretting corrosion on each other. Figures 11 and 12, respectively, show friction marks on the outside of the tubes and worn-out holes in the baffle plates, created by the vibrating motion of the tubes.

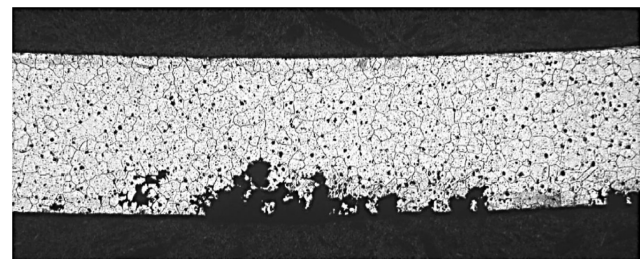
Figure 13: Intergranular corrosion of an aluminium tube. Reprinted by permission from Springer Nature: *Journal of Failure Analysis and Prevention*, Ifezue and Tobins (2015), Copyright 2015.

From the examples given in the section on stress corrosion, the cracks discussed in several publications were intergranular (Turissini et al., 1997; Guo et al., 2011; Corleto & Argade, 2017). Intergranular cracks (without the application of stresses) were found in the cases discussed by Ifezue and Tobins (2015) (together with pitting) and Chandra et al. (2010). Figure 13, from the work of Ifezue and Tobins (2015), clearly shows intergranular corrosion of a section of an aluminium tube, which typically results

from inappropriate heat treatment, e.g. during material production.

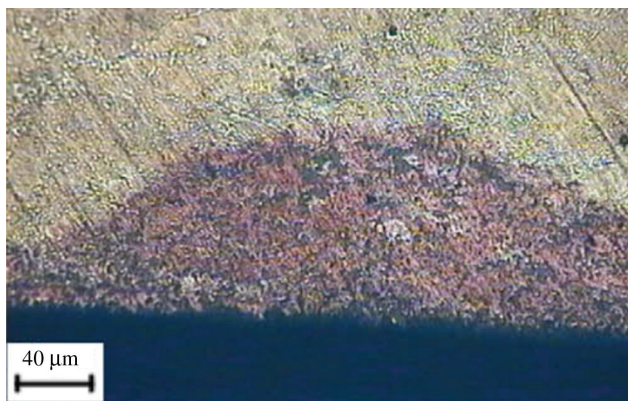
Figure 14: De-zincification of the inner surface of a yellow brass tube. Reprinted from Ranjbar (2010), with permission from Elsevier.

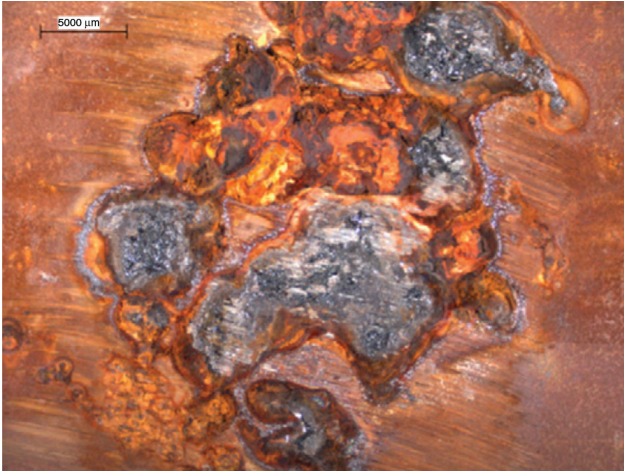
Figure 16: Tubercles observed on the shell surface of a heat exchanger. Reprinted from Huttunen-Saarivirta et al. (2012), with permission from Elsevier.

A failure analysis was done by Huttunen-Saarivirta et al. (2012) on a stainless-steel (type 304) shell-and-tube heat exchanger that was used for only 36 months. On the surface of the shell, where the cooling water flows, corrosion tubercles (Figure 16) were found. Some of them penetrated the metal (with an original thickness of 6.2 mm), while most of them had a depth of 2–4 mm. The investigation showed that the metal had both a major austenite phase and a minor ferrite phase. There was a micro-scale

surface roughness at this ferrite phase, giving bacteria the possibility of attachment, subsequently leading to oxygen concentration cells. These cells locally induced corrosion and created the tubercles.

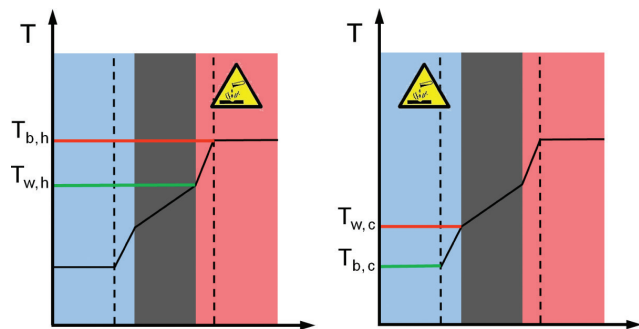
Figure 18: Temperature profile when a corrosive fluid is being cooled (left) and heated (right).

The local differences in temperature also cause different solubility products of substances in the fluid. For most species, the solubility increases with increasing temperature, while some have inverted characteristics (Stumm & Morgan, 2012). Corrosion products are typically among the first category. As explained, the temperature of the bulk fluid in a heat exchanger is different than the metal temperature or the temperature of the fluid in a boundary layer near the wall. Heat transfer to the liquid can cause the corrosion products to dissolve instead of forming a protective layer, because their solubility near the wall is high. This can increase the corrosion rate. When a liquid

is cooled, the corrosion products do not have the tendency to dissolve, but form an adherent scale, protecting the surface from further corrosion (Ross, 1967). In addition to the corrosion products, the corrosive species causing the degradation of the metal also experience this change in solubility. Dissolved oxygen, for example, has an inverted solubility characteristic, so it is less soluble at higher temperatures. The mass transport of oxygen from the bulk fluid to the hotter metal is difficult, so this might counteract the higher corrosion rates expected for a heated fluid (Ross, 1967).

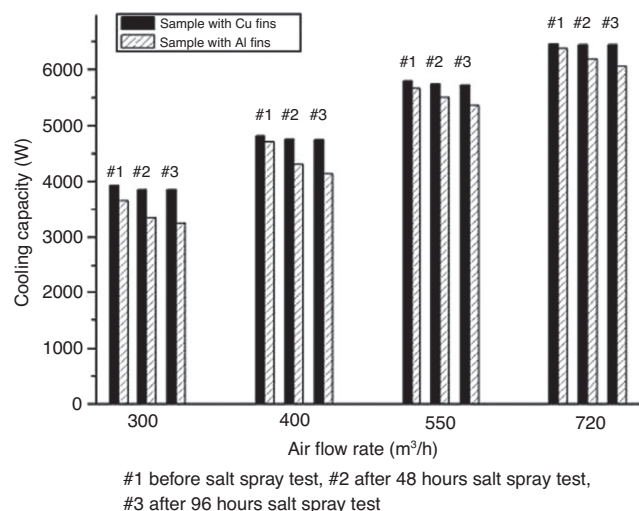
Figure 19: Influence of corrosion on the cooling capacity of a fin-and-tube heat exchanger.

In the study by Zhao et al. (2012), the decrease in heat transfer is attributed to a layer of corrosion products that formed on the fins (mainly Al_2O_3 , aggravated by

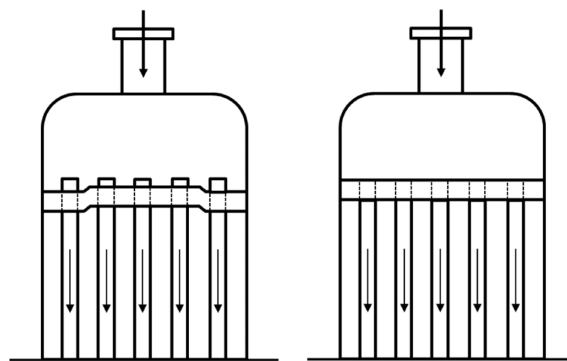
Figure 20: Dead space in a vertical heat exchanger (left) and a correctly rolled heat exchanger (right).

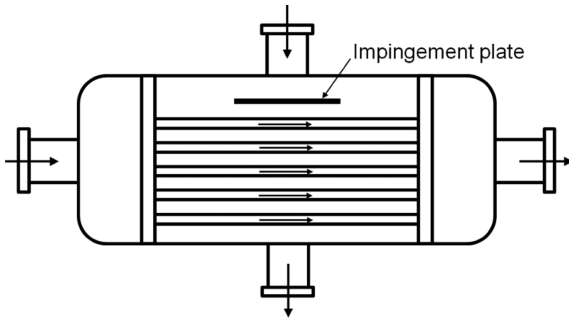
Figure 21: Impingement plate in a shell-and-tube heat exchanger.

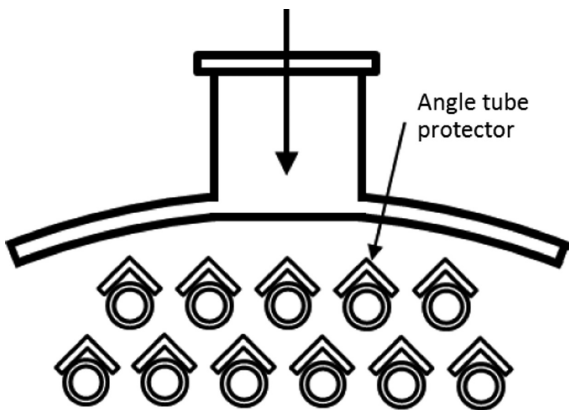
Figure 22: Angle tube protectors in a shell-and-tube heat exchanger. Republished with permission of Taylor & Francis Group LLC, from Kuppan (2000); permission conveyed through Copyright Clearance Center, Inc.

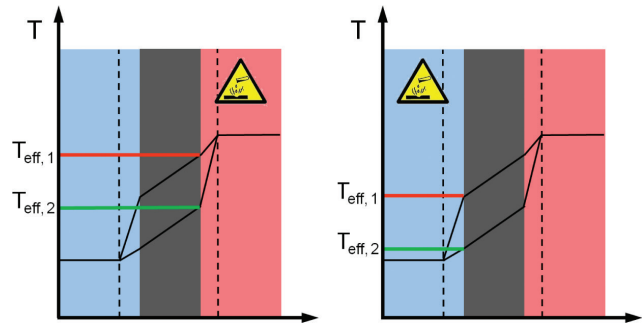
Figure 23: Effect of heat transfer coefficient on the effective temperature near a heat transfer surface.

“effective temperature” as the temperature of the fluid in the boundary layer near the wall, which is, in most cases, closer to the wall temperature than to the bulk fluid temperature. Pakhomov and Parshin advised to maximise the heat transfer coefficient on the side of the heat exchanger where the coolest fluid is present. This will result in the lowest possible effective temperature and reduced corrosion kinetics. In the thermal resistance network of Figure 17, this would mean minimising $R_{conv,c}$ to reduce $T_{w,c}$. Figure 23 shows the temperature profile for heat transfer over a heat transfer surface for the case where a corrosive fluid is being cooled (left) or heated (right). For both cases, the temperature profile is illustrated with the highest heat transfer on both the hot and cold sides. It can be seen that in both cases, the lowest effective temperature occurs when the highest heat transfer is on the side of the cold fluid.

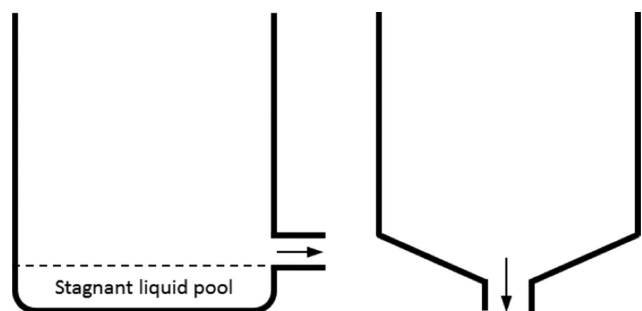
Figure 24: Design of a vessel allowing incomplete (left) and complete (right) drainage.

temperatures or concentrations, non-complete removal of oxygen, and non-uniform distribution of corrosion inhibitors (Kuppan, 2000). A good practice is to filter out abrasive particles, stringy debris, and organisms to avoid erosion corrosion and MIC. Cleaning of the heat transfer surface should be done regularly, because deposits on the metal can induce pitting, crevice corrosion, MIC, and de-alloying. When MIC is a potential problem, organisms attached to the surface can be killed by temporarily recirculating the cooling water, increasing its temperature to a level where the organisms cannot survive. Finally, when performing maintenance, care should be taken to avoid residual stagnant pools of fluid in the device. Of course, this is only possible when the design allows complete drainage. As mentioned before, low velocities can induce pitting corrosion. Furthermore, some of the remaining liquid can dry up, leaving a more concentrated and corrosive solution. Figure 24 illustrates a bad and a good design (Elliot, 1987).

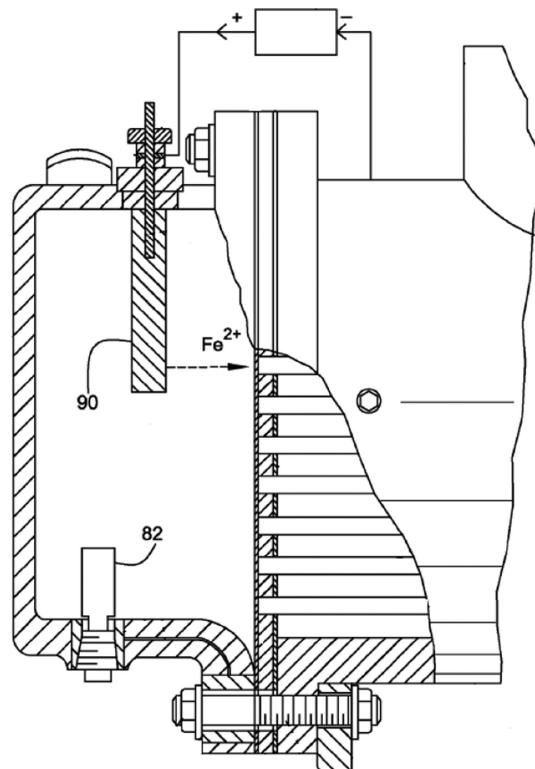
Figure 25: Cathodic protection of heat exchanger tubes by placing the anodes 82 and 90 in the end chamber (Deivasigamani & Preiser, 2013).

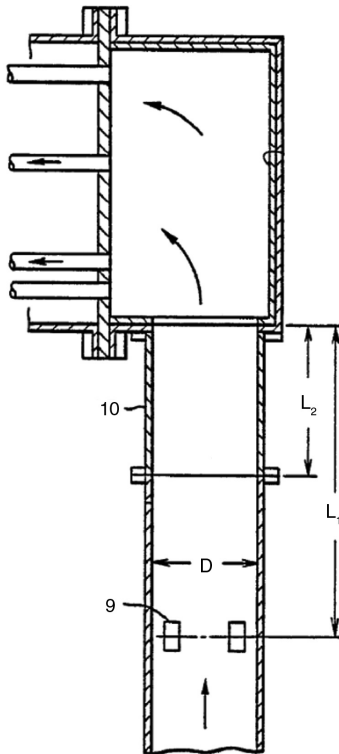
Figure 26: Cathodic protection of heat exchanger tubes by placing the anodes 9 in the piping 10 before the heat exchanger (Noboru et al., 1989).

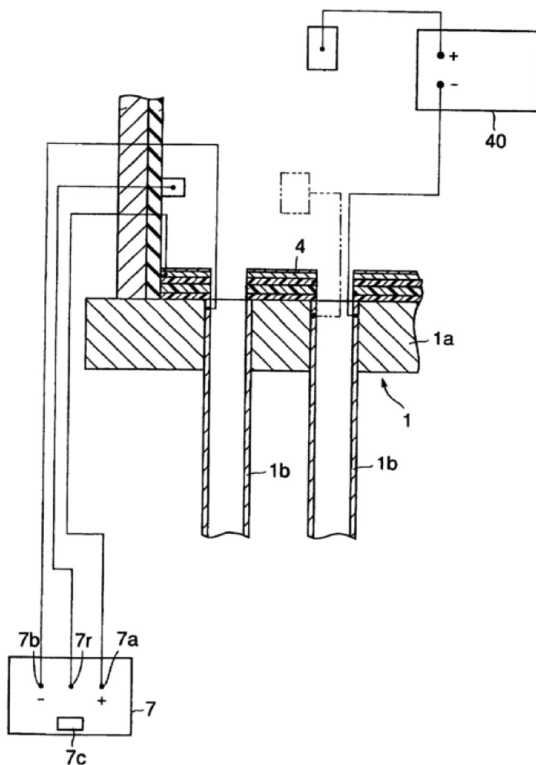
Figure 27: Cathodic protection system to prevent biofouling of the tube sheet and corrosion of the tubes (Inagaki et al., 2002).

In the patent by Inagaki et al. (2002), an invention is described where the goals were to both cathodically protect the tubes and to prevent biofouling of the tube sheet. In Figure 27, the brass tubes are indicated with *1b* and the tube sheet with *1a*. On the tube sheet, a titanium sheet *4* is deposited. With controller *7*, the potentials of the cathode (the tubes) and the anode (the titanium sheet) are controlled so that oxygen evolves at the anode. This oxygen evolution prevents organisms in the seawater from fouling the surface. An additional controller *40* is used to

control the potential of the tubes so that they are cathodically protected.

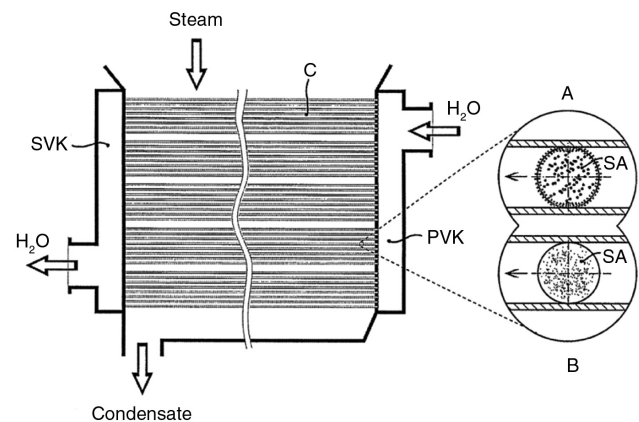
Figure 28: Cathodic protection of heat exchanger tubes with mobile sacrificial anodes (SA).

These balls can be made of a polymer with metallic elements (A) or can be completely metallic (B) (Ivusic, 2004).

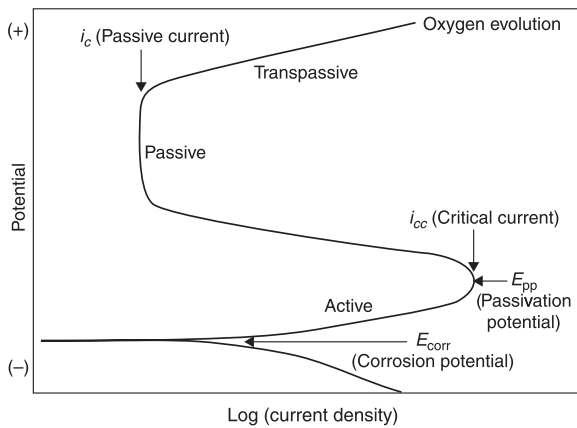
Figure 29: Polarisation curve for a metal with an active-passive transition.

Another electrochemical method of reducing corrosion is anodic protection. As with ICCP, an external power source is required. It serves, however, to shift the potential of the protected metal in the anodic direction. For some metals, like e.g. stainless steels or titanium, this does not increase the corrosion rate because the metals are passivated (Revie & Uhlig, 2008). As can be seen in Figure 29, for metals

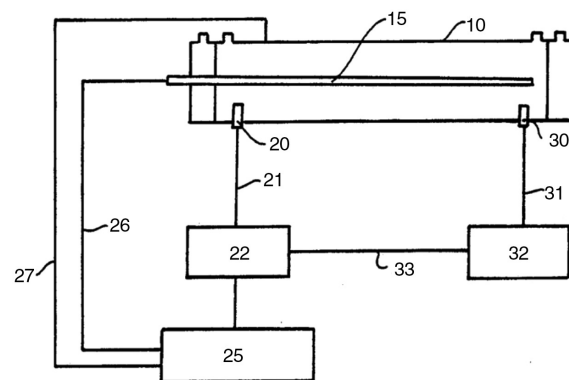
Figure 30: Anodic protection of a shell-and-tube heat exchanger (McAlister, 1987).

The patents by Bennett and Elliot (1981, 1982) also use anodic protection in heat exchangers. In their invention, however, the goal is to prevent biofouling and scaling of the tubes. The tubes are anodically polarised to a potential where they start evolving oxygen. This prevents organisms in seawater from attaching to the surface. This technique is similar to the patent by Inagaki et al. (2002), but there,

the tubes were cathodically polarised and the tube sheet was used as anode.

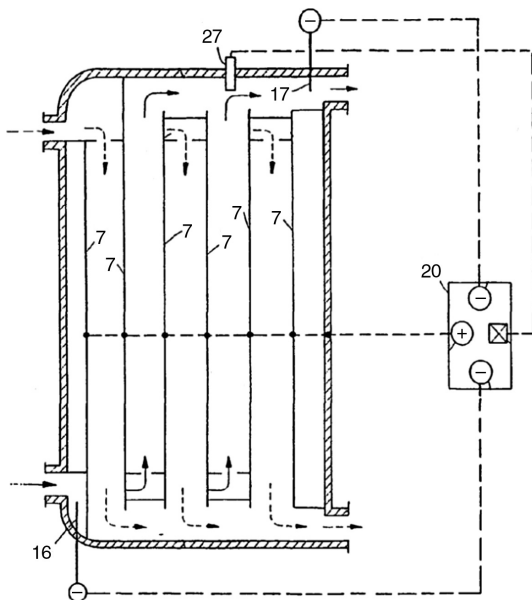
Figure 31: Anodic protection of a plate heat exchanger (Anastasijevic et al., 2004).

Plate heat exchangers can be anodically protected as well, as discussed in the patents assigned to Anastasijevic et al. (2004), Karlsson and Berthagen (1989), and Carlson et al. (1986). For both patents by Anastasijevic et al. (2004) and Karlsson and Berthagen (1989), the cathodes are placed in the inlet and outlet channels. The reference electrode is placed in the outlet channel in the patent by Anastasijevic et al. (2004) and in a separate flow path, further away from the cathodes, in the patent by Karlsson and Berthagen (1989). Karlsson and Berthagen (1989) claimed that this secures the anodic protection in all parts of the heat exchanger. The invention in the patent by Carlson et al. (1986) is based on the patents assigned to Bennett and Elliot (1981, 1982), and serves again to prevent biofouling. Pairs of plates act either as cathode or anode. In the channel with the fouling fluid, e.g. seawater, oxygen is evolved from the anode, thus preventing the deposition of organisms on the plates. The corrosion protection and biofouling control of plate heat exchangers are illustrated in Figures 31 and 32, respectively. The power source 20 in Figure 31 is connected to the cathodes 16 and 17 in the inlet and outlet channel and to the plates 7. The reference electrode 27 is also located in the outlet channel. In Figure 32, oxygen is evolved in the seawater channels 34 from the plates 12 connected to the positive pole of the power source.

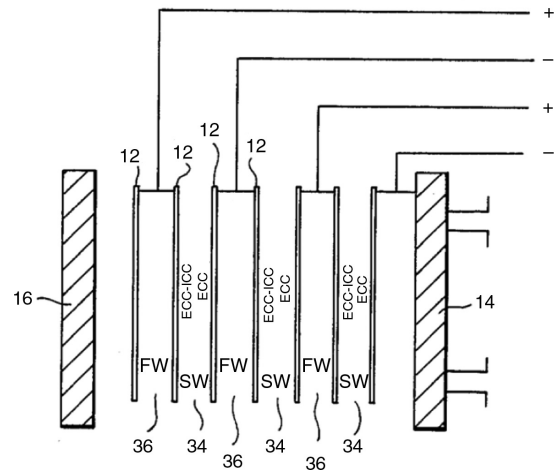
Figure 32: Anodic polarisation of plates to control biofouling in plate heat exchangers (Carlson et al., 1986).
