A REVIEW OF THE FLUVIAL GEOMORPHOLOGY  
MONITORING OF THE RECEIVING STREAMS OF THE  
MOOI-MGENI RIVER TRANSFER SCHEME PHASE 1

Submitted in partial fulfilment of the academic requirements  
for a degree of  
Master of Environment and Development  
in the  
Centre for Environment, Agricultural and Development,  
School of Environmental Sciences  
University of KwaZulu-Natal

2009

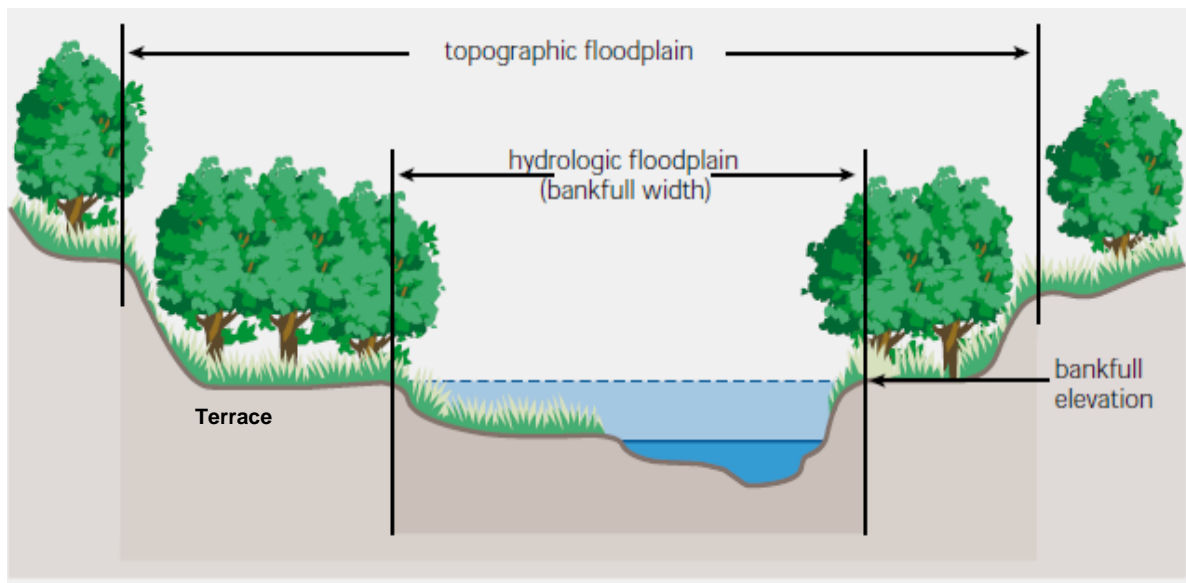
**Figure 2.1** Image showing a stream cross-section, and bankfull width and elevation, the topographic and hydrologic floodplain (FISRWG, 1998: 1-18).

of the active floodplain occurs, the stream energy is spread over a greater area (Figure 2.1).

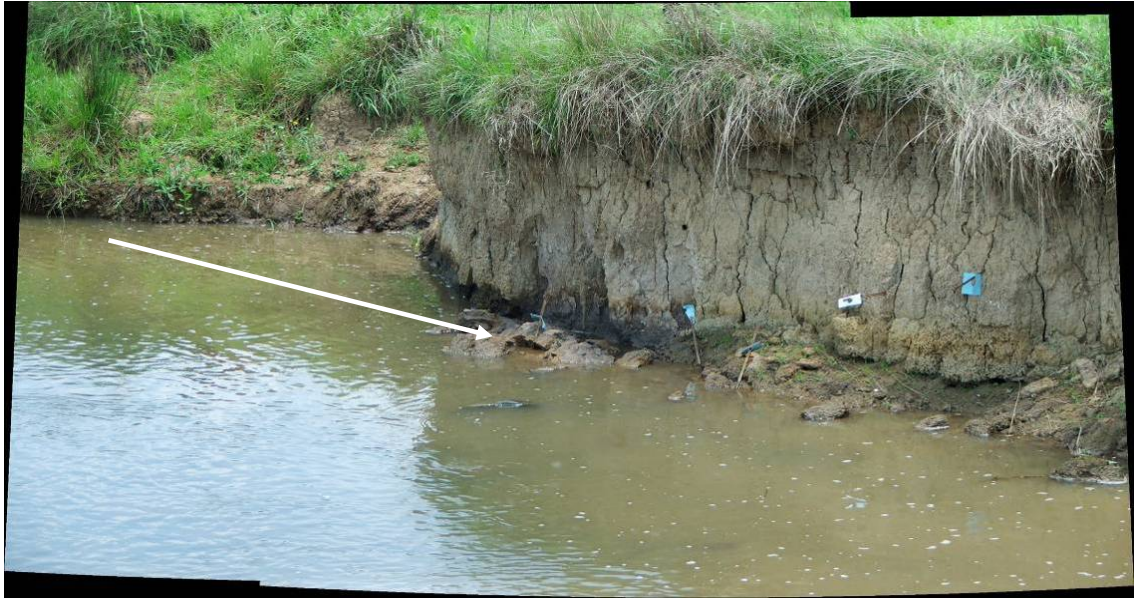
**Figure 3.4 Typical erosion pins site (L3), an example of the distribution of pin (blue markers) along horizontal profile of the stream bank. The arrow indicates where bank slumping has occurred.**

With subsequent erosion pin surveys, the erosion pins were located, measured, labelled with markers and fixed-point photographs were taken. Erosion pins lost were replaced in approximately the same location. Erosion pins that had been partially buried in the streambed sediment or had fallen onto the streambed were reset in approximately the same place. Typical examples of the different distribution of erosion pins to determine the horizontal and vertical erosion profile of the stream bank are seen in Figures 3.3 to 3.5.

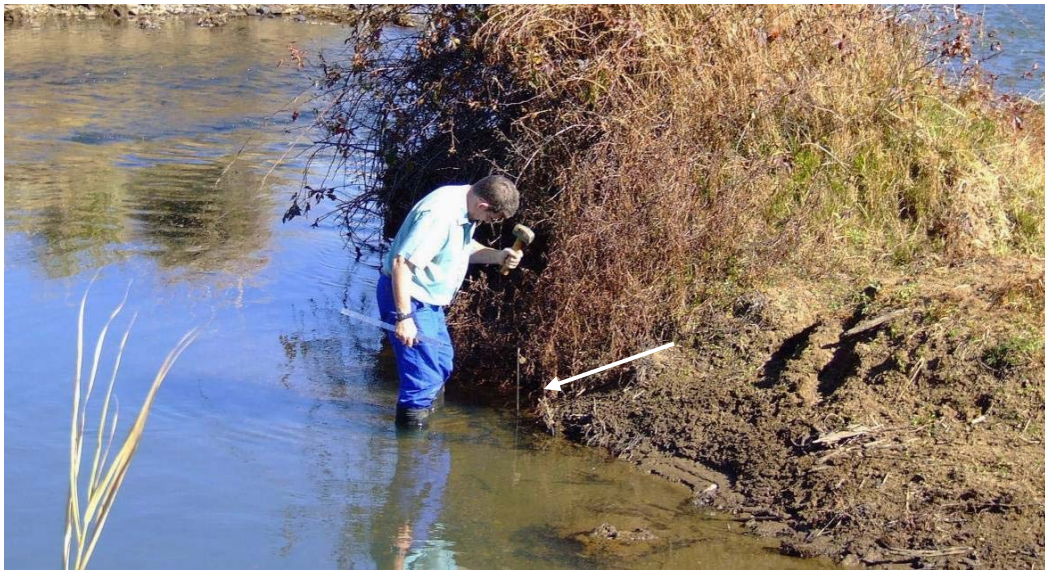
**Figure 3.5 The resetting of deposition pin on the inside of the stream bend at Lions River at the pump-house (L4).**

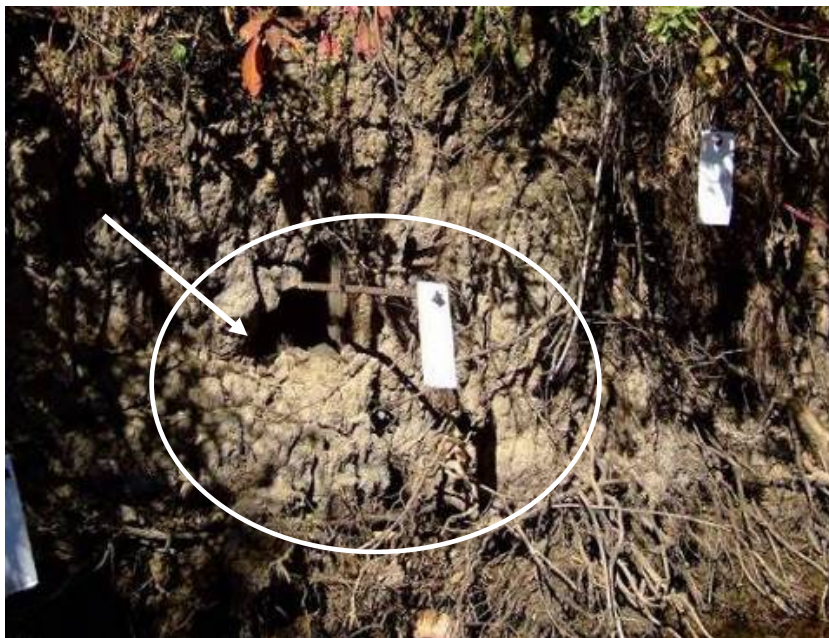
**Figure 4.1 Erosion site M2 showing the difference in localised erosion on either side of the bank erosion pin.**

The issue was raised on how to quantify the erosion that had occurred at the base of the pin. The difference in pin length varied as pin lengths were measured on either side of the pin. The pin itself was seen to either retain the bank soil thus inhibiting the loss of soil, or increase soil loss, this depending on the composition of bank soil type (Thorne, 1981). It was therefore difficult to determine which length should be considered to be representative of the erosion that had occurred at that point, as shown in Figure 4.1. The method described in the report Implementation of Geomorphological Monitoring by Wadeson (2003) was to measure different lengths at each side of the pin, then average these lengths. The procedure of averaging the length of change was not implemented throughout the review period, as the method in the report by Wadeson (2003) was not communicated to the technicians during the review period.

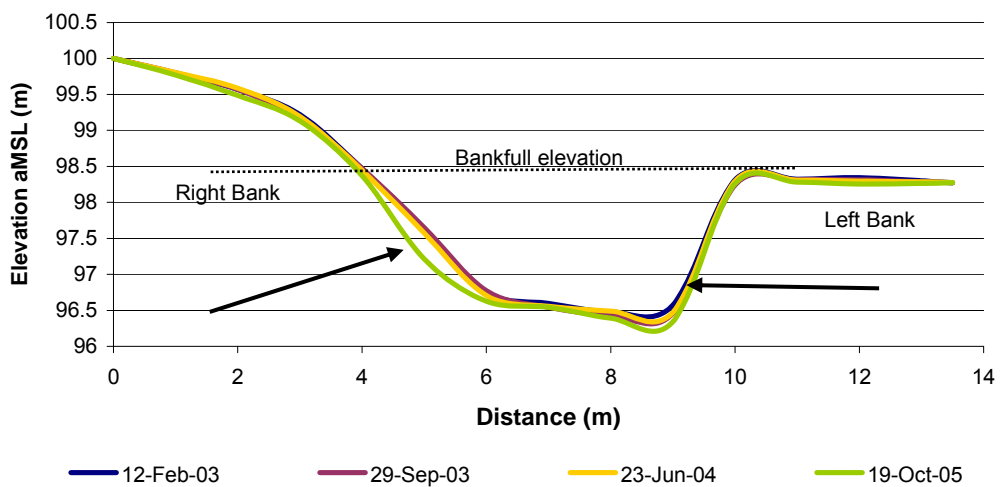
**Figure 4.3 Cross-sectional profile at Mpfana Stream M3 site, which is close to the erosion pin site M3, for the period February 2003 to October 2005. (Erosion of the banks is highlighted by the arrows).**

The cross-section graphs indicate that at M3 (Figure 4.3) and L4 (Appendix 2), surveyed between 23/06/2004 and 19/10/2005, the stream had eroded to a greater extent compared to the other sites. A limitation when comparing all Mporofana control site M1 to the other sites on this receiving stream is that only two cross-sectional surveys were undertaken during this study period, as access to the site was restricted.

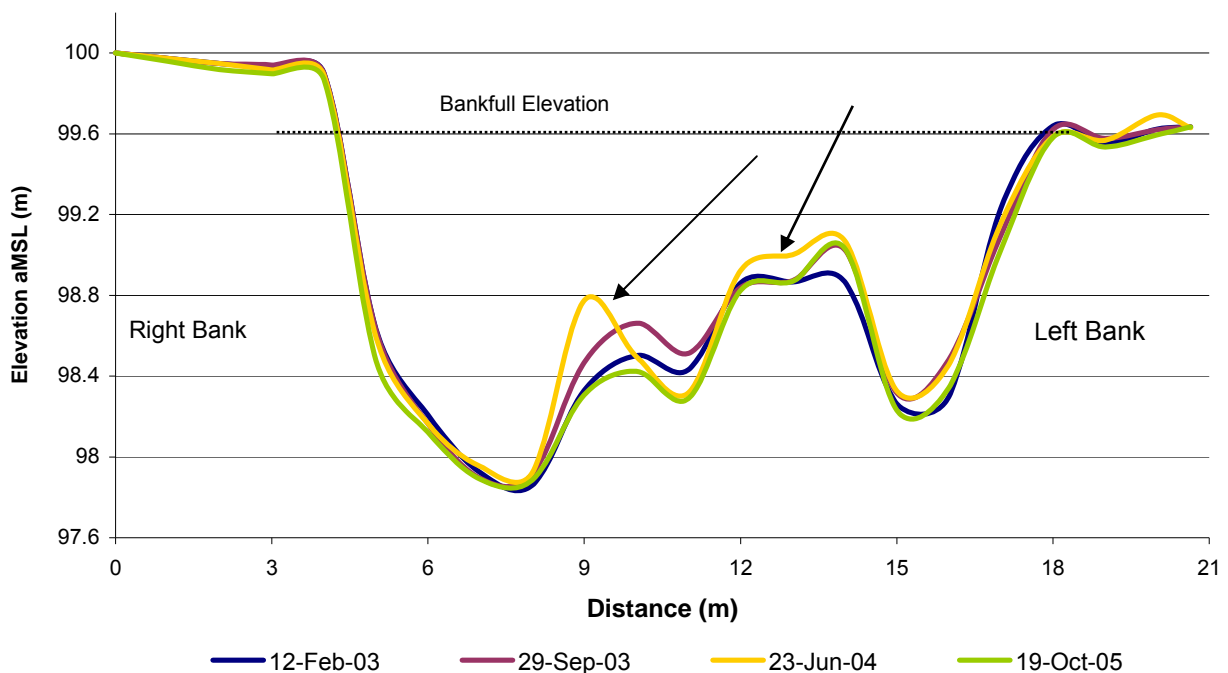
**Figure 4.4 Cross-sectional profile at Lions River L7 site, which is close to the erosion pin site L7, for the period February 2003 to October 2005. (The arrows indicate the areas of deposition).**

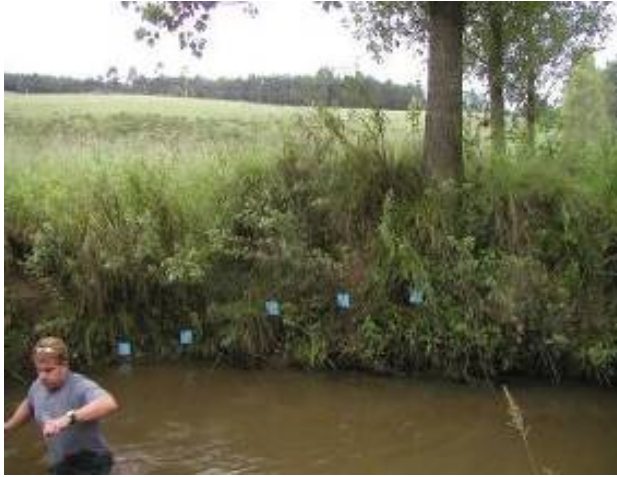
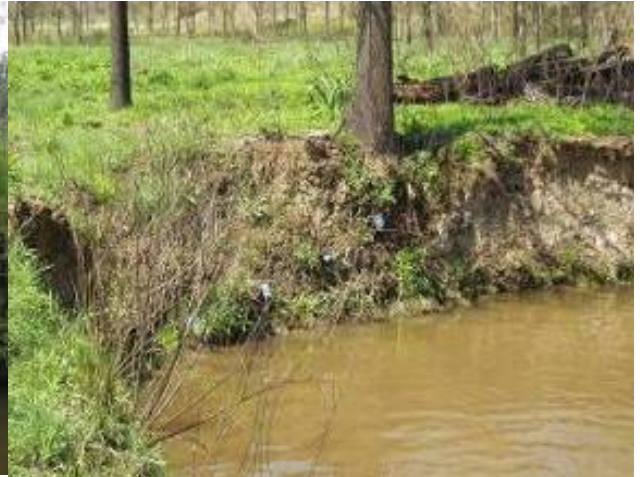
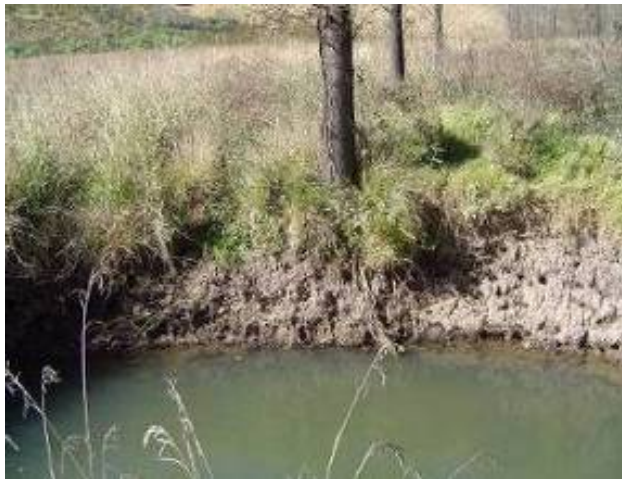
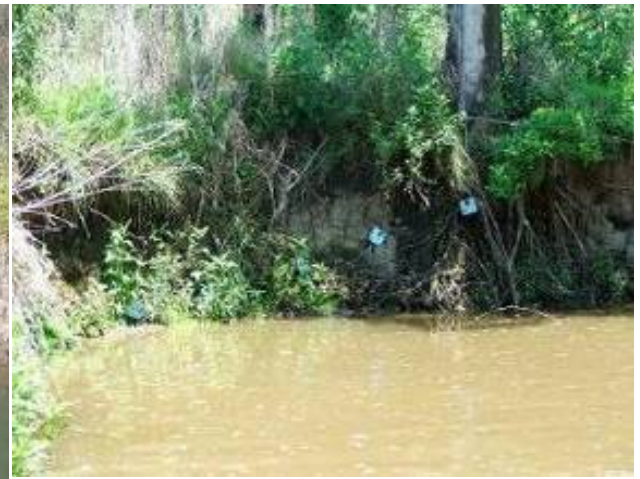
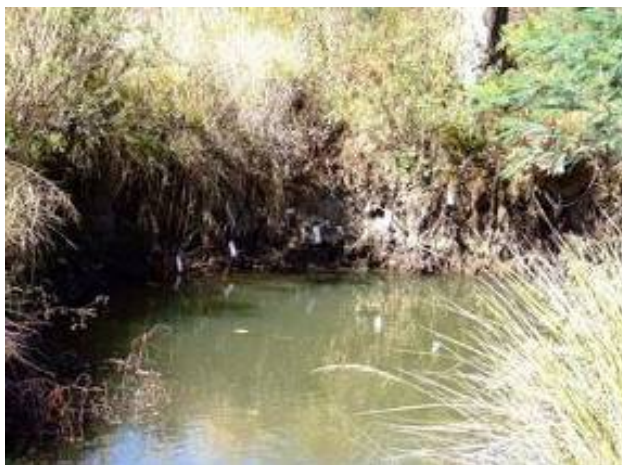
Pre-Transfer 2003 Mpfana pipeline outfall (M2), Photograph of monitoring pins at the time of site establishment, 23-02-03.

Survey 2003, Mpfana pipeline outfall (M2) post 3.2 m<sup>3</sup>/s discharge on the 02-10-03.

M2 Winter Survey 2004 (July)

Summer Survey 2005 (November)

Winter Survey 2006 (June)

**Figure 4.5 Historical photographic record of erosion pin site M2 point downstream of outfall.**

In terms of the project, a typical example of how photographs assist in depicting erosion features in the stream channel can be seen in Figure 4.5.

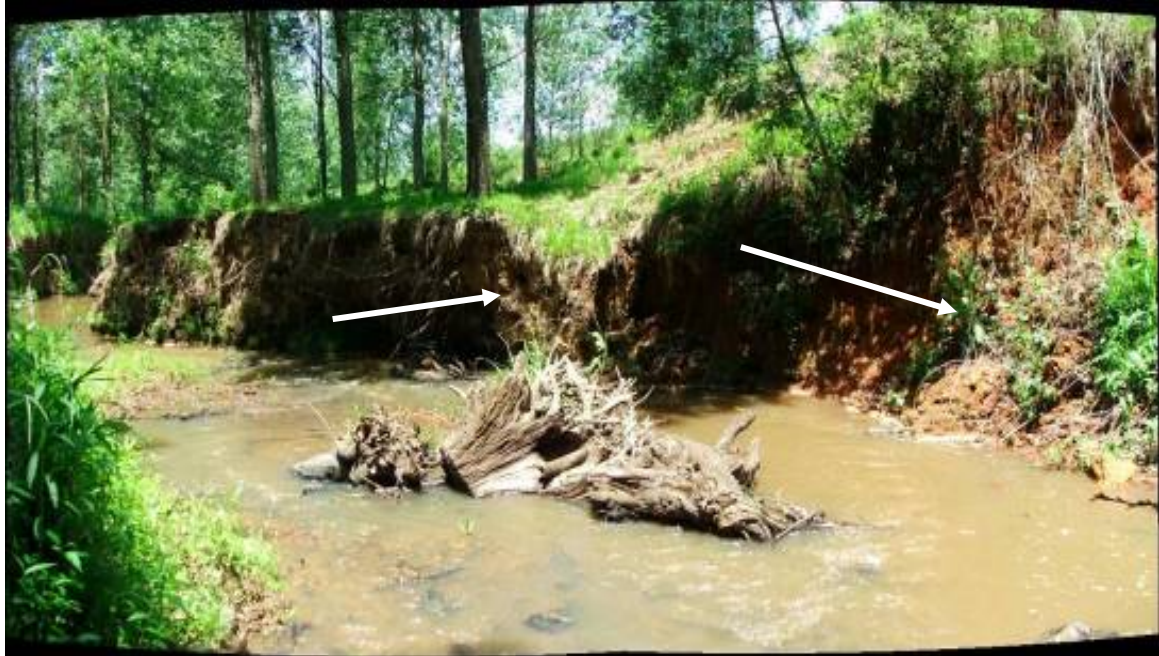
**Figure 4.6 Image of the Mpozana Stream approximately 30 m downstream of an erosion pin site M3. Arrows indicate where extensive bank collapse has occurred.**

Additional photographs, for example the panoramic photograph (Figure 4.6) indicates several areas where bank slumping has occurred. These photographs gave limited understanding of the changes that occurred and only indicate whether there have been changes in the stream bank's appearance and a loss of or change in vegetation cover. The photographs were arranged in chronological order to show the changes occurring at each erosion pin site (see Figure 4.6).

These photographs were taken from a distance and did not give a clear indication of the magnitude of bank erosion that had occurred, but gave an indication of the condition of the bank and the loss of vegetation.
