THE TECHNOLOGY OF FORENSIC EXAMINATION OF BURNED COPPER CORD

Abstract: Technical forensics is a very broad scientific field. This paper reports one of its aspects, which refer to the testing of electrical conductors following a fire in order to identify the real cause of its appearance, namely providing information whether or not the electric cord damage caused the fire and to offer contribution to the authorities. For this purpose, sectional tests of copper electric cord were conducted using microstructure optical microscope as well as X-ray diffraction analysis. The sample preparation process has been also described. The interpretation of the obtained results with the adopted conclusions based on the above-mentioned tests was presented. Based on these analyses, it was concluded that there was a local melting of the conductors influenced by high temperatures achieved in oxygen atmosphere, and that melting was apparent within all samples.

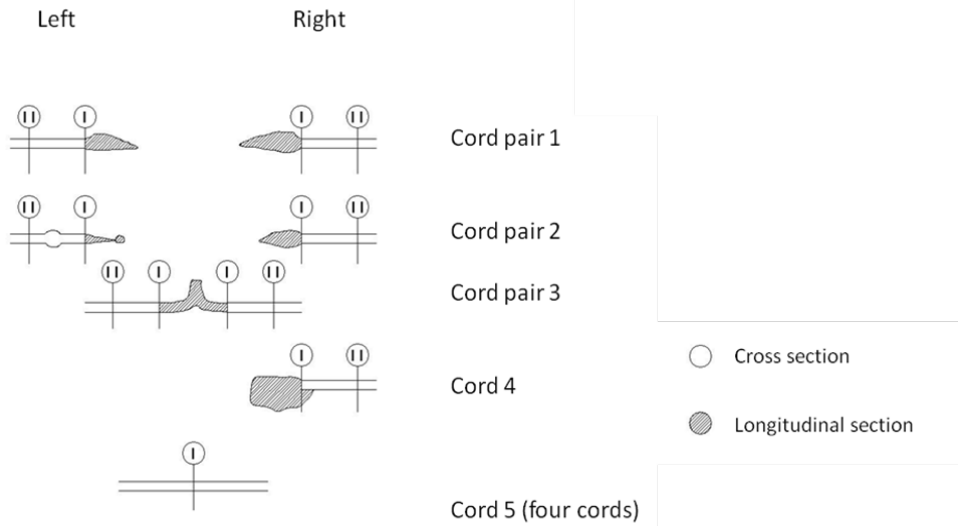
Scheme of the analyzed samples

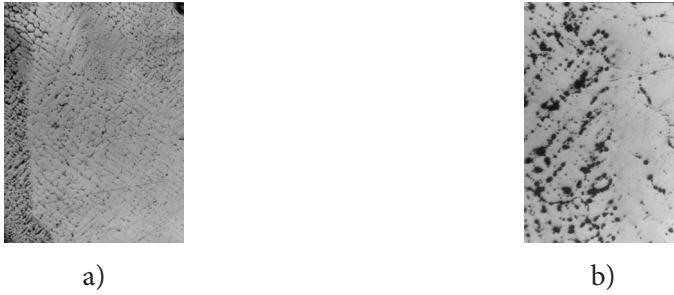
Figure 3.2: *The microstructure of the longitudinal section of cord 3 with magnification of a) 56 b) 224*

Cross section of twisted pair cord 3 (Figure 3) shows large polygonal grains with inclusions. On longitudinal section it can be seen that there has been a merging of the two conductors as well as that the structure is dendritic. There is a noticeable difference in the size of dendritic branches as well as in the quantity of interdendritic microconstituents within the width of longitudinal section.

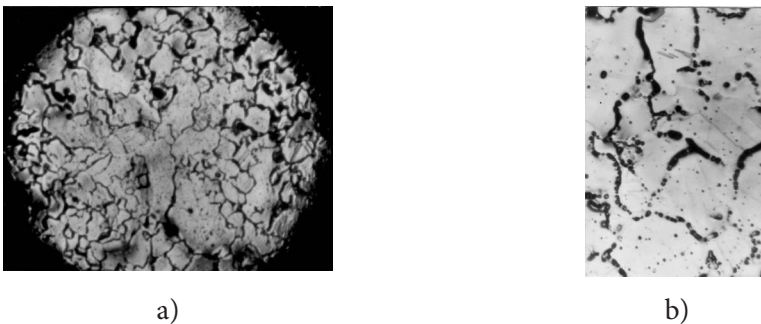
Figure 4.1: *The microstructure of the cross section of cord 4 with magnification of a) 56 b) 336*

On cross section of cord 4, grains are irregular and roughed. Globular inclusions in the structure are visible at the edges of cord 4, which is different from the others. It is a structure formed by annealing cast and not deformed structure, as is the case with other cords. This is even more evident in the second cross section. Longitudinal section shows the cord together with fused material (Figures 4). Dendrites of fused materials, diffusion zones and large polygonal cord grains are observed. Cord grain edges are very bold, which indicates the beginning of the local cord melting. Segregation presence in dendrites of the fused material indicates that this material is solid solution based on copper.

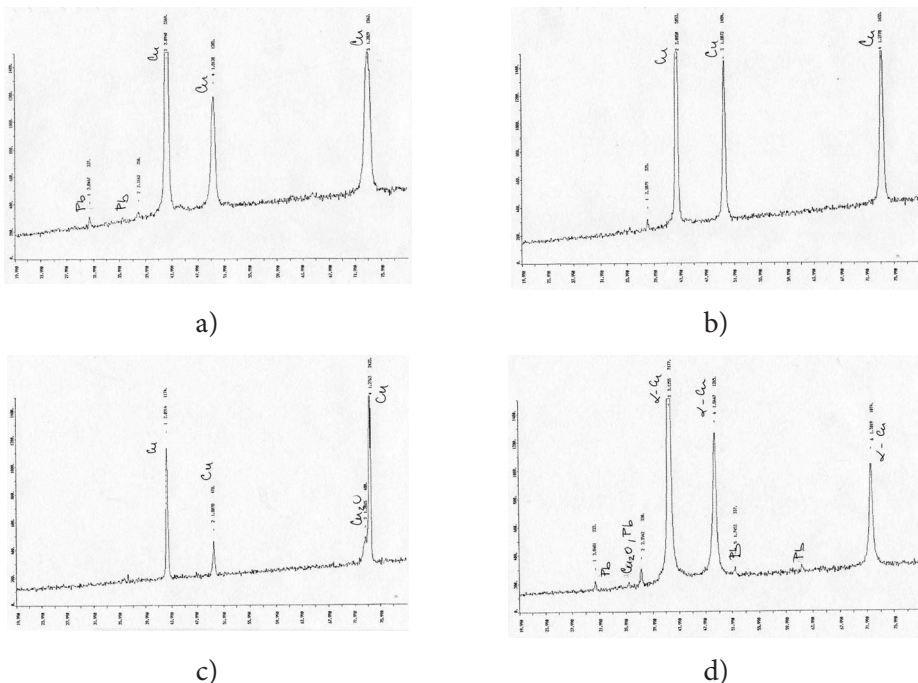
Figure 6: *Radiographs of a) cord 1, b) cord 2, c) cord 3 and d) cord4*

Figure 6 shows the radiographs of examined cords. Depending on the cords, except a reflection of Cu, reflections of Cu_2O , Pb and solid solution based on Cu were detected. Pb is present in the cords labeled 1 and 4 while Cu_2O was detected in cords 3 and 4. As the reflections (peaks) for Cu_2O and Pb are matching, perhaps a reflection of Cu_2O is present in the sample cord 1, especially as this phase is observed in micrograph of this sample cord. Solid solution based on Cu is present in the sample fourth cord.
