# Long-Term Vibration Monitoring of the Effects of Temperature and Humidity on PC Girders with and without Fly Ash considering ASR Deterioration

## Research Article

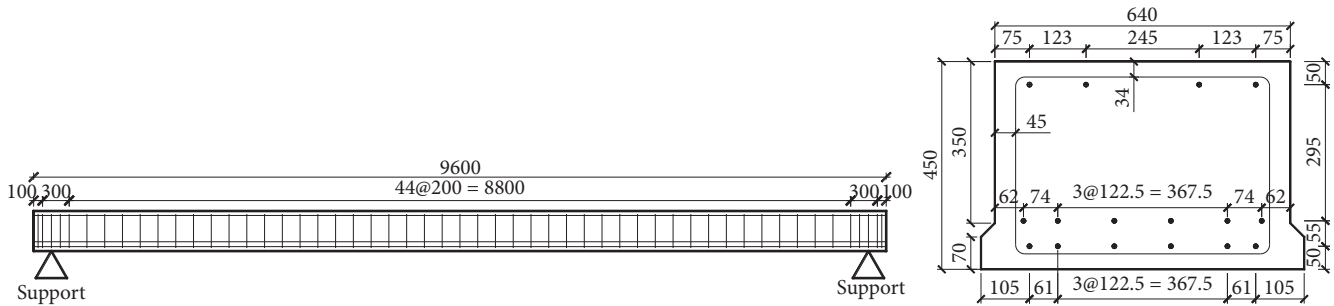
FIGURE 1: Diagram of PC girders (unit: mm).

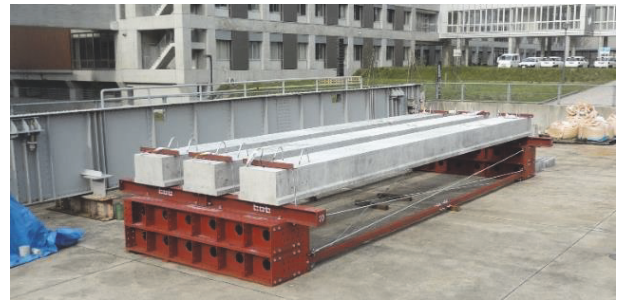
FIGURE 2: PC girders constructed for this study.

the external frames, and subsequently, the PC girders were continuously moistened indoor for approximately one week. Following the initial curing, they were placed in a sunny area of the Kakuma campus to expose them to the outdoor environment for one and a half years (see Figure 2).

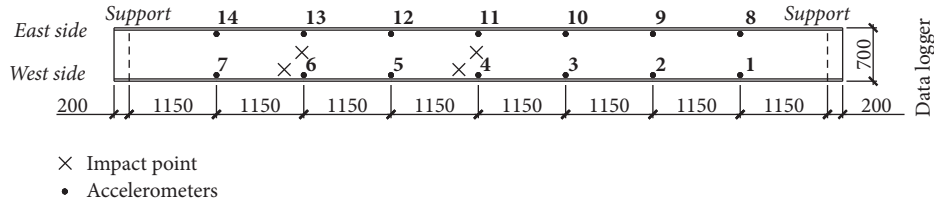
FIGURE 4: Sensor layout on the PC girder.

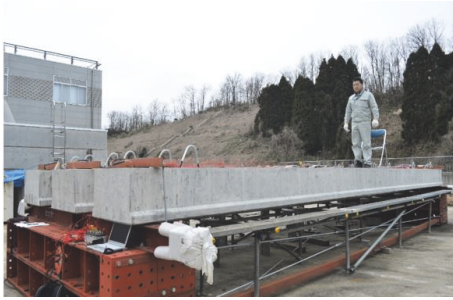
FIGURE 5: Impact test and sensor layout on the PC girder.

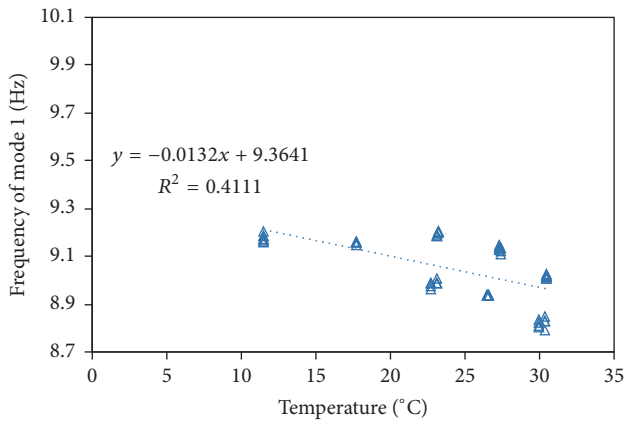
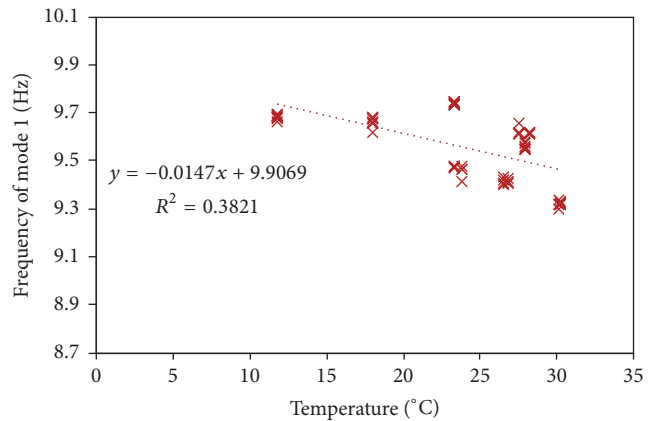
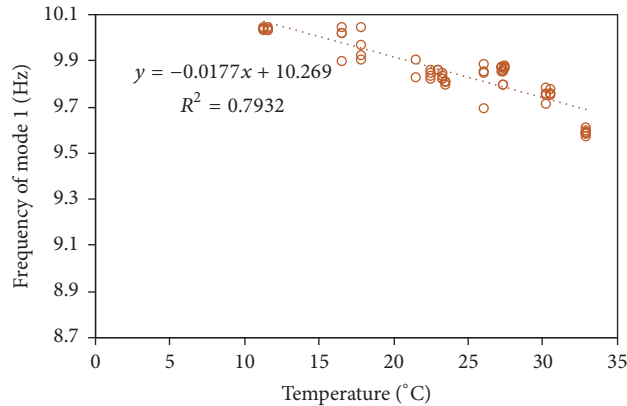
FIGURE 7: ((a)–(c)) Relation of frequencies of mode 1 to temperature.

3. Figures 7, 8, and 9 show the fitted regression lines and corresponding equations. The standard deviations of the error (Std. Error  $\sigma_{\epsilon_f}$ ) were obtained as 0.0493, 0.1775, and 1.0982 for modes 1, 2, and 3 of girder No. 1, respectively, as observed in Table 2. Dividing  $\sigma_{\epsilon_f}$  by the intercept ( $\alpha_0$ ) yields 0.5269, 0.4803, and 3.4872%, which indicate the uncertainties due to other factors such as measurement noise, analysis error or effects of ambient humidity [8], and ASR-induced deterioration. Because the error ratio of the torsional mode was higher than that of the bending modes, it is found that the bending modes could be estimated more accurately than the torsional mode. Similar outcomes were also observed with respect to the vibration modes of the other two girders. To quantify the effect of the measured temperature on the frequency change, the gradients ( $\beta_t$ ) were normalized to the intercepts ( $\alpha_0$ ). The results show that, for all girders, the torsional frequencies decreased by 0.52–0.97% as the temperature increased by  $1^\circ\text{C}$ , whereas the measured frequencies of the bending modes decreased by approximately 0.1–0.2%.

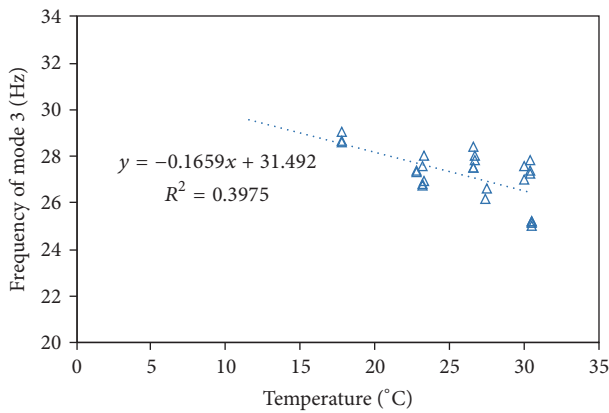
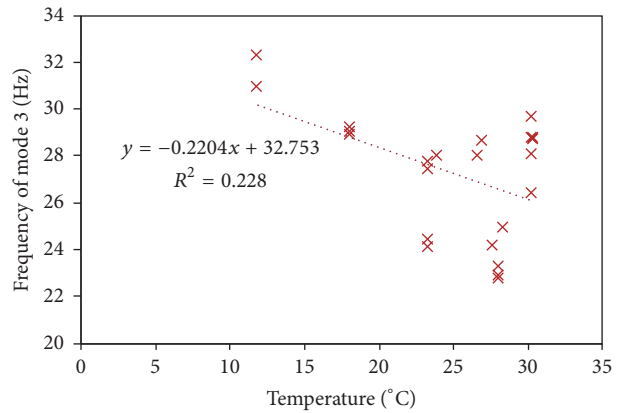
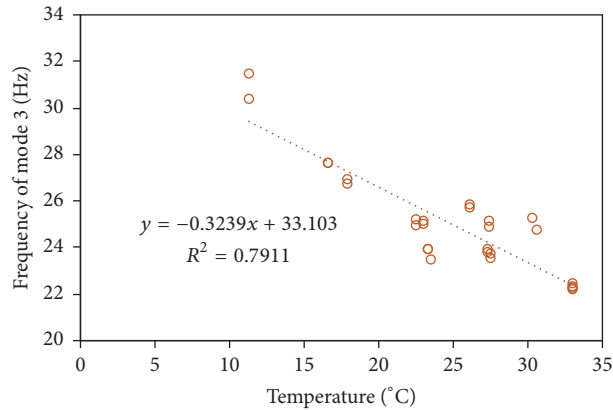
FIGURE 9: ((a)–(c)) Relation of frequencies of mode 3 to temperature.

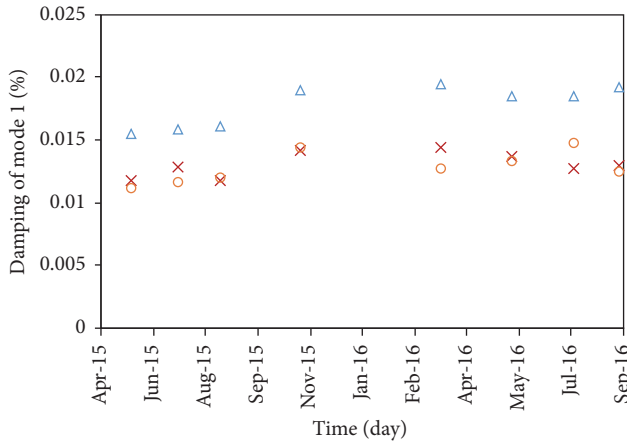
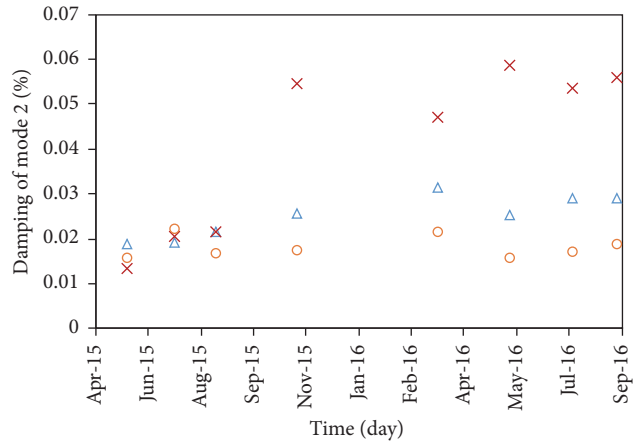
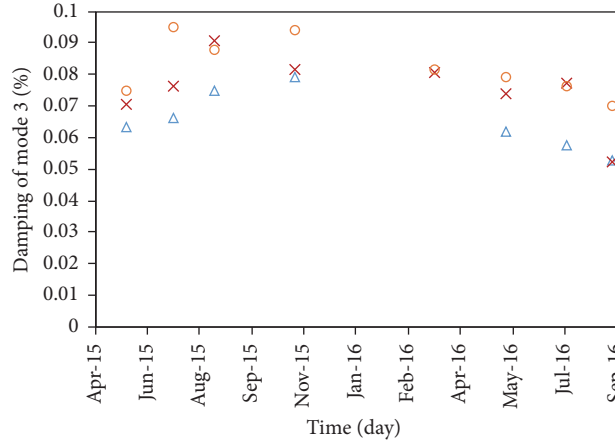
FIGURE 17: ((a)–(c)) Difference in damping ratios of three girders.

damping ratios of the three girders were largely equal at the three initial measurements. The differences became apparent since November 2015. From the data of September 2016, the average damping ratios of girders No. 2 and No. 1 were approximately 2 and 1.5 times, respectively, greater than the identified value of girder No. 3. As the correlations with the changes in the ambient environmental parameters were low, the difference in the damping coefficients in the two bending modes of the three girders was probably due to the increase in the longitudinal crack propagation due to the ASR-induced expansion, which led to the increase in the number of plastic zones in girders No. 1 and No. 2.

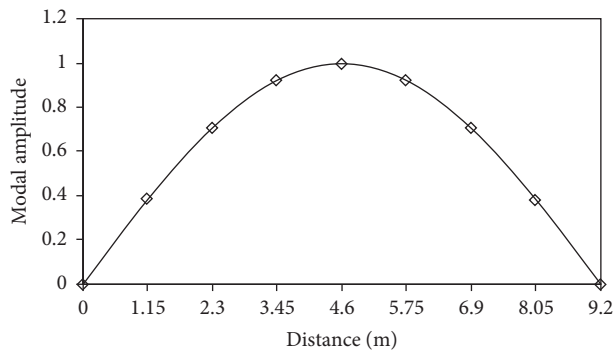
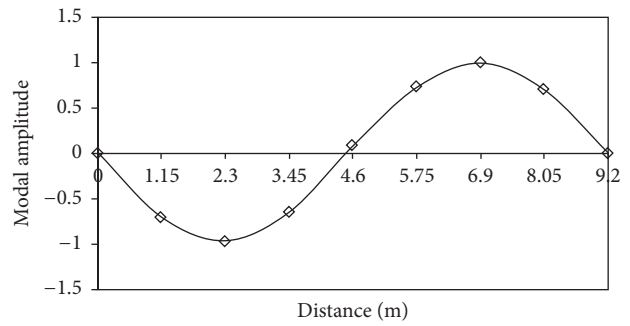
FIGURE 18: ((a)–(b)) Two analytical mode shapes.

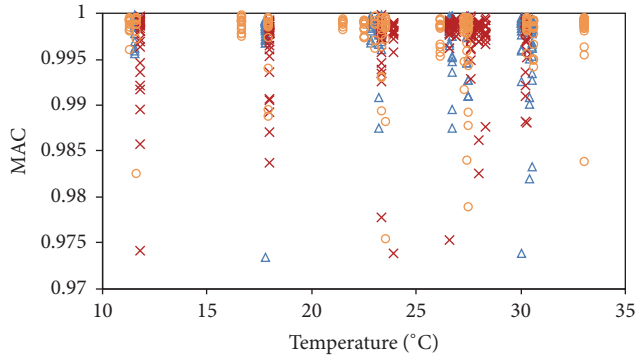
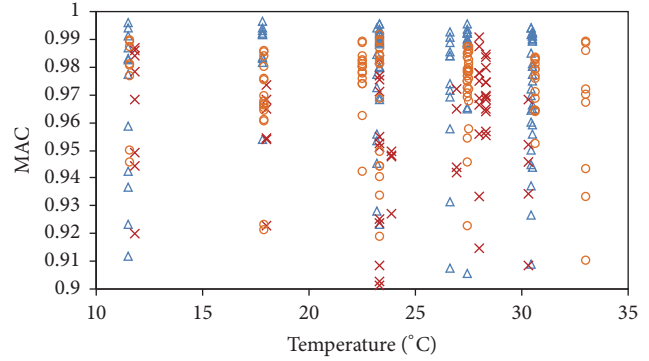
FIGURE 19: ((a)-(b)) Identified MAC values of two bending modes versus measured ambient temperature.

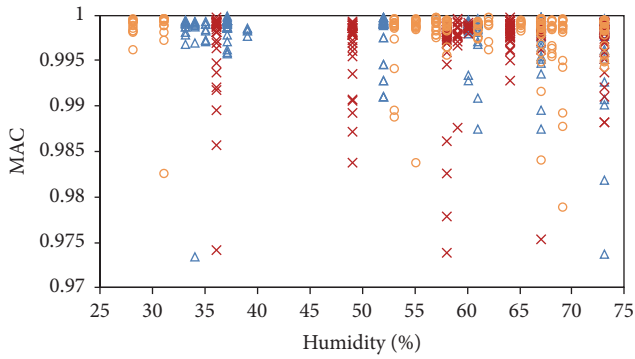
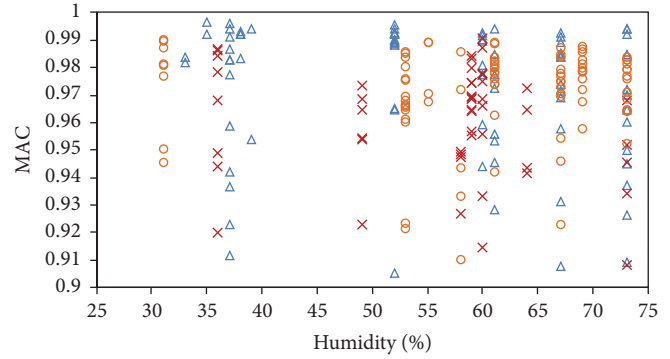
FIGURE 20: ((a)-(b)) Identified MAC values of two bending modes versus measured humidity.

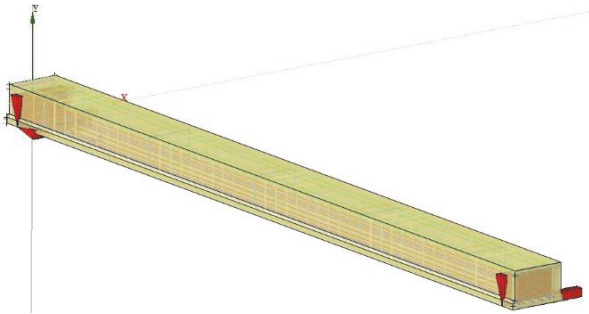
FIGURE 22: A 3D model of the PC girder.

produced using FX+ for DIANA, which is a commercially available program for FE analysis. The properties and boundary conditions of the numerical model were the same as those of the actual PC girder. Figure 22 shows the diagram of a 3D model used for the eigenvalue structural analysis in DIANA [26]. The objective model was a PC girder supported by two points with a span length of 9200 mm. As a PC girder, it contained 16 PC steel strands (SWPR7BL1S 12.7 mm). The strands had D10-type stirrups arranged around them. The PC strands and stirrups were modeled as bars in the beam elements. The bonding forces between the concrete and strands were assumed complete. Table 13 lists the parameters of the concrete for the analysis. Moreover, the stirrups were assumed as linear elastic materials with Young’s modulus  $E_c = 210000 \text{ N/mm}^2$  and Poisson’s ratio  $\nu = 0.3$ . Moreover, the PC steel material was considered made of steel with Young’s modulus  $E_c = 210000 \text{ N/mm}^2$  and Von Mises yield stress  $\sigma_y = 1580 \text{ N/mm}^2$ . The mass density for the steel materials was selected as  $7.7e-9 \text{ T/mm}^3$ . Figures 23(a) and 23(b) show

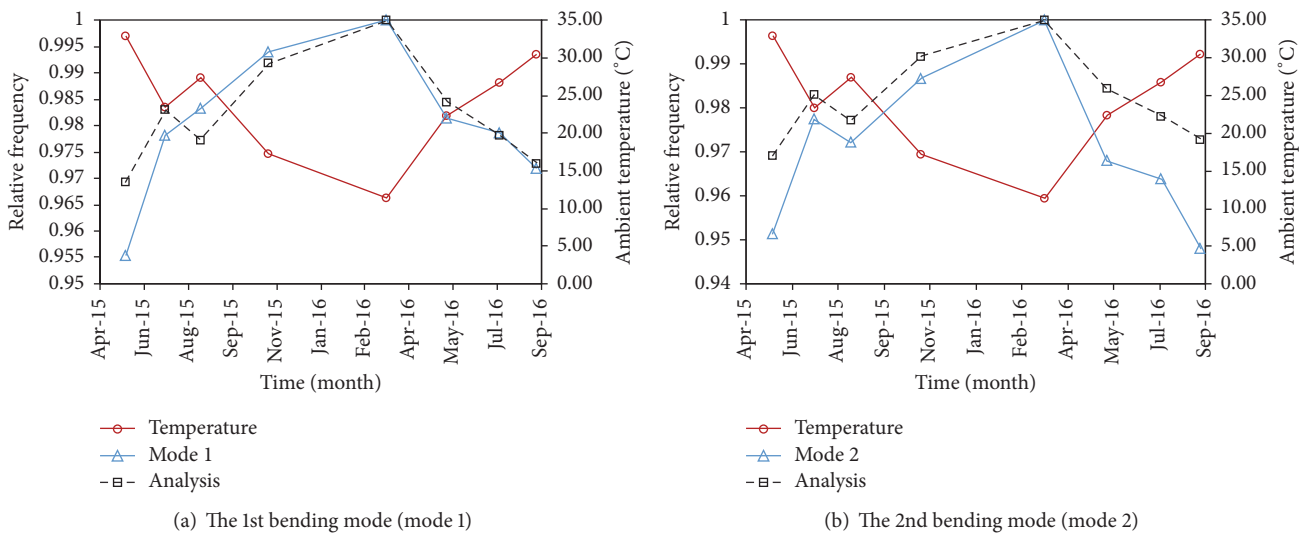
FIGURE 24: ((a)-(b)) Variations in two bending modal frequencies of girder No. 3 over one and a half years.

profile might not accurately reflect the temperature of the girder. Because the main objective of the simulations was to confirm the relationship between the frequency variation and the temperature-induced change in terms of Young's modulus, the frequencies were normalized by the highest frequency in the monitoring period. Figures 24(a) and 24(b) show the variations in the relative vibrational frequencies of the two bending modes of girder No. 3 with respect to time. The figures show that the trend in the frequency variation in both the experimental and analytical results with respect to the temperature is similar. Negative relationships between the frequencies and the ambient temperature were obtained in the results: the temperature increased with the decreases in the frequencies. In addition, both the relative frequencies followed an expected trend. In other words, they increased and reached the maximum values in March 2016 when the measured ambient temperature was the lowest over the monitoring period and, subsequently, decreased until September 2016. In particular, the temperature varied by  $\sim 21.55^{\circ}\text{C}$  from approximately  $\sim 33^{\circ}\text{C}$  in May 2015 to  $\sim 11.45^{\circ}\text{C}$  in March 2016 (between summer and winter). This decrease

led to a variation in Young's modulus of concrete, thereby increasing the analytical frequency of mode 1 by  $\sim 3.1\%$ . This rate was obtained at  $\sim 4.5\%$  with respect to the measurement. The measured temperature then increased gradually by  $\sim 19^{\circ}\text{C}$  from a low temperature to  $\sim 30.45^{\circ}\text{C}$  in September 2016 (between winter and summer). Consequently, the experimental and analytical frequencies decreased by  $\sim 2.8$  and  $\sim 2.7\%$ , respectively. To make a consistent comparison with the other girders, this study assumed that the analytical frequencies of girders No. 1 and No. 2 varied linearly with the variation in the ambient temperature. Based on this assumption, the variation ratios of the analytical frequencies with respect to time of girders No. 1 and No. 2 were estimated and plotted in Figures 25(a), 25(b), 26(a), and 26(b), respectively. As shown in these figures, the variations in the numerical frequencies are not in agreement with the changes in the measured one. In particular, the second bending mode of girder No. 2, which is shown in Figure 26(b), exhibited a higher discrepancy compared to the other results. This noise is likely because of the ASR-induced deteriorations because many longitudinal cracks were observed on the top, bottom,

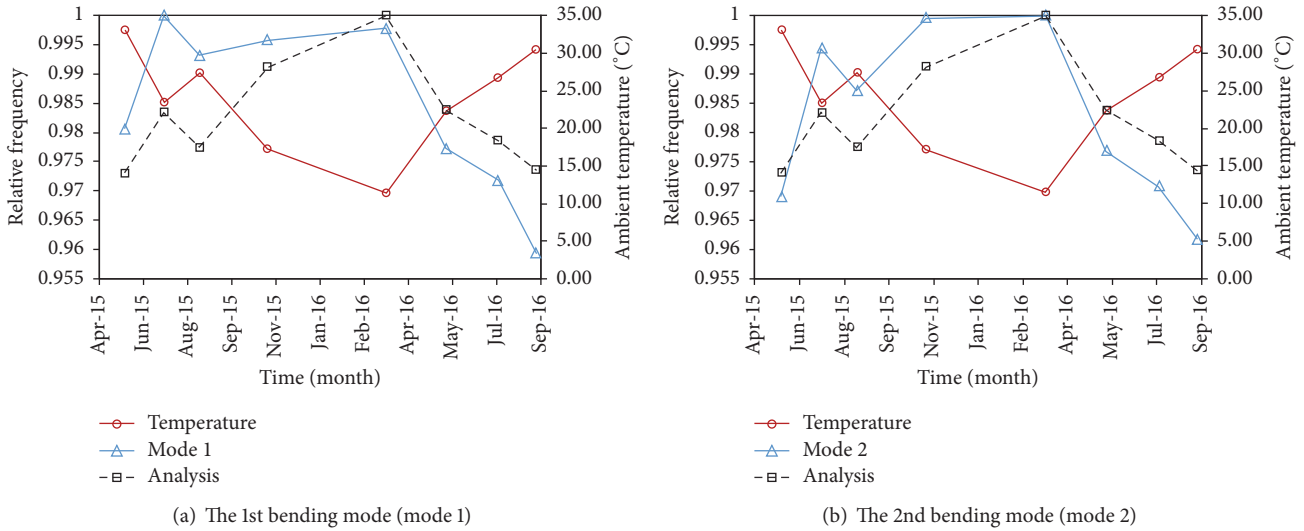
FIGURE 25: ((a)-(b)) Variations in two bending modal frequencies of girder No. 1 over one and a half years.

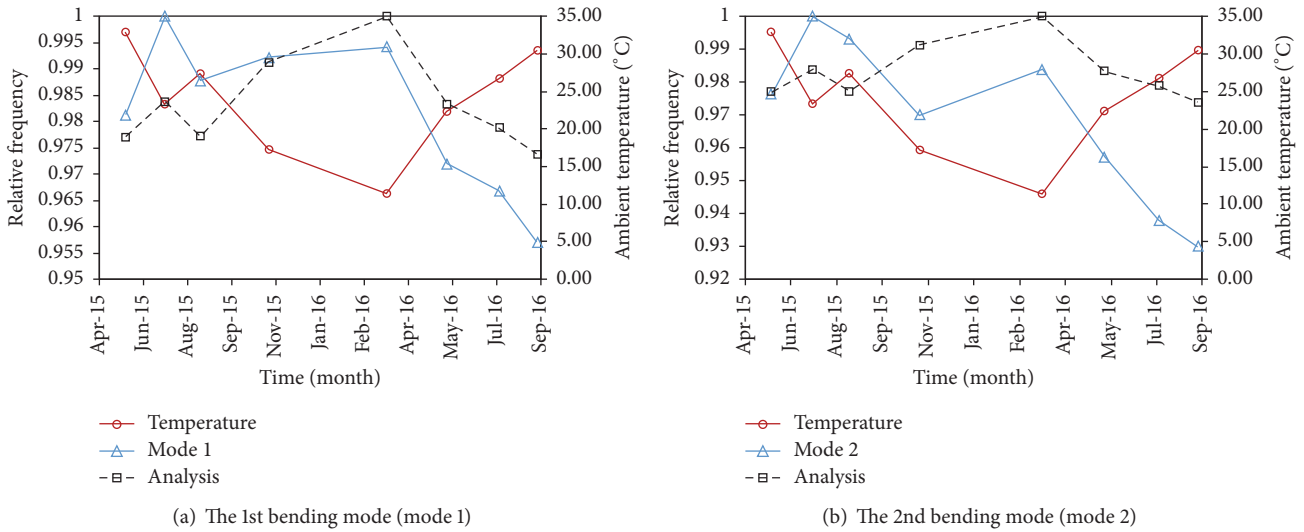
FIGURE 26: ((a)-(b)) Variations in two bending modal frequencies of girder No. 2 over one and a half years.
