Destructive Testing and Finite-Element Modeling of Full-Scale Bridge Sections Containing Precast Deck Panels

DESTRUCTIVE TESTING AND FINITE-ELEMENT MODELING OF FULL-
SCALE BRIDGE SECTIONS CONTAINING PRECAST DECK PANELS

MASTER OF SCIENCE

Civil and Environmental Engineering

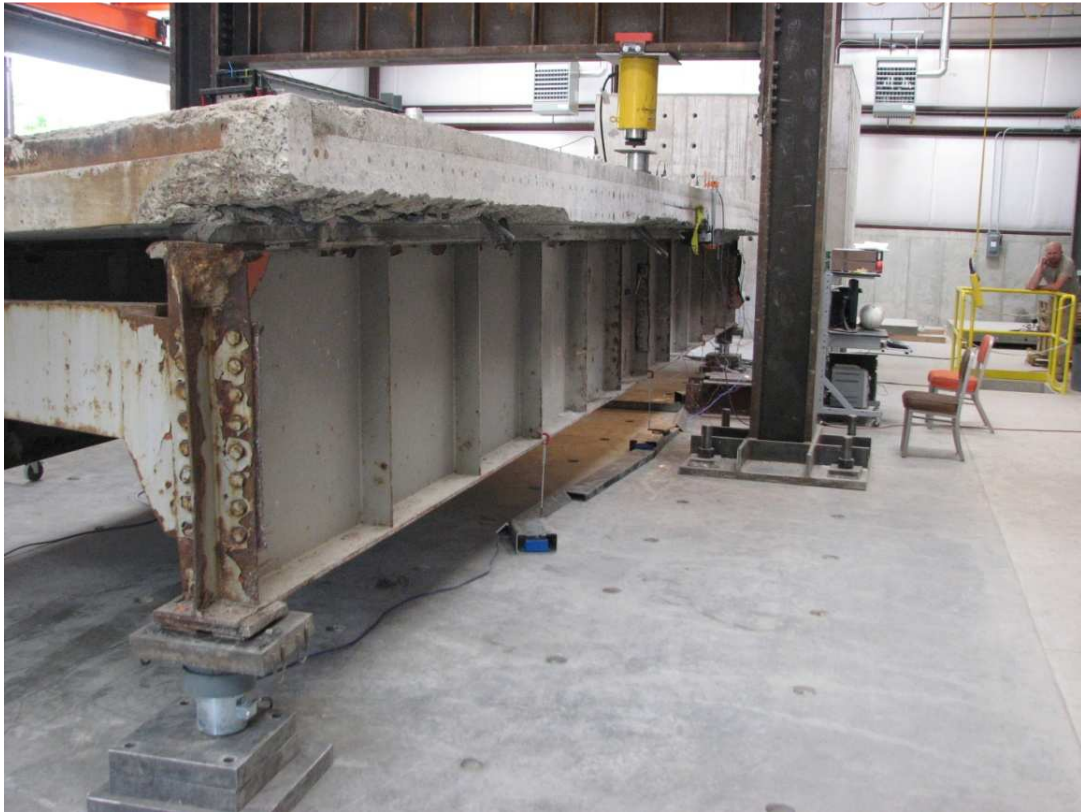
Figure 6. Specimen 1 beneath reaction frame.

All testing was performed at the USU Systems, Materials, and Structural Health (SMASH) Laboratory. The SMASH Lab houses a heavily reinforced concrete strong-floor, which is assumed to be rigid. The strong floor was used to anchor the base-plates of a movable steel reaction frame. The reaction frame consists of two vertical columns that support a horizontal reaction beam. The reaction beam has a heavily stiffened web. The test specimen was oriented beneath the reaction frame so that the reaction beam crossed directly over the centerline of the girder to be loaded as shown in Figure 6.

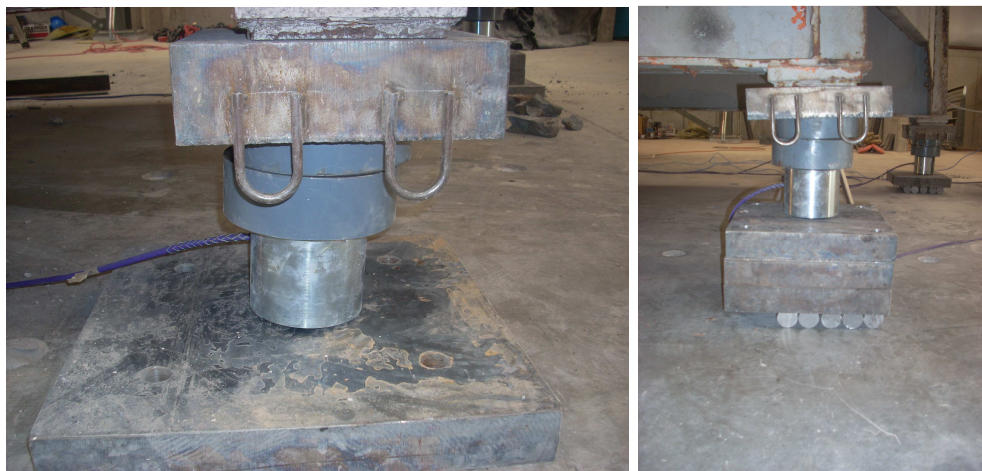
These reactions did not account for any lateral translation of the girder supports. During testing of Bridge Specimen 1 it was noticed that the bridge system was deforming in the axial direction due to excessive plastic deformation of the steel girders. The support reactions remained at the same locations while the bottom flanges of the girders translated laterally above the reactions. This introduced eccentric loading of the load cells and was a large source of error in readings (Figure 7a). To mitigate this problem for Bridge Specimen 2, reactions were constructed which allowed for lateral movement (rollers). For one reaction, five steel cylinders measuring 51 mm (2.0 in.) in diameter were placed between the bottom steel plate and the strong floor (Figure 7b). This effectively created roller reactions, which allowed for longitudinal deformation. The rollers were placed at reactions B1 and C1.

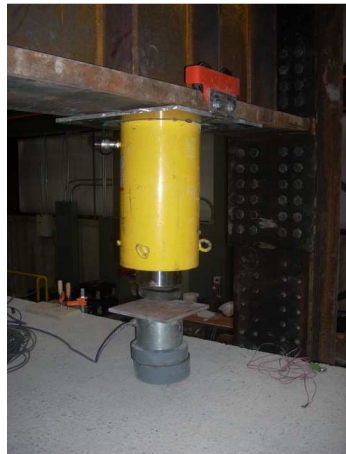
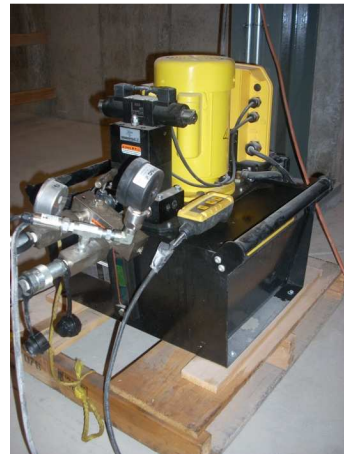
Figure 10. a) Ram, load cell, spherical bearing and b) hydraulic pump.

A static point load was applied to the centerline of the loaded girder. The load was applied with a 5,340 kN (1200^k) capacity ram. The ram was placed between the reaction beam and the concrete deck of Specimen 1. A load cell was positioned beneath the ram monitor the load. A hydraulic pump supplied pressure to the ram (Figure 10b).

Since the concrete deck was super-elevated in the transverse direction, a spherical bearing was used between the deck and load cell. This corrected for the angle between the working line of the ram and the normal line of the concrete deck. Also, the spherical bearing prohibited eccentric loading of the load cell, which reduced error in readings. In some cases, various steel plates were used at the point load location to account for differences in elevation of the concrete deck in the transverse direction. The applied load was monitored with a load cell that matched the capacity of the ram (Figure 10a).

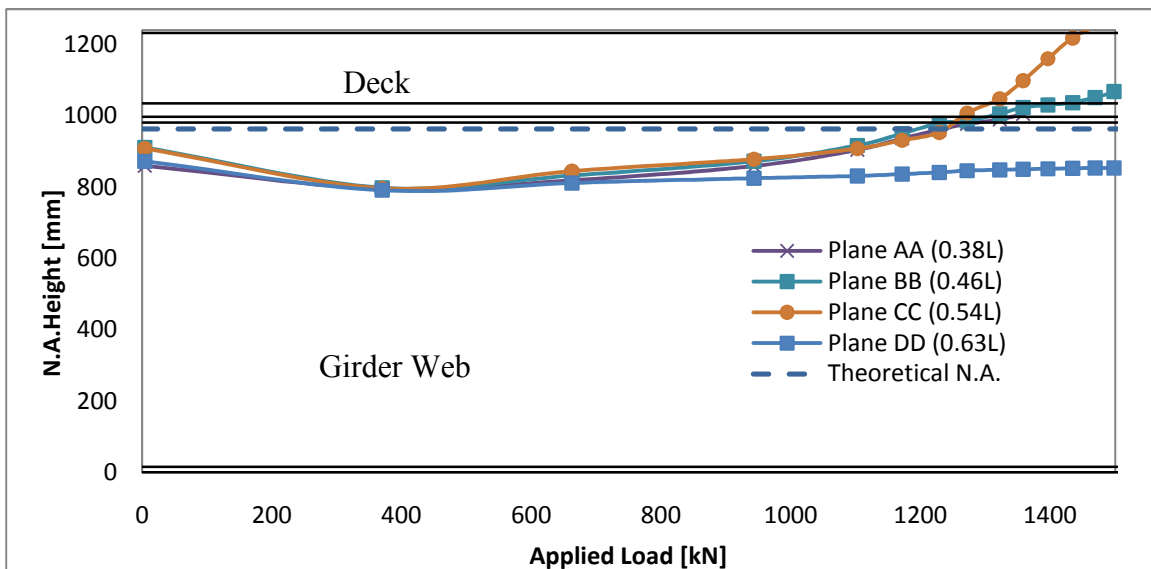
Figure 11. Flexural Test C N.A. locations.

The N.A. locations for various cross-sectional planes along the length of the girder are plotted in Figure 11. In the elastic portion of loading, it can be seen that the measured neutral axis was higher than the centroid of the girder. This indicated that the decking system was contributing to flexural resistance. However, it is also shown that the N.A. was lower than the theoretically calculated elastic N.A. In other words, the decking system was not acting completely composite. In the post-elastic portion of loading, the N.A. shifts upward among cross-sectional planes of high moments (i.e. points close to $0.4L$) as expected. Note that the strain gage data at $0.38L$ ends prematurely compared to the other gages. This was because these gages reached their working limit prior to ultimate loading.

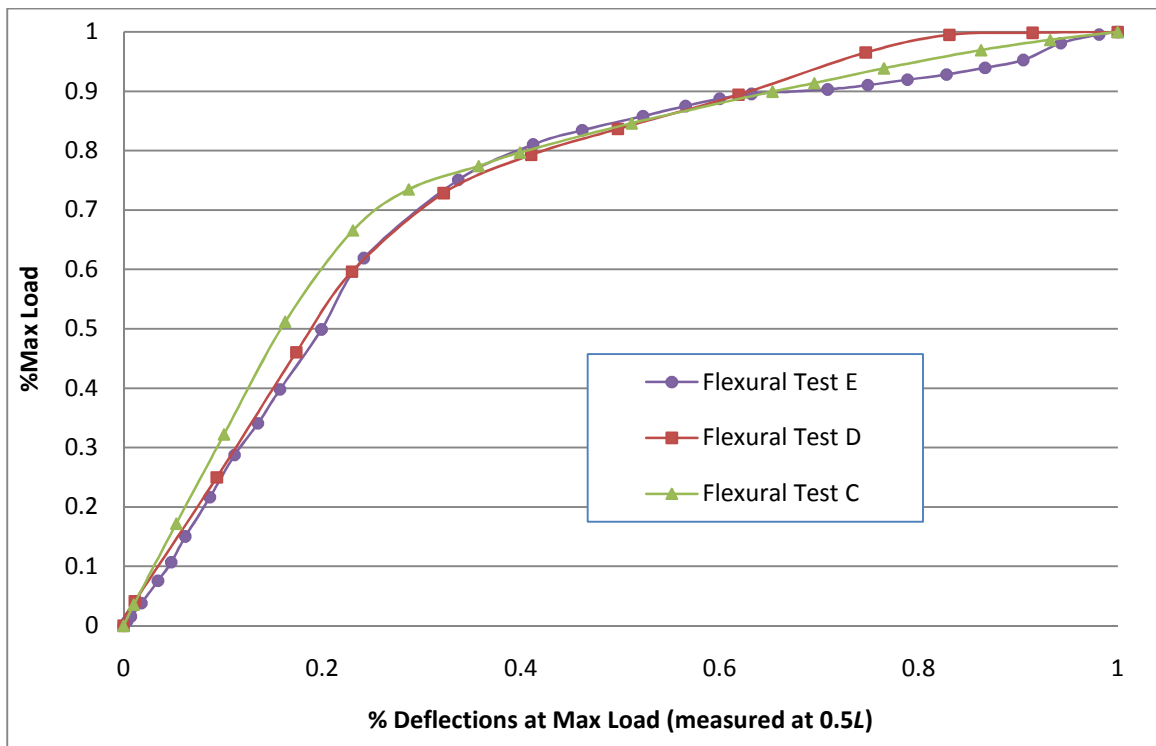
Figure 13: Load vs. deflection plots for flexural tests.

Deflections of the steel girders were measured at $0.5L$ on the loaded girder for all tests, among other locations. The mid-span deflections of the loaded girder are plotted in Figure 13. Because the loading points were not consistent between the tests ($0.5L$ or $0.4L$), the results are presented on a percent-of-maximum basis. The load-deflection curves for these two tests correlate very well.

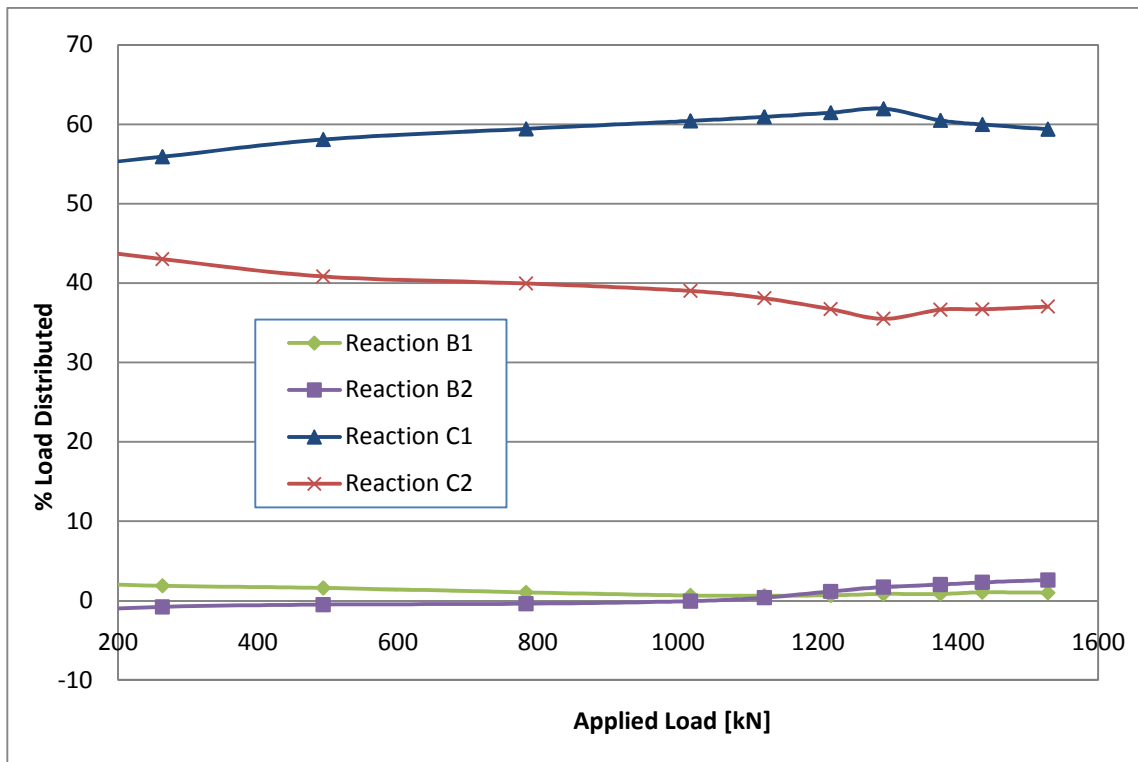
Figure 14. Load distribution for Flexural Test C.

The load cell readings at each reaction were divided by the total applied load to obtain the percentage of load distributed to that reaction. The results are plotted in Figure 14.

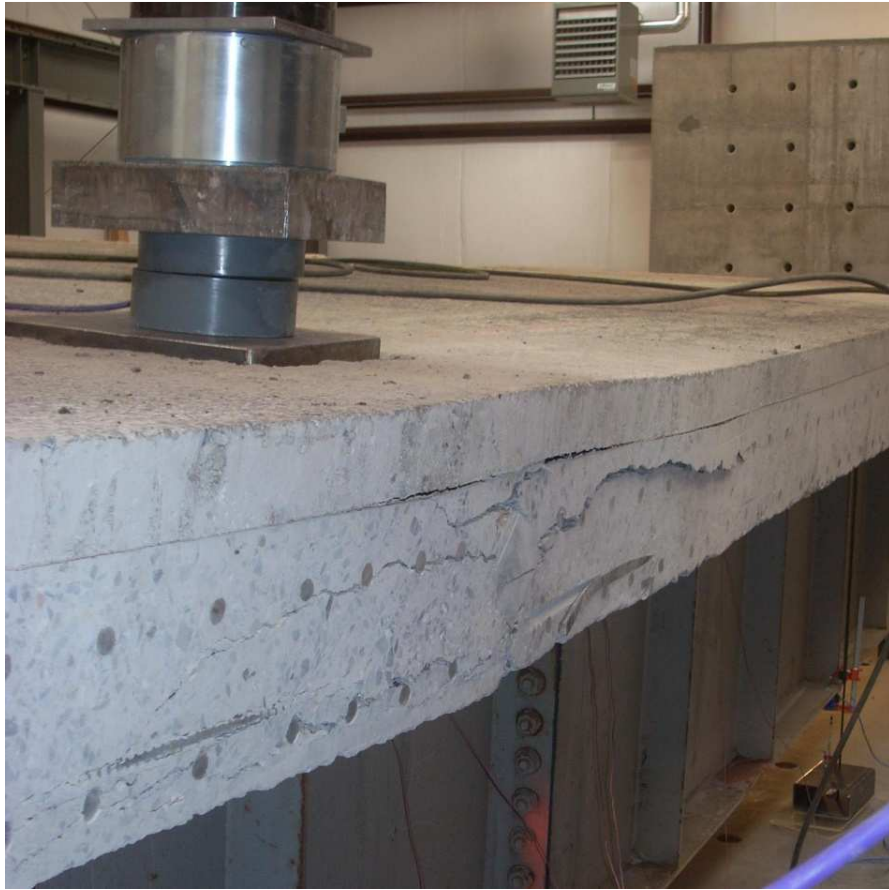
Figure 15. Splitting failure in concrete deck.

This failure effectively eliminated the upper portion of the deck from moment resistance contribution. The deflections started to increase greatly. The load carrying capacity began to decrease as the concrete deck endured more damage. As the degree of deck damage increased, the system capacity began to converge to that of the steel girder alone. As a result, the loading became a function of the hydraulic pump flow rate because the girder was deflecting faster than the fluid could be pumped into the ram.

The splitting failure was likely introduced because of the salvaging process. The concrete cuts made in the field left only a 380 mm (15 in.) overhang distance of concrete (Figure 16). This is relatively small when compared to the 2,407 mm (94.75 in.) girder spacing. The smaller portion of overhang concrete introduced a non-symmetric section. Furthermore, the exact location of the cut produced an unknown clear cover distance of longitudinal reinforcement. The compressive reinforcement development length thus became the limiting factor in compressive concrete strength.

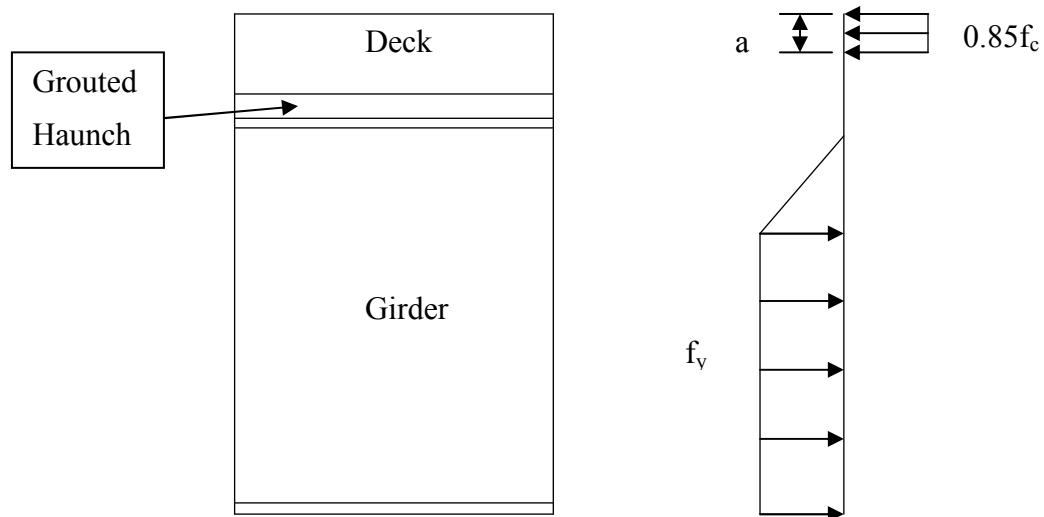
Figure 17. Flexural Test C stresses at 1400 kN (315k).

Using the Whitney stress block the uniform compressive stress, $0.85f_c$, acts across a width, b , and a depth, a (ACI, 2008). For the measured compressive strength of concrete (see Chapter 4) the distance, a , is equal to 65% of the neutral axis depth that is in compression, or 132 mm (5.20 in.). The width, b , was taken to be half of the entire bridge deck width, or 1,580 mm (63.0 in.), which included the overhang. The yield stress in the steel was determined experimentally to be 262 MPa (38 ksi) (see Chapter 4). In order to satisfy force equilibrium on the cross section the compressive stress in the concrete must be 19.7 MPa (2,850 psi). In other words, the splitting failure witnessed in the laboratory initiated when the concrete compressive stress reached this value.

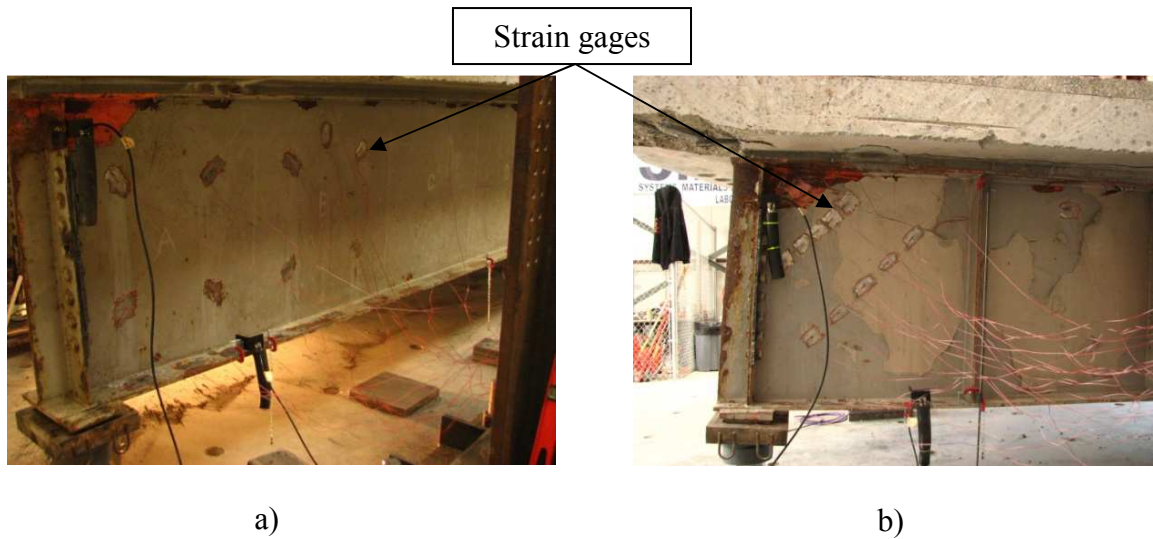
Figure 19. Strain gage configuration for Beam Shear Tests a) B and b) c.

Various strain gages were attached to the girder webs near the predicted shear failure. The orientation and locations of these gages were at particular points of interest to monitor any post-buckling tension struts. Twenty-five and 26 strain gages were used for Beam Shear Test B and C, respectively (Figure 19).

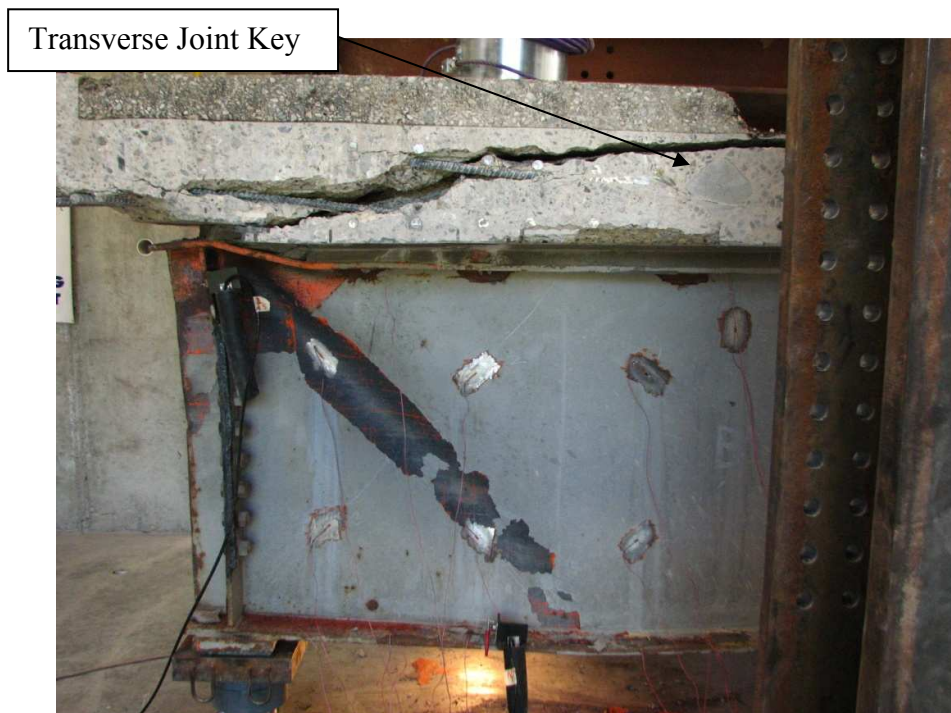
Figure 21. Beam Shear Test B failure.

The maximum shear forces sustained during the tests were taken directly from the nearest load cell reading. Beam Shear Tests B and C had maximum recorded shear capacities of 1,340 kN (301^k) and 1, 1,240 kN (278^k), respectively. This corresponds to a difference in shear capacity of 8.3% between the two tests.

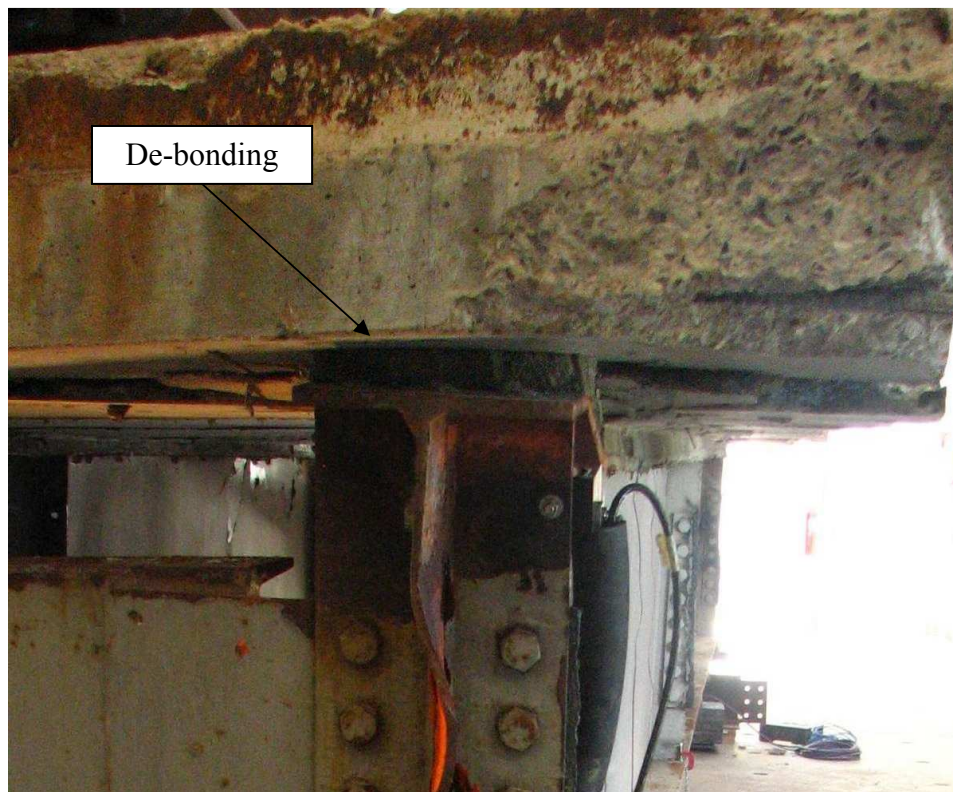
Figure 23. Grouted shear pocket failure.

The second step in the deck failure occurs at approximately 91% of the maximum load after the maximum load was sustained. There was a de-bonding failure of the grouted shear pocket connecting the girder to the deck. This shear pocket was directly above the loaded reaction. The shear studs remained connected to the top flange, and the grout remained bonded to the shear studs. The failure was at the grout/concrete interface. The mass of grout pulled away from the pocket in the deck panel (Figure 23).

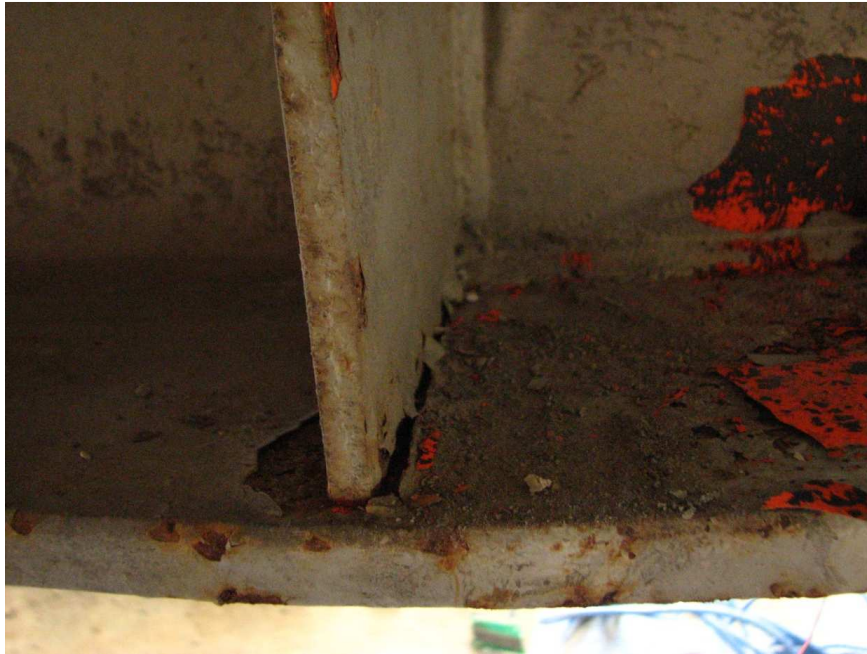
Figure 24. Web stiffener displacement after Beam Shear Test B.

After the failure of Beam Shear Test 1 the condition of the steel girder was inspected. It was discovered that the web stiffeners along both girders were in fact not welded to the bottom flange. Figure 24 shows the displacement of the stiffener nearest to the loaded reaction in Beam Shear Test B. The original position of the stiffener can easily be determined by the peeling of paint at the joint. It was concluded that the unwelded bottom flange connection likely had an effect on the shear-buckling capacity of the system. The other stiffeners were inspected. It was found that the stiffeners directly above supports and at mid-span of both girders were completely welded to the girder; all other stiffeners were only welded to the top flange and web.

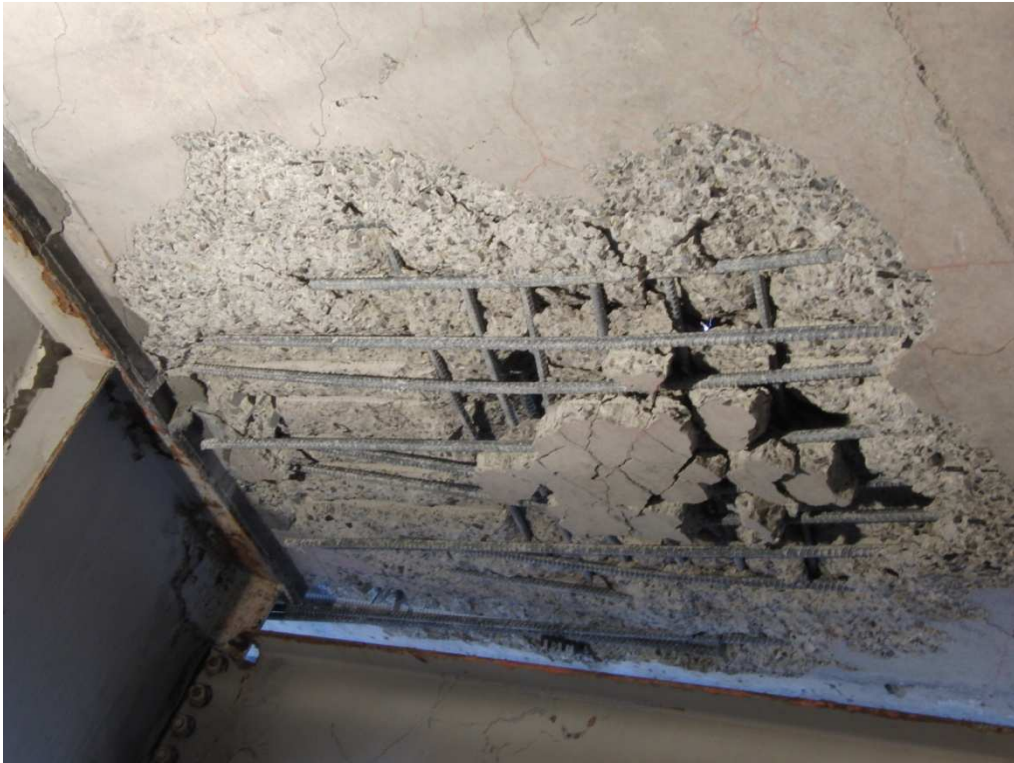
Figure 26. Underside of deck after Punching Shear Test 2 failure.

Two types of failures were experienced. For Punching Shear Tests 2 and 4 a classic punching failure was observed. The concrete deck fractured along a diagonal plane radiating out from the load point. The resulting damage was a cone-shaped shear failure surface. The reinforcement suspended much of the crumbled concrete although its structural capacity was lost. Much of the concrete surrounding the base of the cone spalled off exposing the bottom layer of reinforcement in the panels (Figure 26).

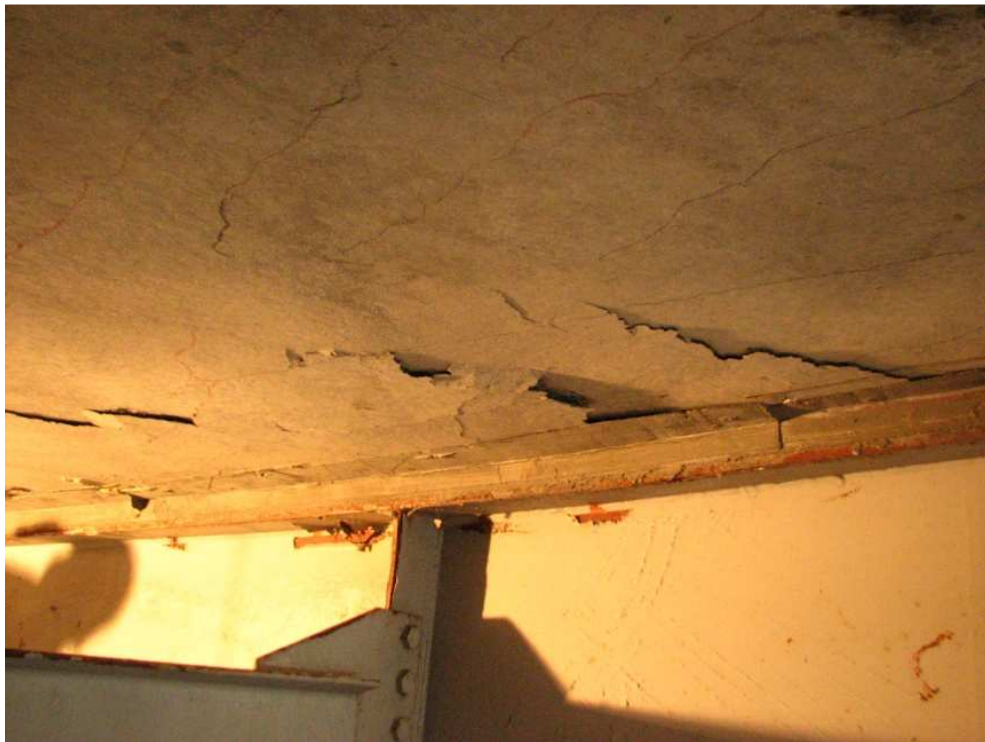
Figure 33. Delamination and Spalling Beneath Point Load at 1,420 kN (320^k).

Prior to Dynamic Test 14, the concrete directly beneath the ram experienced somewhat of a localized bearing failure. There was a visible depression of the spherical bearing into the concrete. There was isolated spalling and delamination of the underside of the deck directly beneath the point load (Figure 33). Also the crack that previously formed propagated along the top mat of reinforcement in both directions to a final length of approximately 4.1 m (13 ft 5 in.). The crack expanded to approximately 13 mm (0.5 in.) wide (Figure 34). The average natural frequency change recorded in Dynamic Test 14 was -1.3%. This was the second largest decrease in average modal frequencies recorded throughout testing. The reduced stiffness was attributed to the aforementioned deck damage.

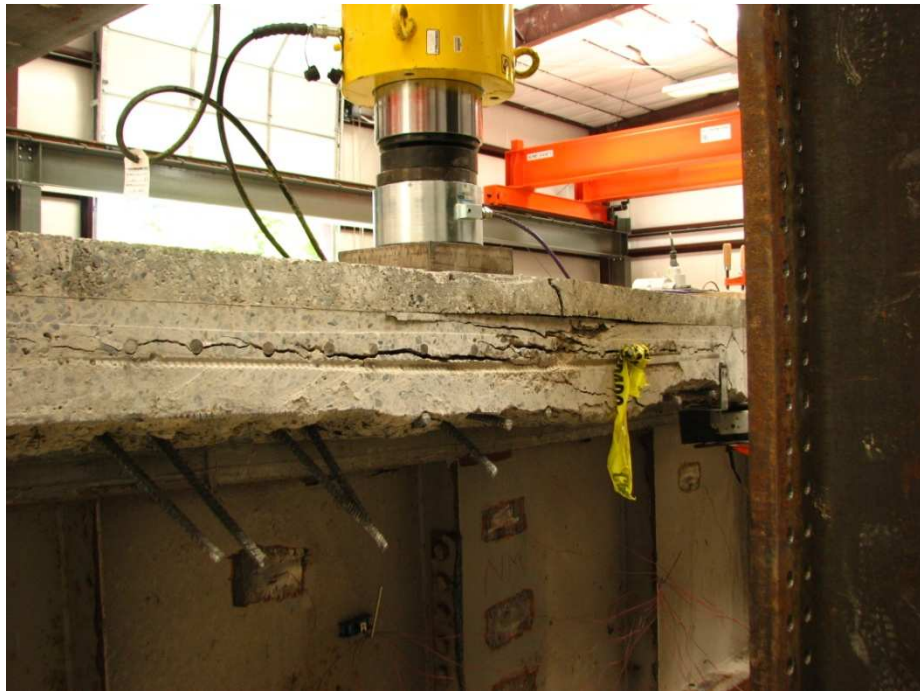
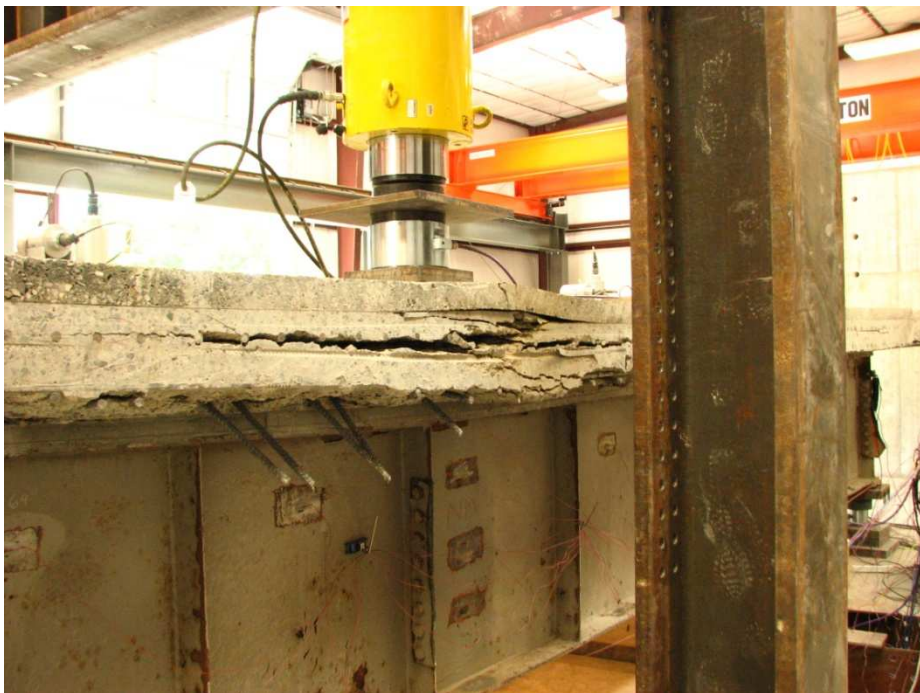
Figure 34. Flexural cracks after a) 1,420 kN (320^k) and b) failure, 1,490 (334^k).

The bridge reached its ultimate capacity prior to Dynamic Test 15. At this point, the crack formed beneath the load point had opened to approximately 76 millimeters (3.0 inches) during the load test. After the load was removed the crack had a residual gap of approximately 38 millimeters (1.5 inches) as shown in Figure 34b. This crack was formed by de-bonding of the upper mat of reinforcement due to excessive compression. The majority of system damage was consolidated to the deck in the region surrounding the point load (i.e.: directly above Girder D). Damage consisted of large cracking, severe delamination on the underside of the deck, and spalling of the concrete. Dynamic Test 15 yielded a change in average natural frequencies of -5.8%. This was the largest decrease in modal frequencies recorded throughout testing. It is concluded that the severe damage of the deck above Girder D is the primary reason for the frequency shift.

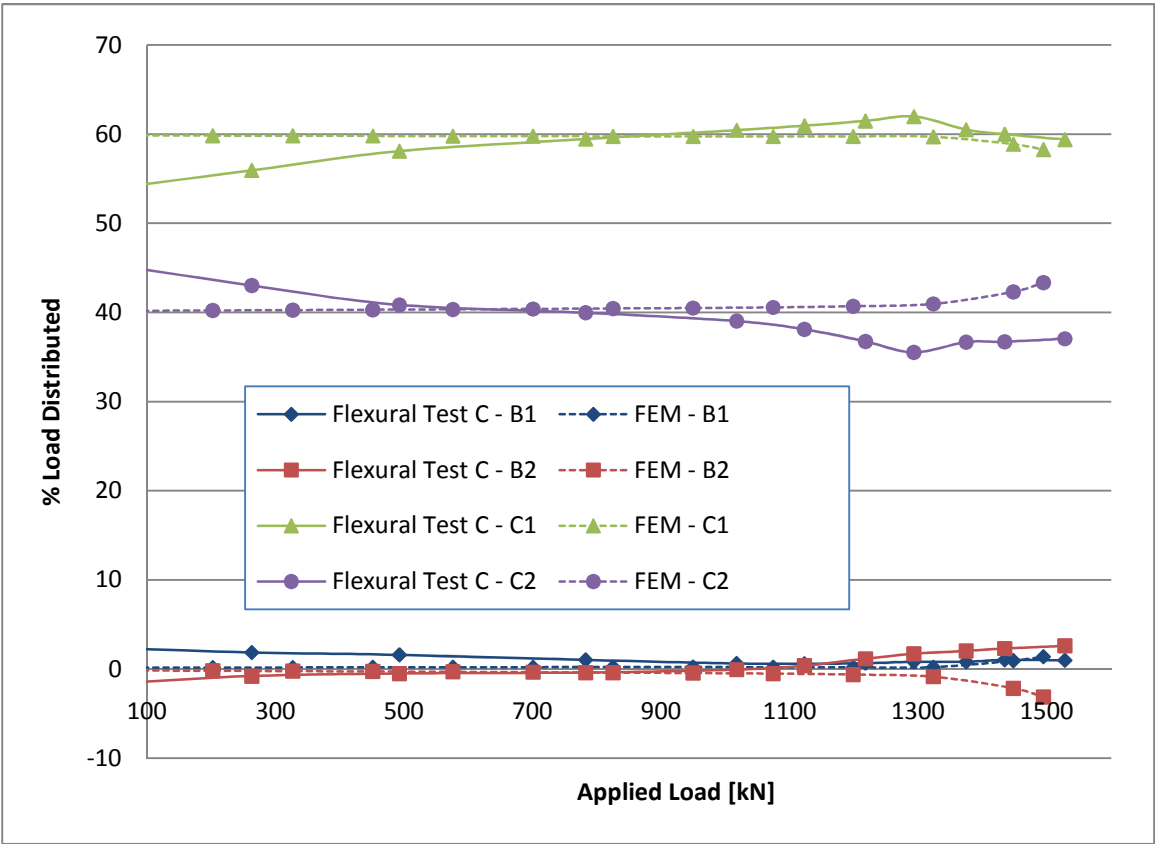
Figure 40. Flexural Test C load distribution comparison.

Furthermore, Reaction C1 carries the maximum load for both models. At an applied load of 1,490 kN (336^k), which is within 4% of the ultimate experimental load, there is only a 1.34% difference in percent distribution at Reaction C1 for both models. This would be the controlling shear reaction in design. Essentially, this shows that the FEM behaves very well in the post-elastic range for load distribution, which was the objective of the model.

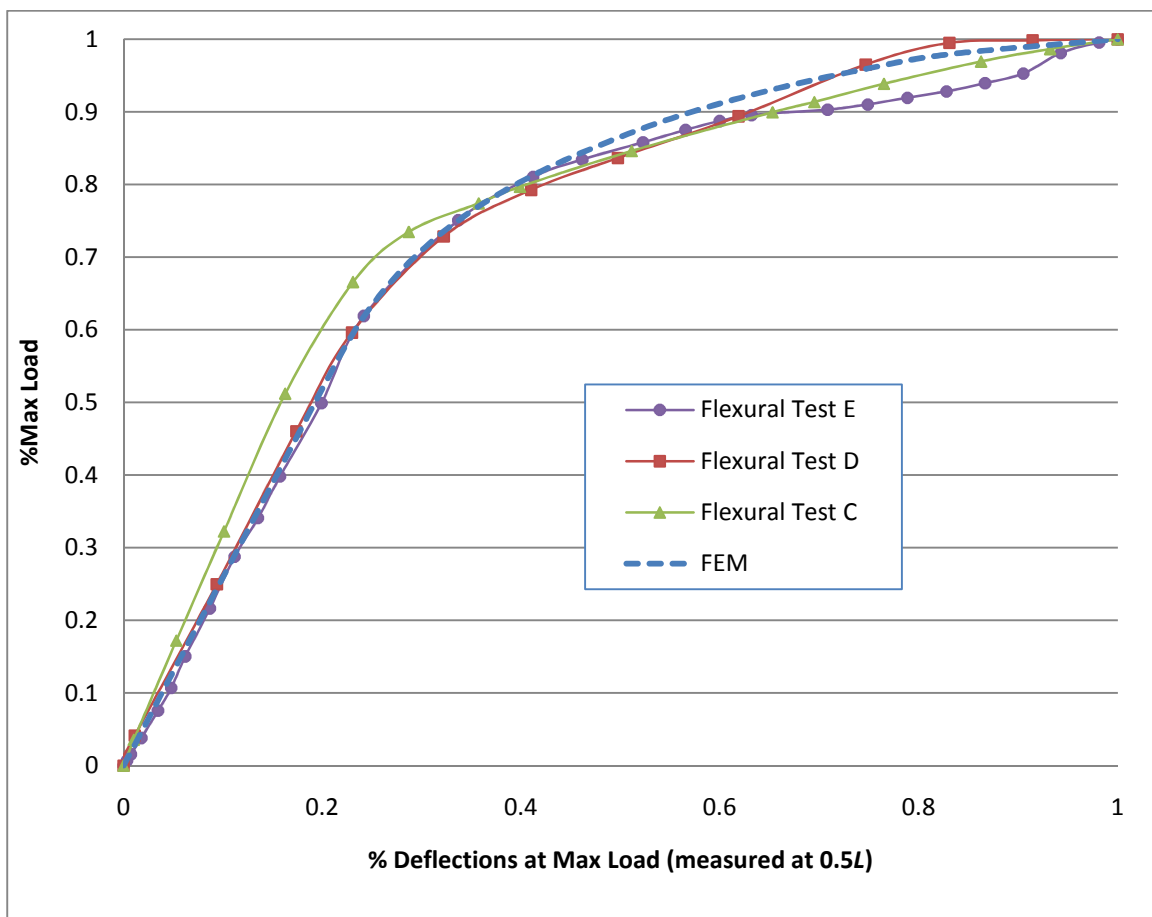
Figure 41. Flexural deflections comparison.

The post-elastic behavior verifies that elastic-plastic failure criterion for concrete was appropriate for this application. The failure replicated in the FEM was not the same as that observed in the laboratory. However, an equivalent plastic failure was obtained in the FEM.

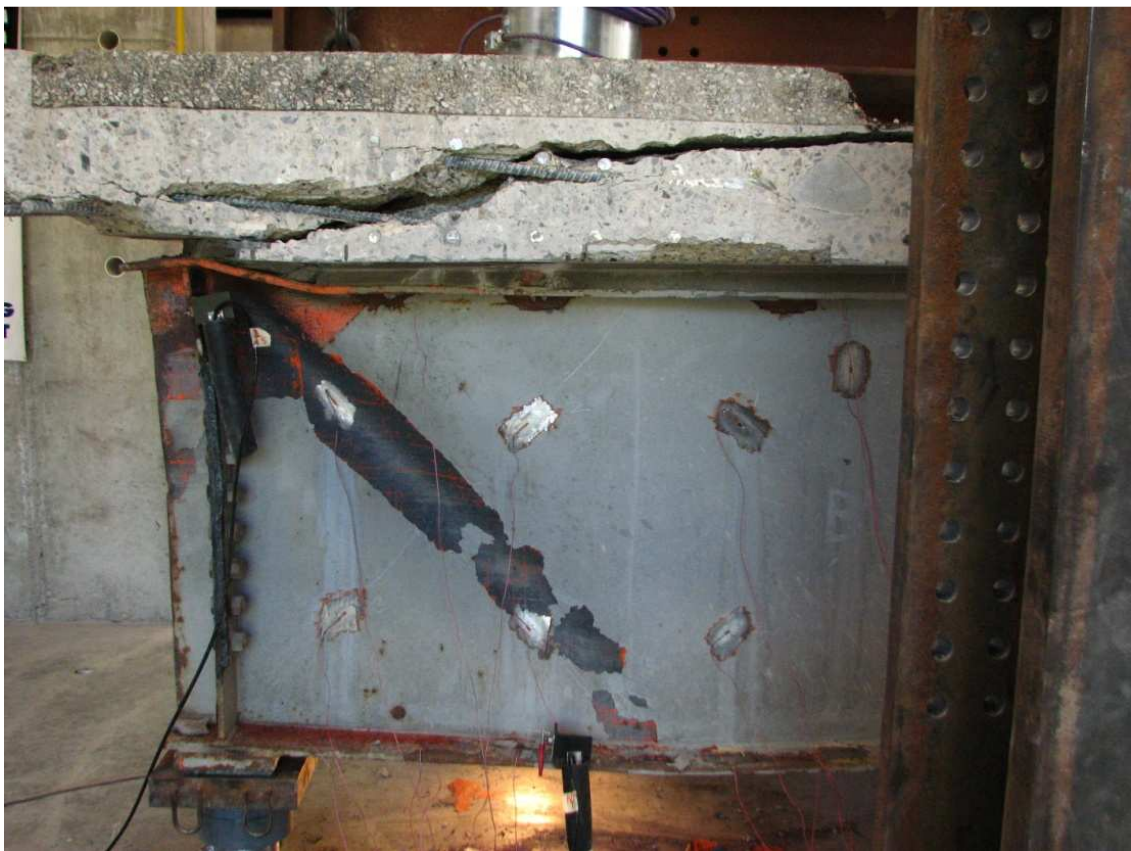
Figure 44. Beam shear buckling comparison: a) experimental buckled shape and b) FEM principal stresses.

In order to verify that the unconverged solution was in fact caused by buckling, the results needed to be inspected. In a nonlinear buckling analysis, the mode shape is not explicitly predicted, although stress and strain plots can be examined in order to extrapolate the deflected shape.

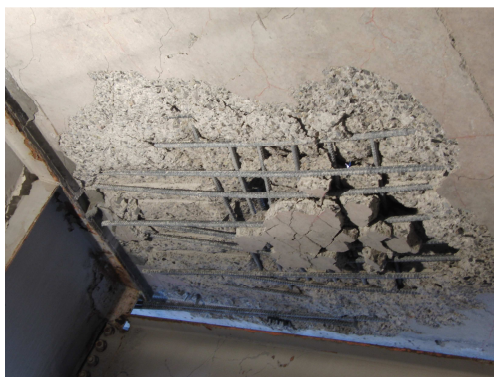
Much of the cracking predicted by the software was isolated to the center of the panel beneath the applied load. Cracking initiated along the underside of the panel where the bending moment and hence greatest tensile stresses were highest. As the load increased shear cracks started to propagate in a conical fashion away from the applied load. The boundary conditions included some degree of fixity at the girder supports and therefore a small negative moment region was induced. At approximately 95% of the applied load the negative moment region produced tensile cracks along the top of the deck. Finally, at 657 kN (148^k) a complete failure surface was encountered through the depth of the deck and failure was reached (Figure 48 and Figure 49).

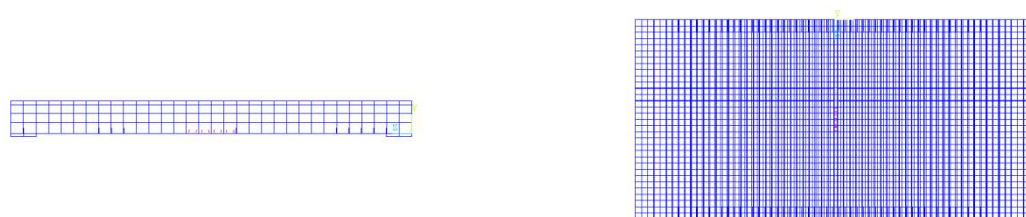
a) 194 kN (43.6^k)

Figure 51. Cracking Sequence of transverse joint panel model.

The transverse joint model behaved considerably different than the continuous panel model. There was much less concrete cracking throughout the failure sequence (Figure 51). A much smaller failure surface throughout the depth of the deck was reached at a much smaller load, 372 kN (83.6^k), which is 4.1% smaller than the average measured ultimate load. The failure surface was more cylindrical than conical. There was also much de-bonding of the contact and target elements connecting the grouted key to the concrete. The de-bonding was predicted towards the bottom portion of the joint. This can be seen by plotting the deformed shape of the FEM (Figure 52).
