Hydraulics of IDEal Drip Irrigation Systems

HYDRAULICS OF IDEAL DRIP IRRIGATION SYSTEMS

Irrigation Engineering

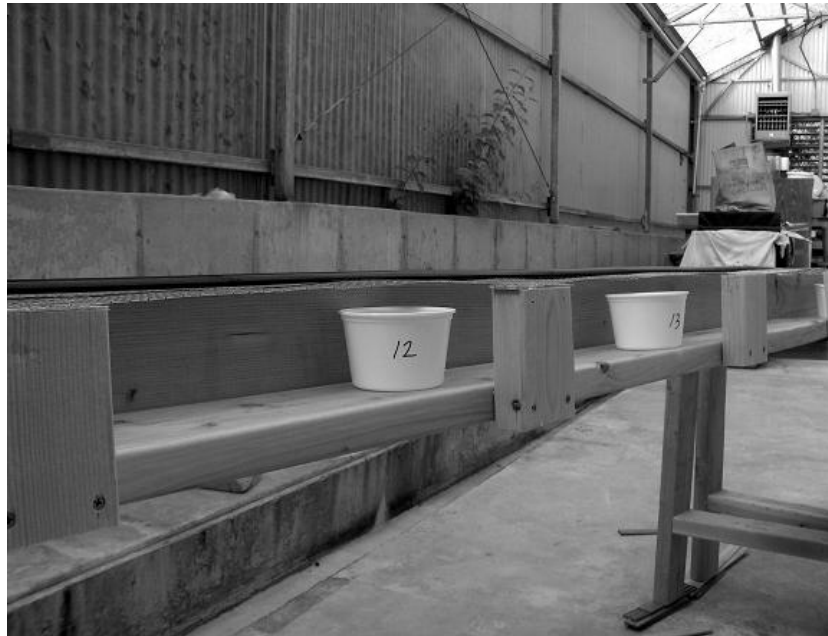
The runway was constructed with two levels. As seen in Fig. 1, the upper level was constructed of metal hardware cloth to support the IDEal lateral. The lower level was a wooden plank that served as a shelf to place containers for measuring individual emitter flow rates. In this manner, the emitters could discharge through the hardware cloth and into the measuring cups, allowing for convenient evaluation of average emitter flow rates.

Fig. 1. Testing runway. The runway included wire mesh to support the lateral and a shelf for the catch cups (two of which are shown here).

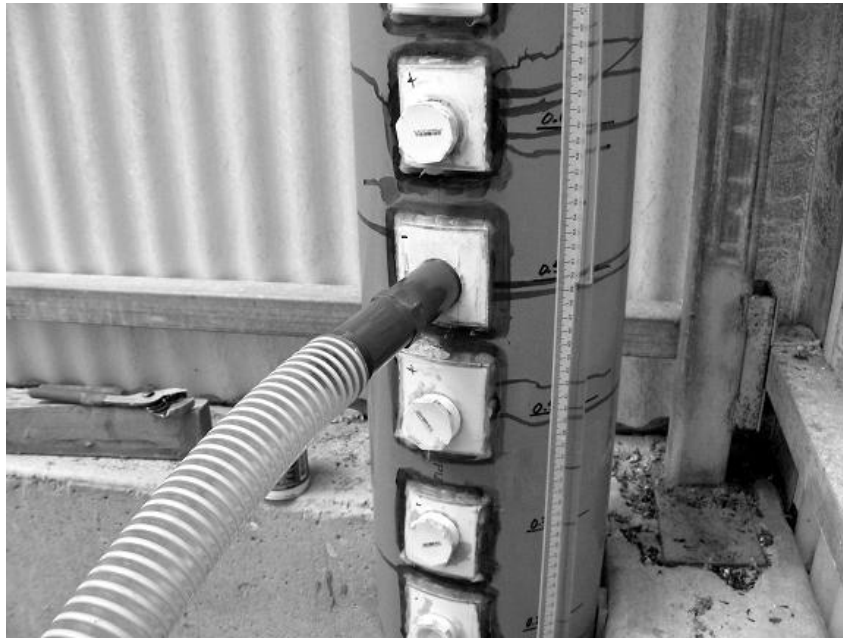
The two constant-head tanks were constructed of 8-inch nominal diameter PIP-PVC pipe and were 3 m tall. The upstream and downstream pipes were capped on the bottom and stood up vertically in each corner, serving as reservoirs, and were secured to the structural steel frame of the greenhouse. The upstream (supply tank) was fed by a common garden hose connected to the potable water supply. One-inch holes were drilled into the sides of each tank at 10-cm intervals, forming overflow holes. In the upstream tank, the holes were plugged using rubber stoppers. The stopper at the desired head on the tank was removed, allowing excess water to overflow, thus maintaining a constant head under steady-state conditions. The tank at the downstream end of the lateral operated in a similar manner, but the overflow holes were threaded so that a hose could be connected to a spout inserted into the overflow hole, facilitating measurement of the flow rate, as seen in Fig. 2. The tanks were sealed to eliminate leakage. Both tanks were

Fig. 2. Downstream tank. The overflow holes were tapped to facilitate flow measurement.

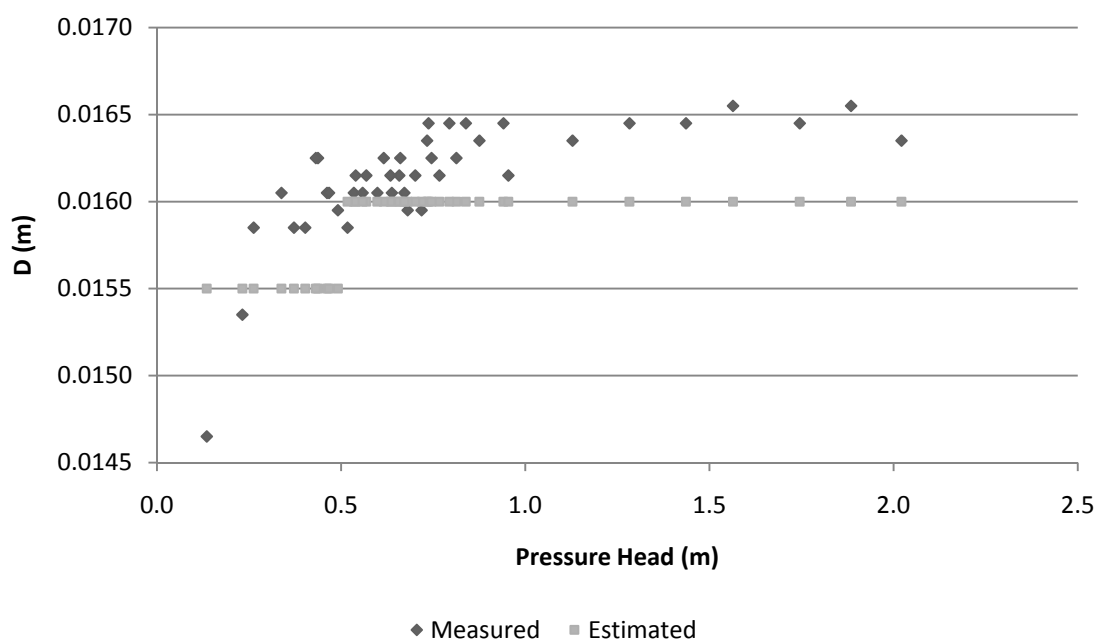
The effective diameter as a function of pressure head is shown in Fig. 11. The fourth estimation method used an effective diameter of 15.5 mm when the pressure head was less than 0.5 m, and an effective diameter of 16 mm when the pressure head was greater than 0.5 m. The first estimation method accounted for 85% of the measured friction loss on average overall (95% when $Re > 4,000$), with a standard deviation of 0.22, a coefficient of variation of 26%, and a correlation coefficient of 0.9923. The fourth

Fig. 11. Effective diameter and pressure head in the 125- μm wall thickness lateral estimation method accounted for 91% of the measured friction loss on average overall (103% when $R_e > 4,000$), with a standard deviation of 0.23, a coefficient of variation of 25%, and a correlation coefficient of 0.9942 (see Fig. C.4). Even at low pressures the lateral inflated to an almost circular cross section; thus, there is little difference between the accuracy of the two estimation methods.

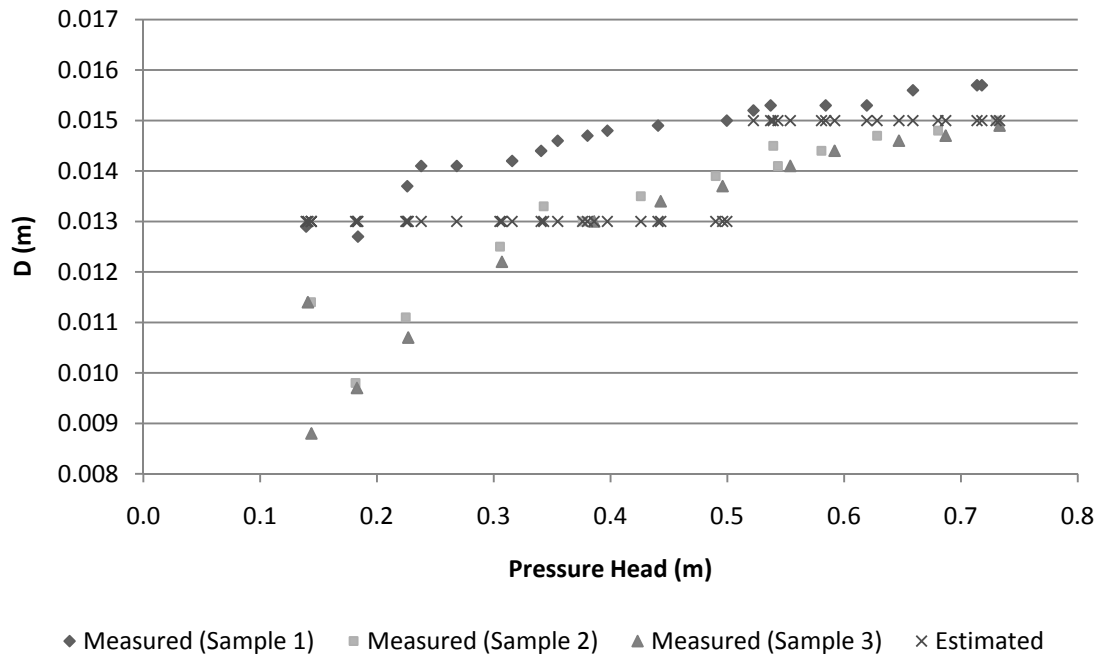
Fig. 14. Effective diameter and pressure head in the 250- μm wall thickness lateral

Three samples of 250- μm wall thickness lateral, all from the same spool, were tested. The average coefficient of variation of measured flows was 0.60%. The effective diameter as a function of pressure head for the three samples is shown in Fig. 14. Sample one varied significantly from samples two and three, displaying a larger effective diameter for a given pressure. Figure 14 shows the results beginning to converge near a diameter of 16 mm above 0.8 m of pressure. The fourth friction loss estimation method used the following criteria: for $H < 0.5$ m, $D = 13$ mm; for $0.5 \text{ m} < H < 1.0$ m, $D = 15$ mm; and, for $2.5 \text{ m} > H > 1.0$ m, $D = 15.5$ mm.

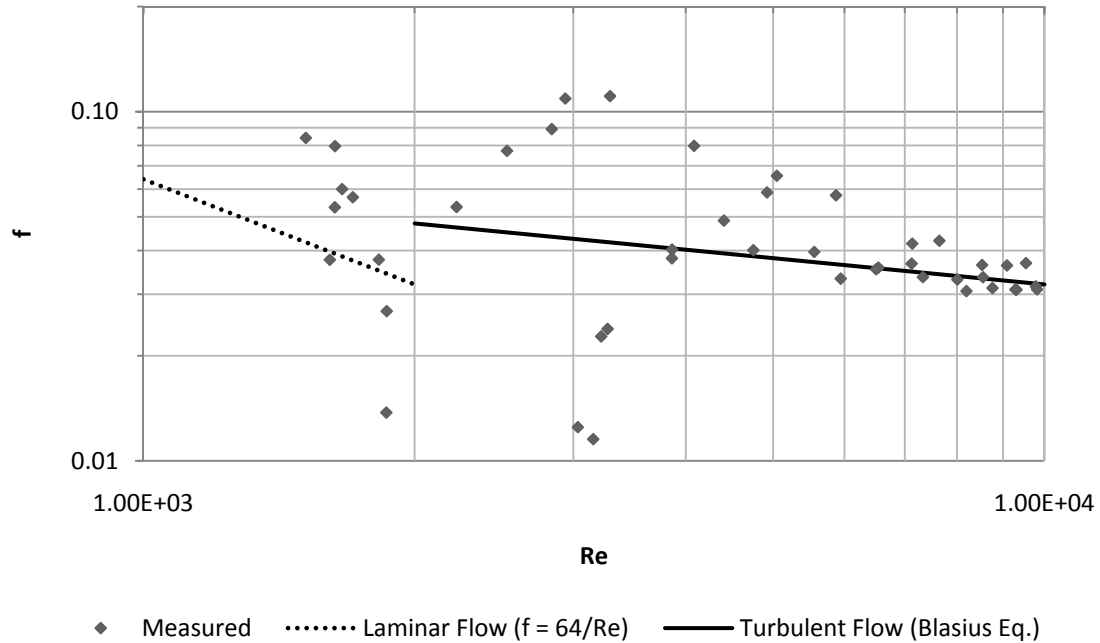
Fig. 15. Friction factor and Reynolds number in the 250- μm wall thickness lateral

The first estimation method accounted for 105% of the measured friction loss on average overall (91% when $R_e > 4,000$), with a standard deviation of 0.66, a coefficient of variation of 63%, and a correlation coefficient of 0.9193. The fourth estimation method accounted for 90% of the measured friction loss on average overall (102% when $R_e > 4,000$), with a standard deviation of 0.21, a coefficient of variation of 23%, and a correlation coefficient of 0.9631 (see Fig. C.6).

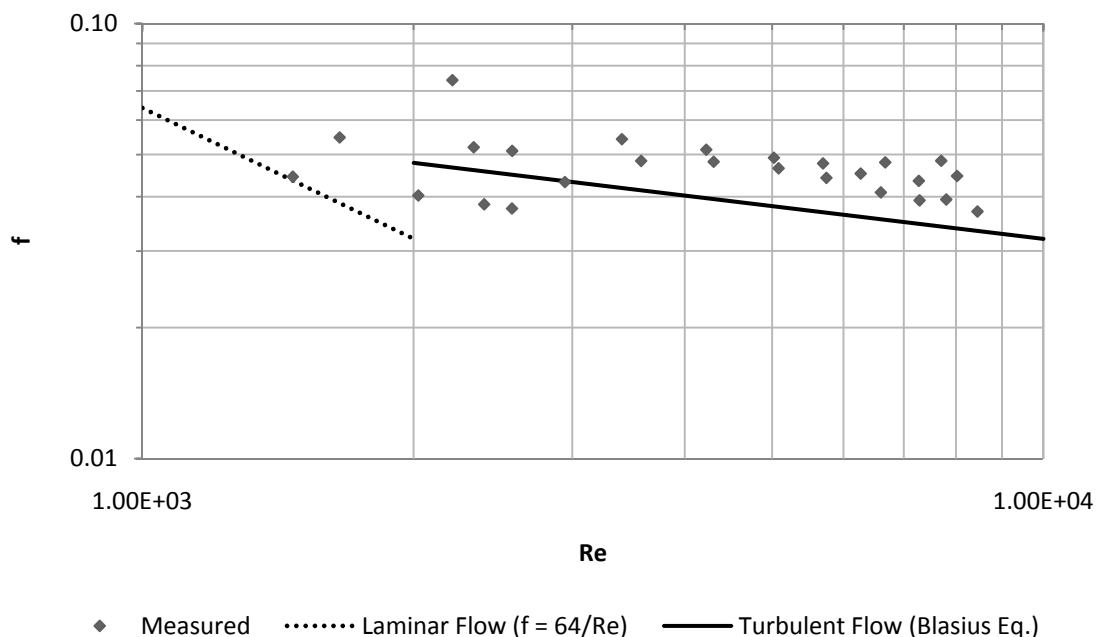
Figure 17 shows the friction factor as a function of the Reynolds number. The measured values became unstable below Reynolds numbers of 3,000, indicating transitional flow. There is no clear distinction of the laminar regime in the measured

Fig. 17. Friction factor and Reynolds number in the 500- μm wall thickness lateral. In this case $4R_h$, as opposed to lateral height, was used as the effective diameter, measured in both the morning and afternoon.

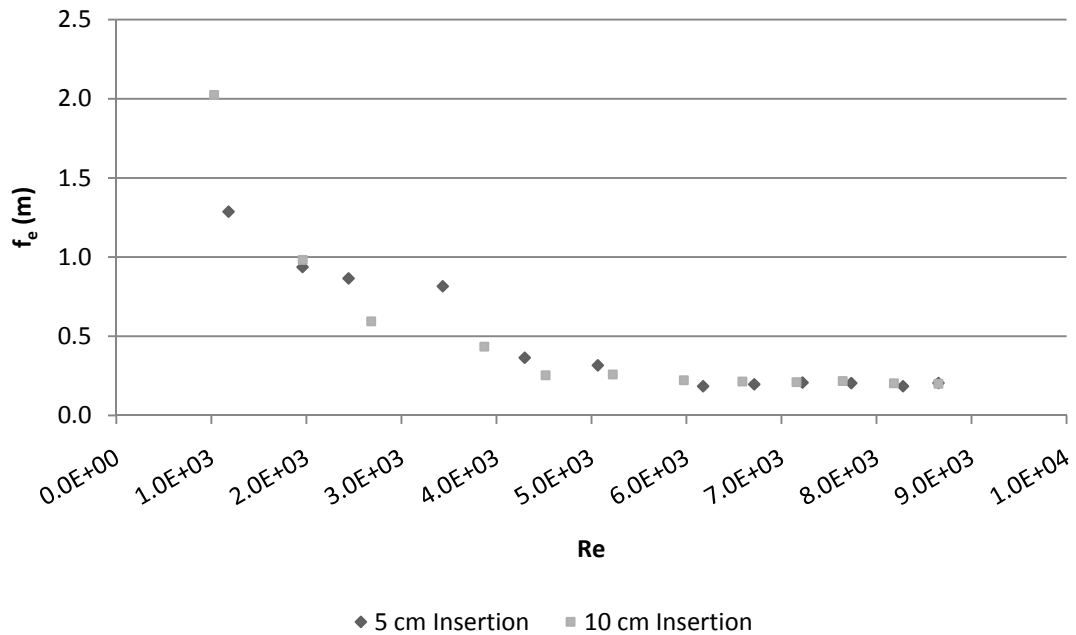
Fig. 18. Measured emitter connection loss expressed as an equivalent length of lateral for micro-tube emitters

The measured data for the emitter connection friction loss as an equivalent length of the lateral (emitter barb loss), f_e , for the micro-tube emitters is found in Fig. 18.

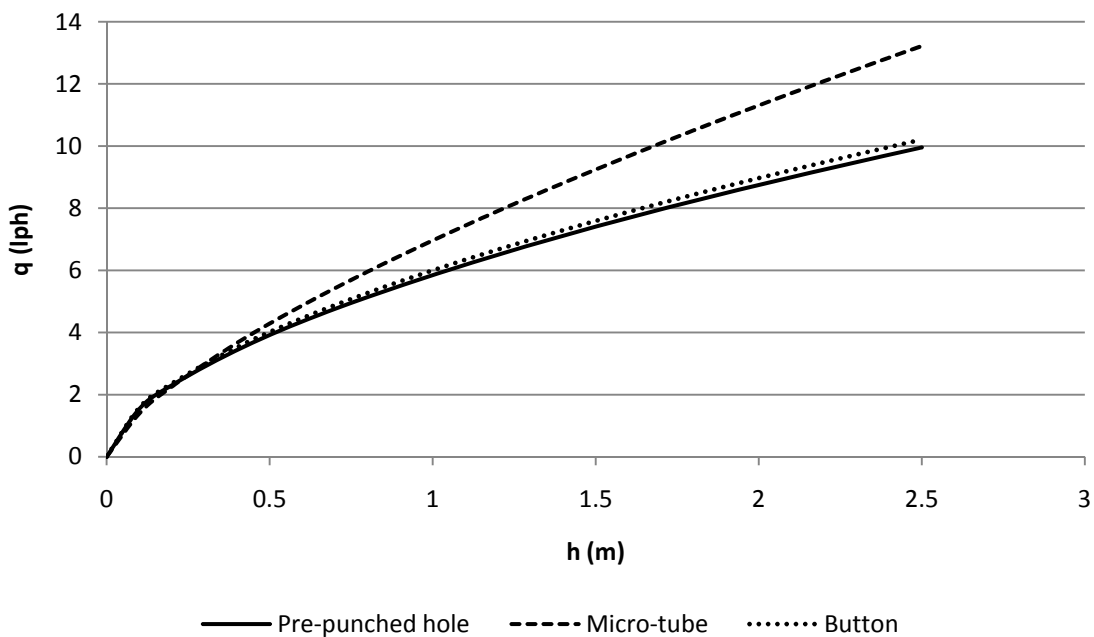
**Fig. 25.** Average emitter head-discharge relationship

The pre-punched holes had the highest coefficient of manufacturer's variation at 0.31, which is unacceptable according to ASABE standards. Consequently, the pre-punched holes on average exhibited the lowest CvU at 69.4%. The pre-punched holes had an average flow of 5.85 lph for a pressure head of 1 m, which was the lowest of the three emitter types tested. The micro-tubes displayed the best coefficient of

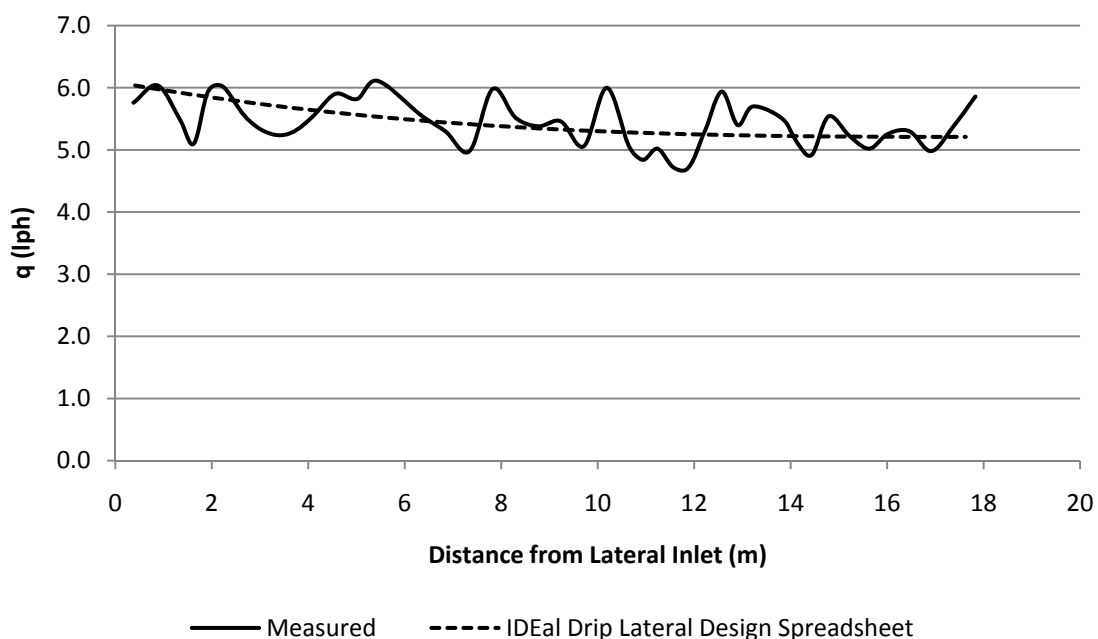
Fig. 26. Distribution of emitter discharge along the lateral. Measured values for an 18-m long lateral using micro-tubes at 1 m of inlet pressure head are compared to the estimate using the IDEal drip lateral design spreadsheet.

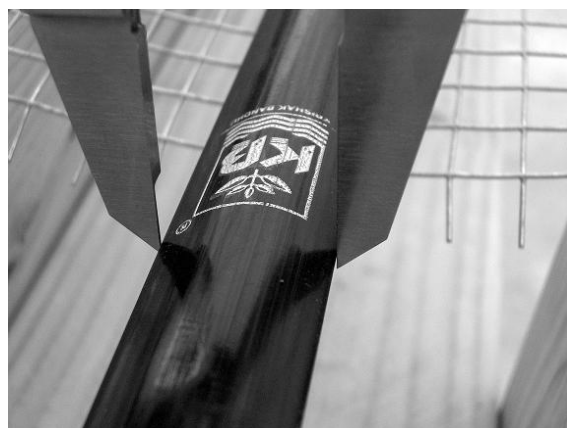
Fig B.6. Lateral cross-section measurement using calipers

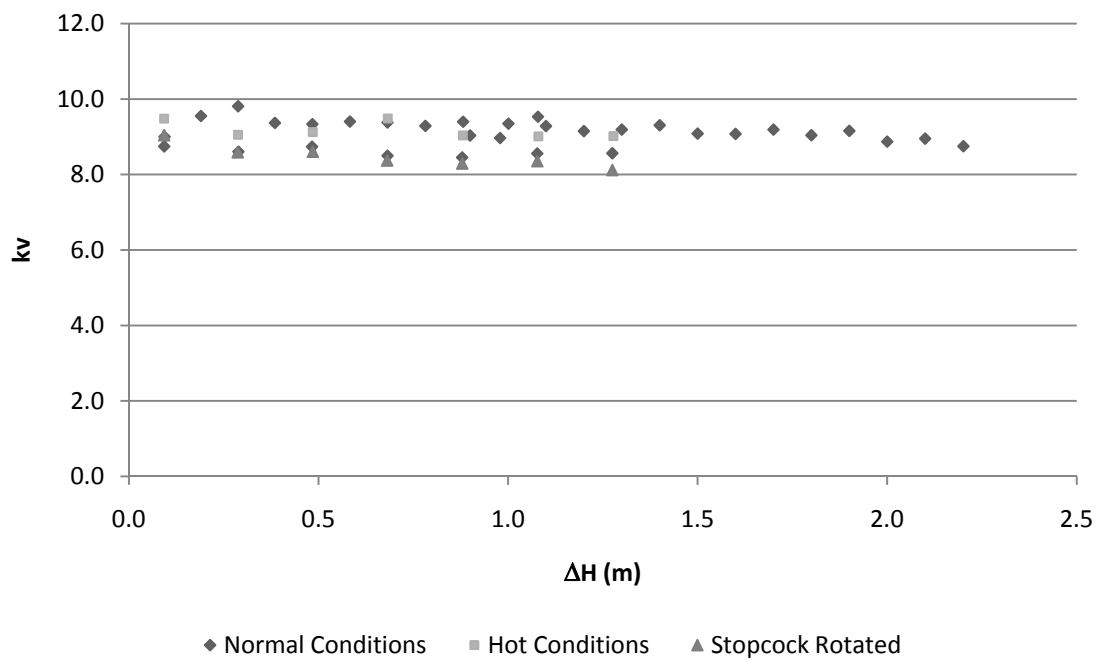
Fig. C.3. Valve loss coefficients for valve 1 under various conditions

The results are shown in Fig. C.3. The average valve loss coefficient for valve 1 under hot conditions was 9.17, compared to an average k_v of 9.08 for “normal” conditions.

Thus, it can be determined that for this range of conditions, air temperature did not have a significant impact on valve performance. The average temperature of the water supply was approximately 13°C, and it is probable that the flow of cold water through the valve maintains the valve at a colder temperature than the surrounding air. This will not necessarily be the case under actual field conditions.

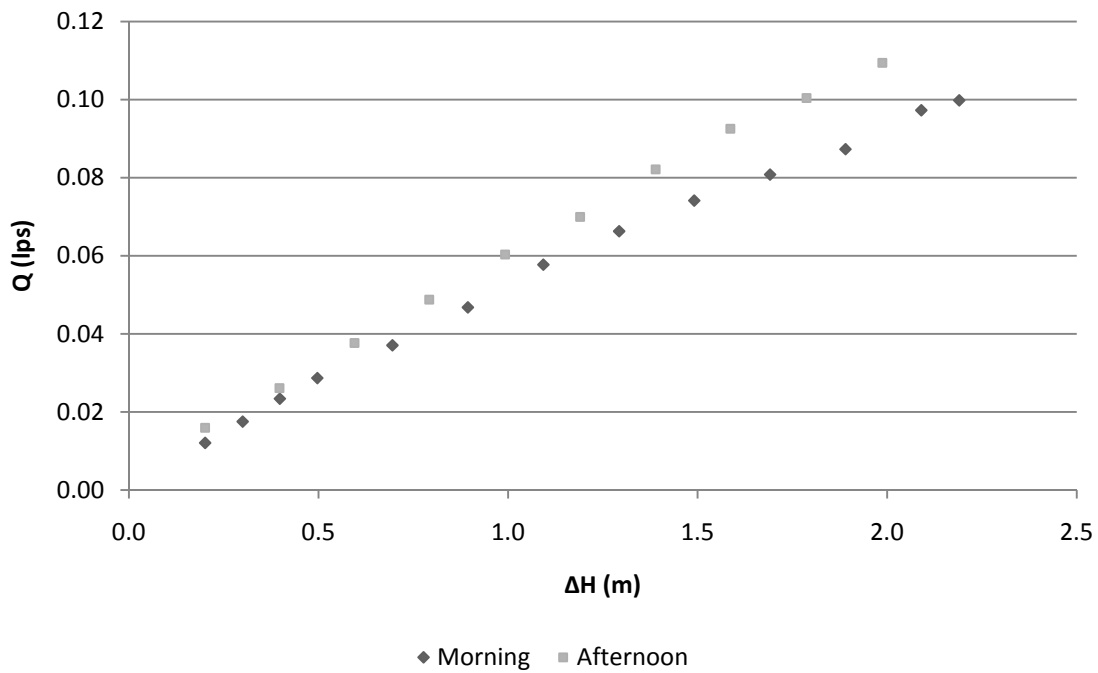
Fig. C.8. Measured head-discharge data for the 500- μm wall thickness lateral.

The measured head-discharge of the 500- μm wall thickness lateral is shown in Fig. C.8. This figure shows two curves exhibited by the same sample, but taken at different times of the day; one in the morning and one in the afternoon. The lateral shows a higher discharge in the afternoon for a given pressure. Figure 16 shows the measured effective diameter (equal to $4R_h$) of the lateral as a function of pressure recorded in the morning and the afternoon. The lateral exhibited a greater effective diameter in the afternoon for a given pressure. The typical morning ambient air temperature range in the greenhouse was 20-30°C. Afternoon air temperatures often exceeded 35°C.

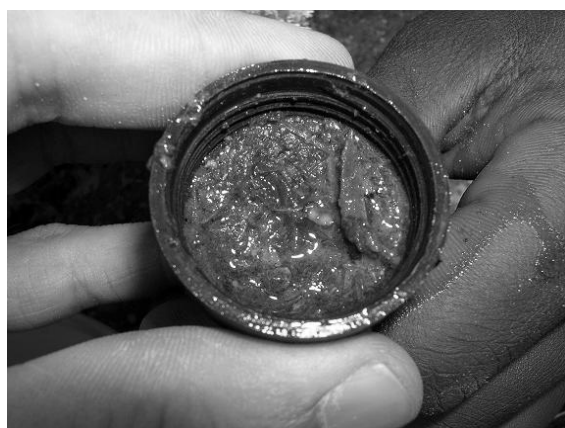
Fig. H.4. Clogged inline filter. EC1

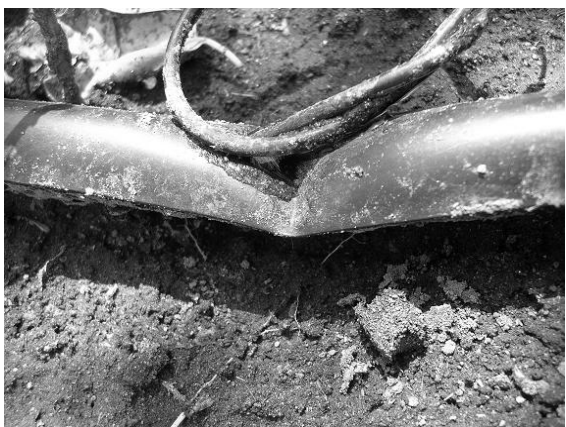
Fig. H.5. Kink in the lateral due to microtopography. EC1.

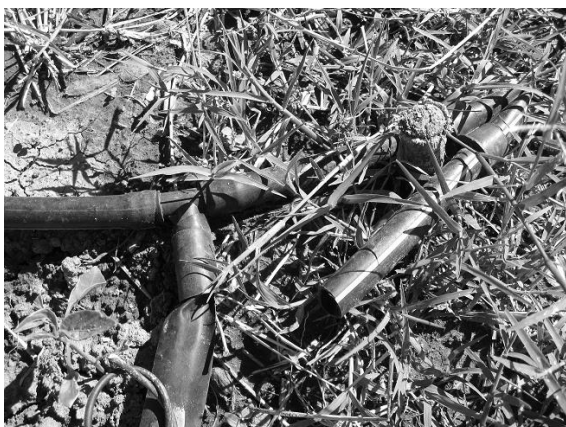
Fig. H.15. Improper submain staking. This causes a curved submain, which kinks the lateral. EC4.

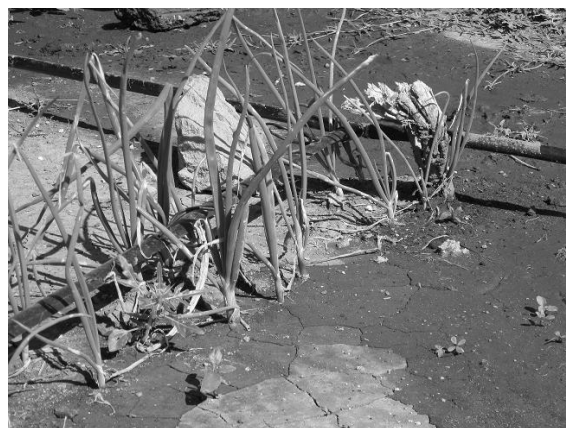
Fig. H.18. Lateral and submain tension. This caused the lateral to be elevated above ground. FTC2.

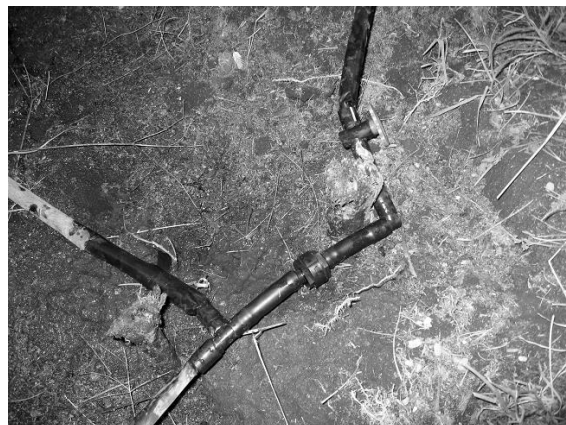
Fig. H.20. Improper placement of the header bag. This causes kinks in the laterals and mainline DH1.

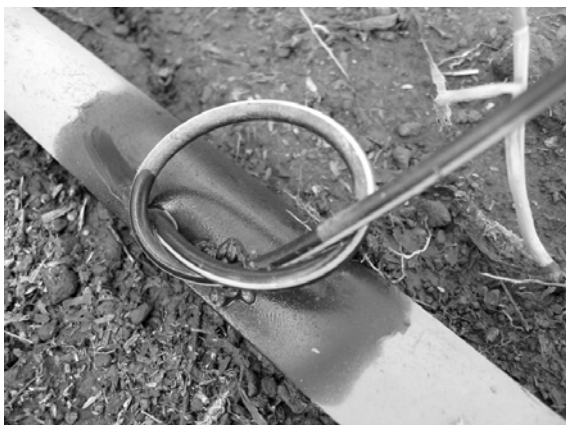
Fig. H.21. Incorrect emitter insertion. The emitter inlet points upstream, and the hole is punched off-center. DH1.

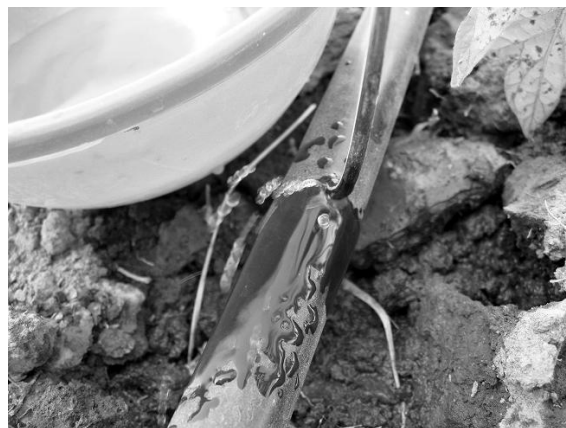
Fig. H.26. Leak at the emitter-lateral connection. AG2.

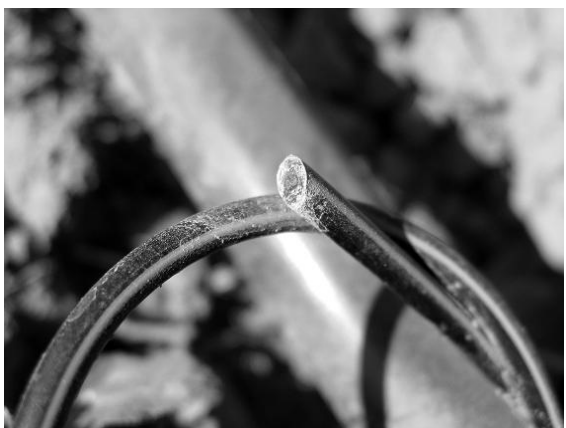
Fig. H.29. Emitter outlet clogged from discharging into soil. AGFTC.

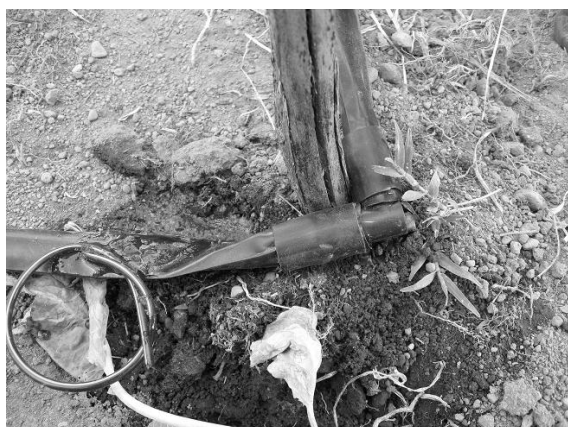
Fig. H.41. Lateral at end of submain kinked due to improper staking. Golba2.

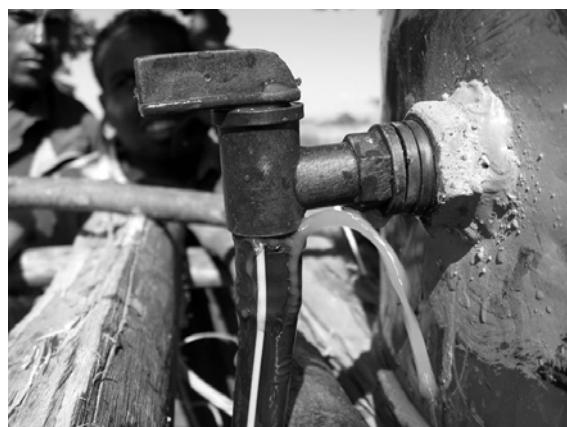
Fig. H.42. Leak at the mainline-tank tap connection. ANFTC.
