KfK 3789
November 1986

Temperature Escalation in PWR Fuel Rod Simulator Bundles due to the Zircaloy/Steam Reaction: Post Test Investigations of Bundle Test ESBU-2A

S. Hagen, H. Kapulla, H. Malauschek,
K. P. Wallenfels, B. Buescher
Hauptabteilung Ingenieurtechnik
Projekt Nukleare Sicherheit

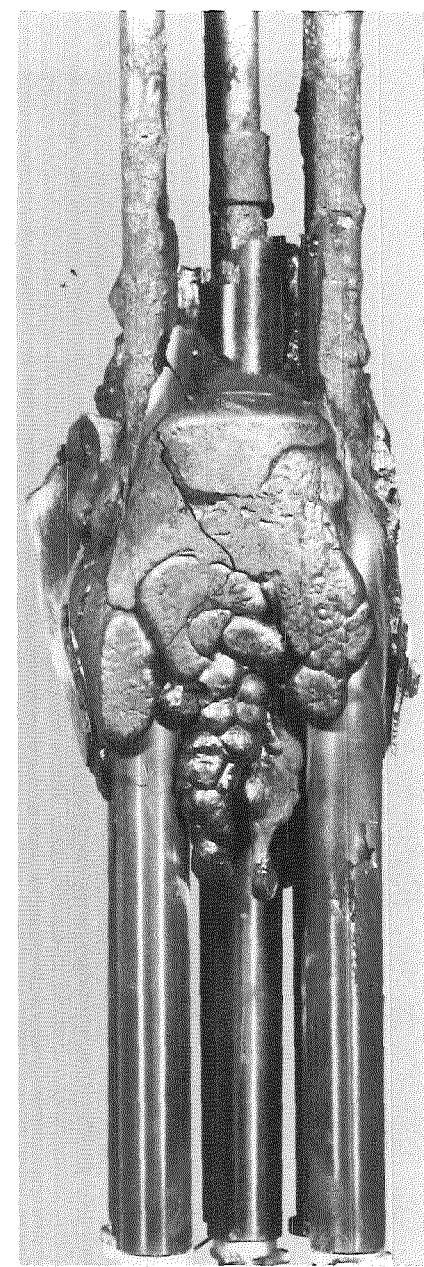
FIGURE 9: CLOSE-UP OF THE LOWER PORTION OF THE ESBU-2A BUNDLE

The appearance of the bundle after removal of the rubble is shown in Figures 9 and 10. The smooth surface is clearly recognized. In particular, the right-hand photo in Figure 9 shows the sequence of formation of the blockage from single droplets which have been frozen in the lower end of the bundle. Then more and more melt refroze on top of these droplets blocking the whole bundle, so that more and more melt was blocked within the bundle region. The lower part of the refrozen melt shows pure wetting of the solid surface as indicated by the large wetting angles and small contact areas. Melt viscosity, oxygen content and relatively cold fuel rods simulators were probably the main influence on the refreezing behaviour in this region.

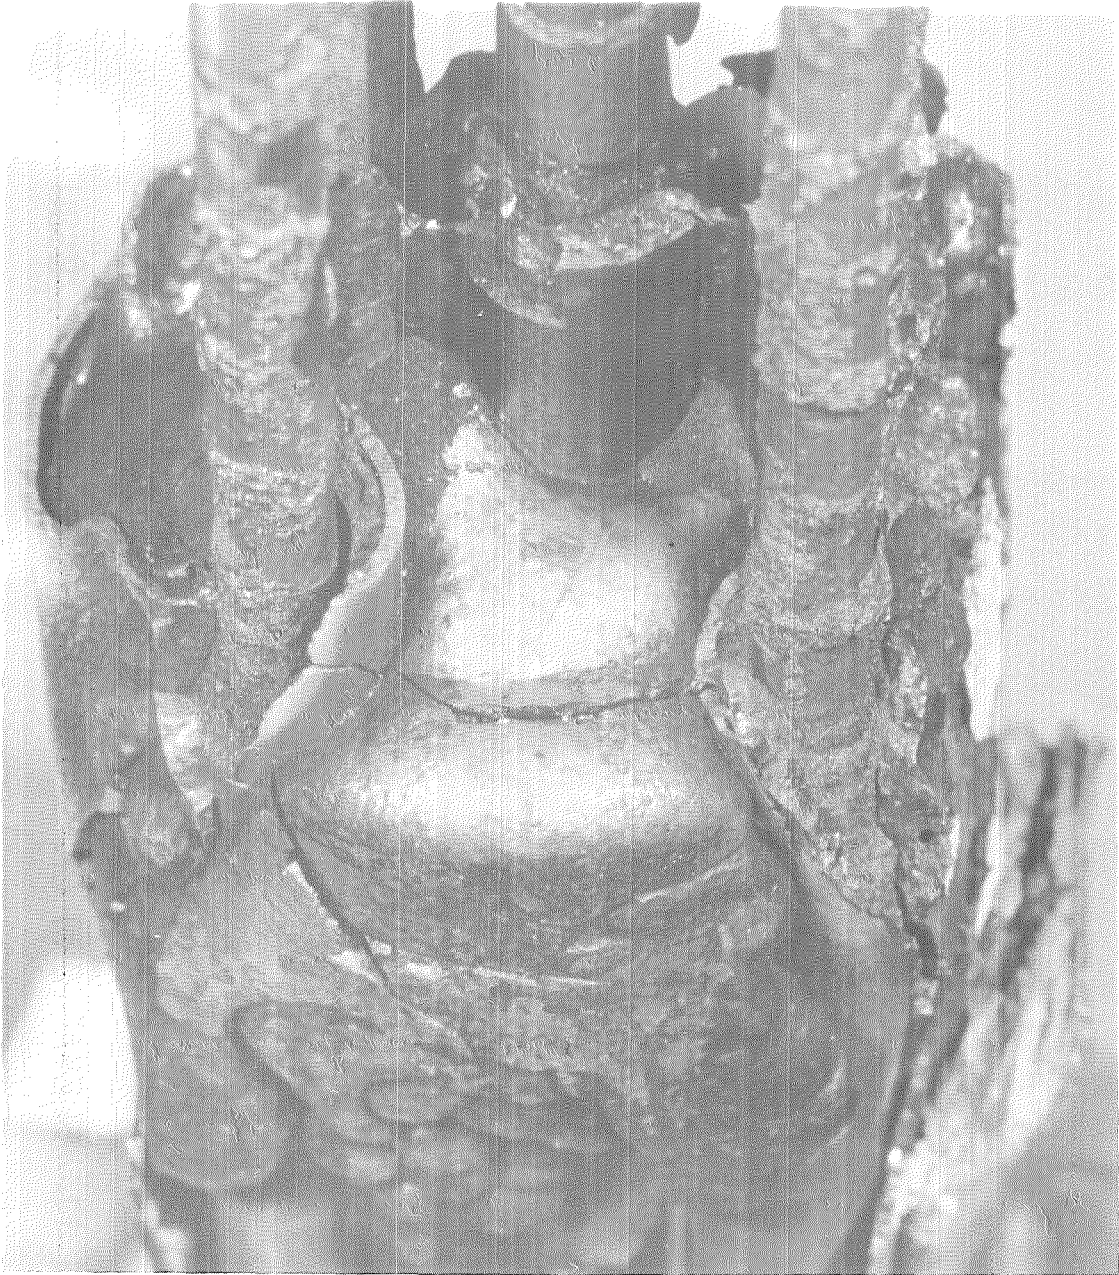
FIGURE 10: ENLARGED VIEW OF THE ESBU-2A BLOCKED REGION FROM ABOVE: TWO ORIENTATIONS

The upper surface of the blockage (Figure 10) has a smooth surface and wets the remaining simulators rather well (small wetting angle and large contact surface).

This indicates that the melt interacted with the oxidized fuel rod simulators and steam. The composition of the melt and these interactions will be the primary subject of the posttest examination in this region .

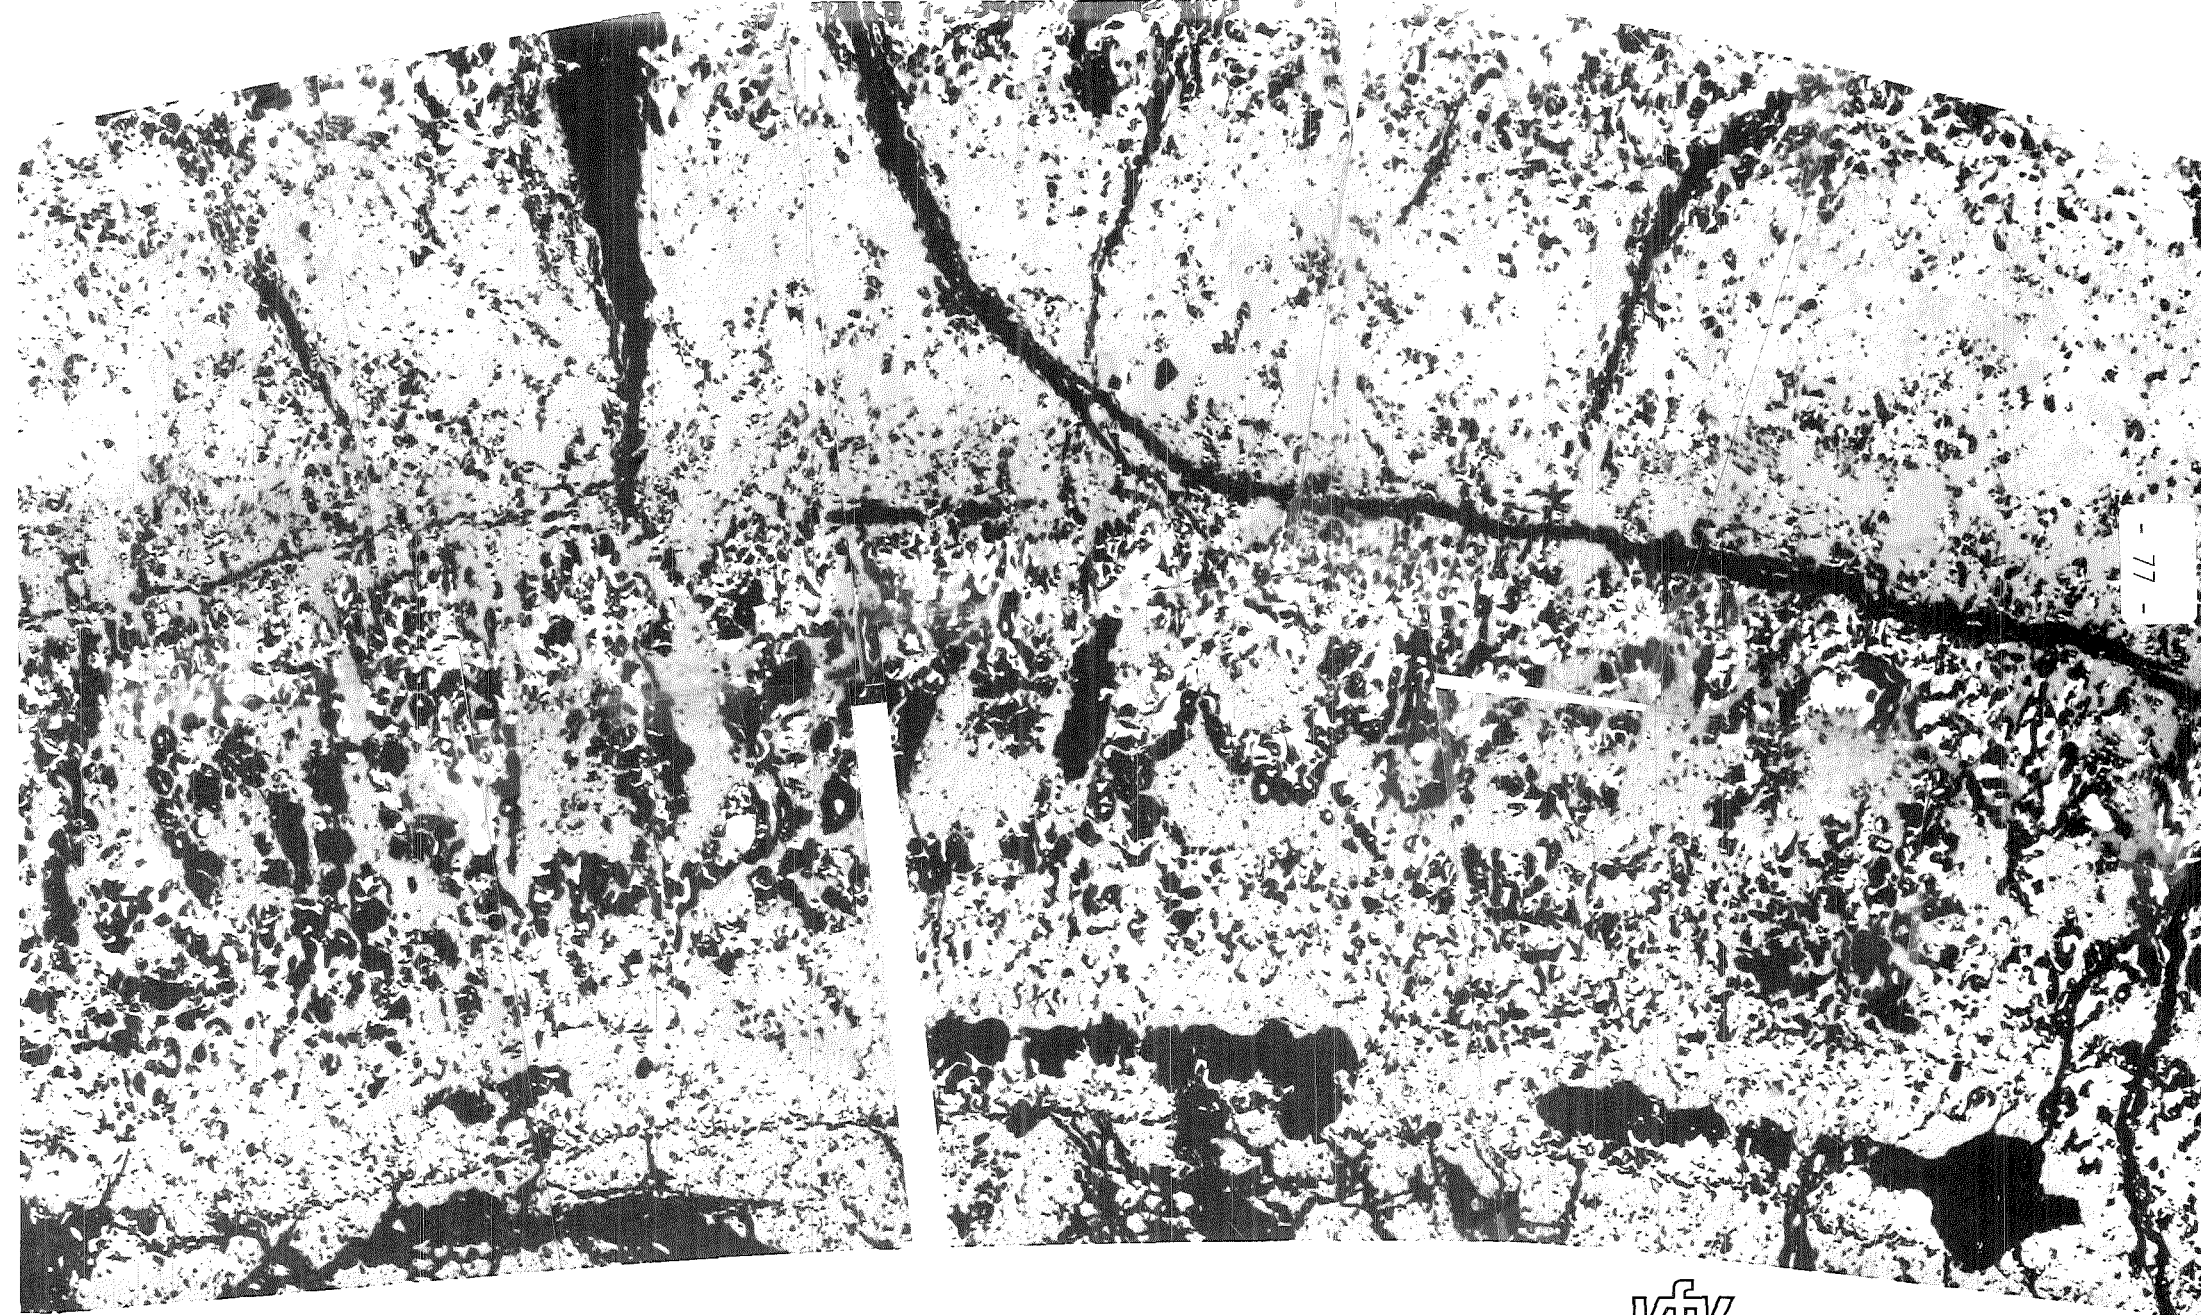
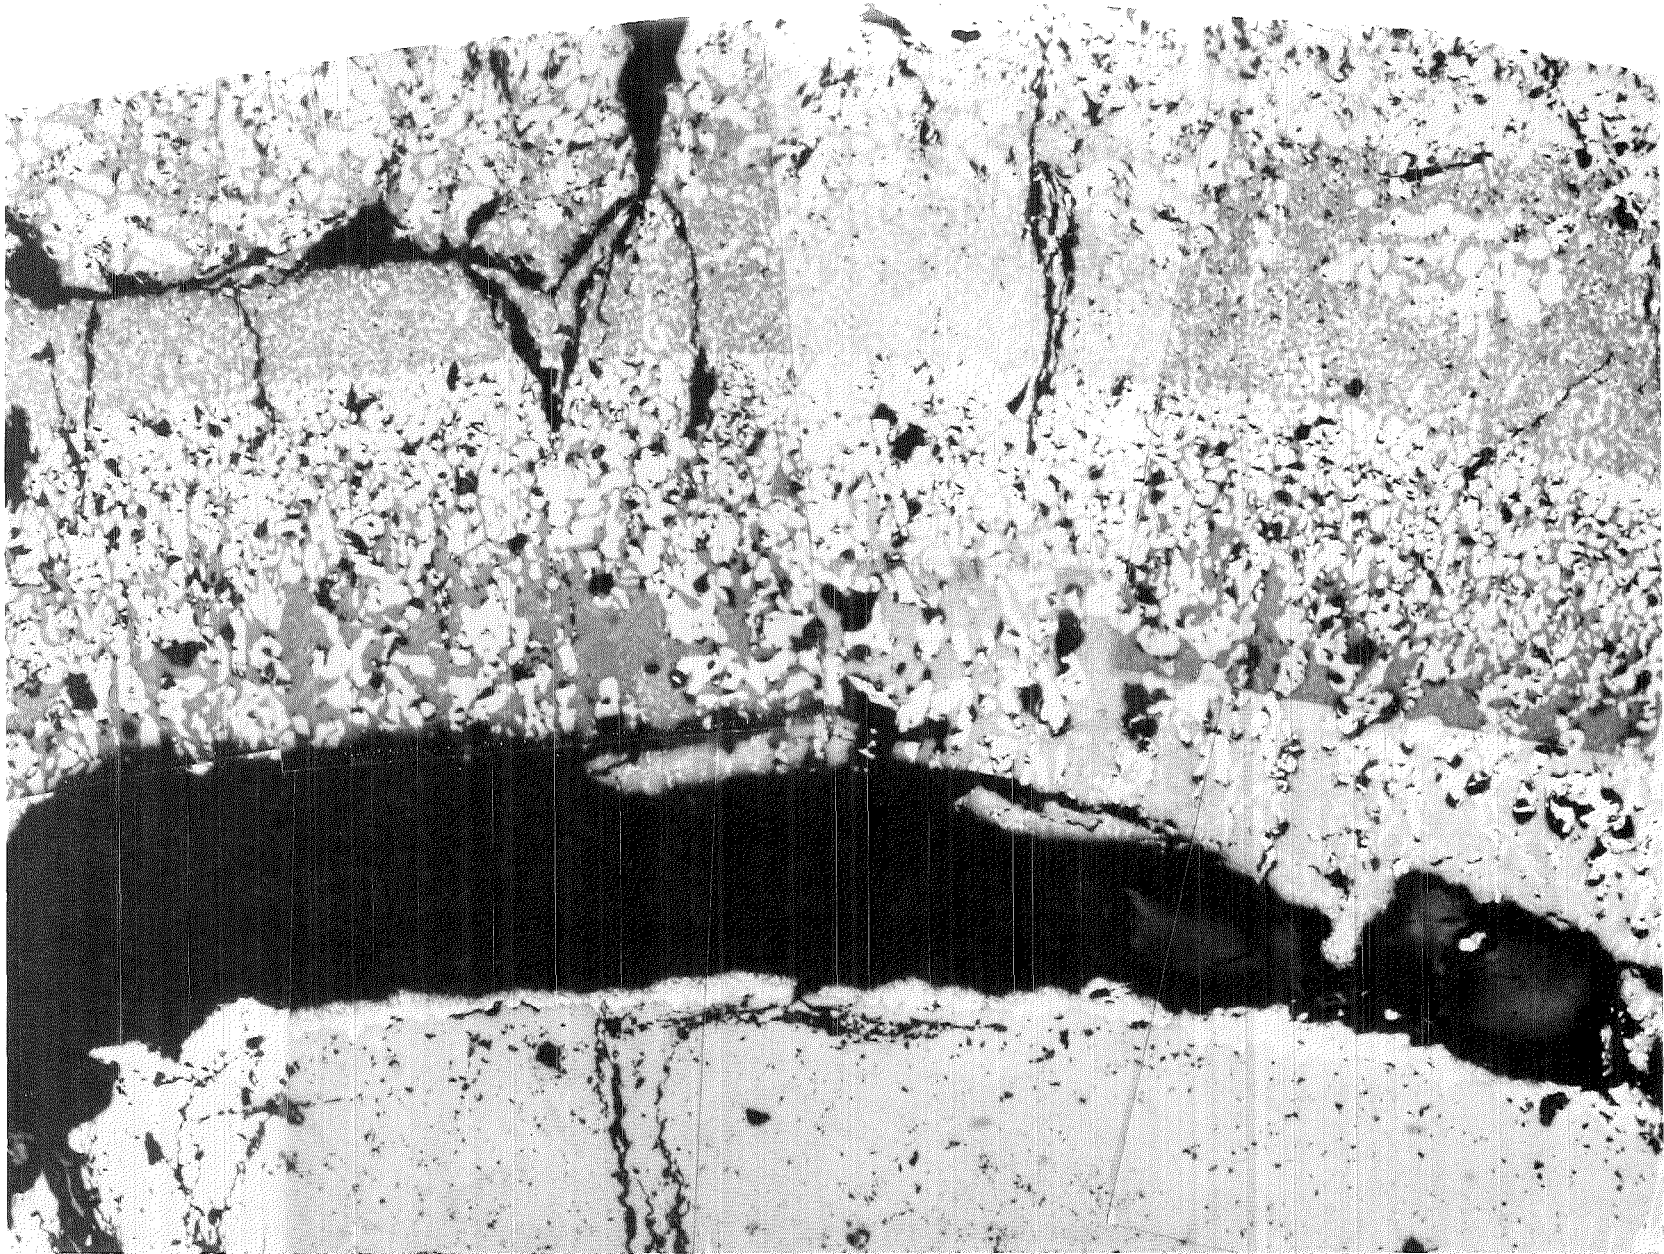
Figures 56 to 63 show an enlargement of the cladding region for center rod 5 between 121 and 79 mm elevations. In these figures the uranium oxide is at the bottom and the refrozen melt at the top of the photos. The middle region contains the oxidized cladding. At all elevations the attack of the melt on the oxidized cladding can be seen.

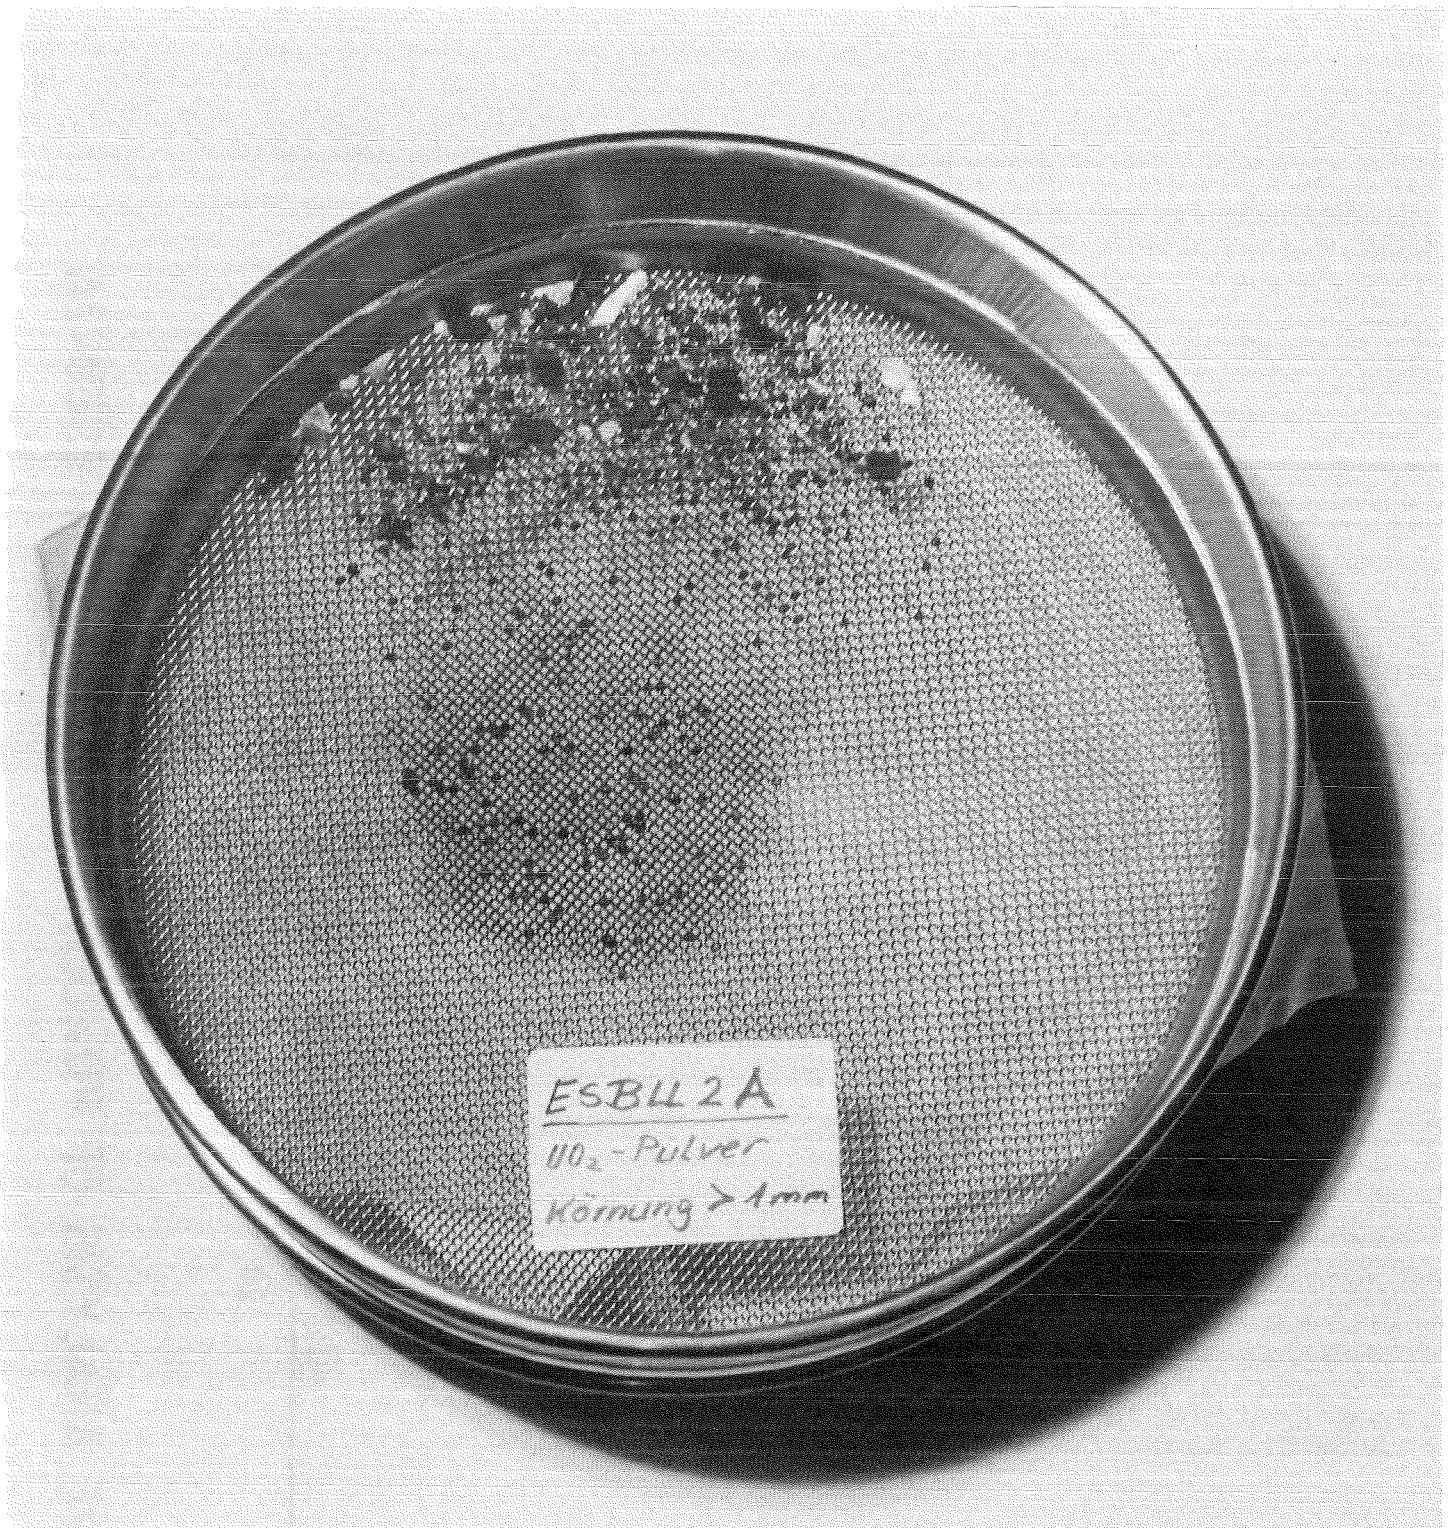
Fig.96 Remnants of the sieve analysis on the sieve with mesh size 1mm. (ESBU-2A)

The powdery rubble underwent sieve analysis. Figure 96 shows the remnants of this analysis with a mass size of larger than 1 mm. In Figure 97 the sieve analysis of the powdery rubble is given. About 25% of the powdery rubble has a grain size between 20 and 56 μ , and more than half of the grains have a size less than 0.2 mm.
