# Microstructure and mechanical properties of Zircaloy-4 claddings hydrogenated at temperatures typical for LOCA conditions

*QWS19, Karlsruhe 2013*

Institute for Applied Materials, IAM-WPT, Program NUKLEAR

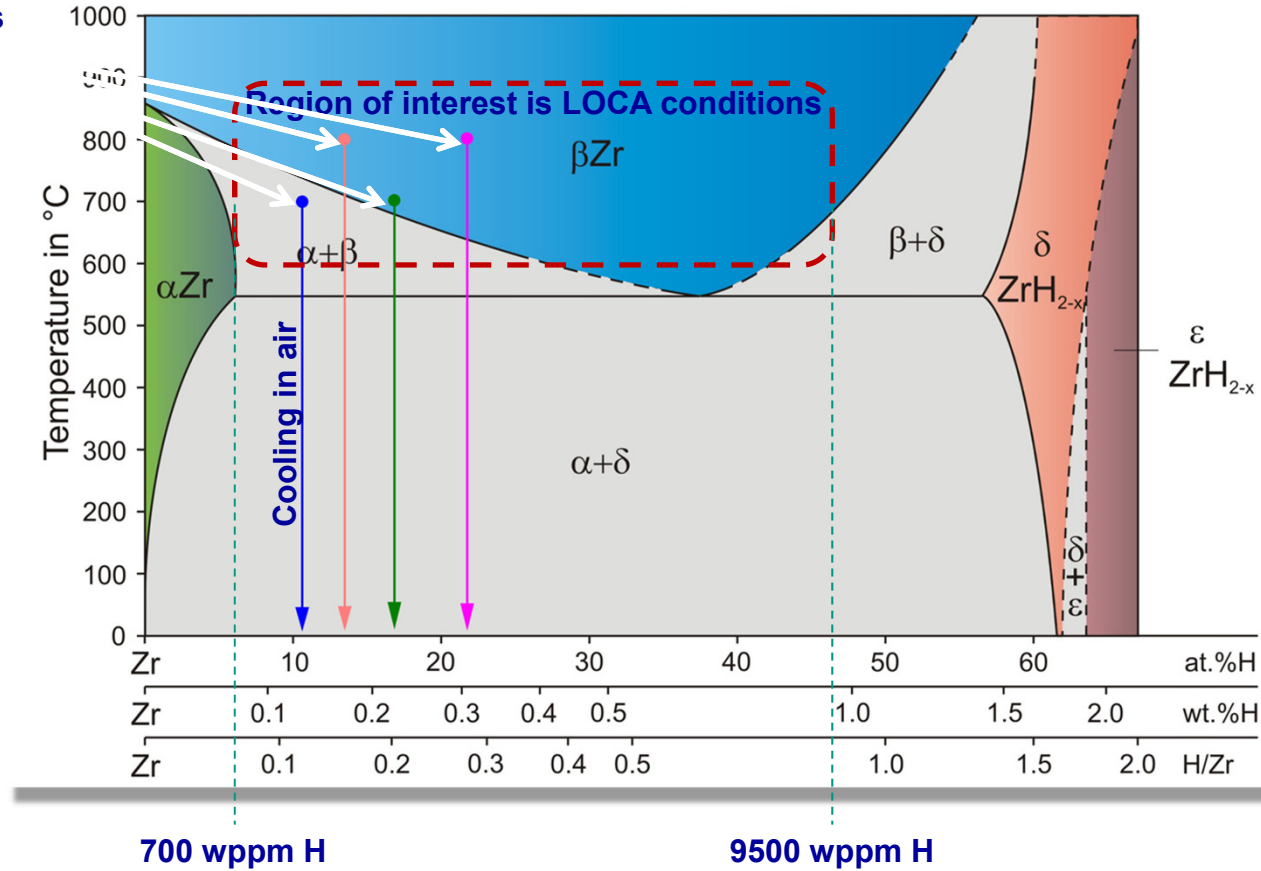
# Equilibrium phase diagram of Zr-H system\*

selected examples  
of our tests

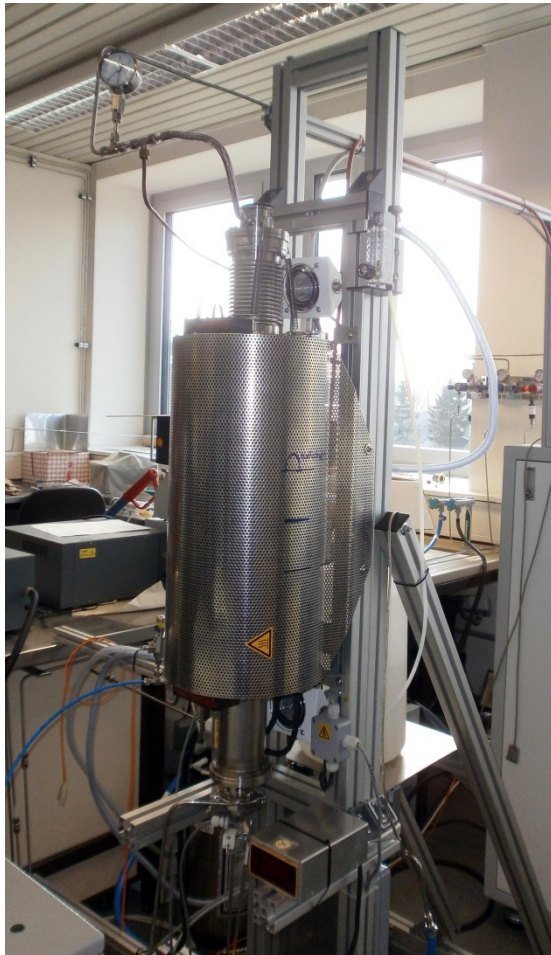
Hydrogenation facility  
LORA furnace

Hydrogen gas partial  
pressure was 0.1 bar

Estimated cooling rate was  
5 K/s

H<sub>2</sub> duration was  
2 to 12 minutes

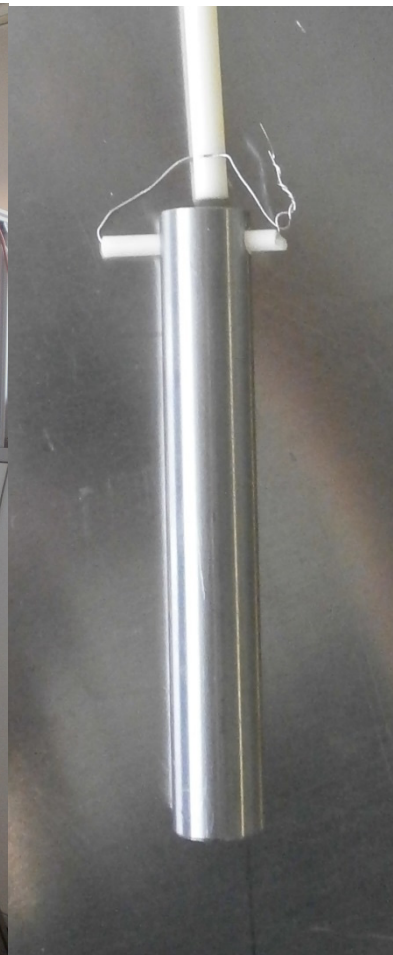
Specimen before  
hydrogenation

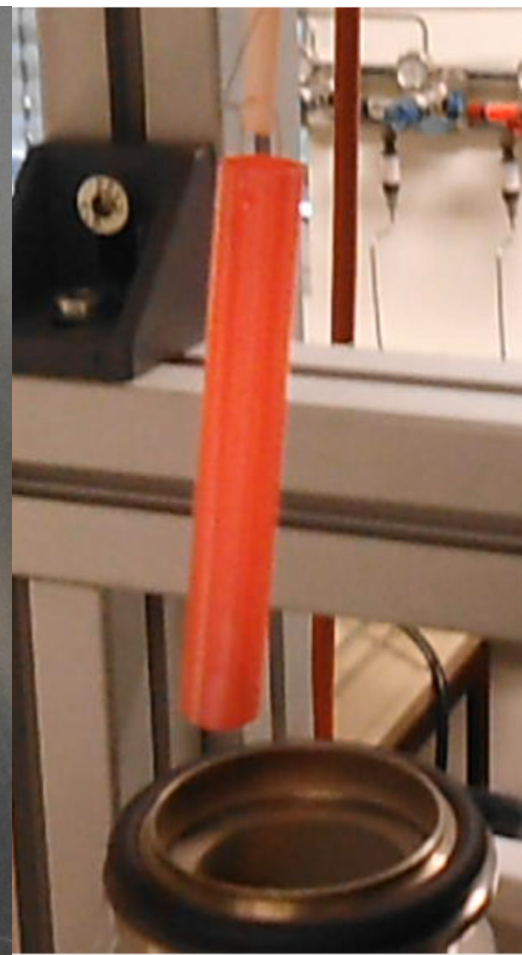
Specimen withdrawal in air  
after hydrogenation

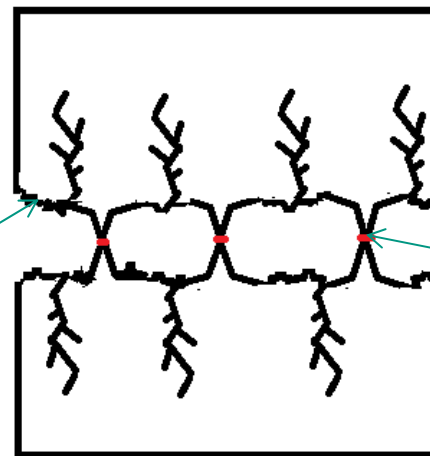
900 °C

1170 wppm H

1640 wppm H

Brittle fracture

Ductile fracture  
on needles of  
 $\alpha$ -Zr(O)

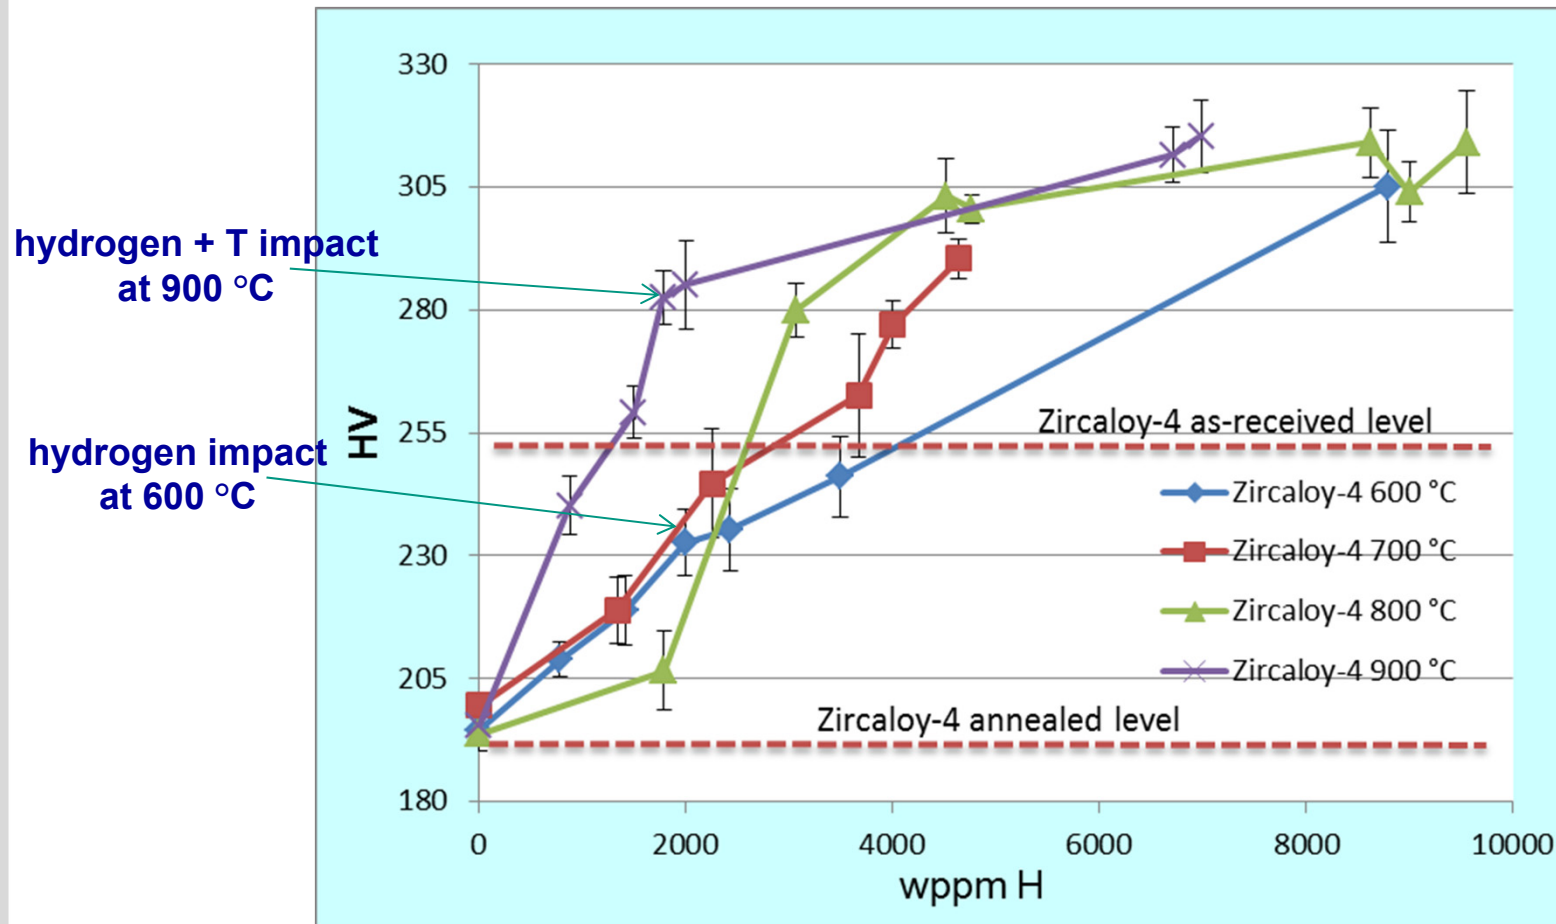
# Microhardness of annealed and hydrogenated Zircaloy-4

The diagonal length of resulting indented square was about 10  $\mu\text{m}$ .

- Microhardness tests showed a relationship between hydrogen content hardening, annealing softening and hardening due to  $\beta \rightarrow \alpha$  transformation during cooling phase.

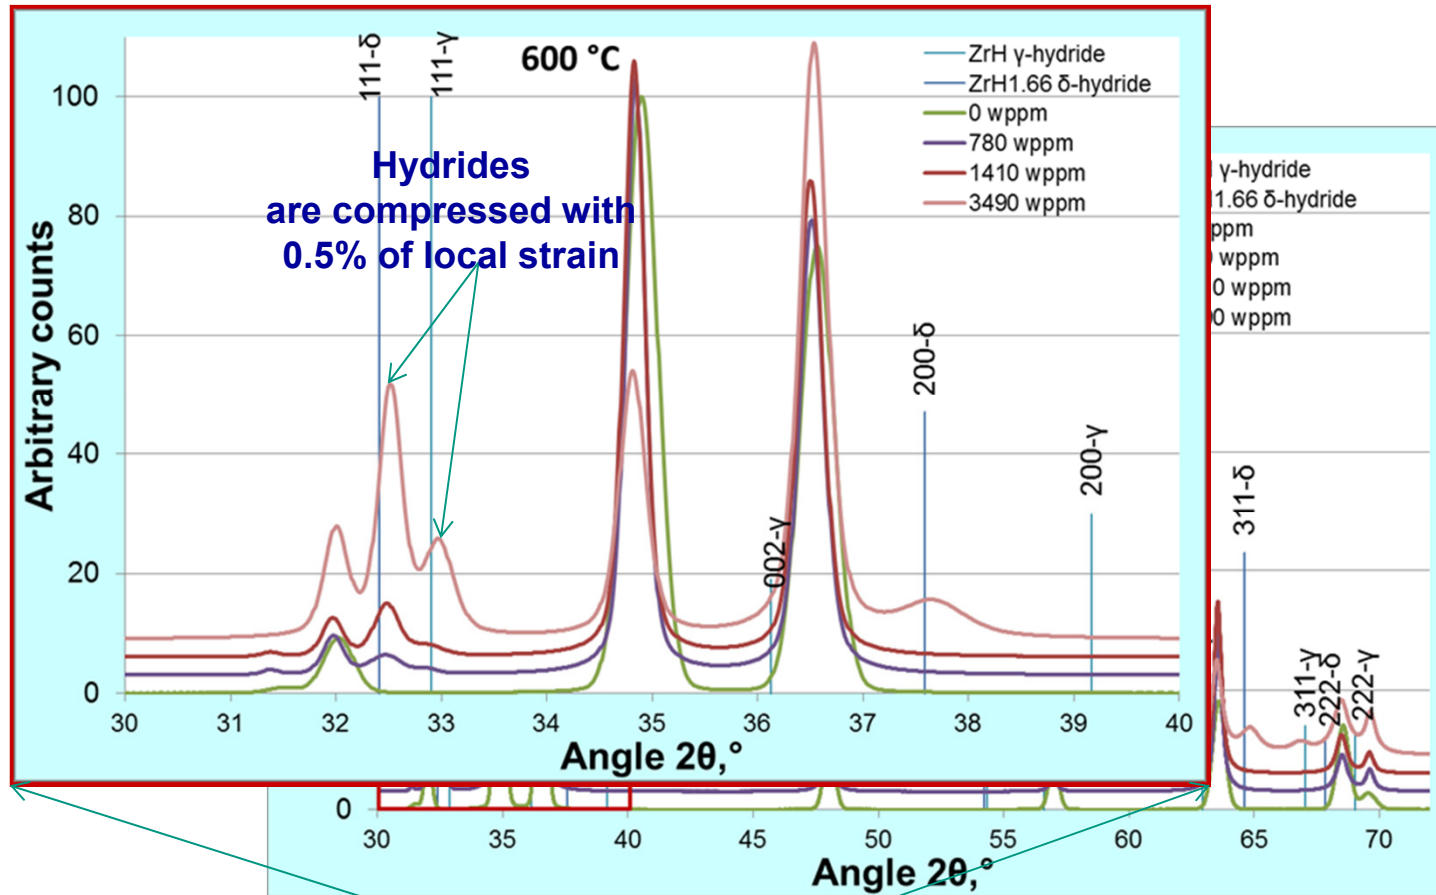
# X-Ray profiles of Zircaloy-4 samples hydrogenated at 600 °C

- The XRD-analysis showed the presence of  $\gamma$ -,  $\delta$ -phases of zirconium hydrides in all of performed experiments. With the increase of hydrogen content the hydride peak intensity was also increased. Simultaneously the hydrogen should be partially dissolved in the lattice which is indicated by increase of the lattice parameter “c”.

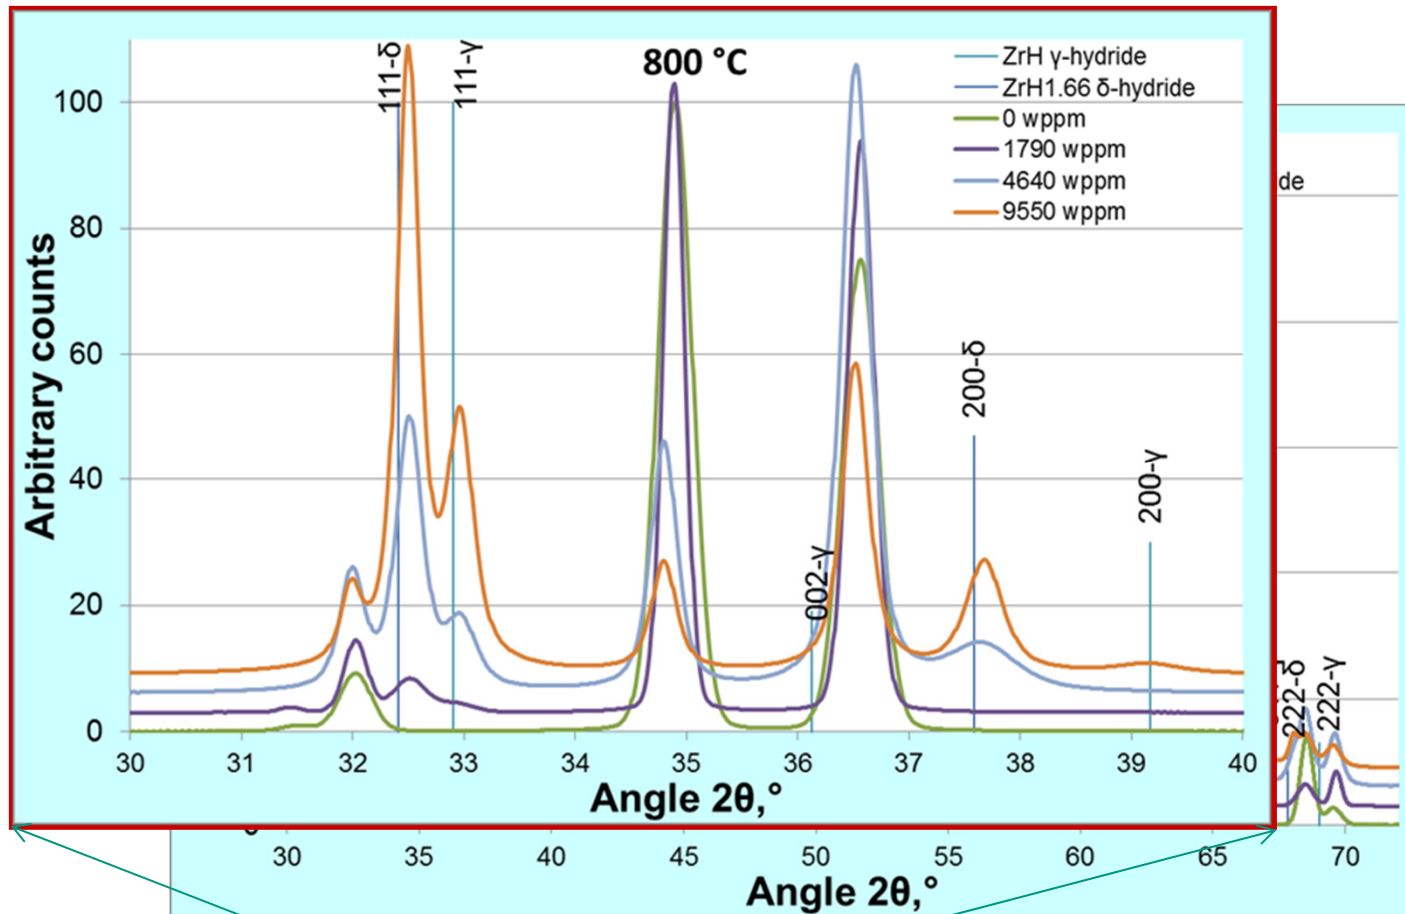
# X-Ray profiles of Zircaloy-4 samples hydrogenated at 800 °C

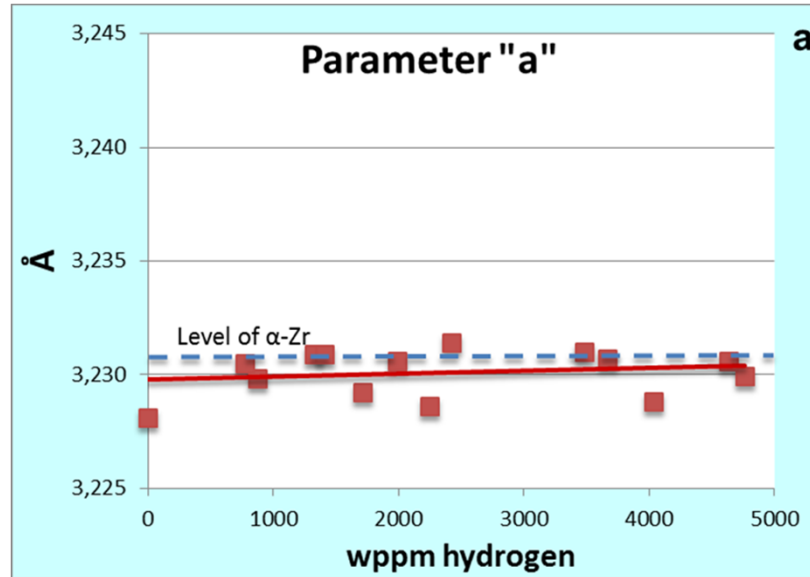
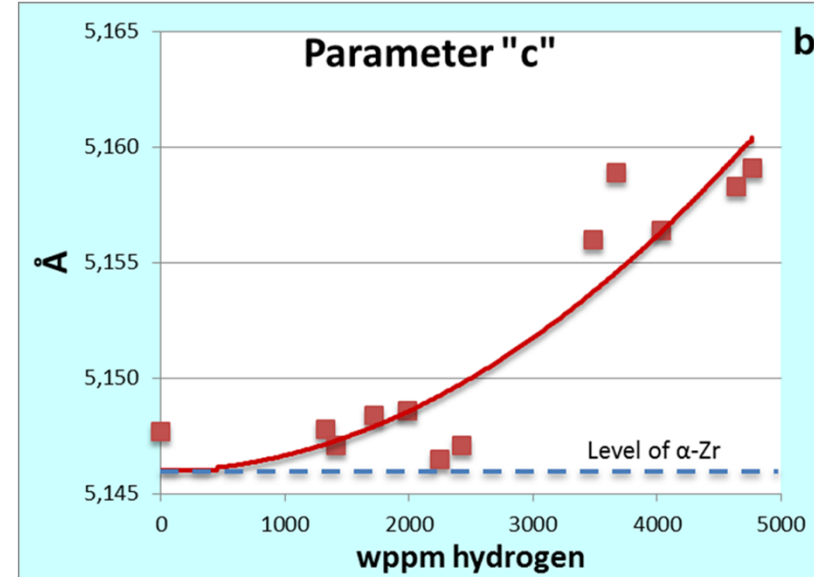
# Change of lattice parameters after hydrogenation of Zircaloy-4 samples
