Experimental program QUENCH at KIT on core degradation during reflooding under LOCA conditions and in the early phase of a severe accident

J. Stuckert, M. Steinbrueck, M. Grosse

IAEA TM on DBA and SA

Institute for Applied Materials, IAM-WPT, IAM-AWP; Program NUKLEAR

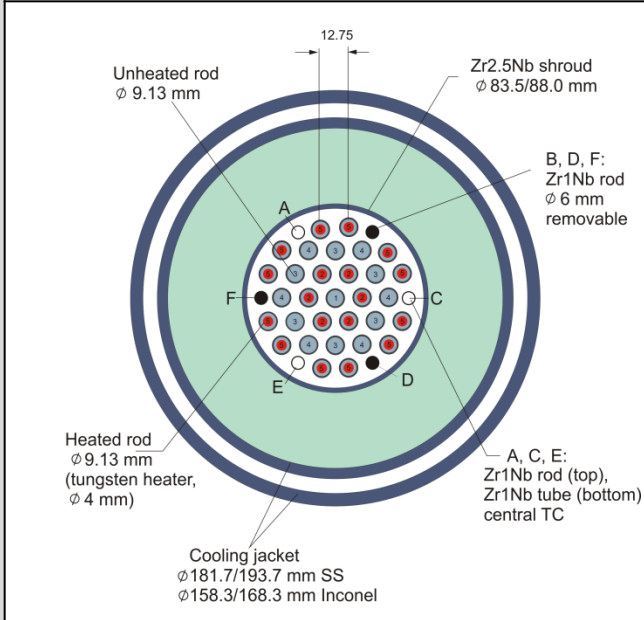
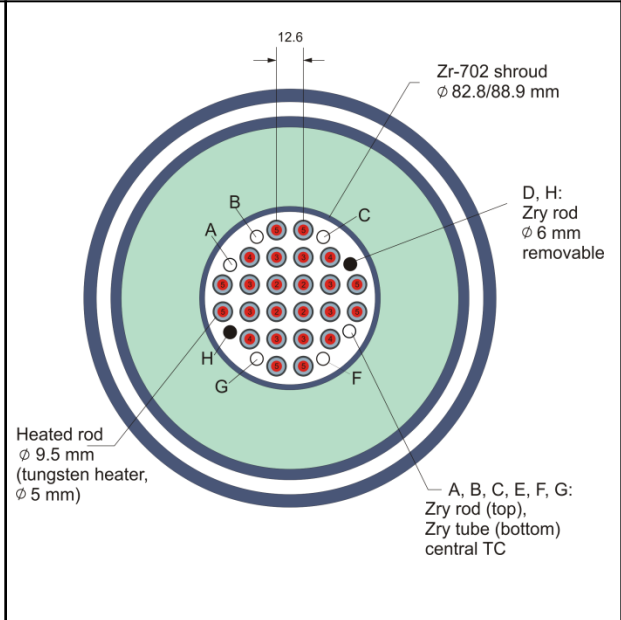
Composition of bundles

QUENCH-12 VVER
 claddings: **E110** - alloy
Fuel rod simulators:
 18 heated
 13 not heated
 6 corner rods
metallic surface ratio: Q12/Q14=1.22

QUENCH-14 (typical geometry)
 claddings : **M5[®]** - alloy
Fuel rod simulators :
 20 heated
 1 not heated
 4 corner rods

QUENCH-15
 claddings: **ZIRLO[™]** - alloy
Fuel rod simulators :
 24 heated
 0 not heated
 8 corner rods
metallic surface ratio: Q15/Q14=1.09

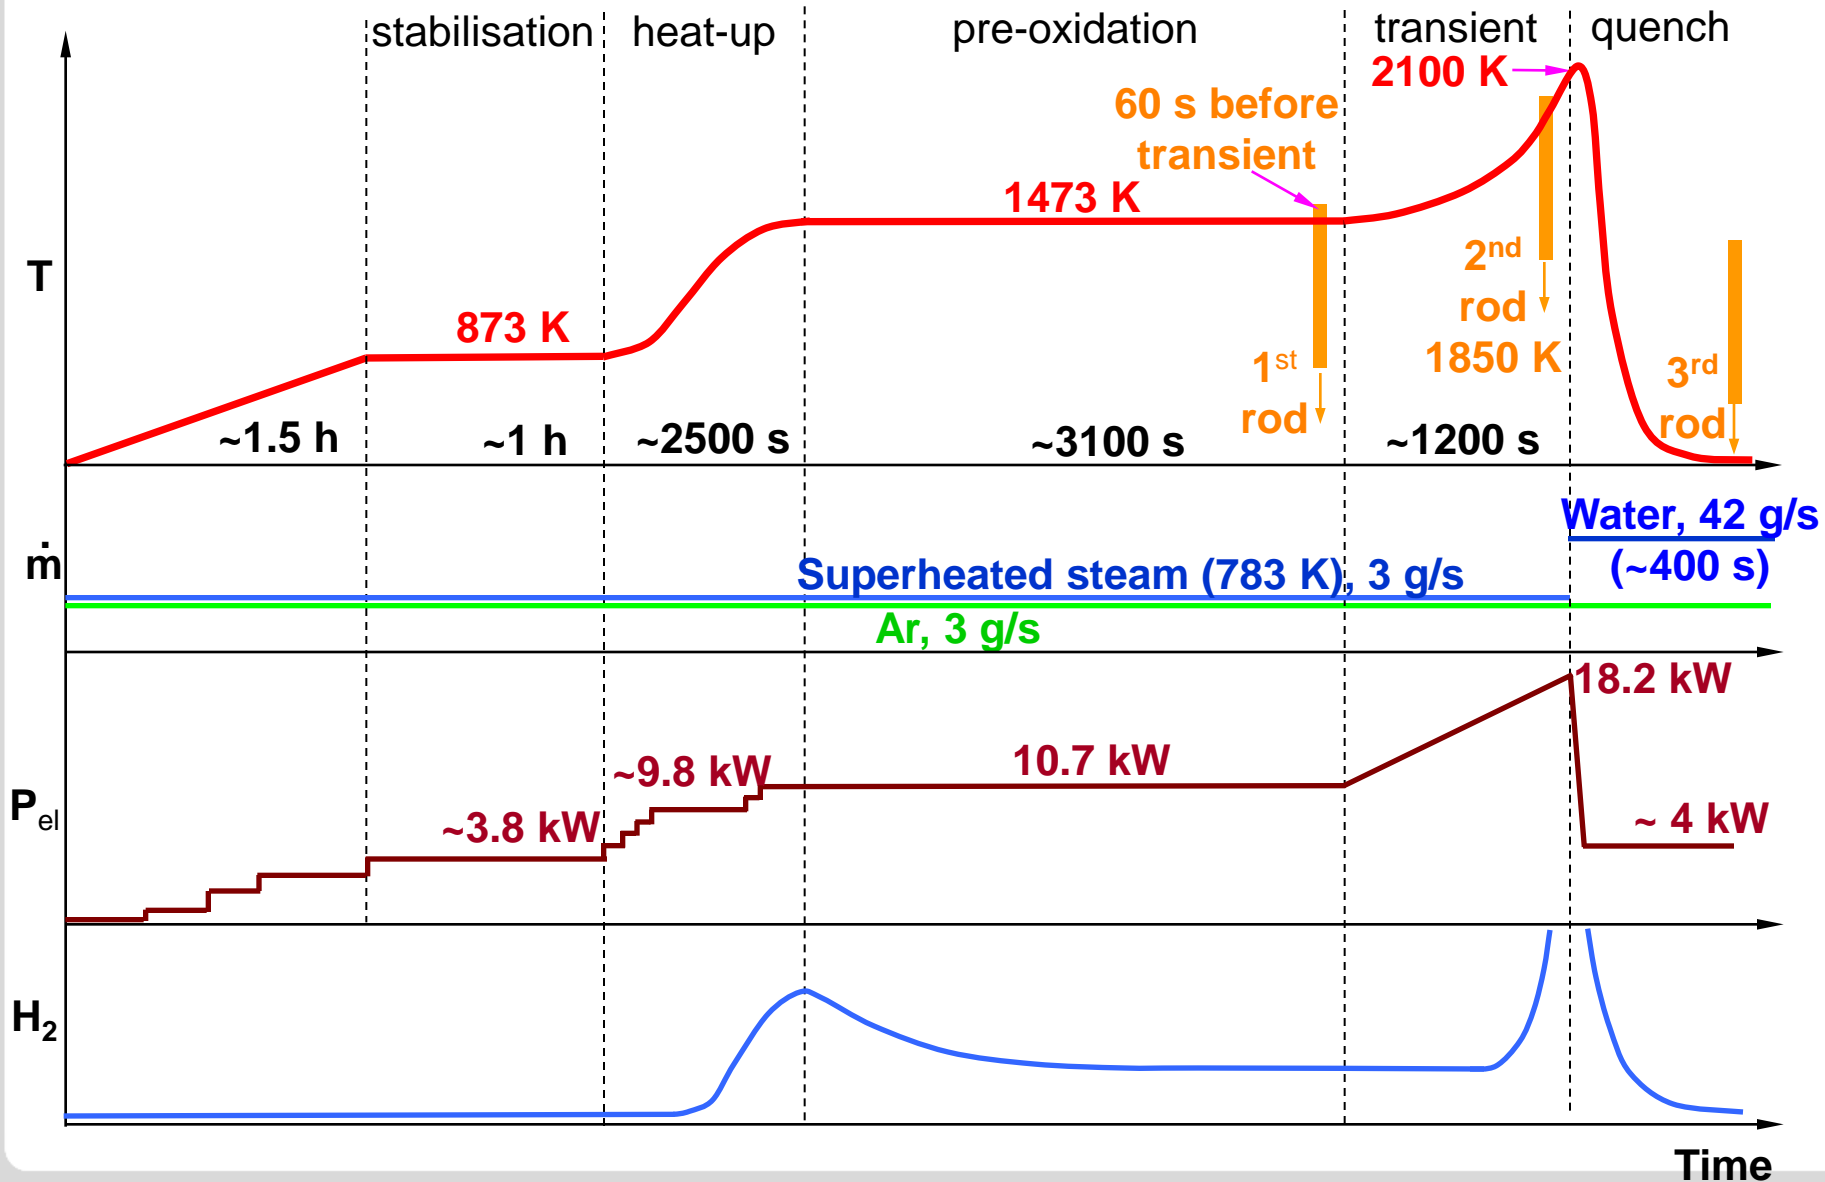
Performance of QUENCH-14 (M5[®]) – similar to Q-06 (Zry-4), Q-12 (E110) and Q-15 (ZIRLO[™])

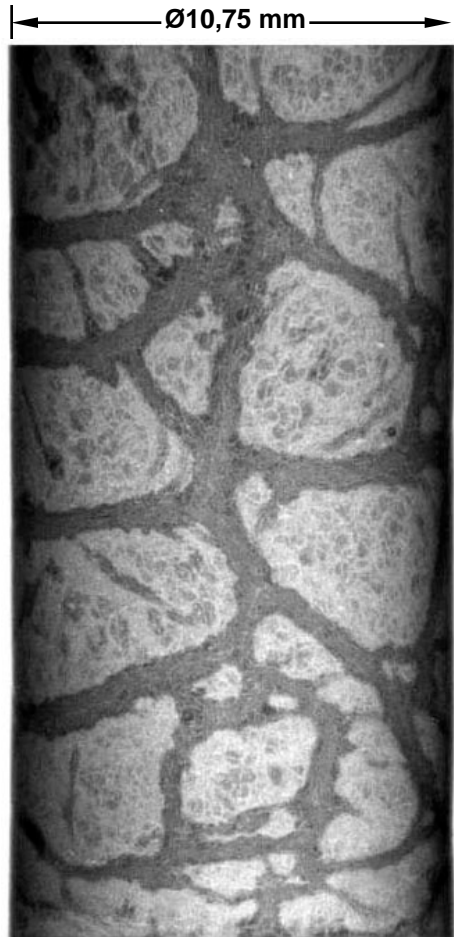
Crack development in the cladding,
cooled down with steam.
Crack density ~ 4 cm/cm²

Oxidation of cracks developed during flooding: low contribution to hydrogen production

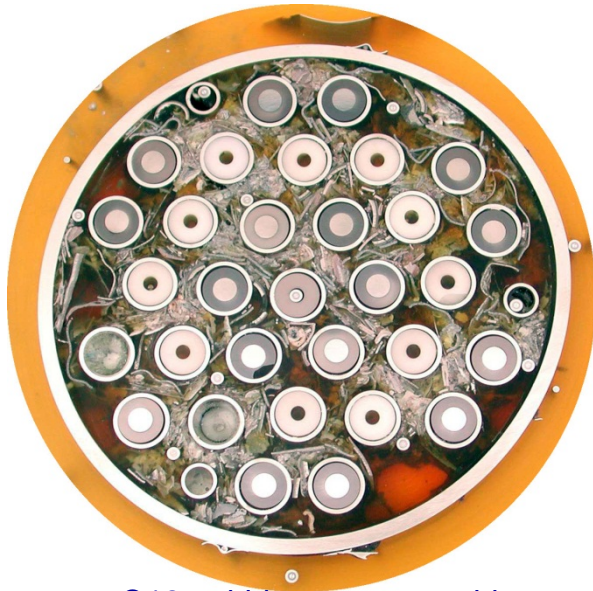
Q12: rubble on spacer grid consists of spalled cladding scales and fragments of partially oxidized cladding

Weakening of protective oxide layer by breakaway oxidation: QUENCH-12 (VVER, old E110) vs. QUENCH-06 (Zry-4)

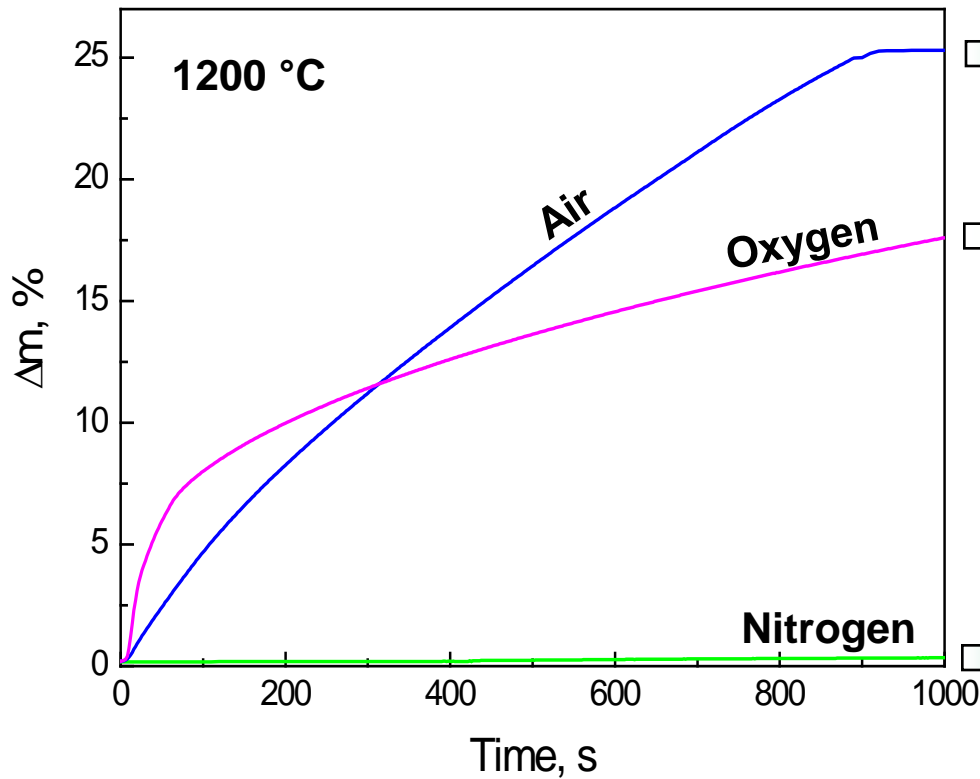
Oxidation of Zircaloy-4 in O₂, N₂, and air /thermogravimetric measurements/

Significant nitride formation in air but not in pure nitrogen

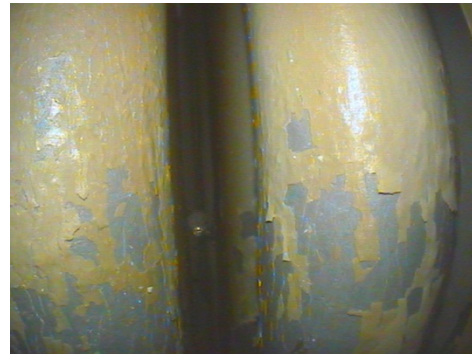
Endoscope observation
at ~850 mm

**prior nitrided scale
re-oxidised during quench
and spalled**

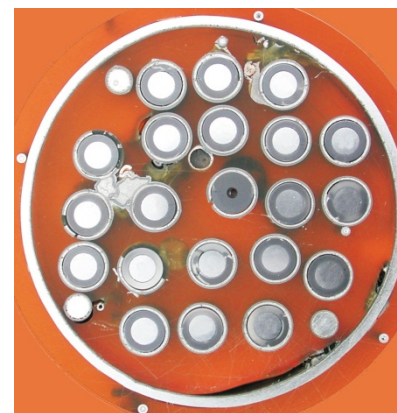
Eutectic melt induced upper 1200°C by absorber rod: complementary tests Q-07 (B₄C rod) and Q-08 (without absorber)

QUENCH-07: formation of significant melt amount and melt relocation

B₄C ↔ Fe eutectic at ~1150°C
Zry ↔ SS eutectic at ~1300°C

QUENCH-08: moderate melt formation; no noticeable melt relocation

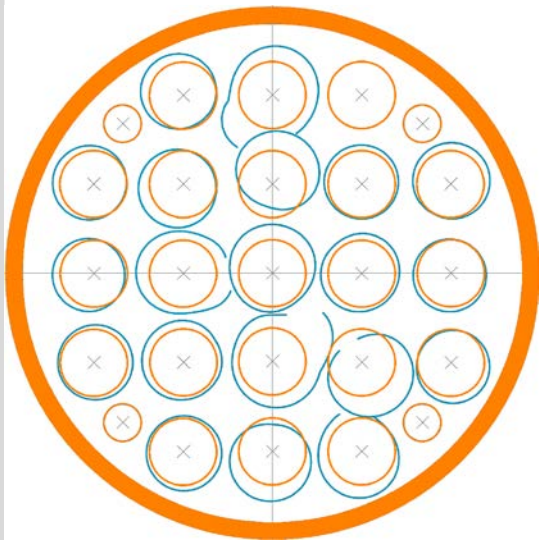
ballooning and burst of claddings
in comparison
to pre-test fuel rod positions
in the QUENCH-LOCA bundle
