B4: Phase changes in liquid metals for direct energy conversion

Alkali Metal Thermal to Electric Converter (AMTEC)

N. Díez de los Ríos, A. Onea, M. Lux, W. Hering, J. L. Palacios, R. Stieglitz

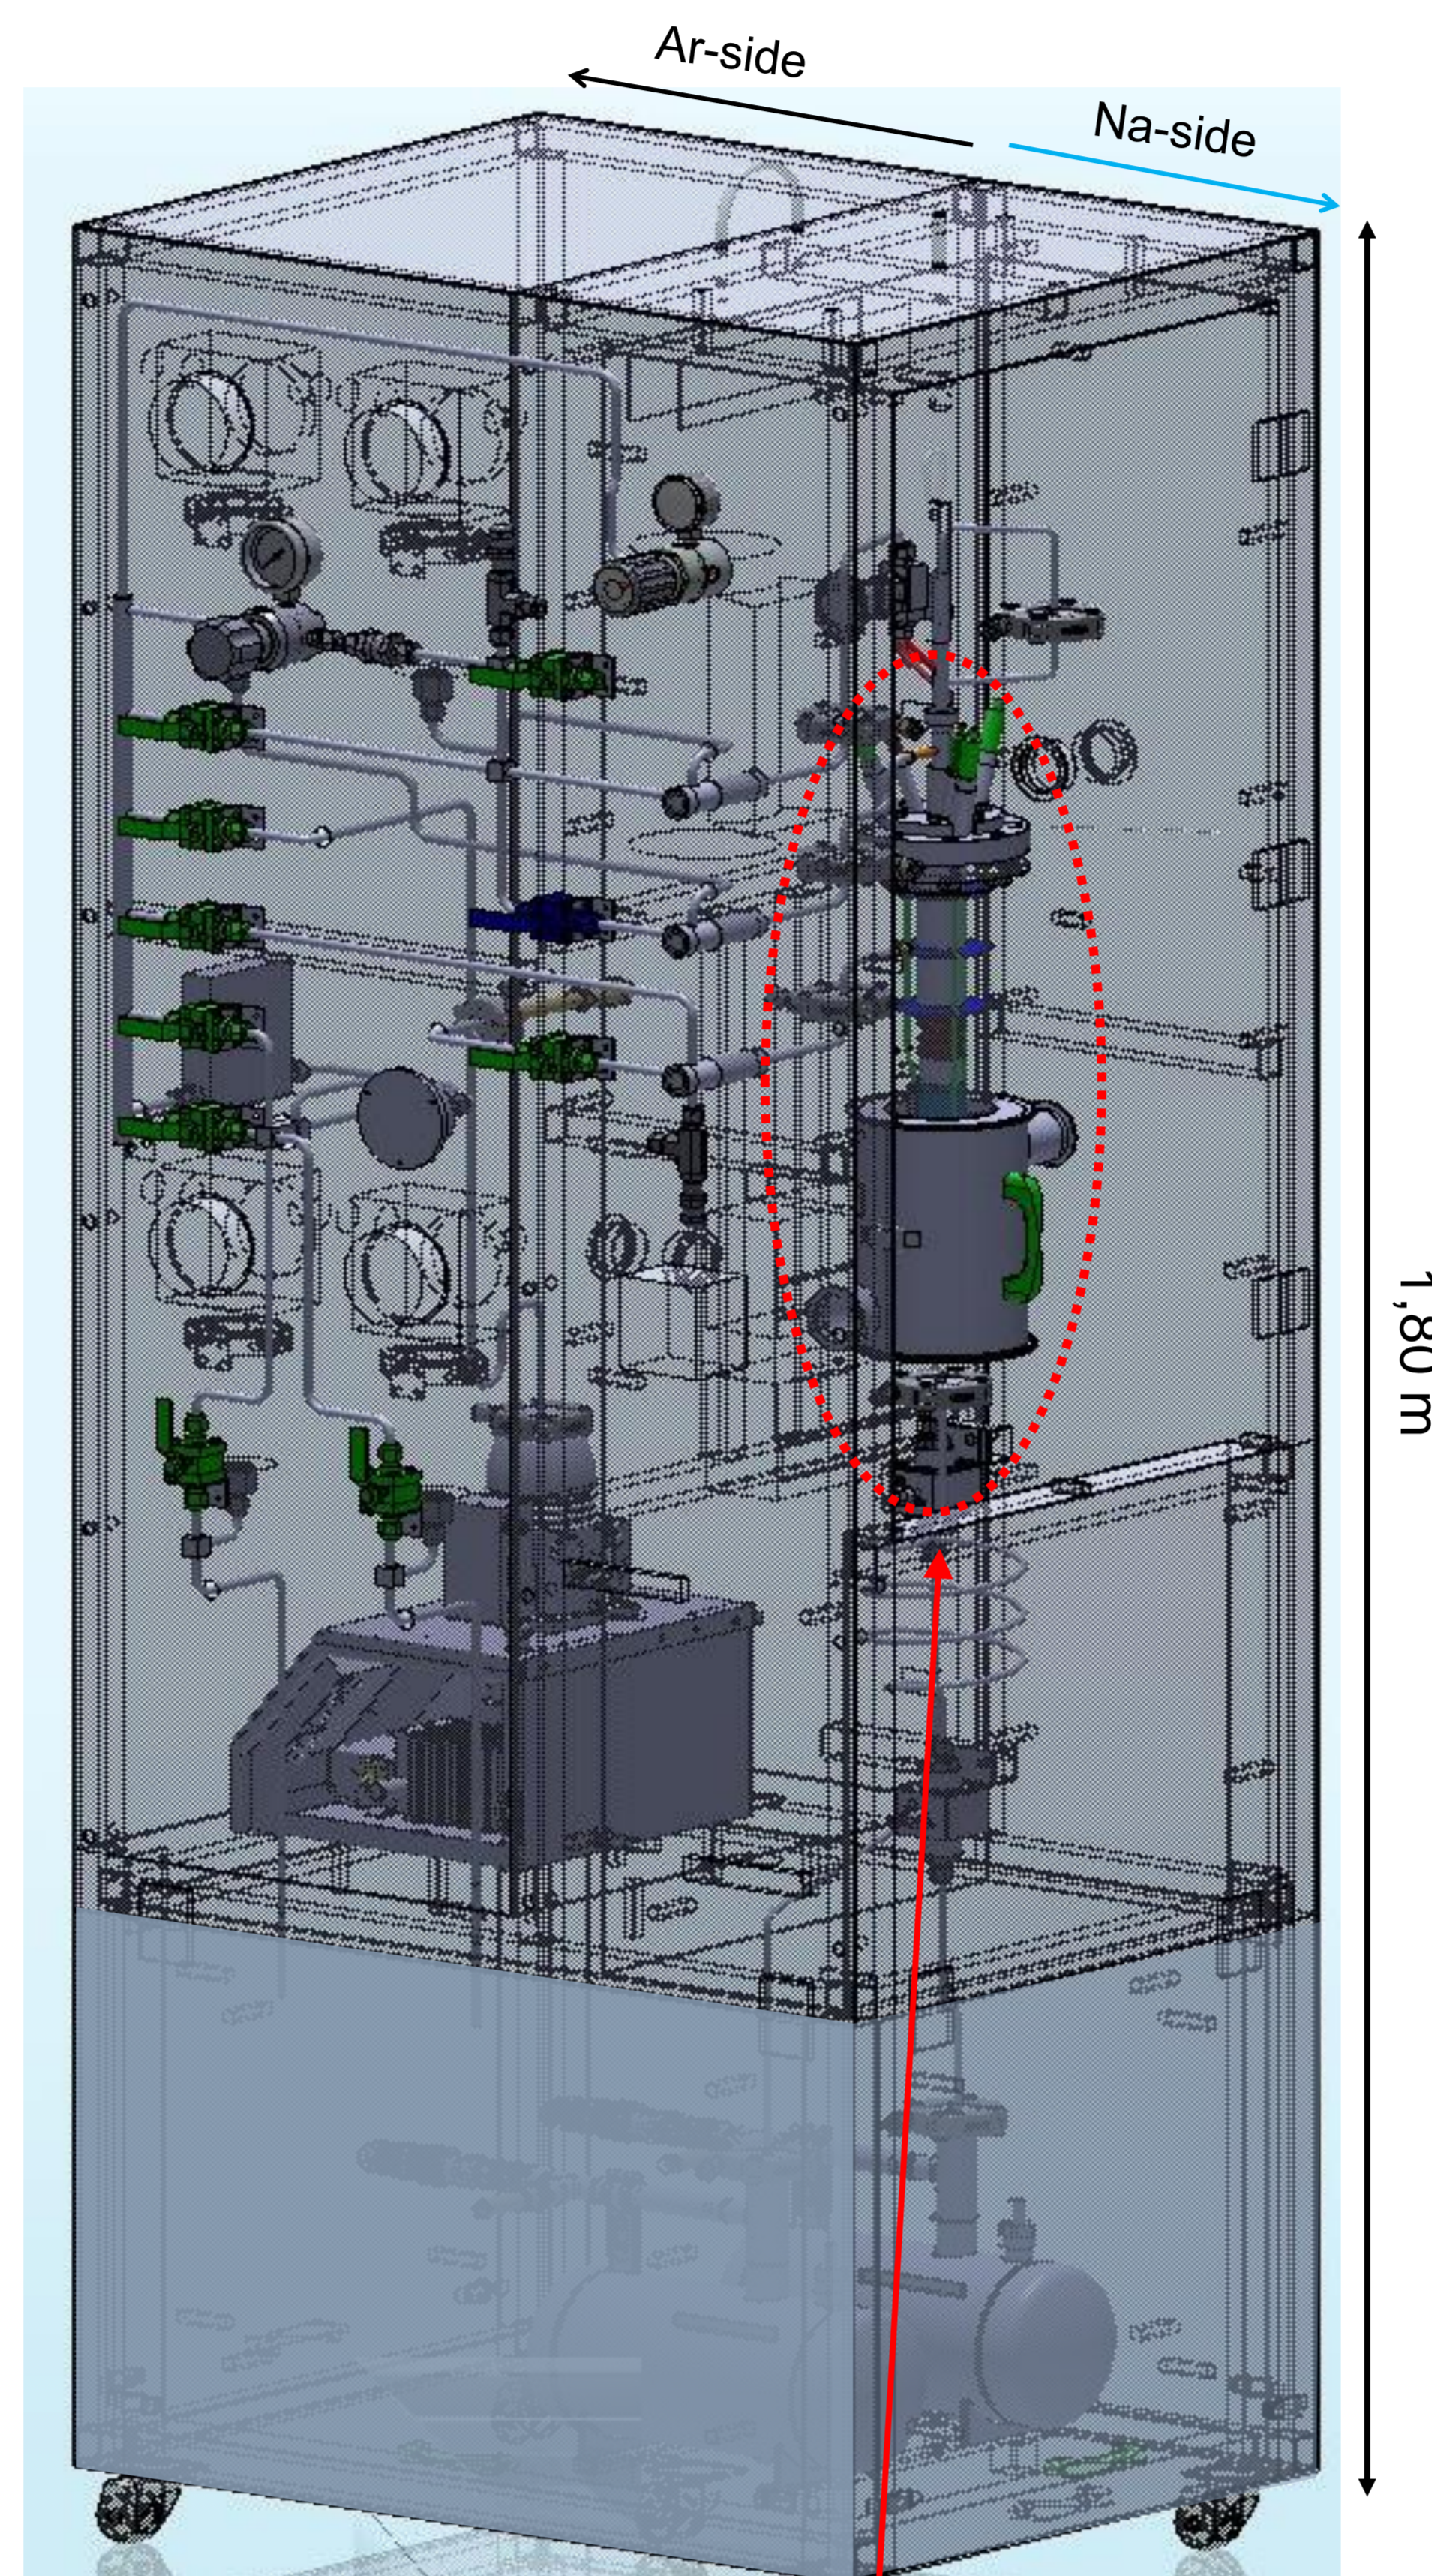
AMTEC Test Facility (ATEFA)

- Compact design
- Control Na-flow and pressure trough Ar (p_{Ar} & \dot{m}_{Ar})
- Na-side separated from Ar-side
- Separable cell and storage tanks
- Safety aspects:
 - Na-side isolated in a metallic containment
 - In case of power loss (PC) manual control possible
 - Highest pressure 1.5 bara
 - Metallic tub for Na collection
 - In case of fire Na containment will be floated with Ar
 - Tanks tested to overpressure

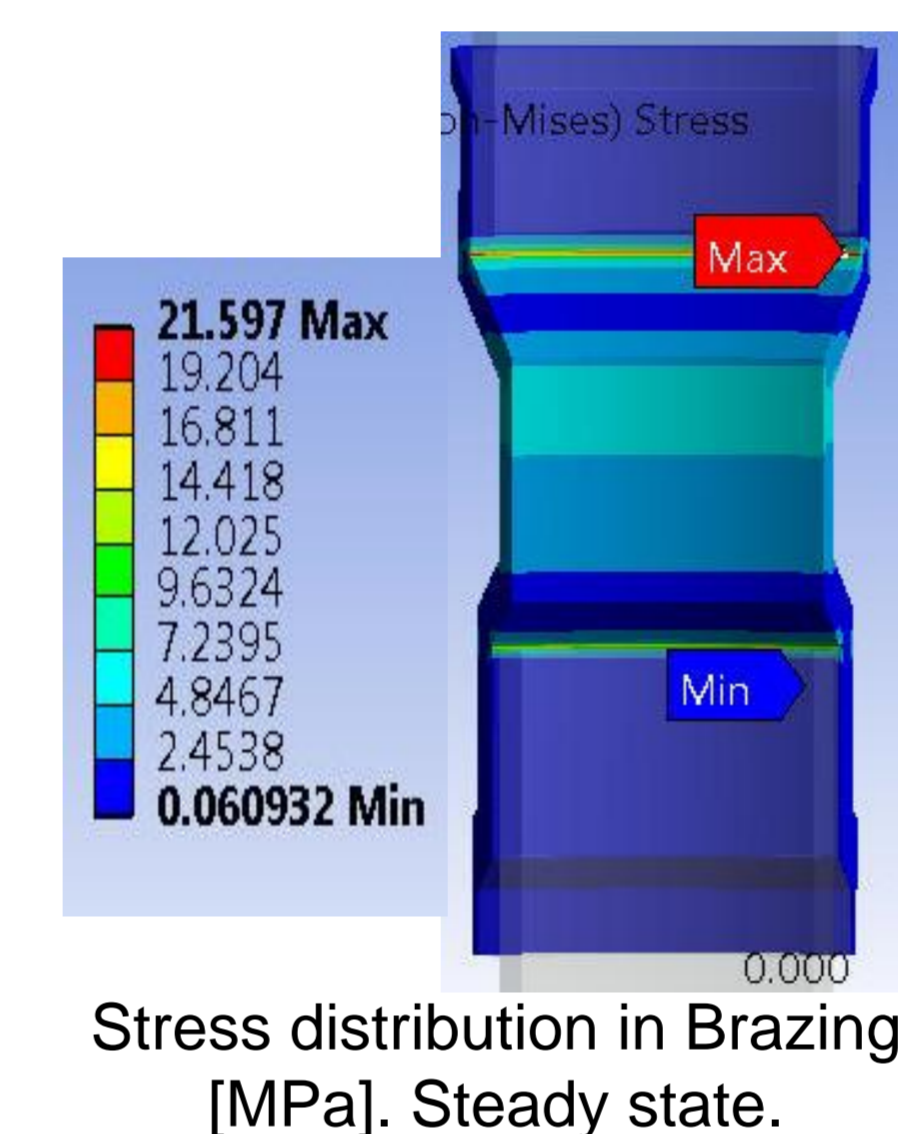
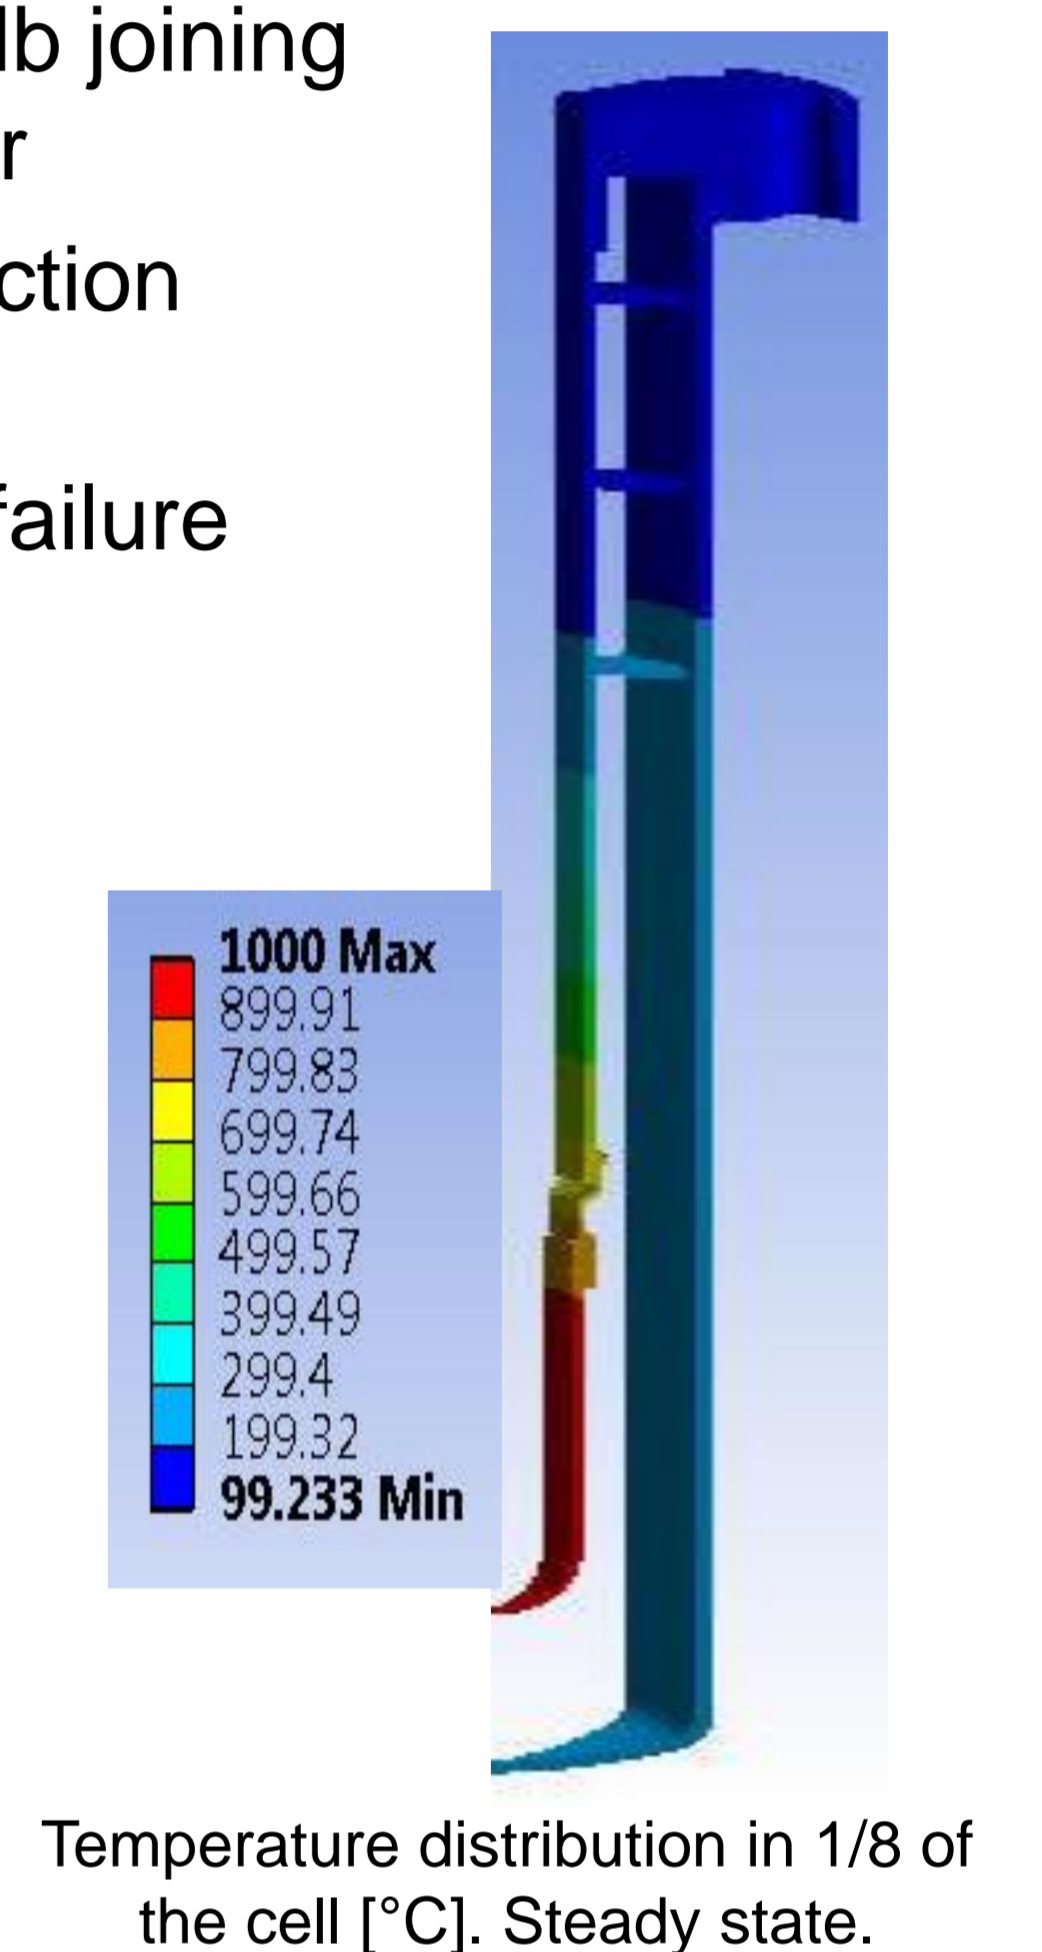
Safety analysis

- Temperature and stress distribution in cell obtained (steady state and transient analysis)
- No failure at working conditions (1.5 bar, 1000 °C) → safe design
- Highest stresses in BASE-Nb joining → possible failure at ≥ 6 bar
- Cooling under forced convection (transient) → no failure
- High ΔT along BASE → no failure

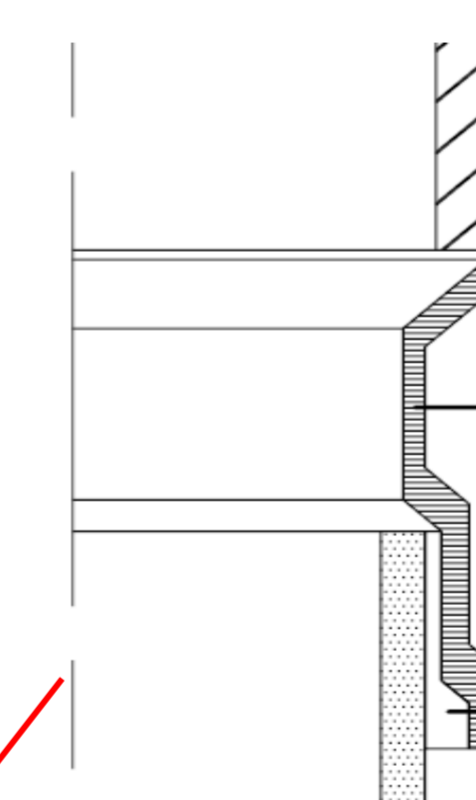
Ceramic to metal joining

- TiNiNb Sealing → tested in the nineties at INR
- New sealing materials (active brazing alloy)

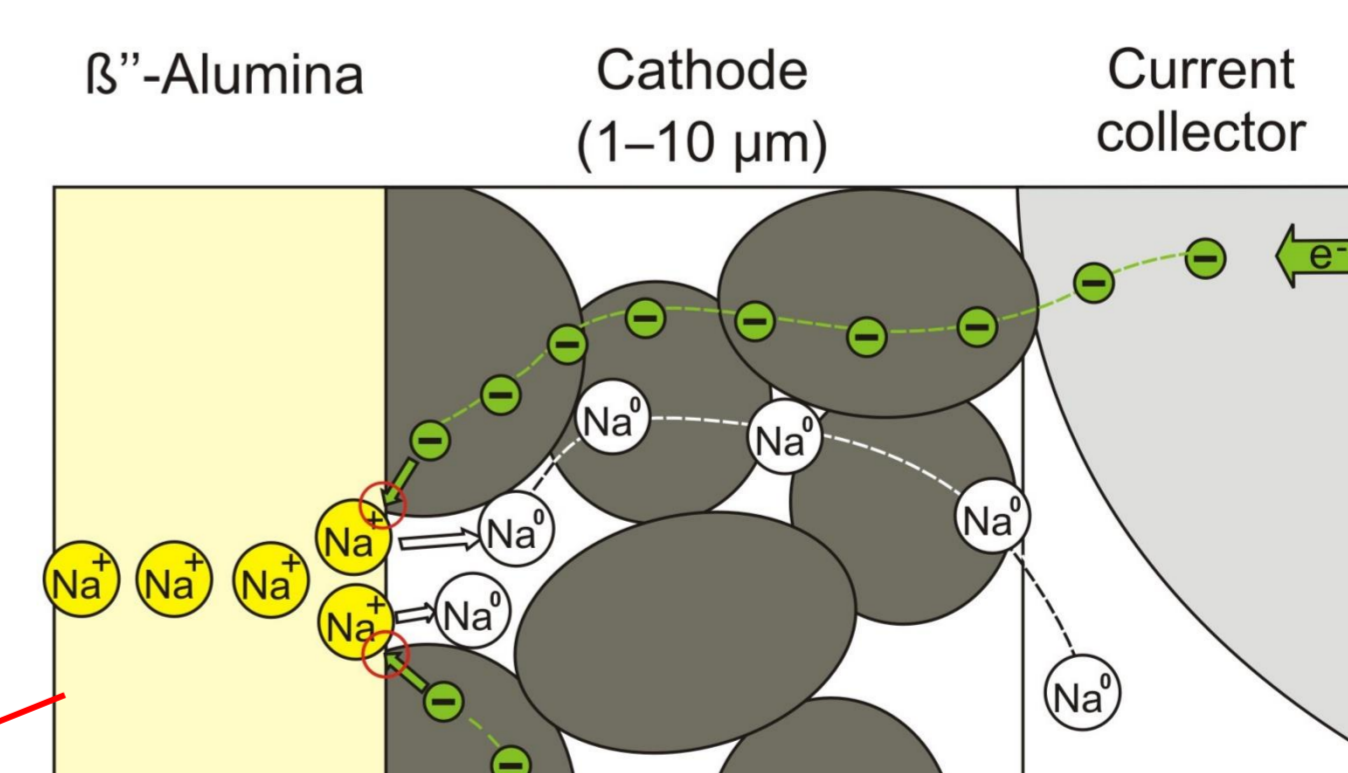
Electrode (Cathode) and current collector

- Magnetron sputtered cathode
- Grid / foam current collector

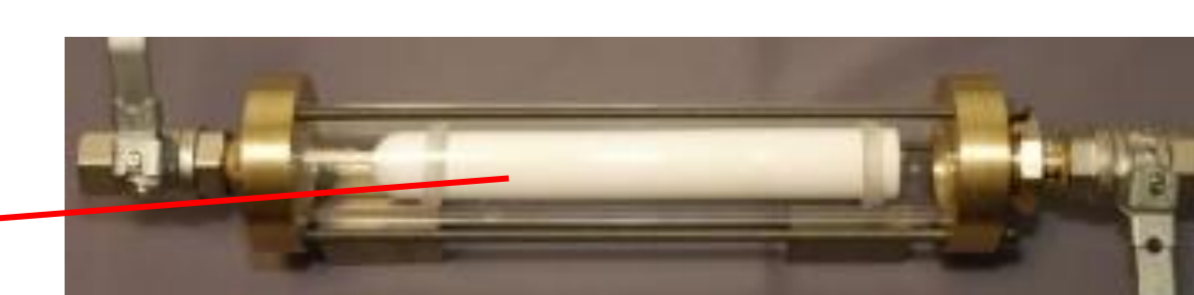
BASE (B''-Alumina Solid Electrolyte)

- Surface cleanliness
- Surface microcracks

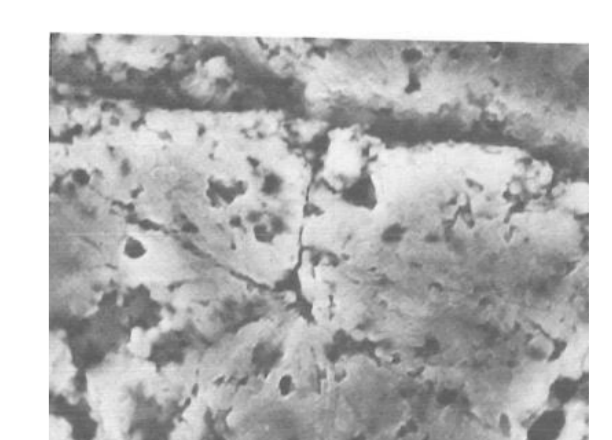
Surface microcrack (Tennenhouse, 1975)
